Re: Monthly Report Summary #53 for the South Orange County Reliability Enhancement (SOCRE) Project

South Orange County Reliability Enhancement Project CPUC Site Inspection Form

Project:	South Orange County Reliability Enhancement (SOCRE) Project	Date:	March 15, 2022
Project Proponent:	San Diego Gas & Electric (SDG&E)	Report #:	VS139
Lead Agency:	California Public Utilities Commission (CPUC)	Monitor(s):	CPUC/WSP Compliance Monitor
CPUC PM:	Andrew Barnsdale, Energy Division	AM/PM Weather:	Sunny and warm with a slight breeze
CPUC CM (WSP):	Joe Donaldson	Start/End time:	1130 to 1315 hrs
Project NTP(s):	Notice to Proceed (NTP)-1, NTP-2, NTP-2 Addendum 1, NTP-3, NTP-4, and NTP-5

Project:	South Orange County Reliability Enhancement (SOCRE) Project	Date:	March 29, 2022
Project Proponent:	San Diego Gas & Electric (SDG&E)	Report #:	VS140
Lead Agency:	California Public Utilities Commission (CPUC)	Monitor(s):	CPUC/WSP Compliance Monitor
CPUC PM:	Andrew Barnsdale, Energy Division	AM/PM Weather:	Partly cloudy, cool and breezy
CPUC CM (WSP):	Joe Donaldson	Start/End time:	1200 to 1330 hrs
Project NTP(s):	Notice to Proceed (NTP)-1, NTP-2, NTP-2 Addendum 1, NTP-3, NTP-4, and NTP-5

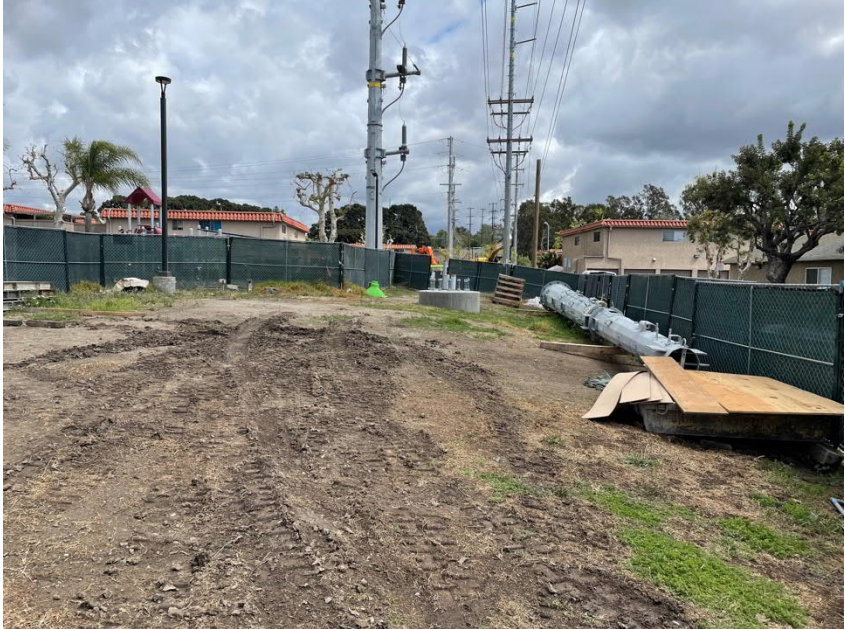
A crew continued to work in the "Westport" area west of the railroad tracks (Photo 5). They had poured the tubular steel pole (TSP) foundation and were working on the conduit trench (Photo 6). BMPs remain in place in the construction area (Photo 7), and the laydown yard was wet and muddy but had no erosion issues (Photo 8).

Photo 8 – Laydown yard for the Westport work area. Photo facing east.
