Re: Monthly Report Summary #55 for the South Orange County Reliability Enhancement (SOCRE) Project

South Orange County Reliability Enhancement Project CPUC Site Inspection Form

Project:	South Orange County Reliability Enhancement (SOCRE) Project	Date:	May 5, 2022
Project Proponent:	San Diego Gas & Electric (SDG&E)	Report #:	VS142
Lead Agency:	California Public Utilities Commission (CPUC)	Monitor(s):	CPUC/WSP Compliance Monitor
CPUC PM:	Louis Torres, Energy Division	AM/PM Weather:	Sunny, warm and calm
CPUC CM (WSP):	Fernando Guzman	Start/End time:	1130 – 1300
Project NTP(s):	Notice to Proceed (NTP)-1, NTP-2, NTP-2 Addendum 1, NTP-3, NTP-4, and NTP-5

Project:	South Orange County Reliability Enhancement (SOCRE) Project	Date:	May 18, 2022
Project Proponent:	San Diego Gas & Electric (SDG&E)	Report #:	VS143
Lead Agency:	California Public Utilities Commission (CPUC)	Monitor(s):	CPUC/WSP Compliance Monitor
CPUC PM:	Louis Torres, Energy Division	AM/PM Weather:	Partly cloudy, mild and breezy
CPUC CM (WSP):	Fernando Guzman	Start/End time:	1130 – 1300
Project NTP(s):	Notice to Proceed (NTP)-1, NTP-2, NTP-2 Addendum 1, NTP-3, NTP-4, and NTP-5

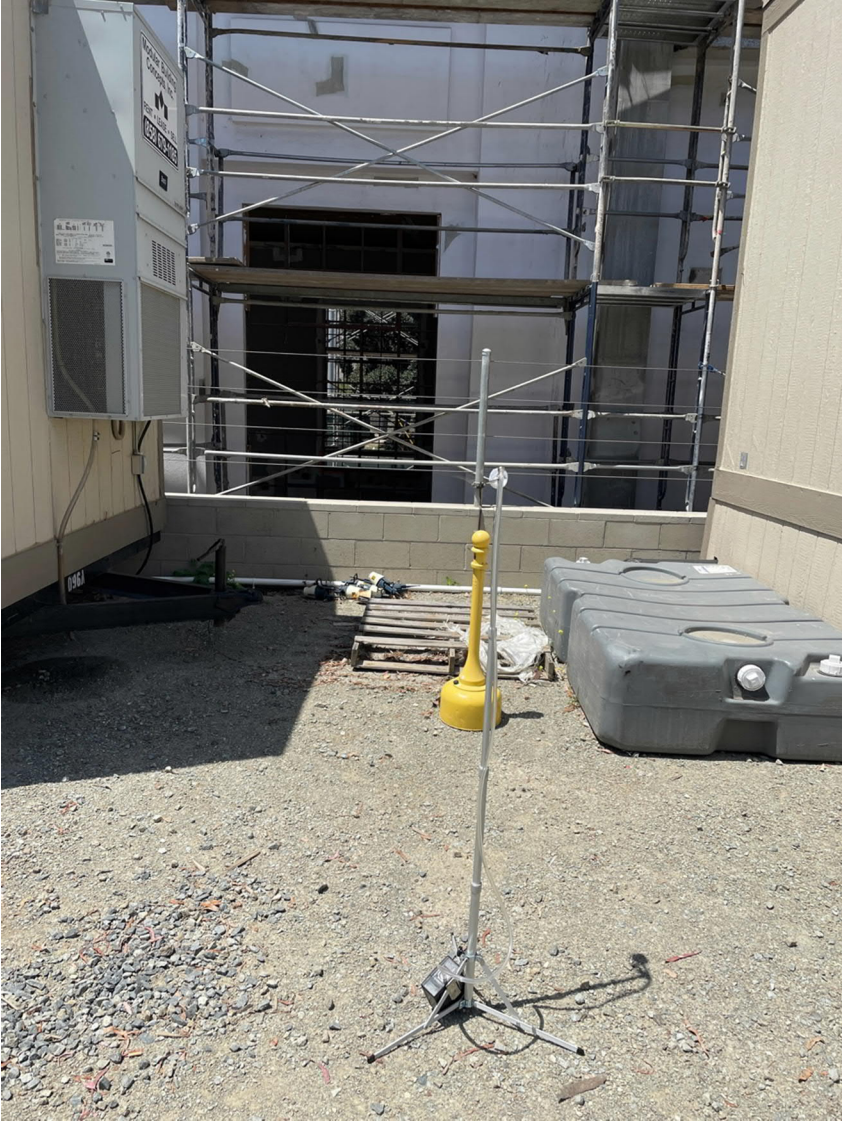
A crew was again performing cleanup operations and painting of the old utility building. The crew had scaffolding erected around the building and had set up air quality monitoring equipment (Photo 2).

Photo 2 – Air quality monitor around the old utility building. Photo facing west.

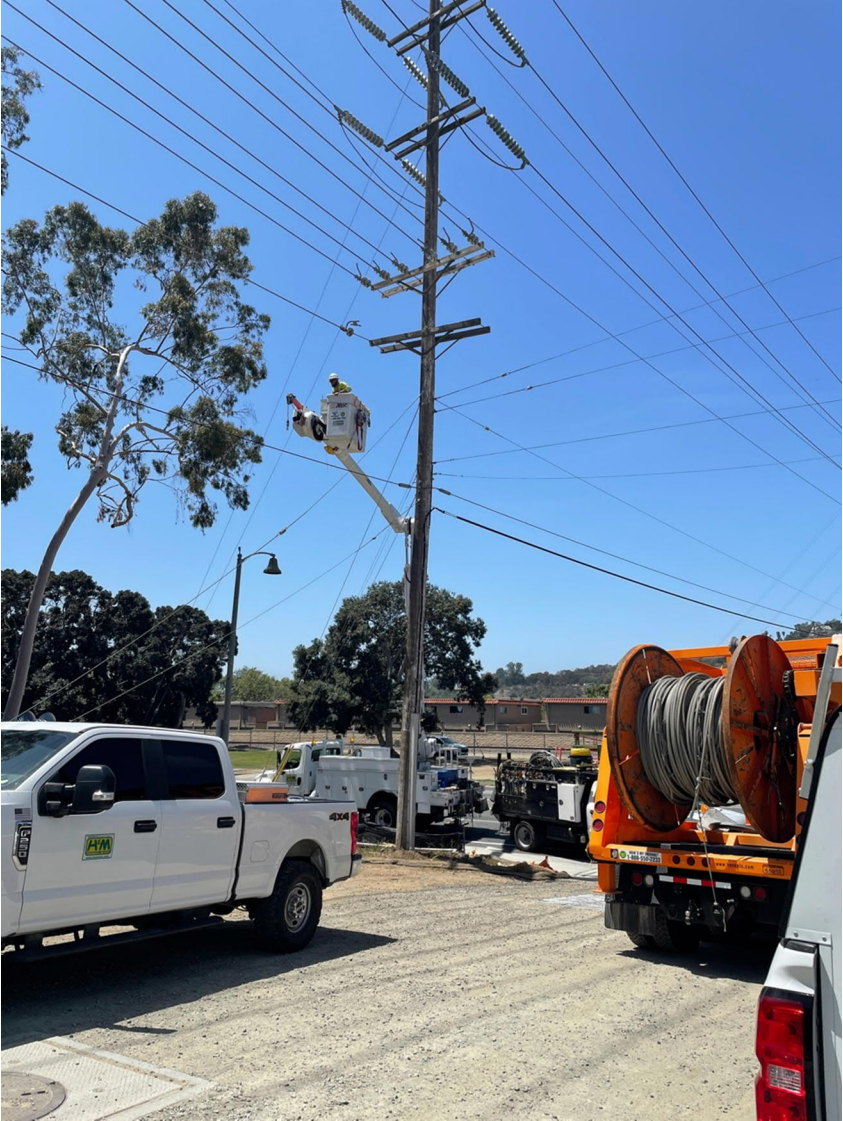
A crew was conducting some wire work on the existing poles at the southwestern corner of the substation construction area (Photo 3).

Photo 3 – Wire work conducted at the southwest corner of the project site. Photo facing southwest.

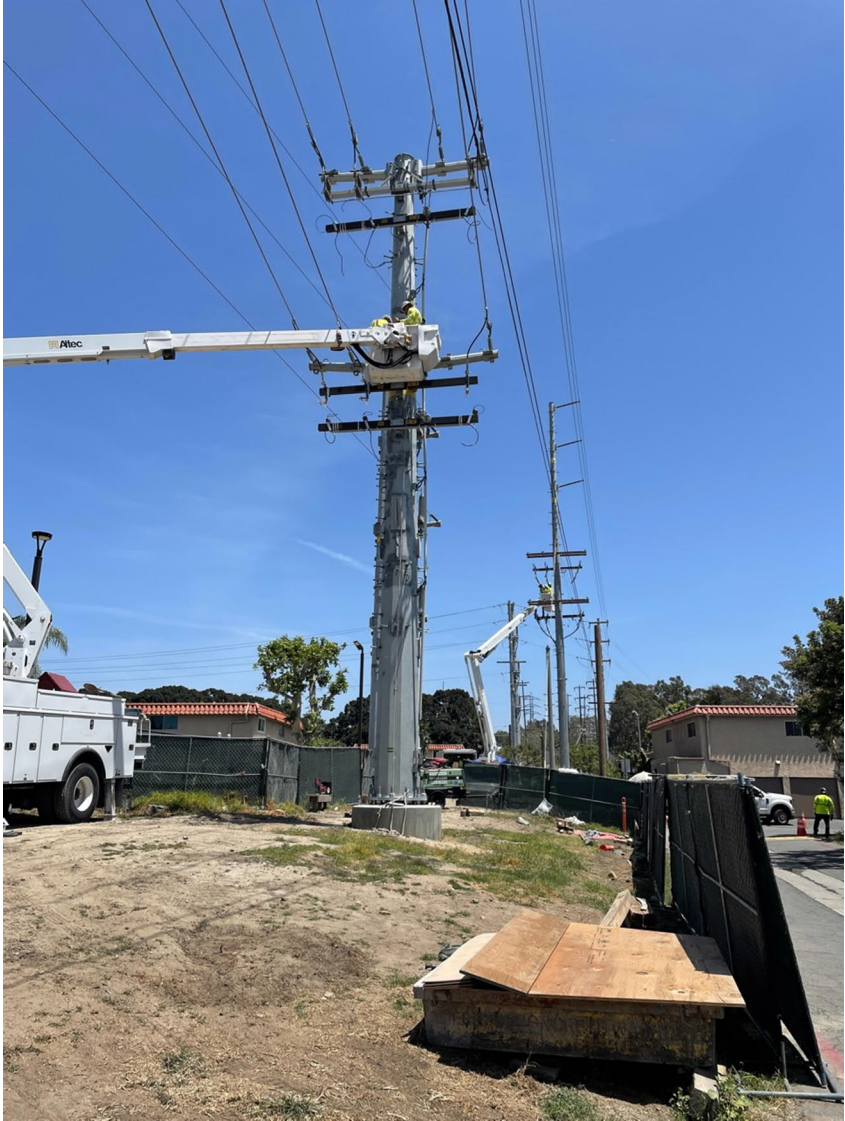
Overhead crews were conducting wire work in the work areas west of the railroad tracks (Photo 8), and there was a crew pulling wire through the new conduit pipes and up into the TSPs (Photo 9). The work areas appeared to be well maintained and free of trash.

Photo 8 – Wire work conducted on the tubular steel pole located west of the railroad tracks. Photo facing east.

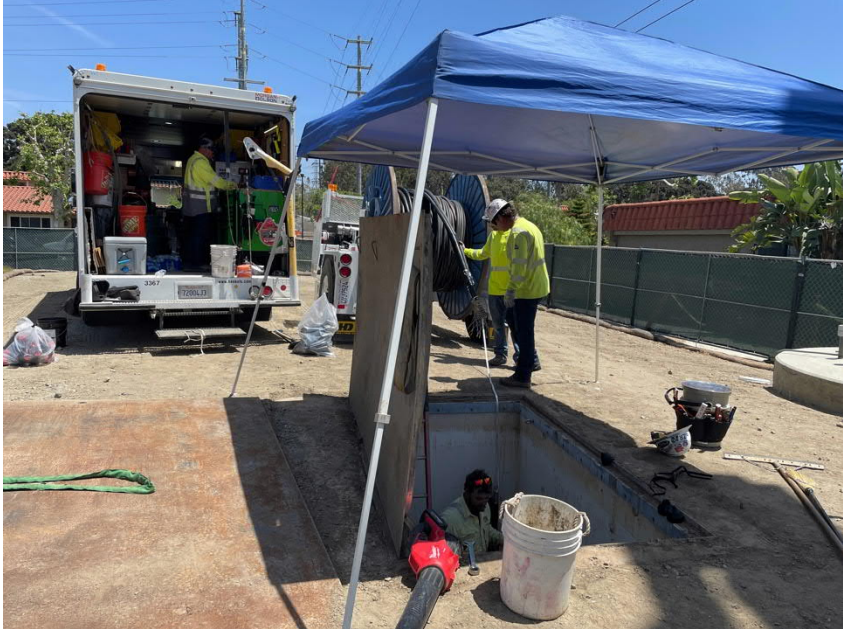
Photo 9 – Crews pulling wire through the new conduit piping. Photo facing east.

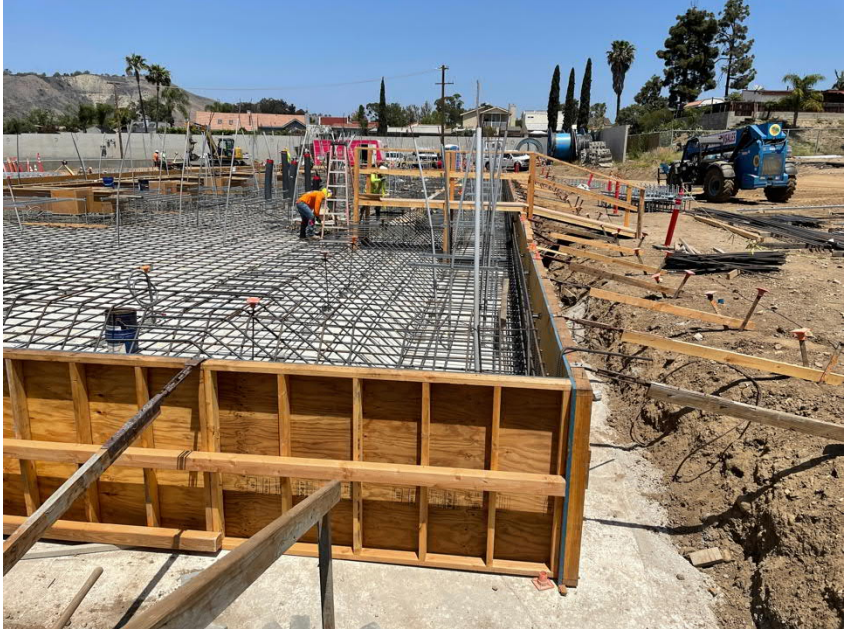
A crew was working on the site drainage system around the new substation (Photo 1). Another crew was working on the substation foundation (Photo 2). Concrete washout equipment was in place, the area was fairly free of trash, and a water truck was conducting dust suppression.

<p>Photo 2 – Foundation work for the new substation. Photo facing north.</p>

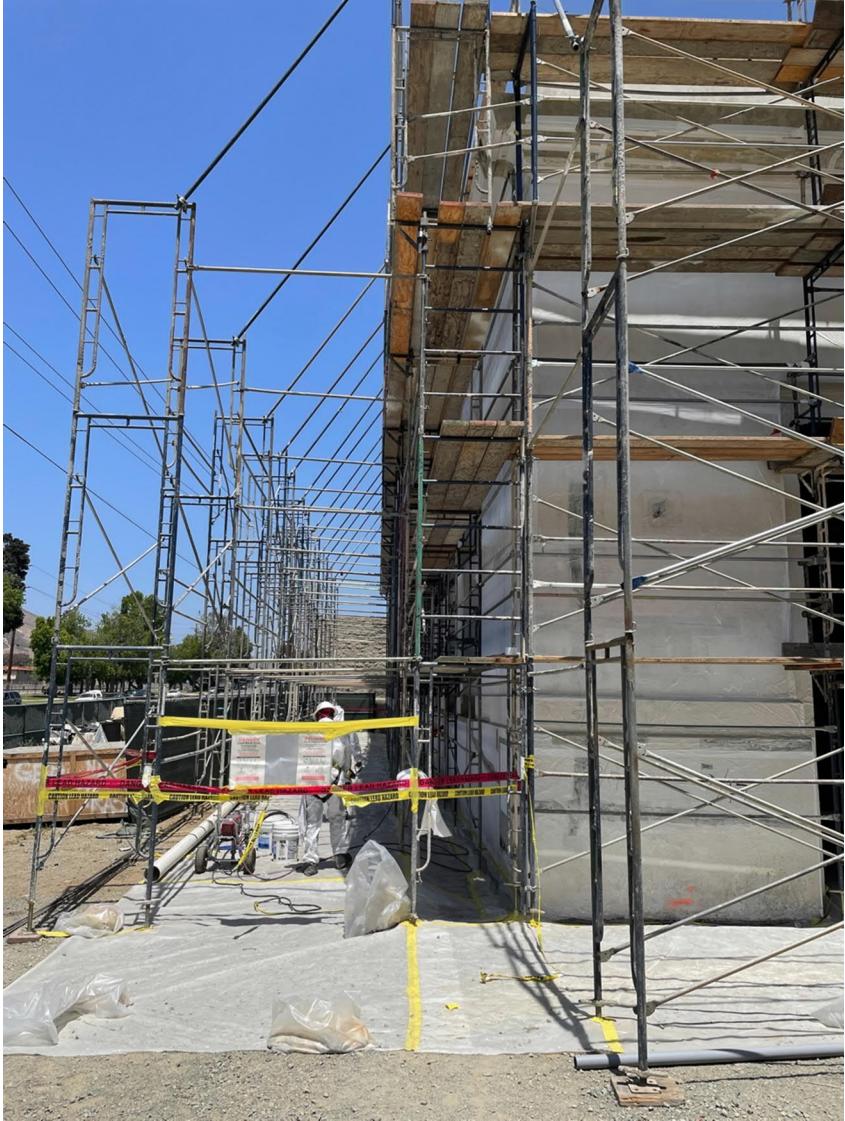
Crews continued to work on the old utility building, with scaffolding and air quality monitoring equipment in place (Photo 3).

Photo 3 – Cleanup work continues on the old utilities building. Photo facing north.

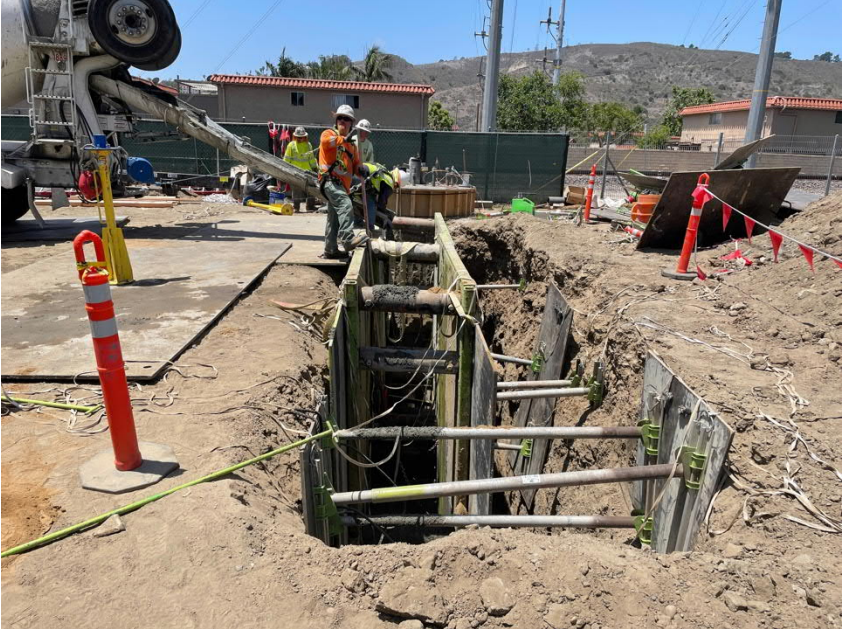
The crews had poured the last tubular steel pole (TSP) foundation in the old bore pit area and had installed the conduit piping. While I was onsite a crew was pouring slurry into the conduit trench (Photo 4). The concrete washout bin was full but was unneeded since the crew washed out the slurry mix into the trench. The work site was quite dusty and I spoke with the EI about performing dust control.

Photo 4 – Pouring slurry in a conduit trench within the old bore pit site. Photo facing west.

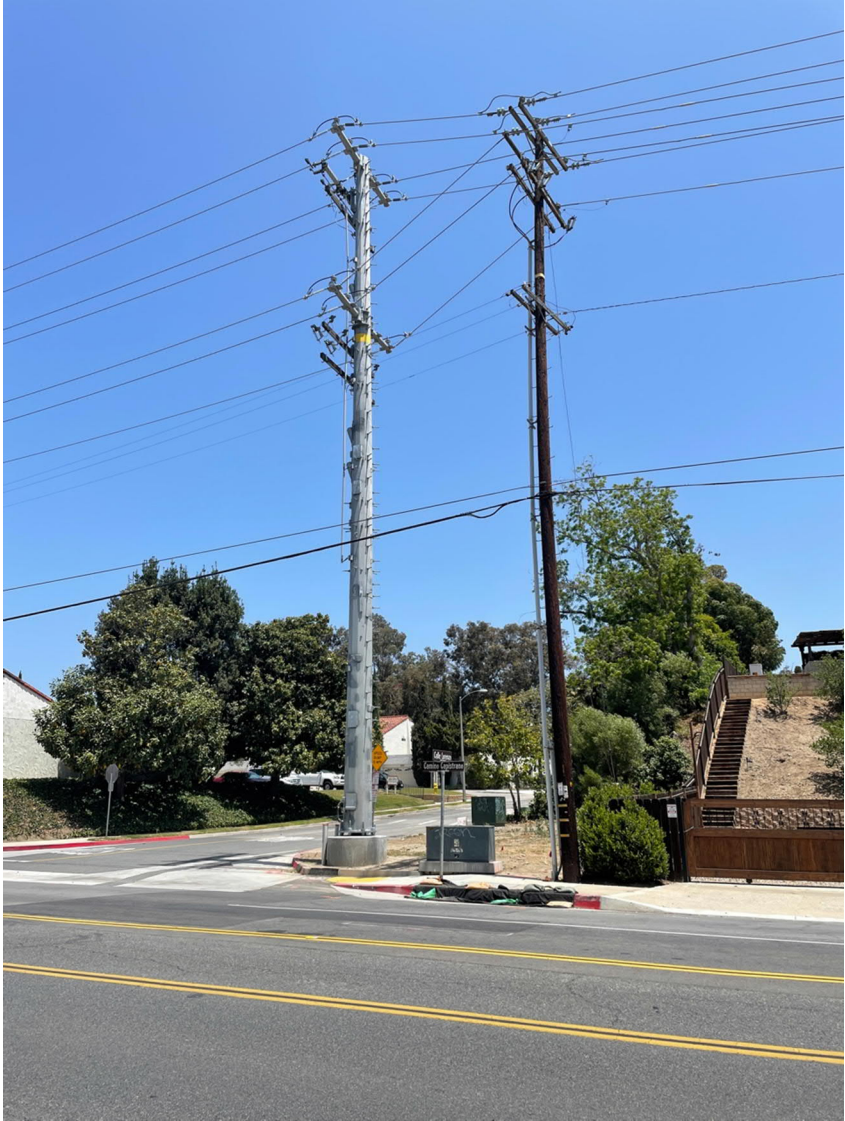
We proceeded to the intersection of Camino Capistrano and Calle Lorenzo where crews had installed the TSP (Photo 5). The area had been cleaned up and the construction fencing had been taken down.

Photo 5 – New TSP installed at the intersection of Camino Capistrano and Calle Lorenzo. Photo facing east.
