**Re: Monthly Report Summary #61 for the South Orange County Reliability Enhancement (SOCRE) Project**

CPUC Site Inspection Reports

## South Orange County Reliability Enhancement Project CPUC Site Inspection Form

<b>Project:</b>	South Orange County Reliability Enhancement (SOCRE) Project	<b>Date:</b>	November 14, 2022
<b>Project Proponent:</b>	San Diego Gas & Electric (SDG&E)	<b>Report #:</b>	VS153
<b>Lead Agency:</b>	California Public Utilities Commission (CPUC)	<b>Monitor(s):</b>	CPUC/WSP Compliance Monitor
<b>CPUC PM:</b>	Andrew Barnsdale, Energy Division	<b>AM/PM Weather:</b>	Sunny, warm and calm
<b>CPUC CM (WSP):</b>	Fernando Guzman	<b>Start/End time:</b>	1130 – 1400 hrs
<b>Project NTP(s):</b>	Notice to Proceed (NTP)-1, NTP-2, NTP-2 Addendum 1, NTP-3, NTP-4, and NTP-5

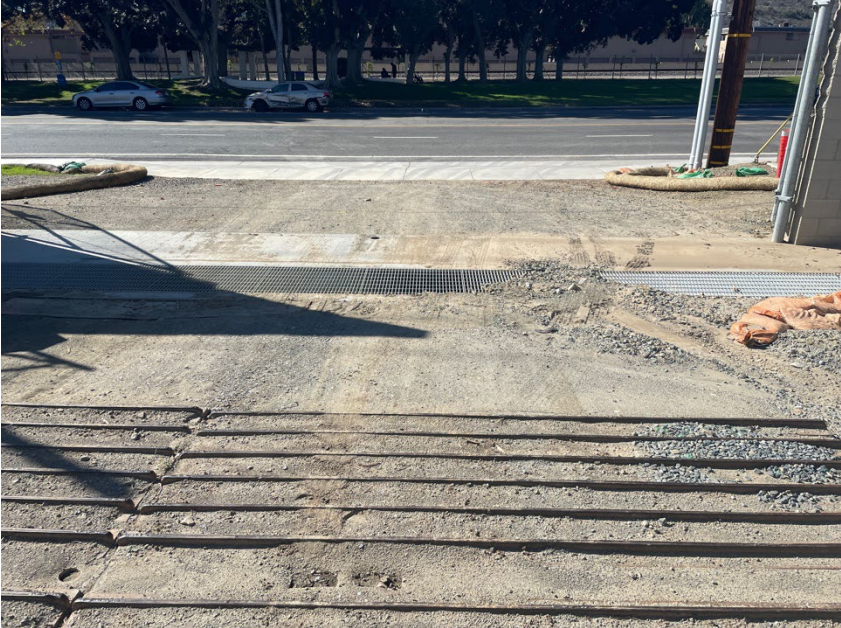
Photo 6 – Rumble plate at the north entrance to the site requiring some cleaning out. Photo facing west.
11/14/22	SOCRE Project

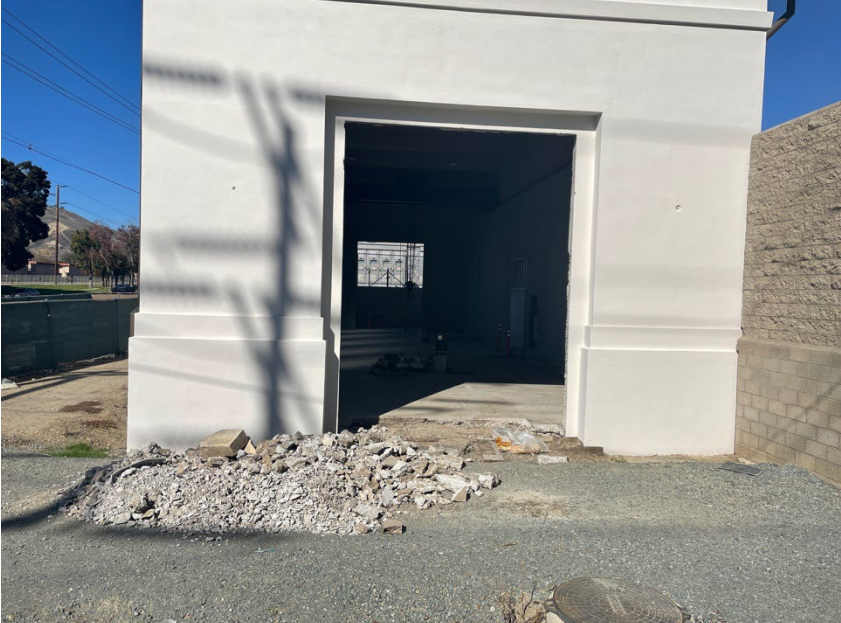
Work had begun on the building around the new substation (Photo 3). The staging area east of the substation was in good condition, with no trash or runoff issues (Photo 4). Some trenching and conduit installation was being conducted around the retaining wall (Photo 5). Some minor concrete removal was underway around the base of the former utility structure (Photo 7).

Photo 7 – Some concrete work in process at the base of the former utility structure. Photo facing north.
