Re: Monthly Report Summary #70 for the South Orange County Reliability Enhancement (SOCRE) Project

South Orange County Reliability Enhancement Project CPUC Site Inspection Form

| Project: | South Orange County Reliability Enhancement (SOCRE) Project | Date: | August 11, 2023 |

| Project: | South Orange County Reliability Enhancement (SOCRE) Project | Date: | August 31, 2023 |

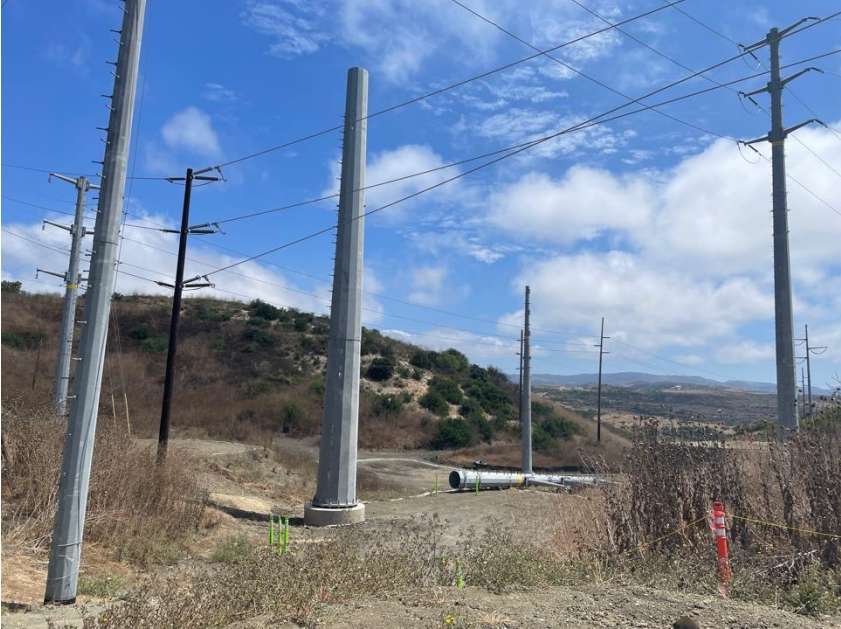
Segments of several TSPs remained to be installed (Photos 10 and 11). According to the LEI removal of the existing wires are required before remaining segments could be erected.

| REPRESENTATIVE SITE PHOTOGRAPHS | | | |
|---|---|---|--|
| 8/11/23 | SOCRE Project – Phase 2 | | Photo 10 – Additional TSP work to be completed. Photo facing east. |

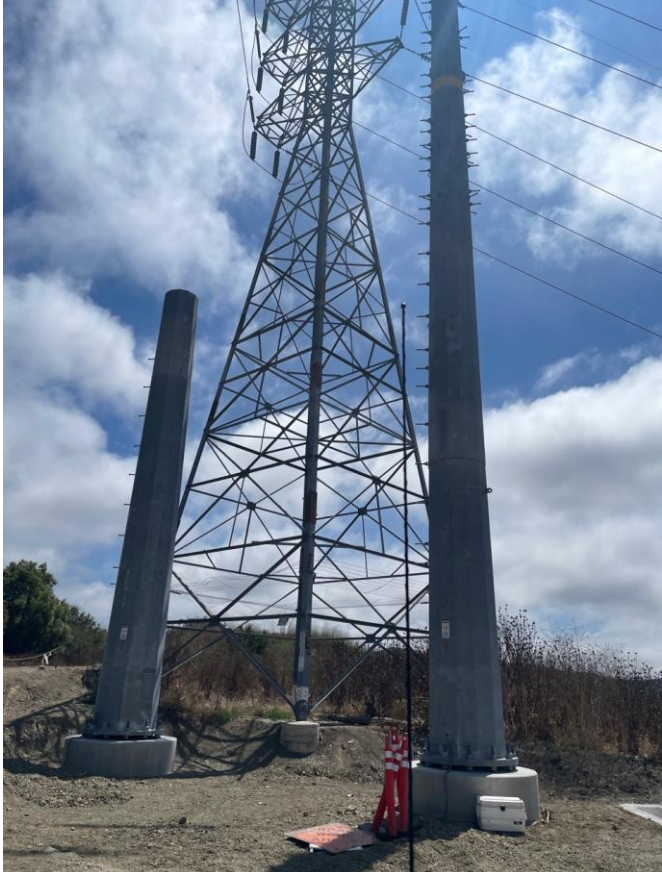
| REPRESENTATIVE SITE PHOTOGRAPHS | | | |
|---|---|---|--|
| 8/11/23 | SOCRE Project – Phase 2 | | Photo 11 – TSPs awaiting installation. Photo facing south. |

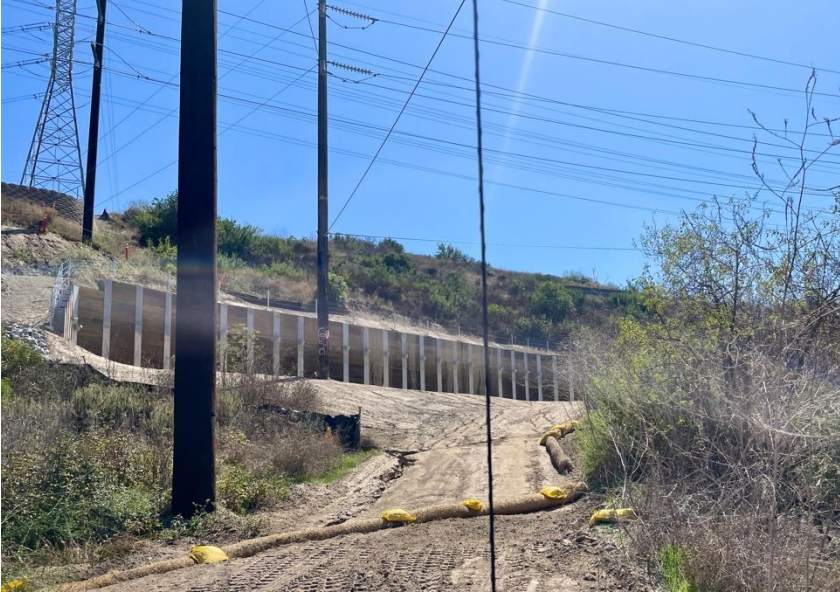
I drove through the Phase II work area with the EI to inspect the area after the tropical storm. Minor riling was noted on several of the steep access roads (Photos 9 and 10), but otherwise things appeared stable.

| REPRESENTATIVE SITE PHOTOGRAPHS | | | |
|---|---|---|---|
| 8/31/23 | SOCRE Project – Phase 2 | | Photo 10 – Minor riling on the access road below TSP 45. Photo facing east. |

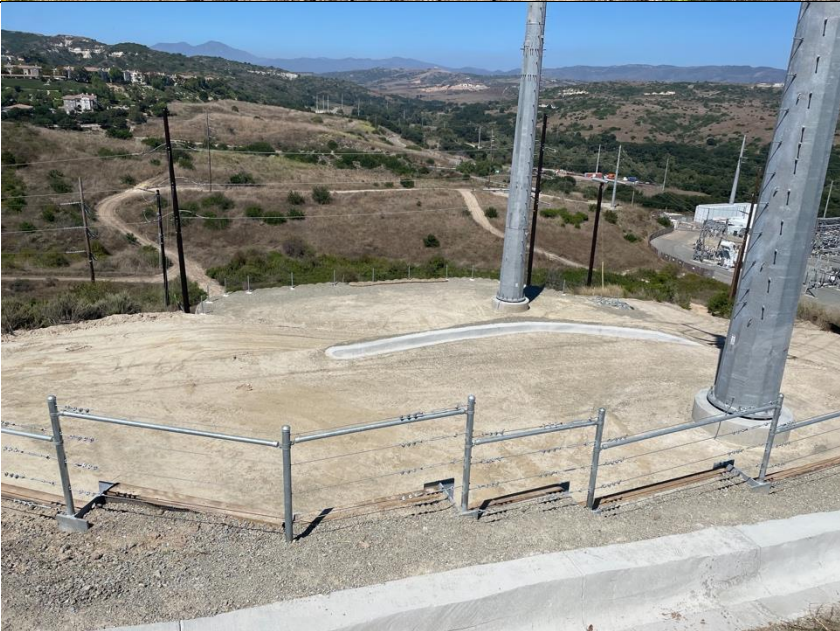
The TSP at location 18 was erected (Photo 11).

| REPRESENTATIVE SITE PHOTOGRAPHS | | | |
|---|---|---|---|
| 8/31/23 | SOCRE Project – Phase 2 | | Photo 11 – The TSP was erected at Location 18. Photo facing north. |
