PROJECT MEMORANDUM SYCAMORE-PEÑASQUITOS 230-KV TRANSMISSION LINE PROJECT

Date: May 5, 2017
To: Billie Blanchard, CPUC Project Manager
From: Sheila Hoyer, CPUC Monitoring Supervisor
Subject: Weekly Report #17 – April 23 to April 28, 2017

This report provides a summary of the construction and compliance activities associated with the SDG&E Sycamore-Peñasquitos 230-kV Transmission Line Project for the week of April 23 to April 28, 2017.

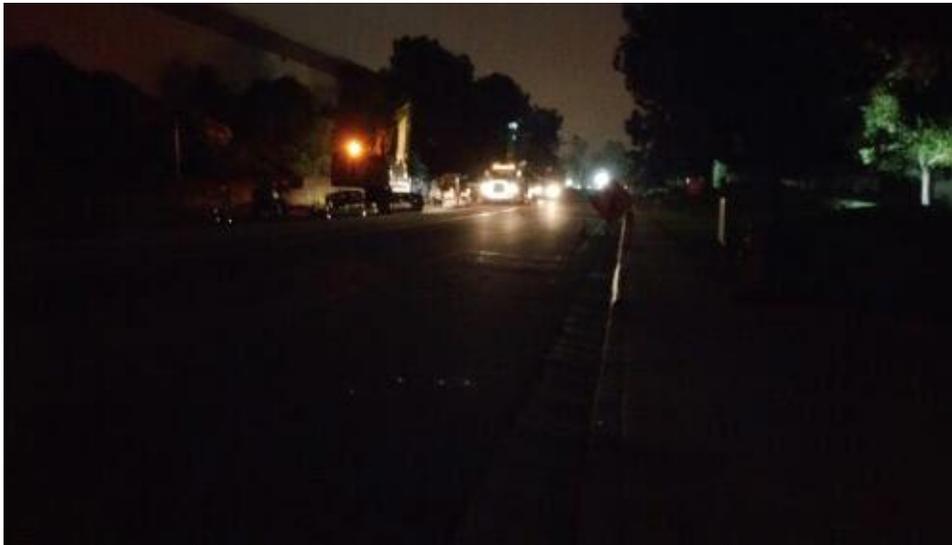
Approach to staging area on Trade St. from east. Plates being delivered ; no flagger present, but this is compliant per Safety Officer (equipment properly lit).

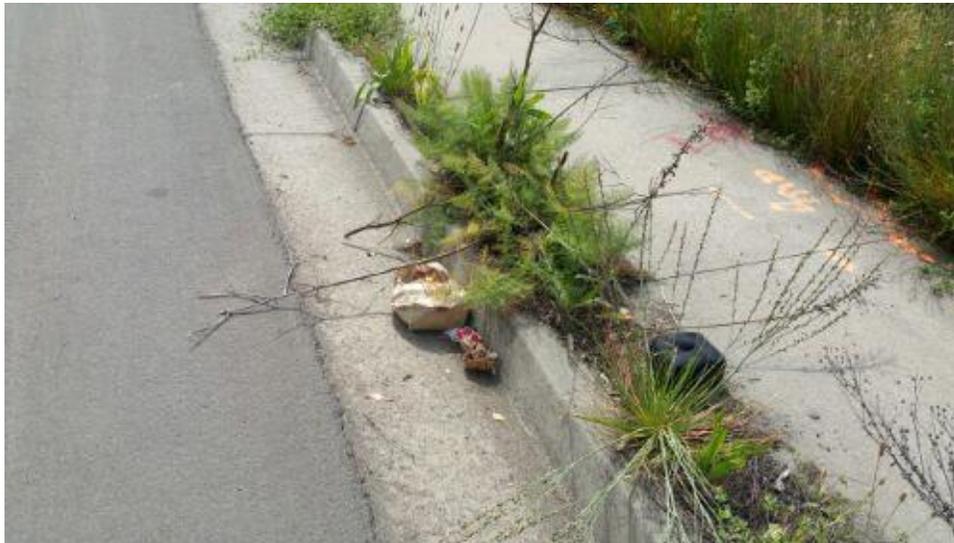
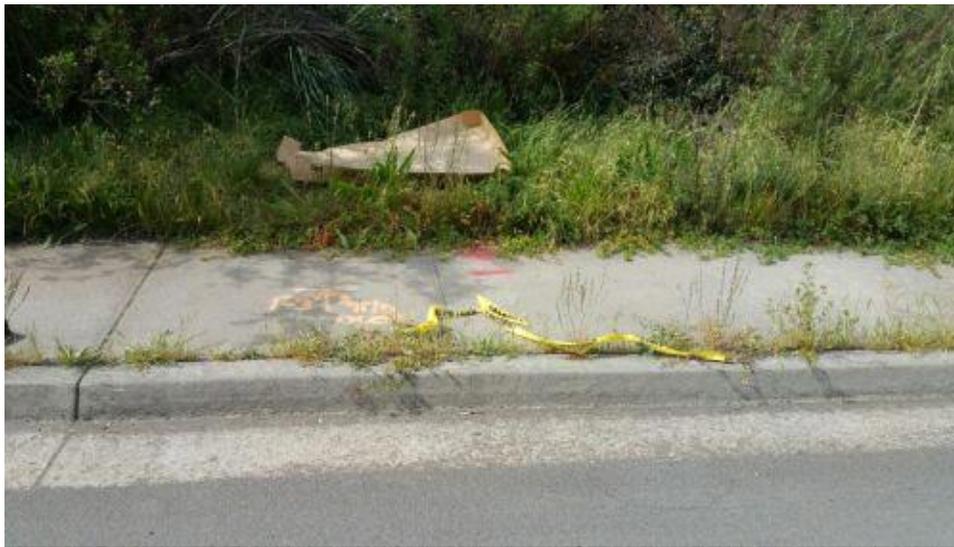
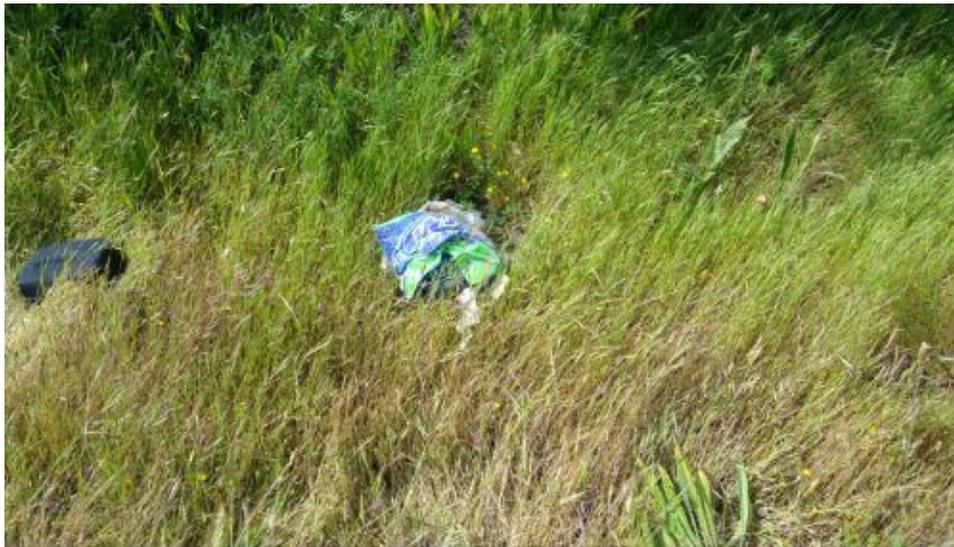
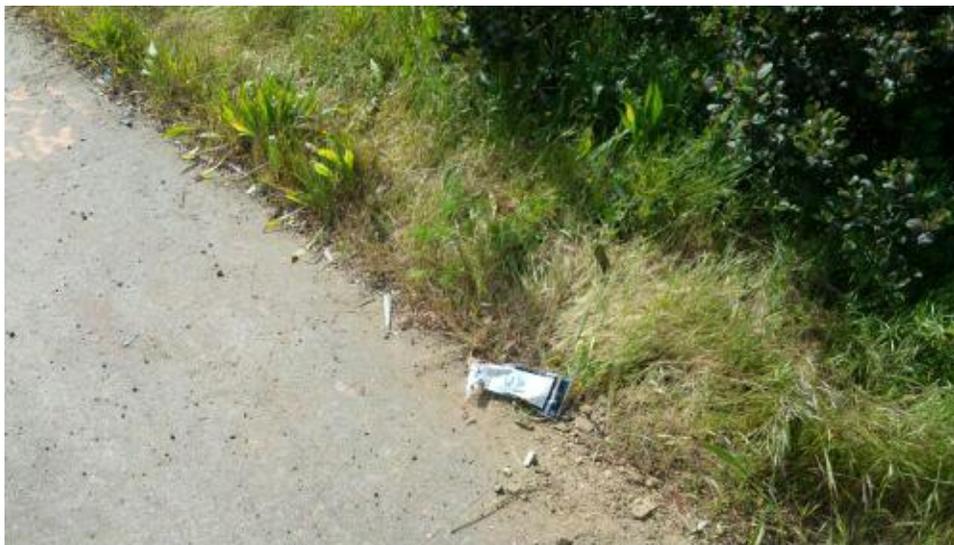
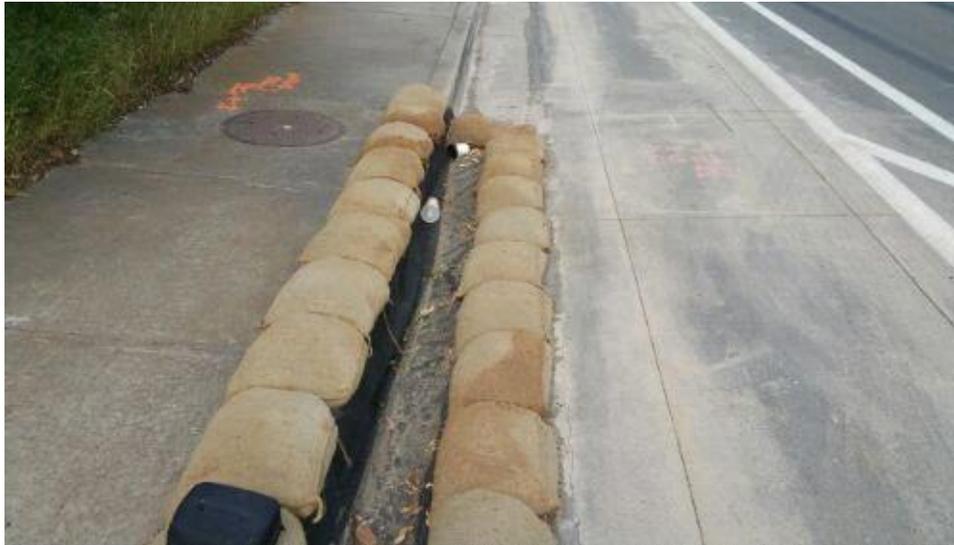
Incident Category	Compliance Level
MMCRP Compliance Level	Level 1: Minor Problems
Incident Start Date	2017-04-24
Resolution Date	2017-04-25
Summary of Incident	I did not observe trash receptacles at work sites. I observed relatively high amounts of trash near work areas, including ear protection, fresh Cheetos, un-rotted banana, oil container.

Caption Litter, Carroll Rd.

Q9 Notes Oil container, organic and inorganic trash found in work areas at higher than base levels: I counted all trash near sidewalk on opposite sides of Carroll Rd and noted 50 discrete pieces on south side, where work was done vs. 6 on north side.

4. A Level 1 Minor Problem Report related to trash was filed by the CPUC monitor on April 24, 2017. Trash was observed along the construction alignment near work areas. An Incident Report was sent to SDG&E on April 24, 2017. SDG&E mobilized a crew the afternoon of April 24, 2017 to pick up trash/litter observed along the Project ROW where active construction had been occurring. During the nightly tailboard held on April 24, 2017, litter and trash management procedures were reviewed with the construction crews. Crews were reminded that trash receptacles are located at lighting towers and are on each construction work vehicle. On the morning of April 25, 2017, SDG&E's Lead Environmental Inspector (LEI) conducted a final sweep of the Project ROW to verify that the work areas remained clean after the night construction shift. Moving forward, SDG&E's LEI/EI's will document pre- and post-work conditions after each construction

shift to verify that all food scraps, wrappers, bottles, and other trash generated by construction crews are deposited in trash receptacles and removed from the Project site. Proper disposal of trash will continue to be addressed at the construction tailboards. All vehicles and equipment were checked for leaks. All equipment staged along the ROW had drip pans in place to capture oil drips and leaks. One hazardous materials release occurred on April 24, 2017 between stations 206 + 00 and 207 + 00 during the relocation of a gas line. The release was from a front loader that had a hydraulic leak. The hydraulic leak released approximately 4 pints of hydraulic fluid onto the equipment and the soil (no hydraulic fluid was released onto the asphalt). The hydraulic fluid on the vehicle and on the impacted soil was cleaned with absorbent pads, and properly placed and stored in a labeled on-site hazardous waste drum on April 24, 2017. The release was reported to the California Office of Emergency Services and the San Diego County Department of Environmental Health (DEH) on April 24, 2017. Although the release did not exceed federal reportable quantity thresholds, release reporting was advised by San Diego County DEH staff. The Cal-OES Control Number is 17-3003. No other reportable releases and/or spills occurred during this reporting period.

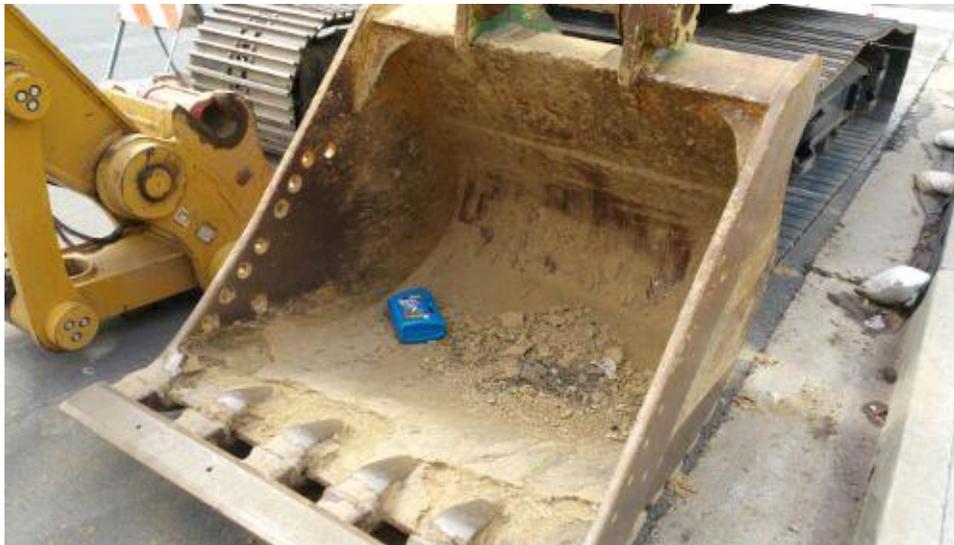
Caption Improper waste disposal, Carroll Rd staging area.

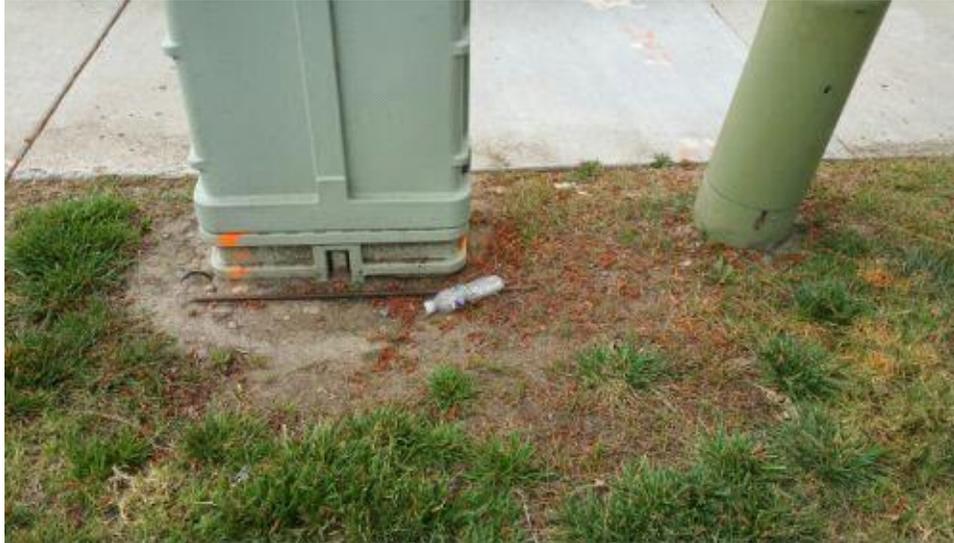
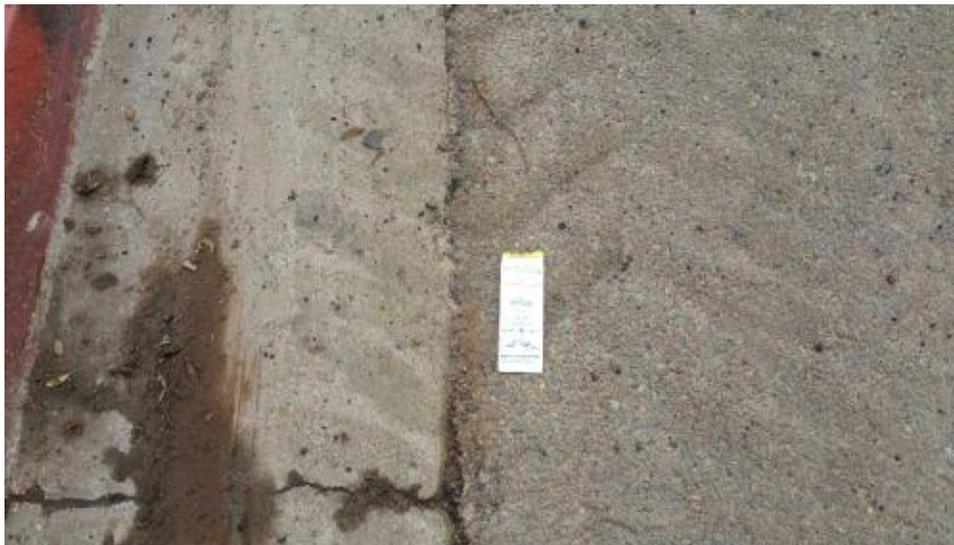
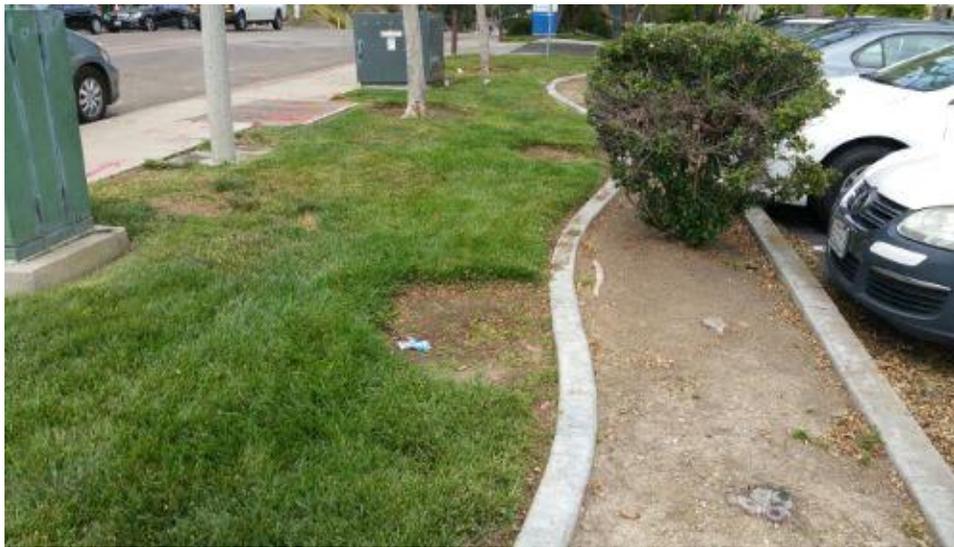
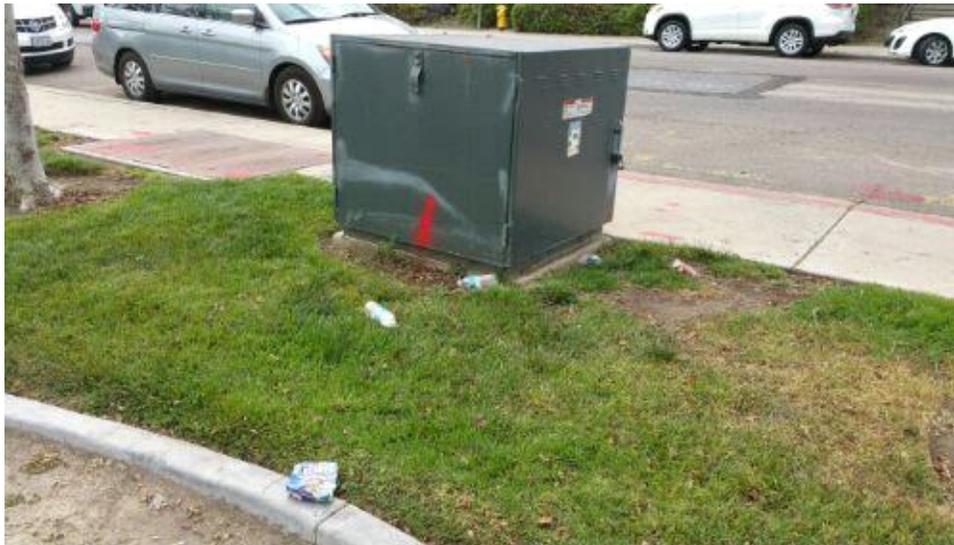
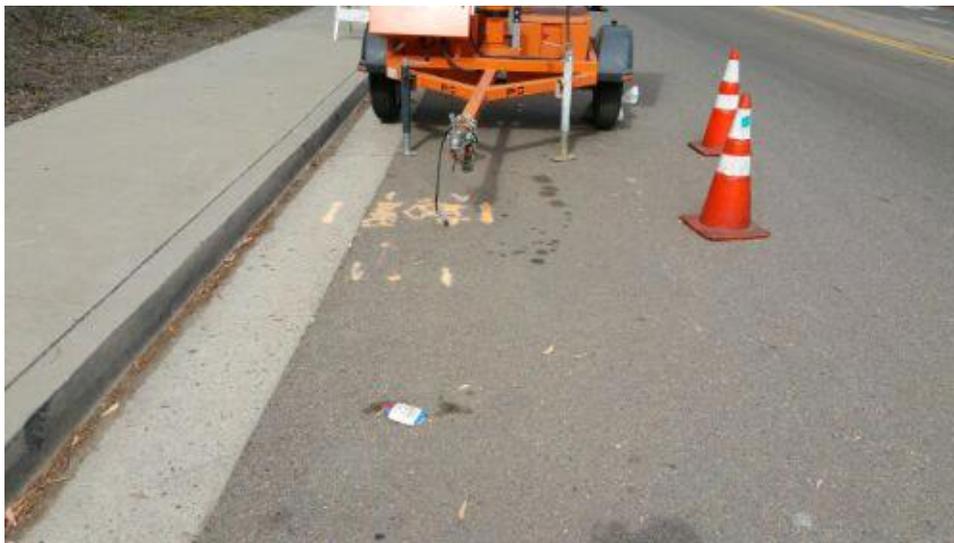
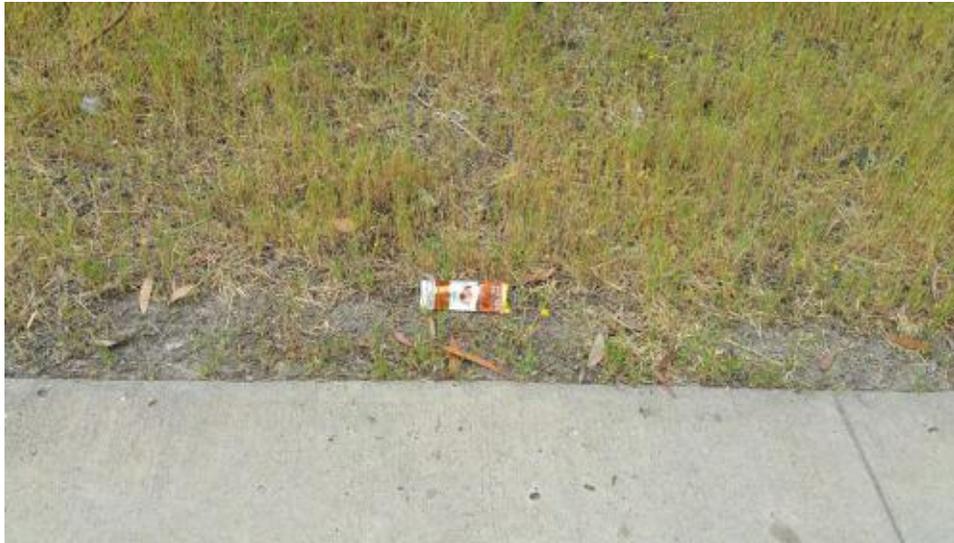
Caption Litter, Trade St.
Photo Attributes Capture Date/Time: Mon Apr 24 2017 09:57:00 GMT-0700 (PDT)
Coordinates: 32.888741, -117.165016
View Direction: South

Caption Litter, Trade St.
Photo Attributes Capture Date/Time: Mon Apr 24 2017 09:55:39 GMT-0700 (PDT)
Coordinates: 32.888785, -117.165341
View Direction: East

Caption Litter, Trade St.

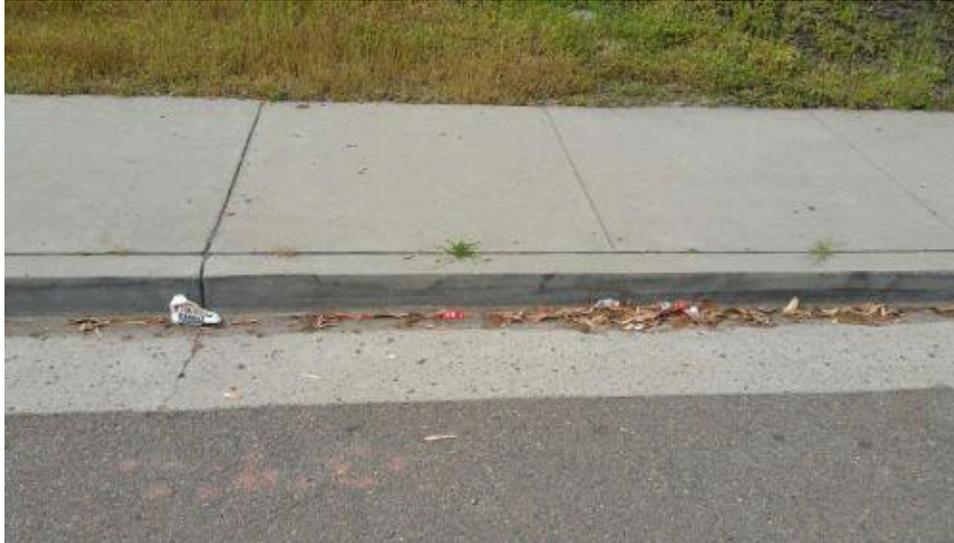
Caption Litter. Trade Pl.

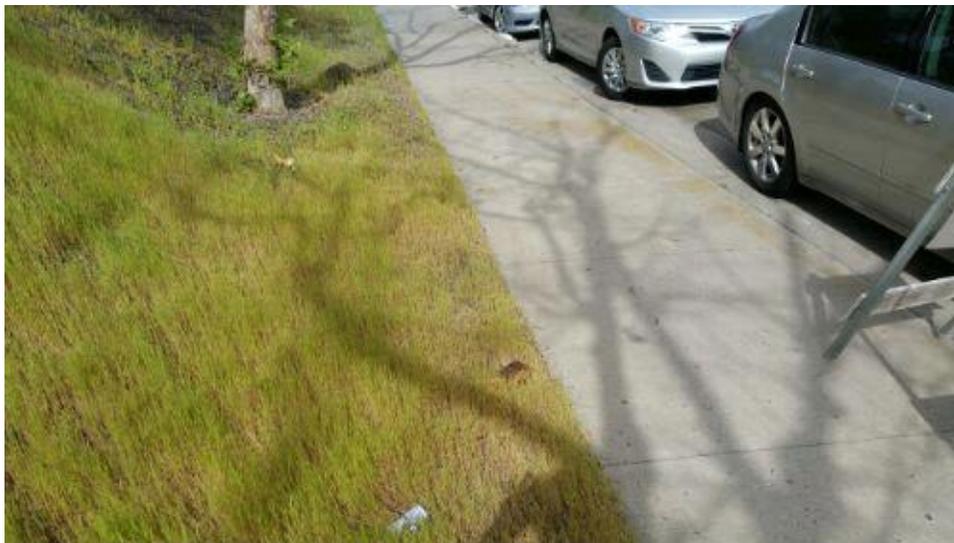
Caption GatorAde bottle, half eaten banana shown, water bottle, wrapper, and condiment package nearby. Trade St.

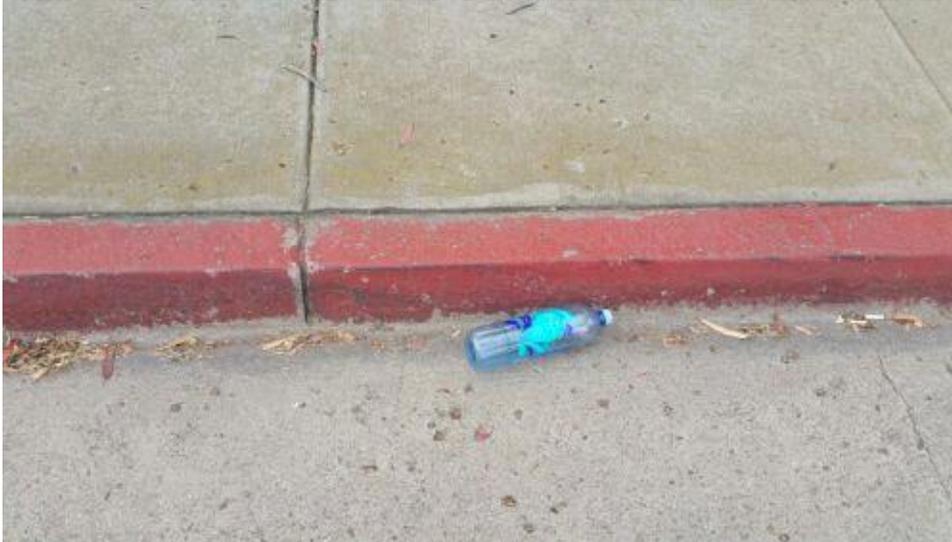
Caption Litter (unknown source), Trade St.

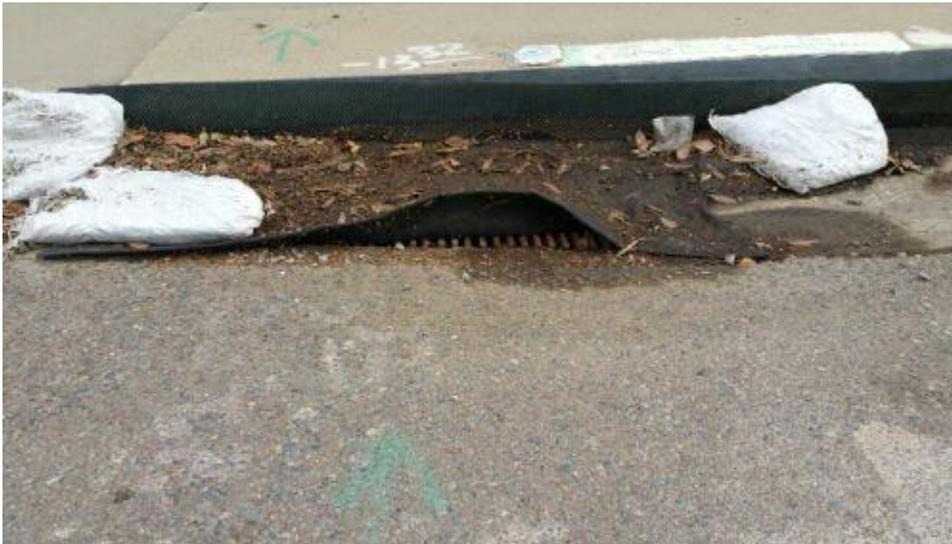
Caption Upturned filter fabric; Trade St.

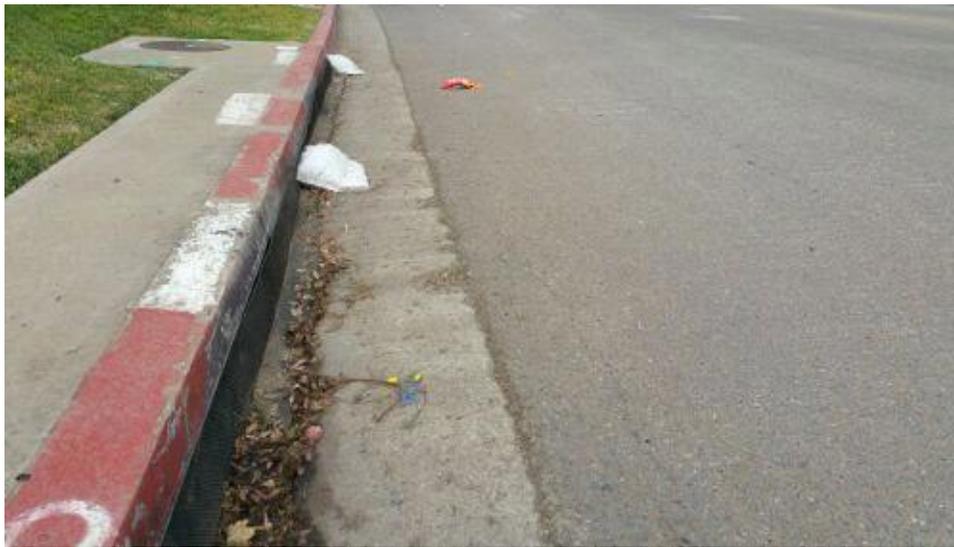
Caption Litter; discarded earplugs and fresh Cheetos; Trade St & Carroll Way.

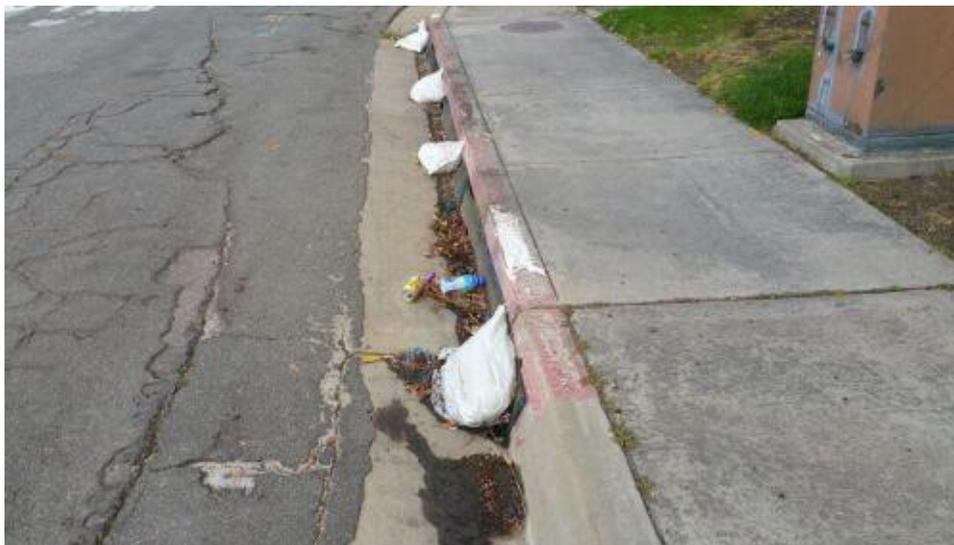
Caption Litter (source unknown) Trade Pl & Dunbrook.

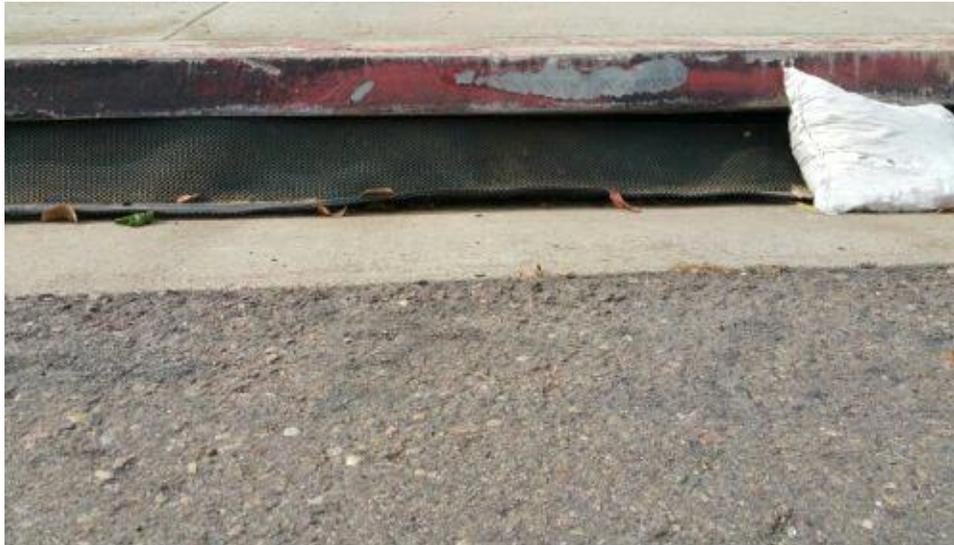
Caption Filter fabric not flush with road surface; Trade PI & Dunbrook.

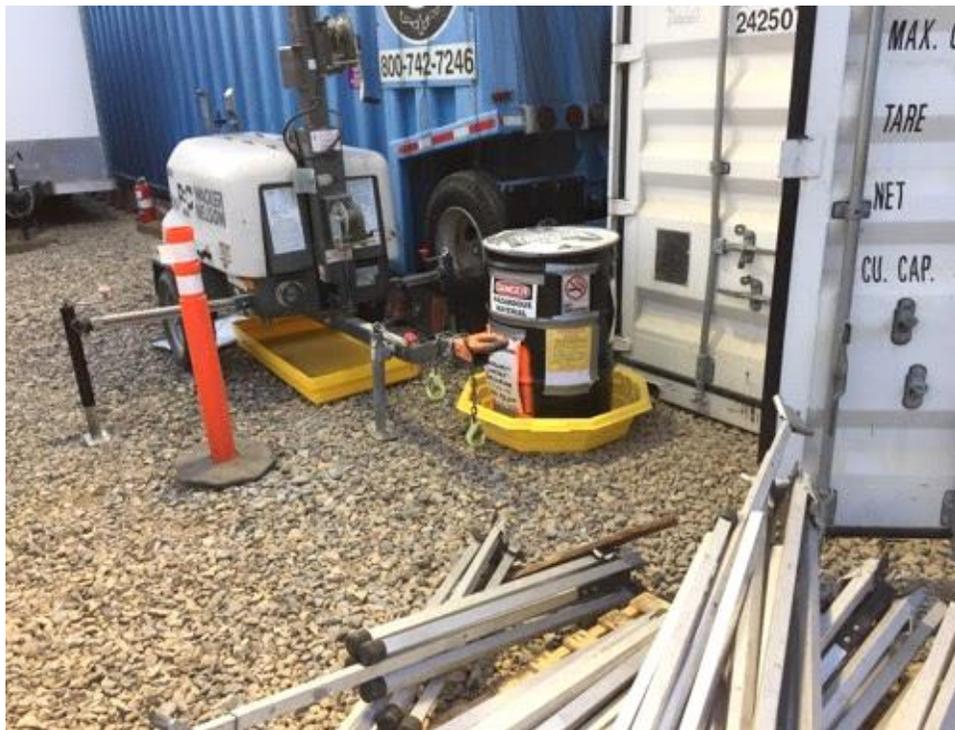
Caption Hazardous waste properly stored and labeled.
