Re: PG&E's Accelerated Gas Transmission System Aerial and Ground Leak Survey Trends Report

# **Accelerated Natural Gas Transmission System Aerial and Ground Leak Survey Trends Report**

**Pacific Gas and Electric Company**

February 1, 2011

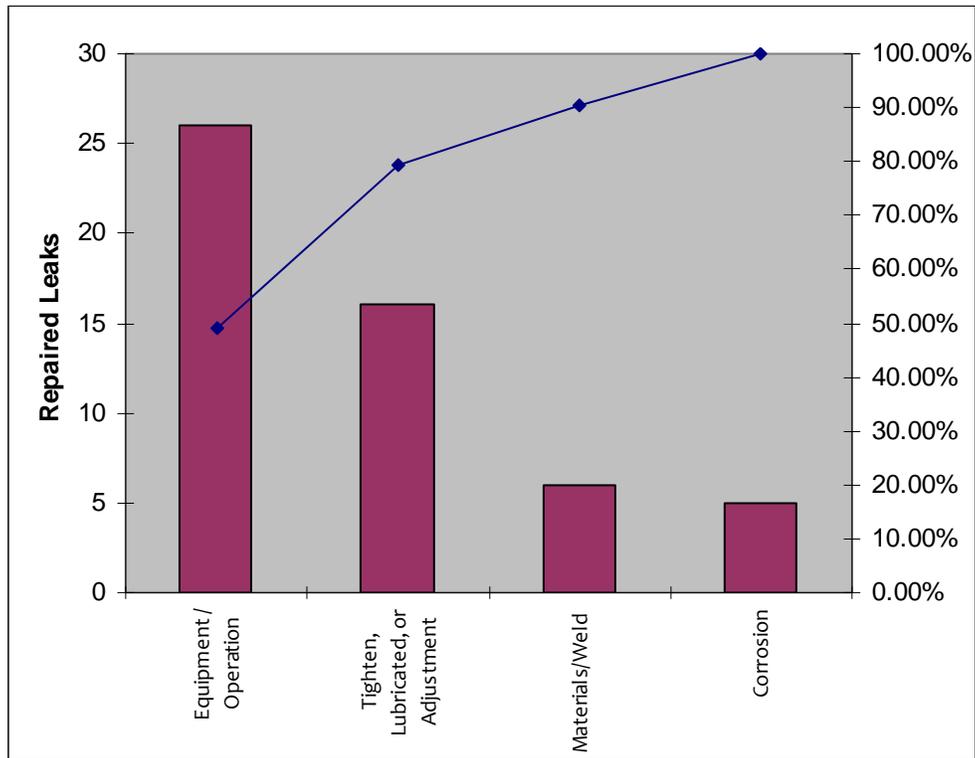
Figure 1 - Leaks by Cause

- Equipment-related leaks were the leading cause of leaks repaired as part of this Accelerated Leak Survey. Equipment leaks occur on transmission appurtenances and include failures at threaded components, gaskets, valve packing, etc. PG&E found that most of these equipment leaks were associated with PG&E high pressure regulator (HPR) sets serving one to two customers and on facilities generally less than 1 inch in diameter.

- The next highest cause of leaks fell within the category “Other.” These are leaks where PG&E performed an immediate response and repaired the leak by tightening, lubricating, or adjusting. The 16 leaks identified in this category could have been considered equipment leaks as they are associated with thread and lubrication components failure. These leaks are also ones that, as discussed below and in the attached expert consultant’s report, may not even have been reportable in the first place.<sup>13</sup>

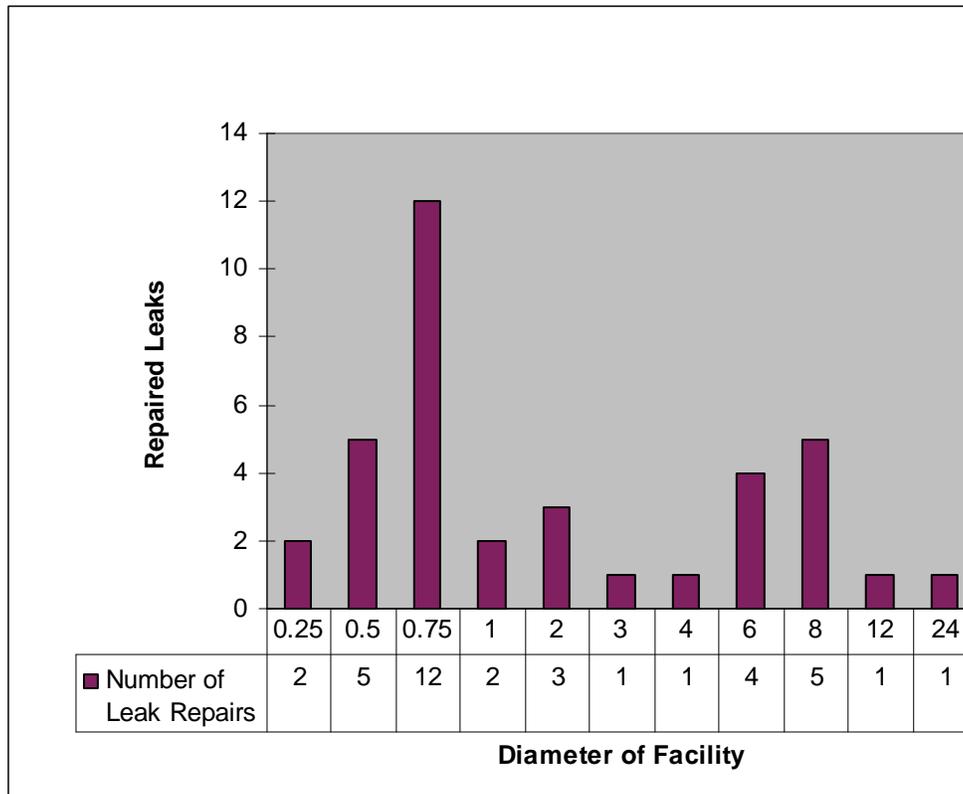
Figure 2 - Size of Facility

Note: Excludes the 16 leaks designated as leaks repaired by tightening, lubrication, or adjustment.

As shown by Figure 2 above, ninety-five percent of the leaks found and repaired (excluding the 16 leaks repaired by tightening, lubrication or adjustment) were on facilities less than 12 inches in diameter. Two leaks were found on facilities equal to or greater than 12 inches in diameter, as follows:

- On October 6, 2010, an indication of a potential leak was identified via the Accelerated Leak Survey on Line 153 in the City of Oakland. The leak was caused by external corrosion along a welded seam of pipe. A 25-foot section of 24 inch diameter pipeline was removed and replaced to complete the repair.

- 
- On October 11, 2010, an indication of a potential leak was identified via the Accelerated Leak Survey on Line 177A near PG&E's Cumming Creek Pressure Limiting Station near Fortuna in Humboldt County. The leak was found to be caused by a pin-hole within a girth weld. A sleeve was welded into place to complete the repair.
