# Public Housing Broadband Site Visit Report

CALIFORNIA ADVANCED SERVICES FUND  
BROADBAND PUBLIC HOUSING ACCOUNT

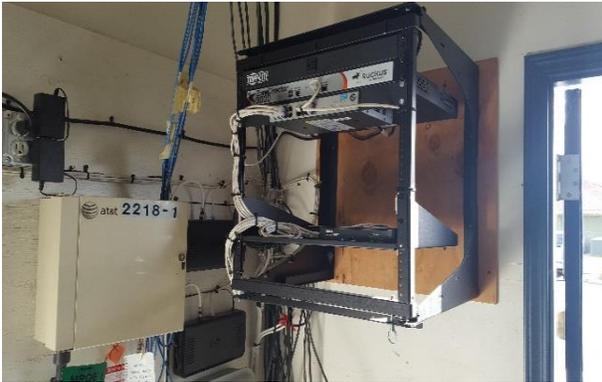
**Figure 5: Parc Grove and Northwest MDF Room**

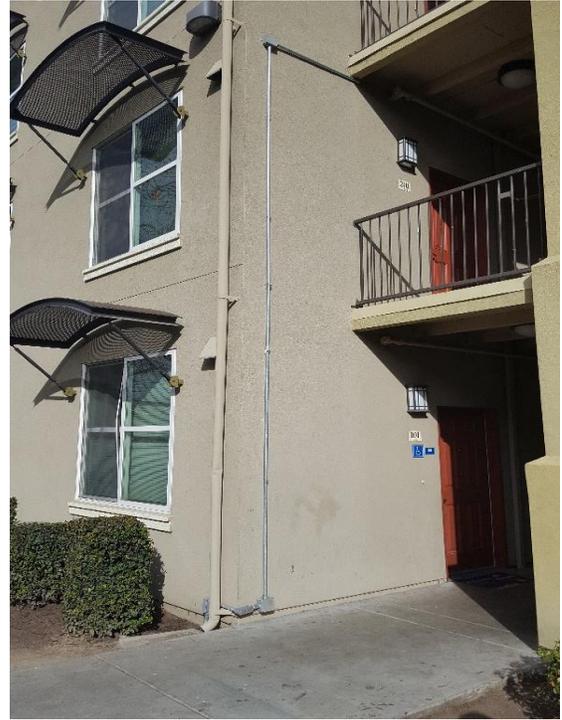
**Figure 8: Parc Grove Northwest WAP cabling**

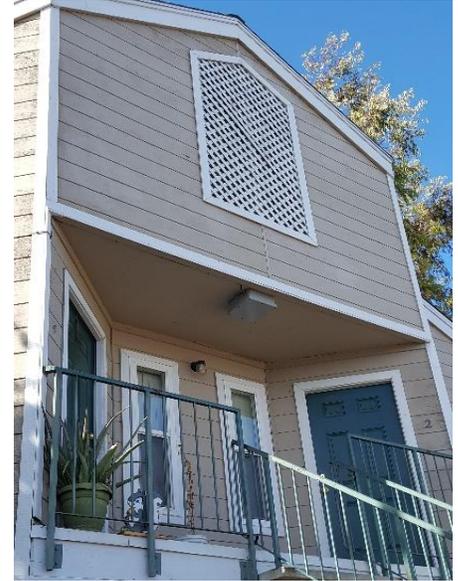
Figure 29: Quincy St. Apartment WAP

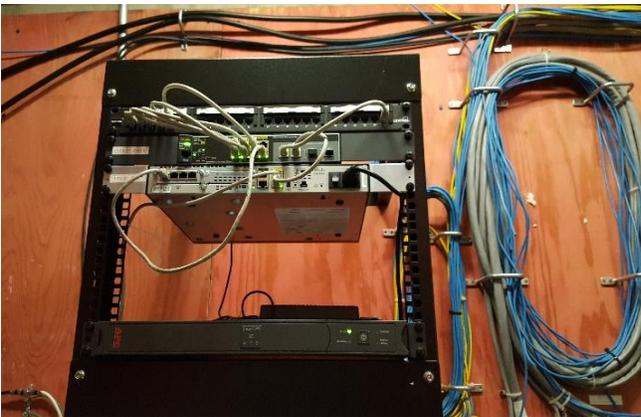
Figure 30: Lakeside Senior Apartments MDF Room

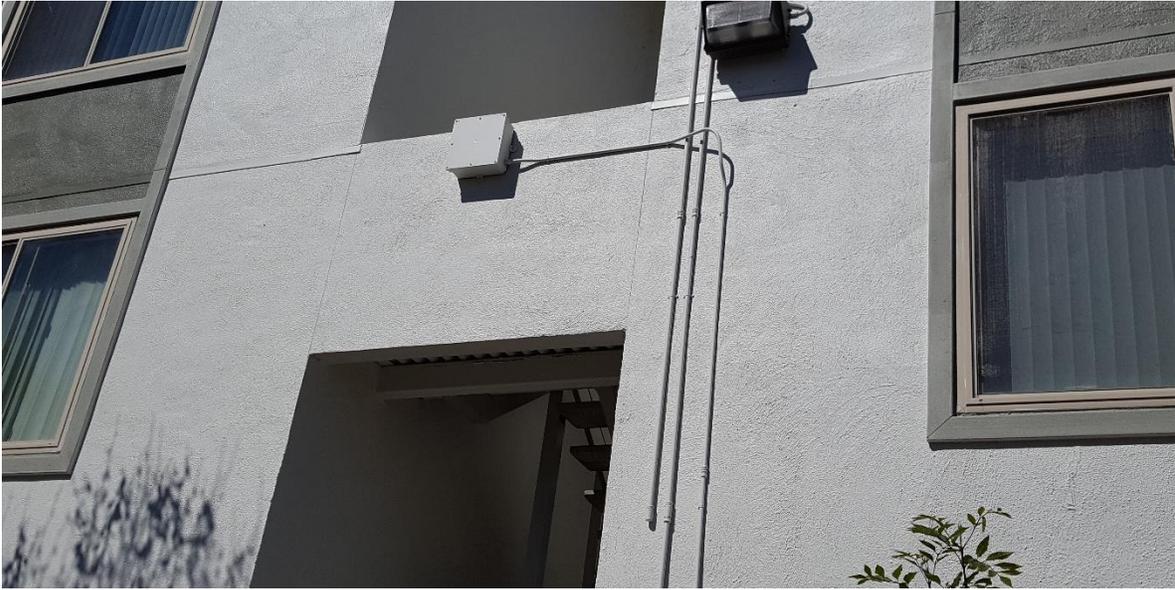
**Figure 212: Banneker Homes Apartments WAP and cabling**

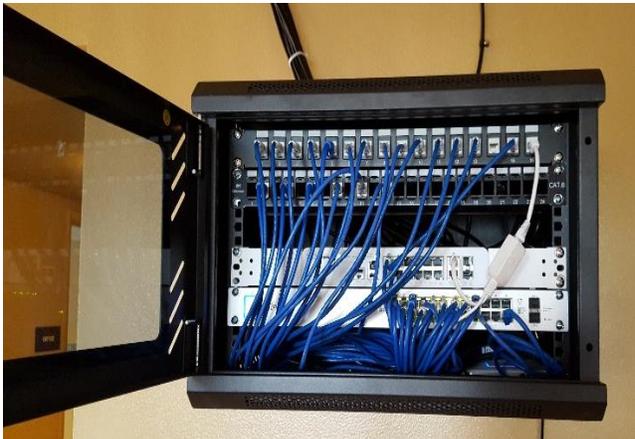
**Figure 223: Central Ave Village Square Apartment MDF Room**

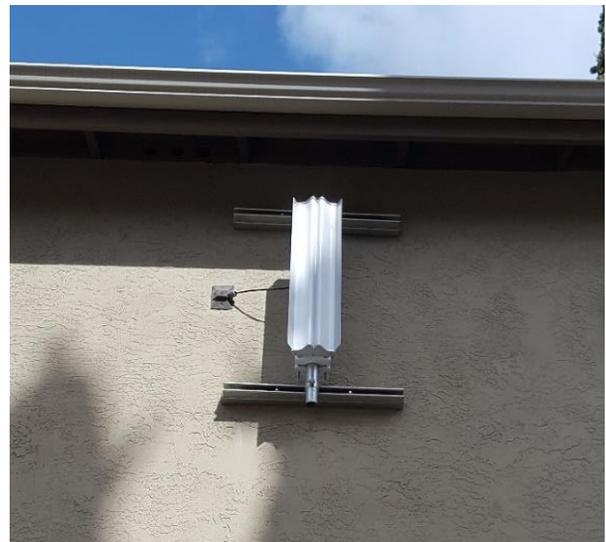
**Figure 50: Manzanita (Cypress Cove) Sectorial Antenna**

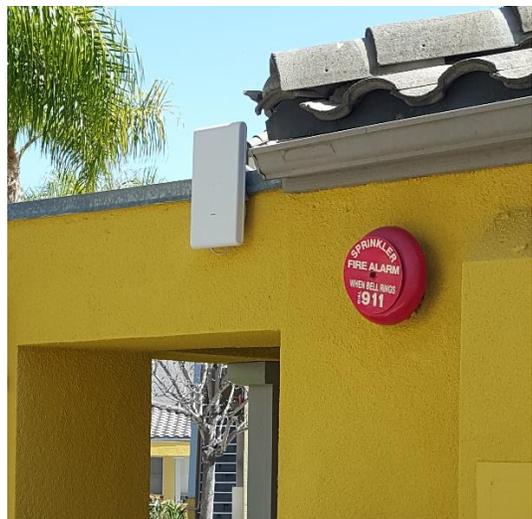
Figure 314: Cedar Nettleton Nano Cell WAP

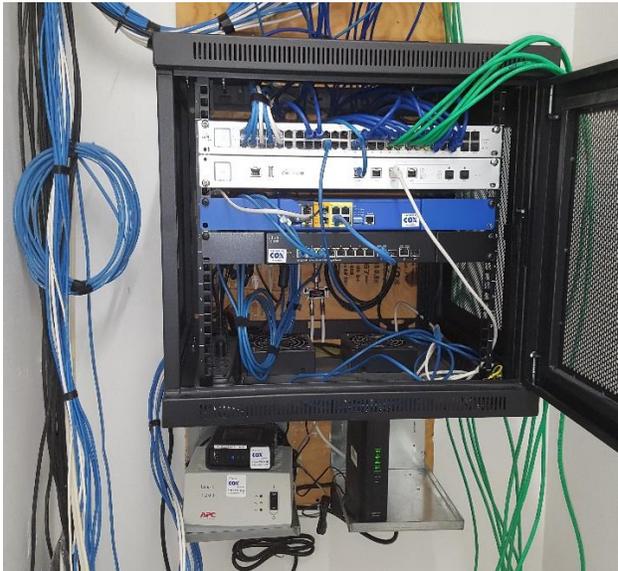
**Figure 325: Mission Cove Senior MDF Room**

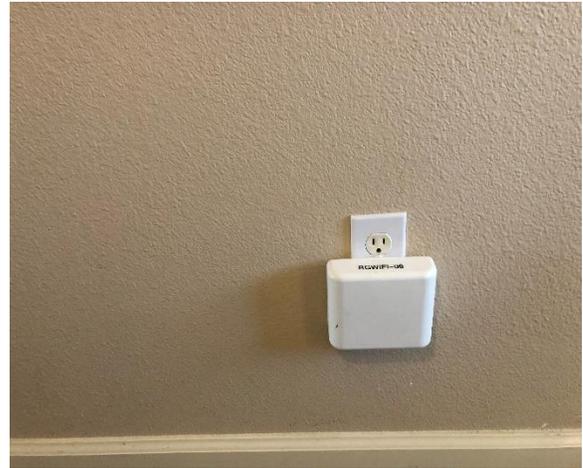
Figure 441: Rodeo Gateway WAP Repeater

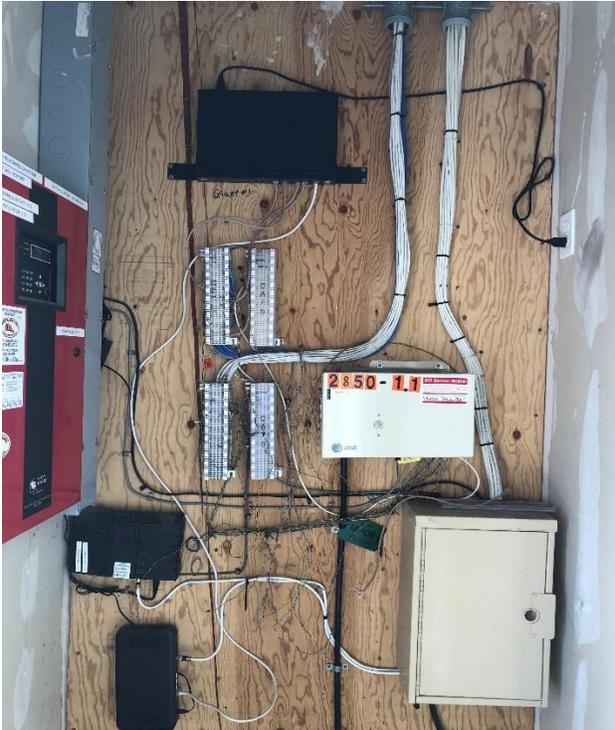
Figure 73: Giant Road MPOE 1A

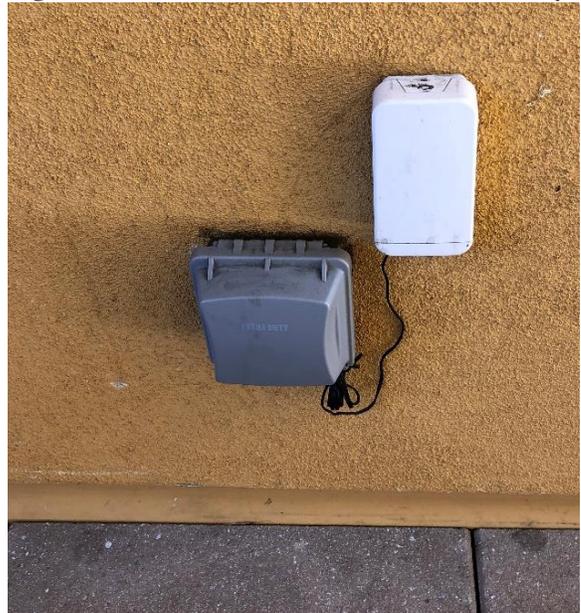
**Figure 626: Seven Directions WAP in the walkway**
