CALIFORNIA PUBLIC UTILITIES COMMISSION
Safety and Enforcement Division
Wildfire Safety and Enforcement Branch

Incident Investigation Report

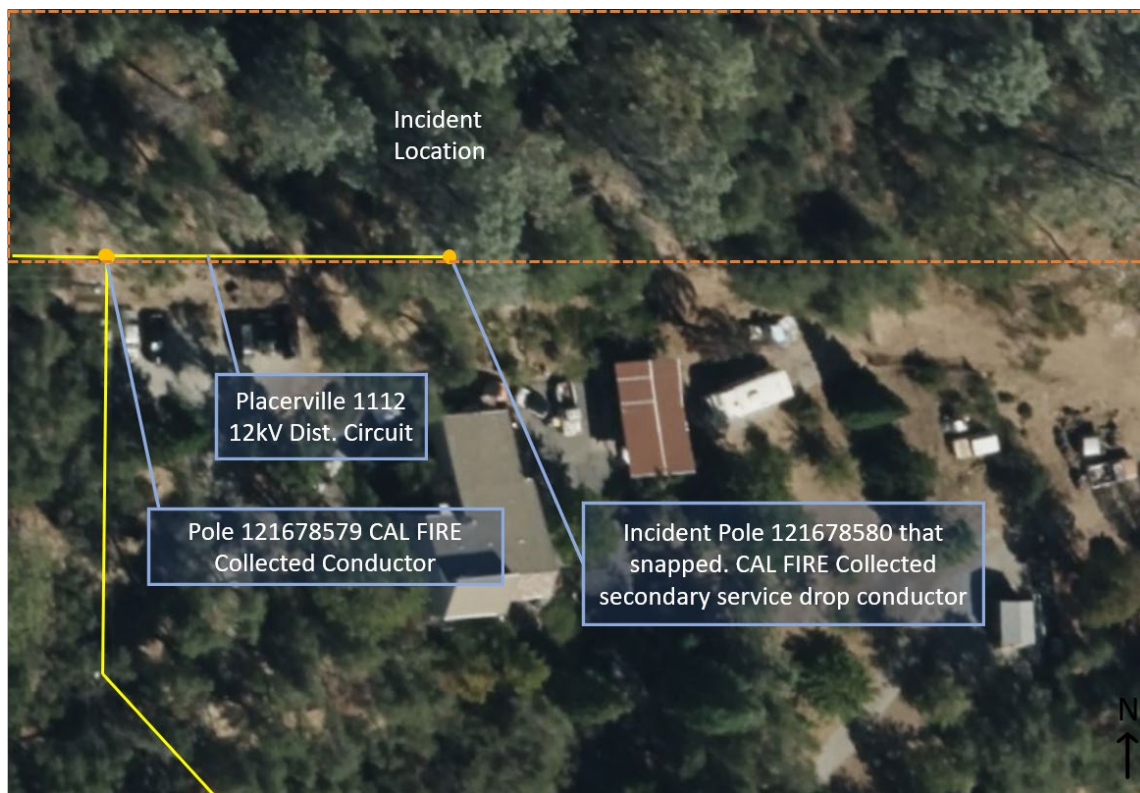
Figure 1: Incident Location of the Pay Fire.

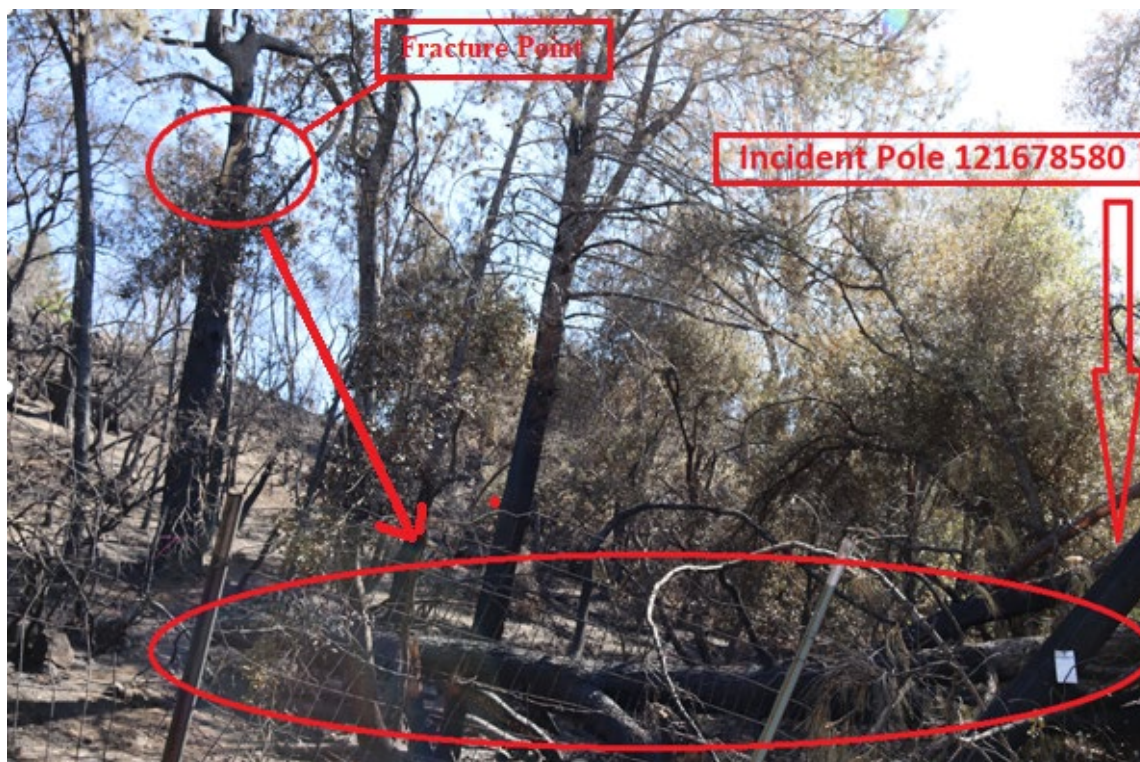
Figure 2: Fractured Subject Tree and Incident Pole 121678580.²

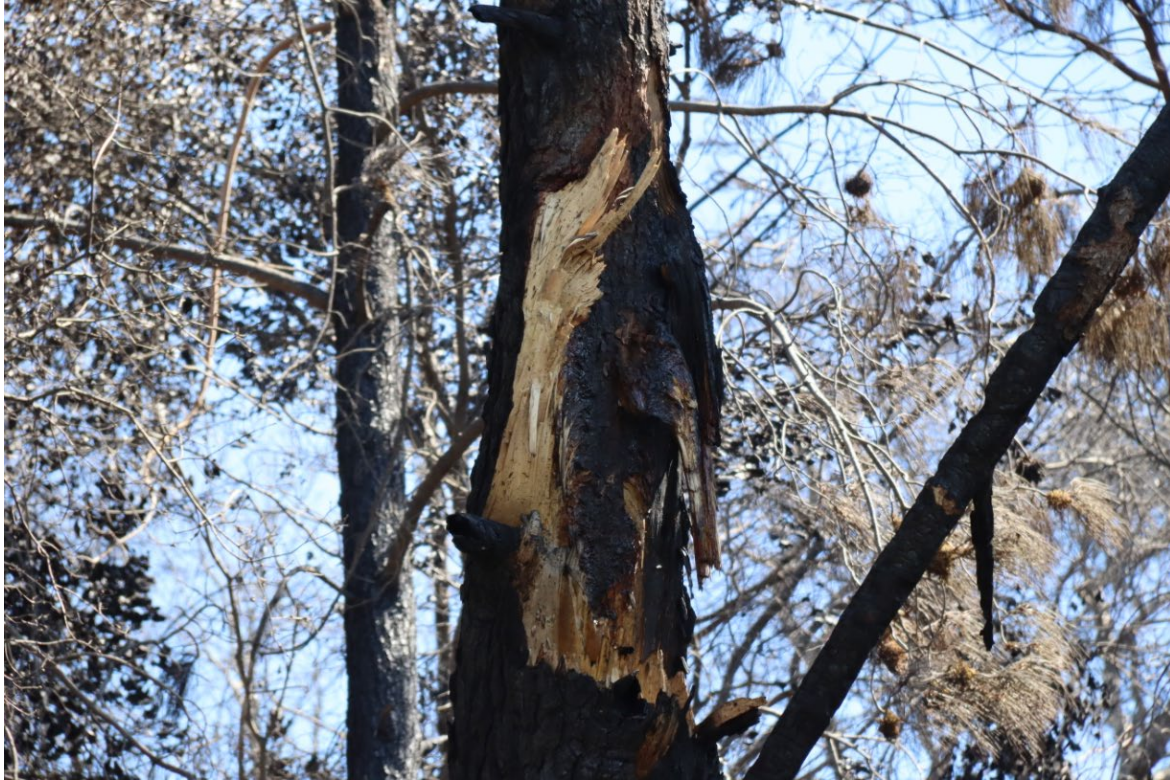
Figure 3: Close up view of the fracture point on the Subject Tree.⁷

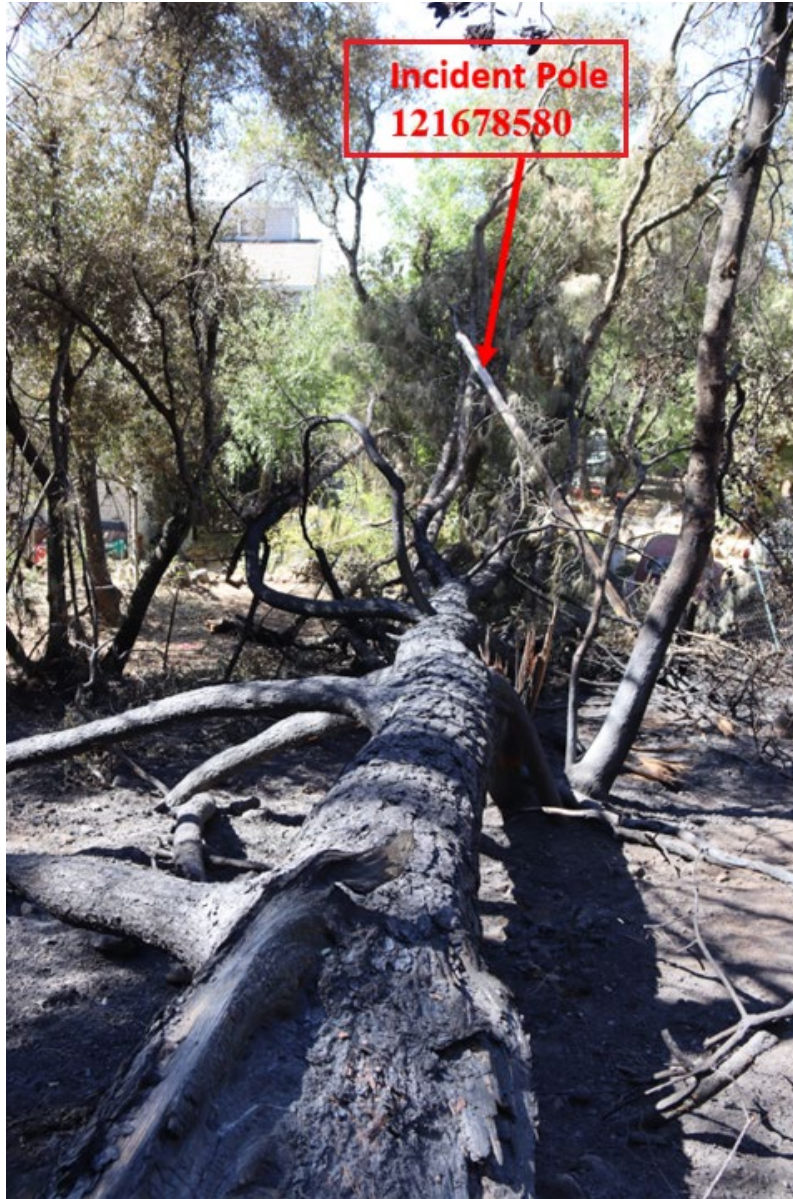
Figure 4: Southern view of the fractured Subject Tree limb and Incident Pole 121678580.⁹

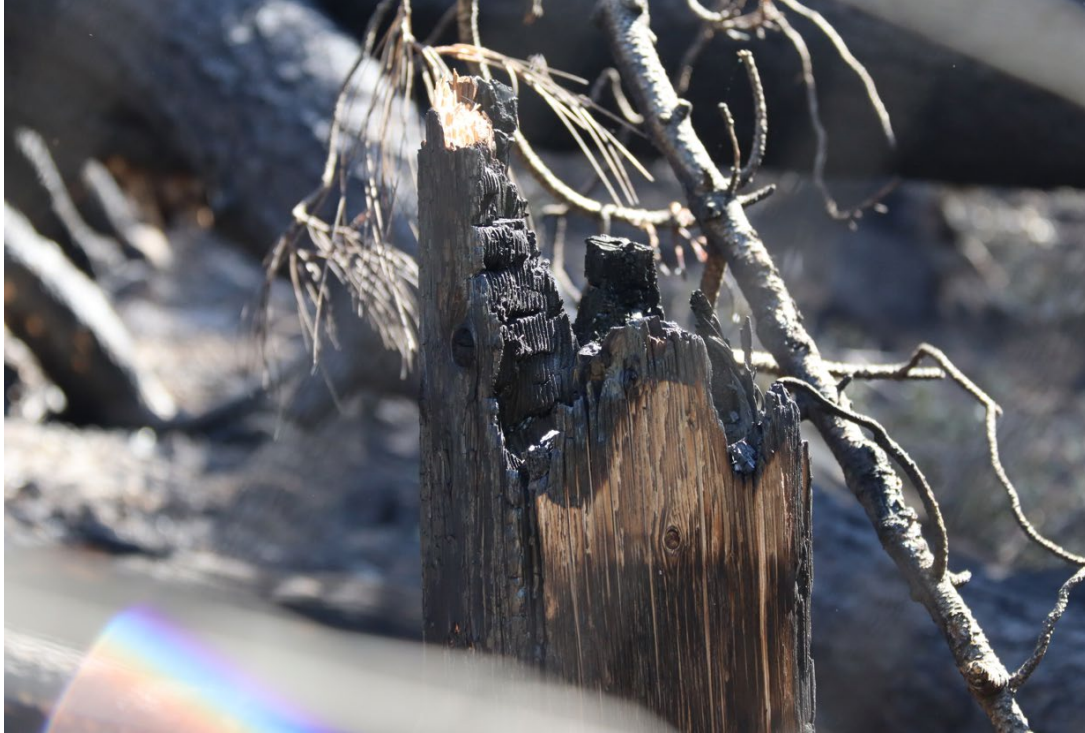
Figure 5: Stump of Incident Pole 121678580.¹⁰

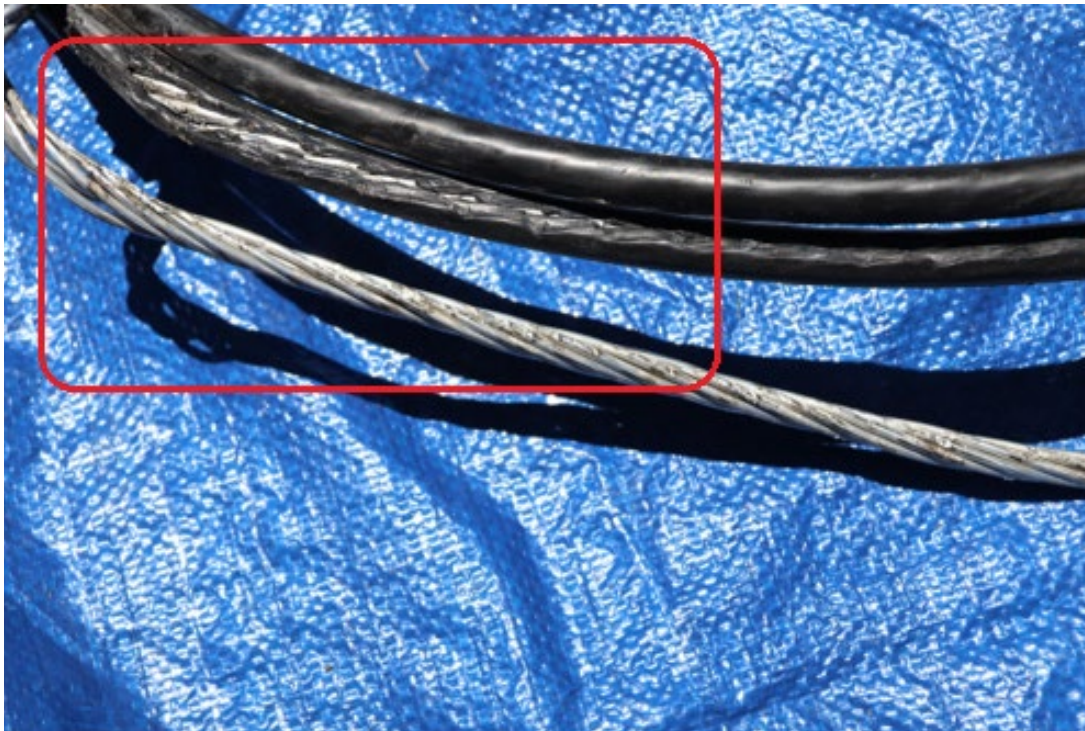
Figure 6: Secondary service drop conductor from Incident Pole 121678580 and messenger cable showing several arc damage areas on both cables.¹¹

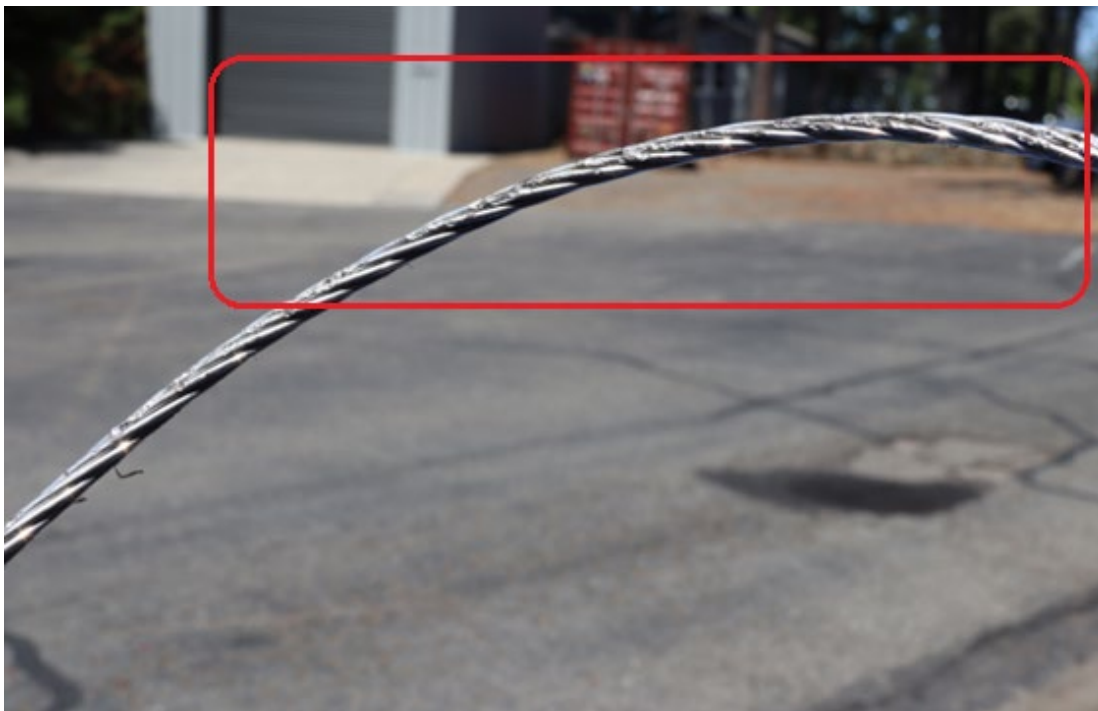
Figure 8: Messenger cable from Incident Pole 121678580 showing signs of arc damage.¹³

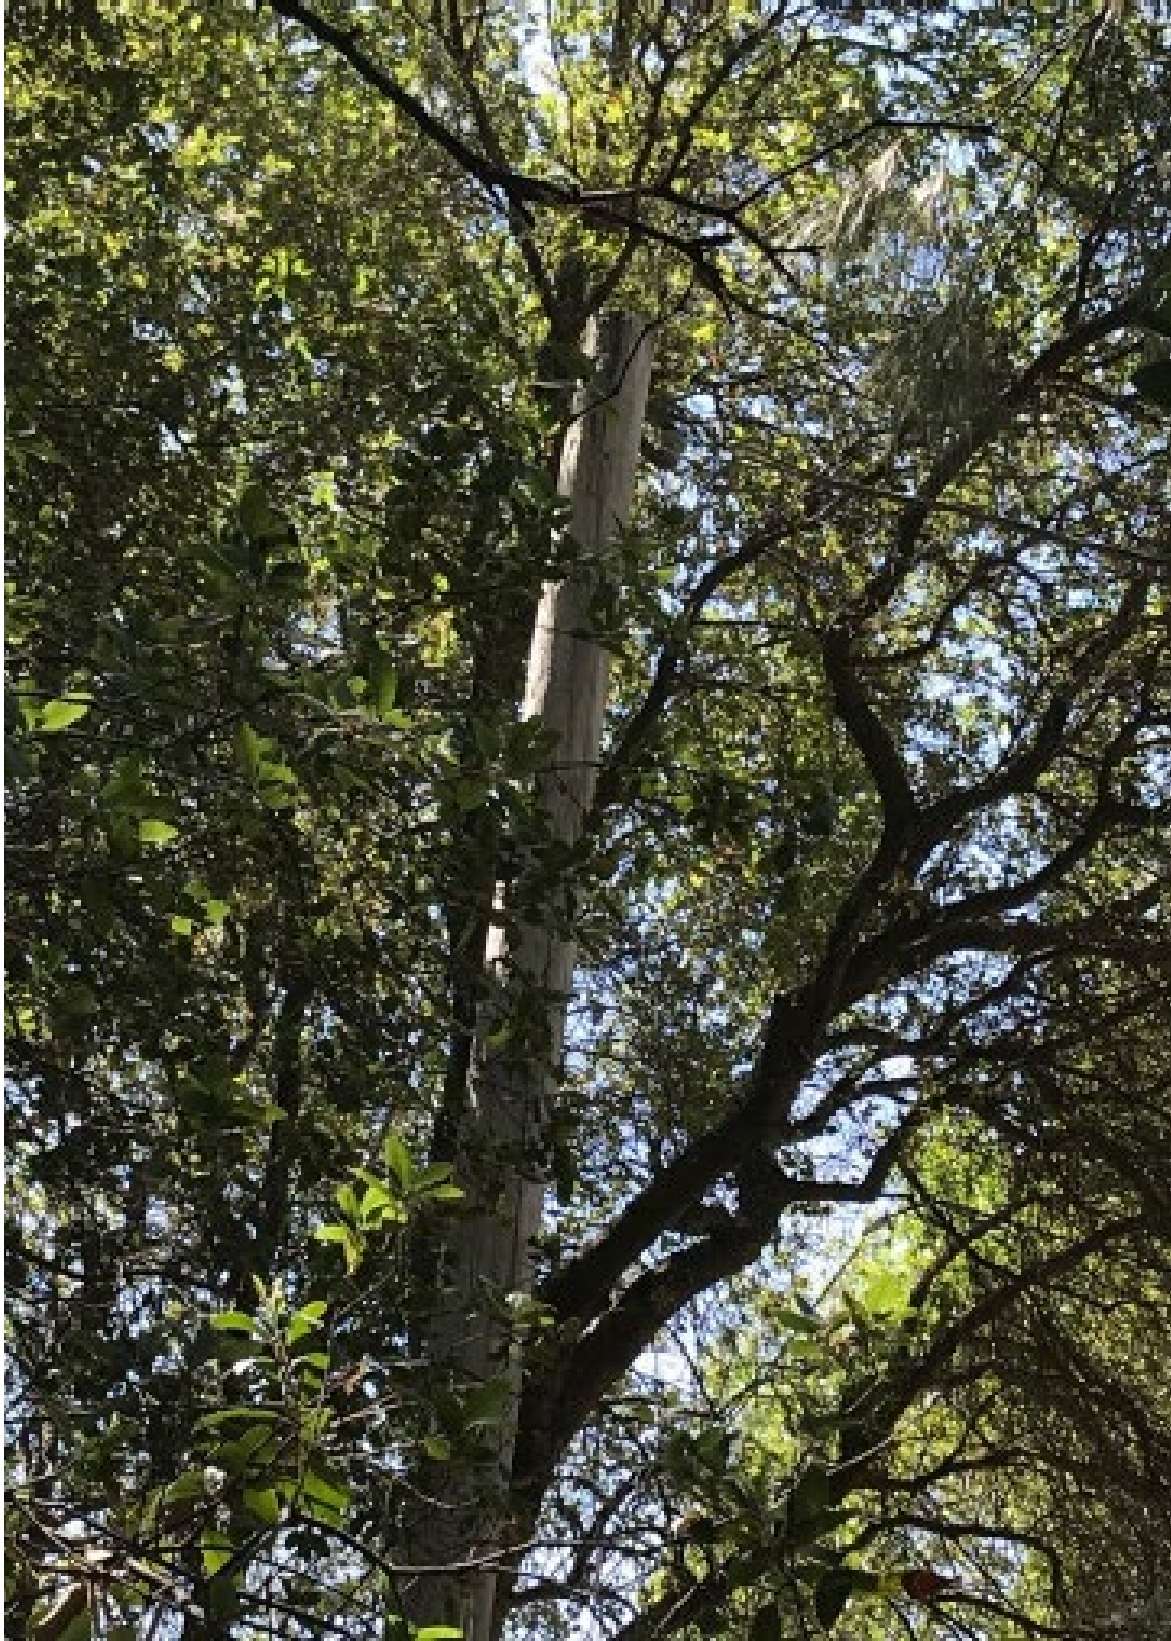
Figure 9: PG&E's May 8, 2021 detailed inspection showing immediate abrasion from a nearby tree on the Incident Pole.
