# Mammoth Lakes Incident Investigation Report

SAFETY AND ENFORCEMENT DIVISION  
GAS SAFETY AND RELIABILITY BRANCH

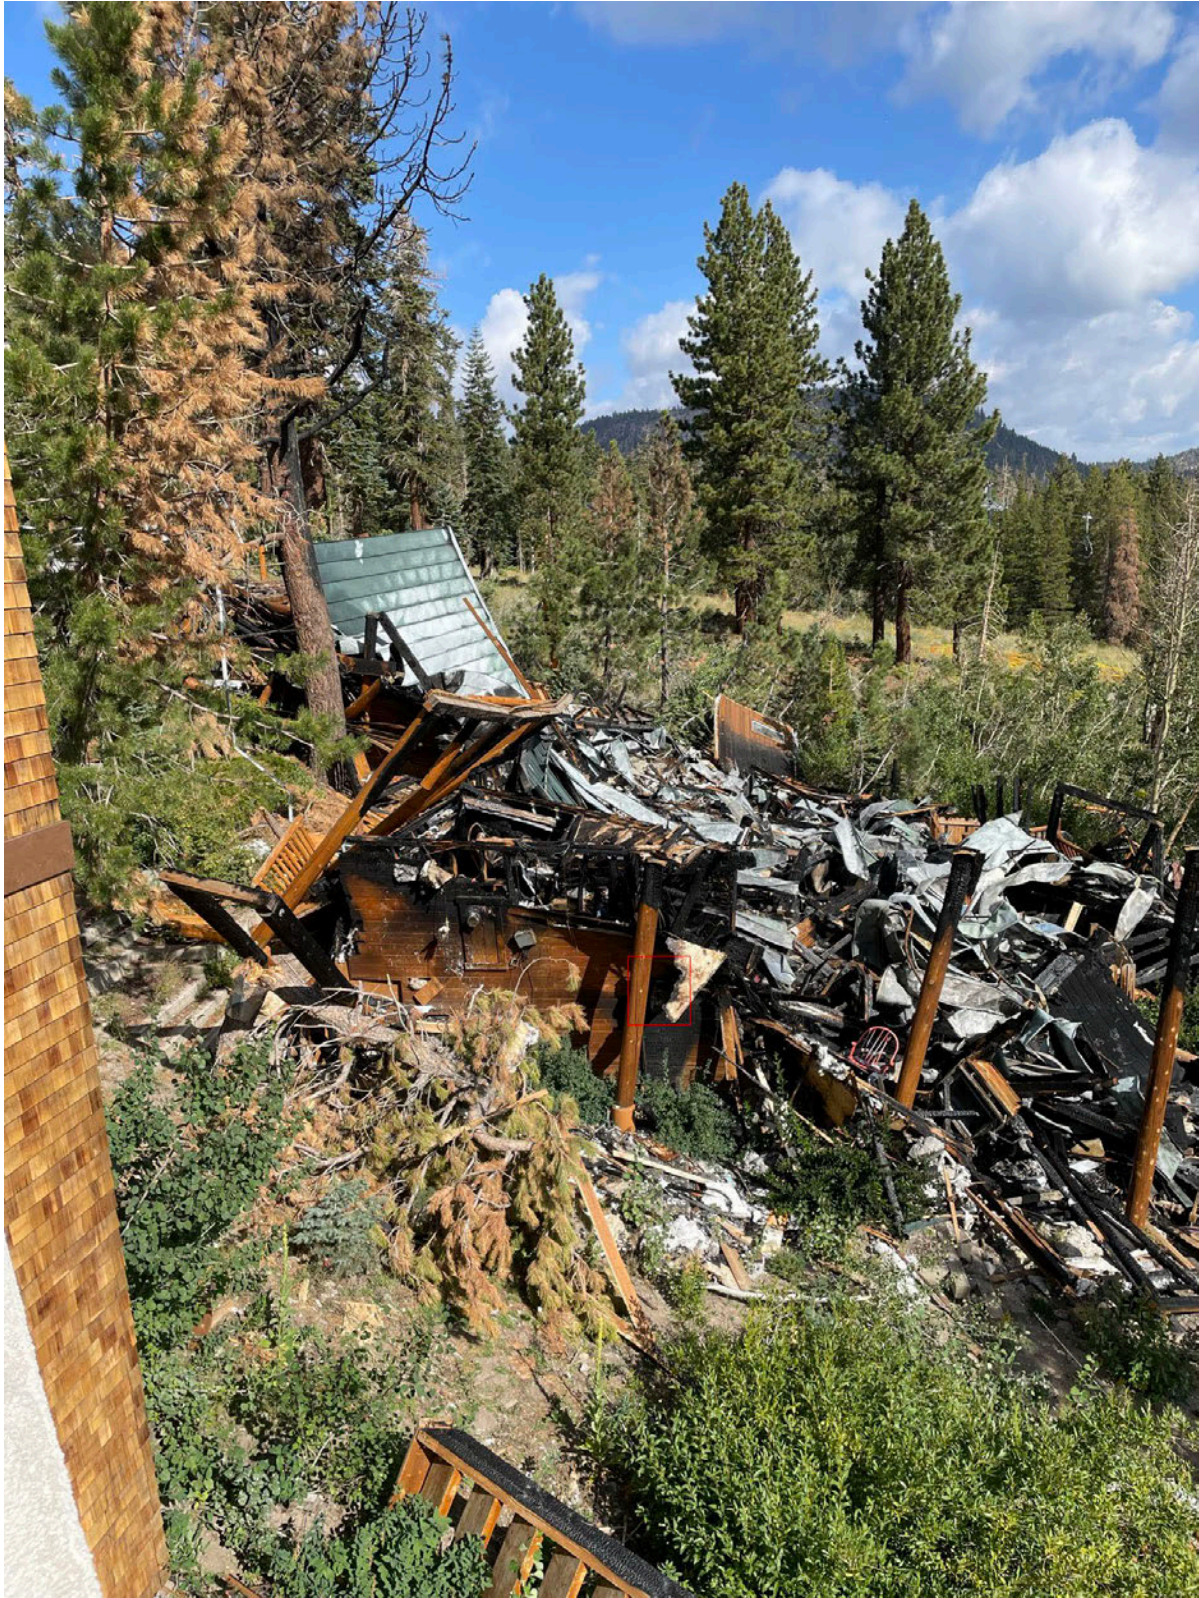
Figure 4. Incident site taken from the south on 9/21/23. Customer service meter was found behind a wooden beam still attached to the exterior of the home, marked by the red square.

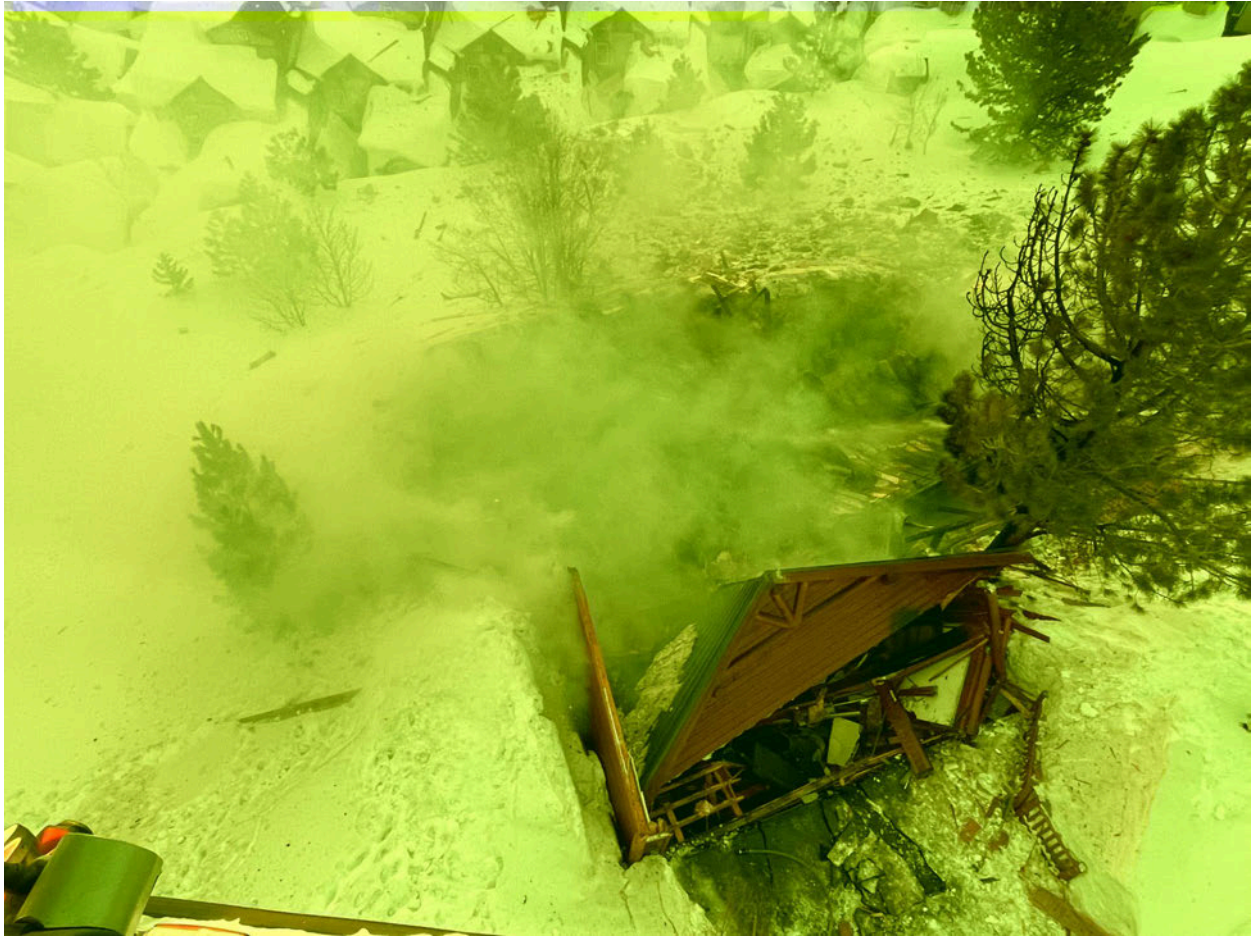
Figure 5. Aerial photo taken of the incident site from the west on 4/1/23. Debris on rooftop in the background is approximately 150 feet from center of incident site.
