L-406 Crimea St Fire Road Incident Investigation Report

CPUC - SAFETY AND ENFORCEMENT DIVISION GAS SAFETY AND RELIABILITY BRANCH

Event Date: March 24, 2024 DOT No. 1394795 CPUC SED No. G20240324-3678 SoCalGas No. 240323-15720

SOCALGAS INCIDENT CRIMEA STREET FIRE RD, VENTURA INVESTIGATION REPORT

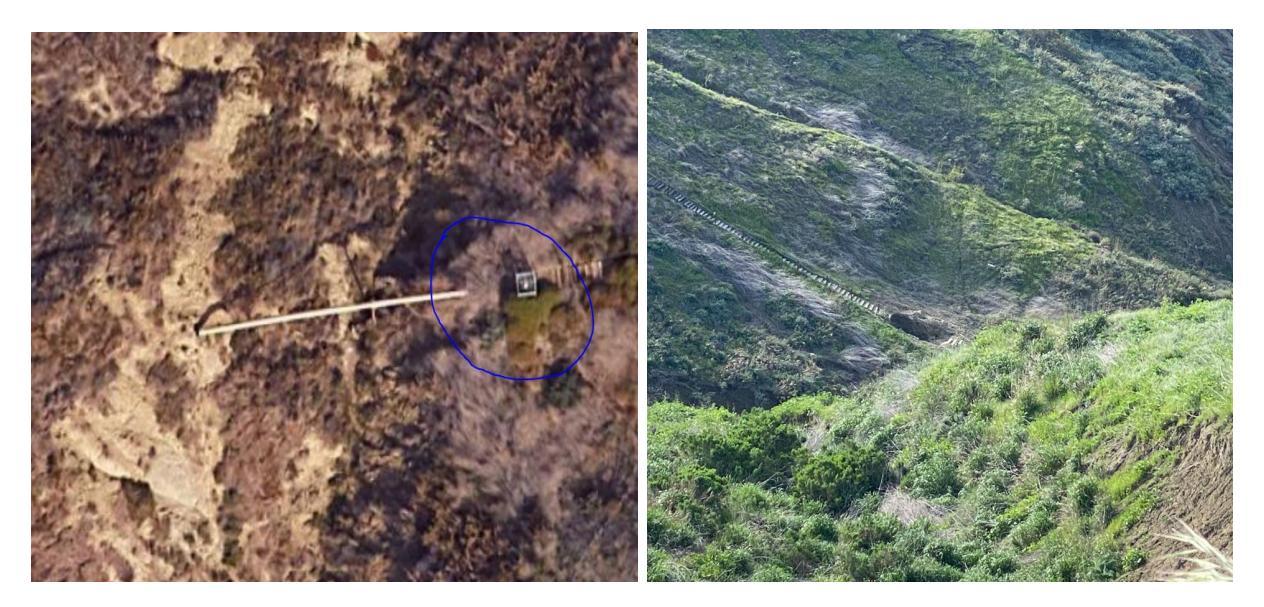
Figure 1. SoCalGas' Transmission Gas Control L-406 Pressure Loss Event

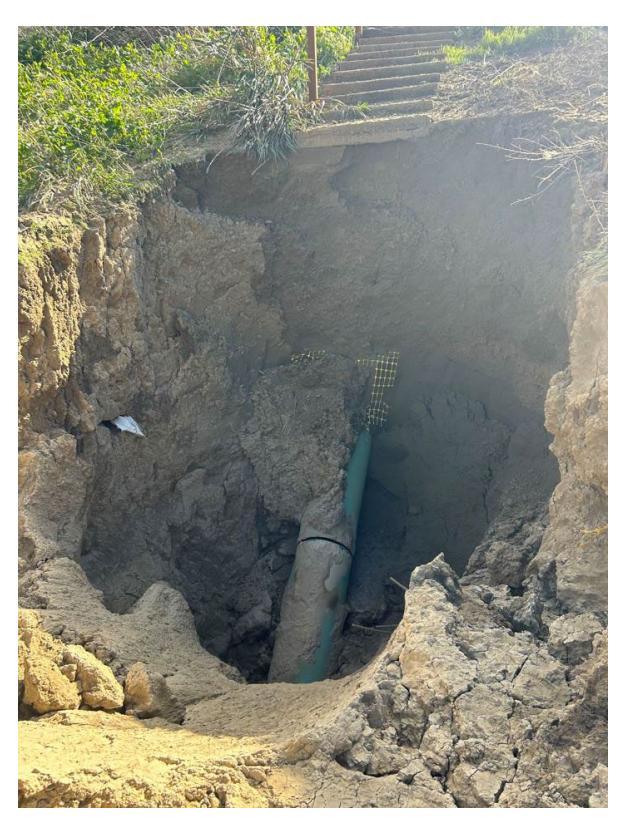
According to SoCalGas records, a leak was assessed by SoCalGas on L-406 through instrument notifications, remote visual observation and by drone. L-406 was visually assessed to be horizontally separated at the arroyo span mudslide area. SoCalGas-provided data responses on May 1, 2024, showing ariel drone photos of the affected site. A photo of the 22-inch L-406 shows the pipeline resting in a washed-out, dried mud hole and separated horizontally at an existing coated girth-weld.

Figure 2. L-406 arroyo span mudslide incident site

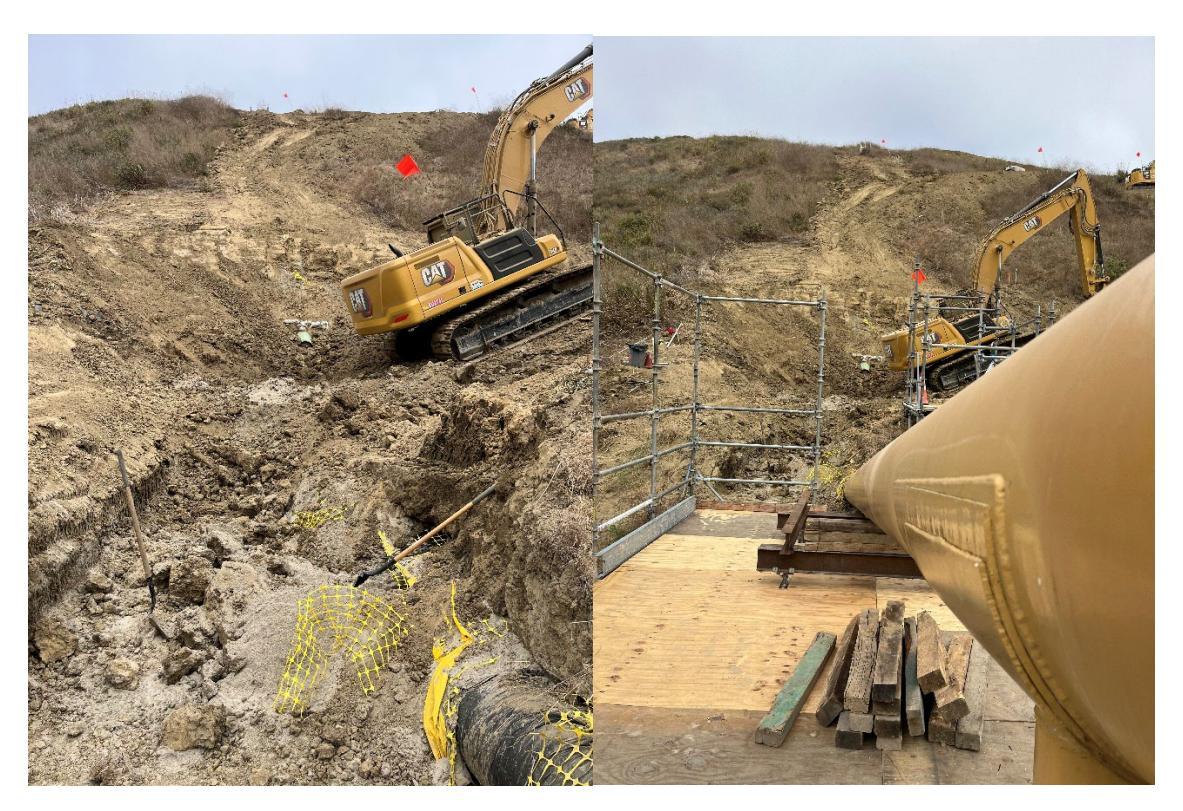
Figure 4. Partially excavated L-406 at arroyo span mudslide location and separated 22-inch pipe

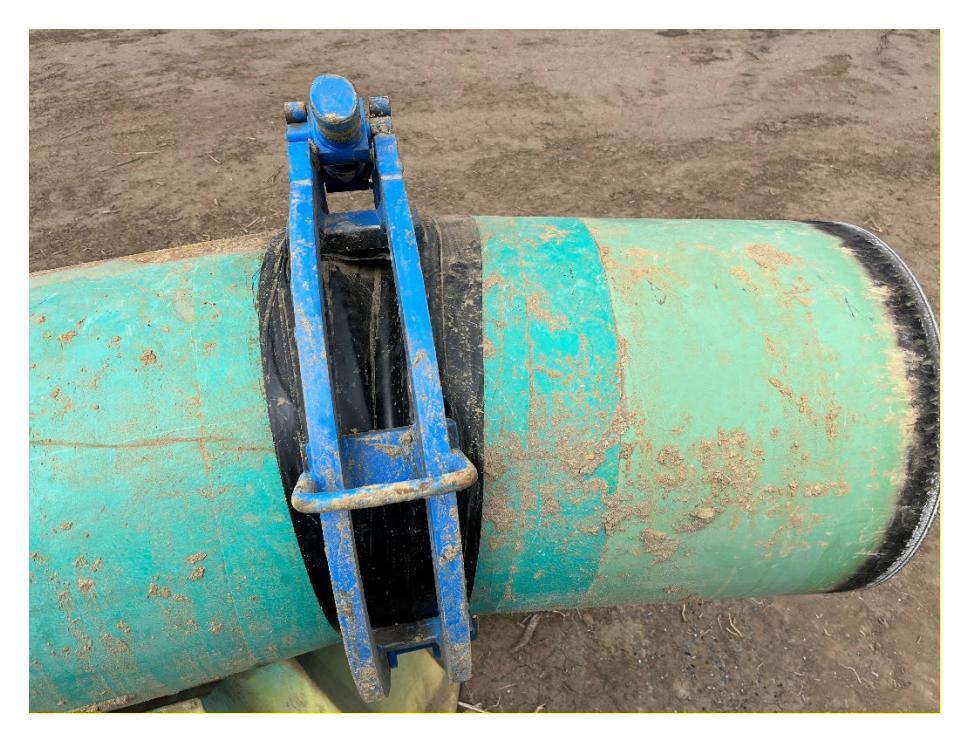
Figure 5. Extracted L-406 22-inch pipe segments at weld separation

Based on SED investigation, the failure of L-406 was the result of soil movement (natural force) which caused excessive axial loading leading to the failure at the girth weld. Area topography, soil type and large amounts of rain (atmospheric river) over the preceding months saturated and vertically eroded the soil on the side of the hill above the pipeline. In addition, Based on California Department of Conservation, California Landslides Database, the area where the landslide occurred, did not experience any landslide events in the past five (5) years (unknown geohazard site). Therefore, SED did not find any GO 112-F, Reference 49 CFR, Parts 191 & 192 violations by SoCalGas.

On August 28, 2024, SED conducted a field investigation and met with SoCalGas' representative at the site. On August 24, 2024, SoCalGas had cut out the section of pipe removed it and staged it at a lay-down construction yard and SED took photos of the damaged section of pipe that had been separated at the weld. SED took incident site pictures of pipeline the landslide area and took field measurements of the arroyo pipeline span adjacent to the incident site. SoCalGas stated that it is planning to have the damaged section and welds tested with lab analysis of material involved in incident. As of the date of this report, the sections of failed pipes and failed weld have not been analyzed.

SoCalGas should conduct a post-incident investigation including sending the failed section of L-406 to a laboratory for testing and examination to determine the causes and contributing factor(s) of the failure, minimize the possibility of a recurrence, and share the post-incident investigation result with SED.

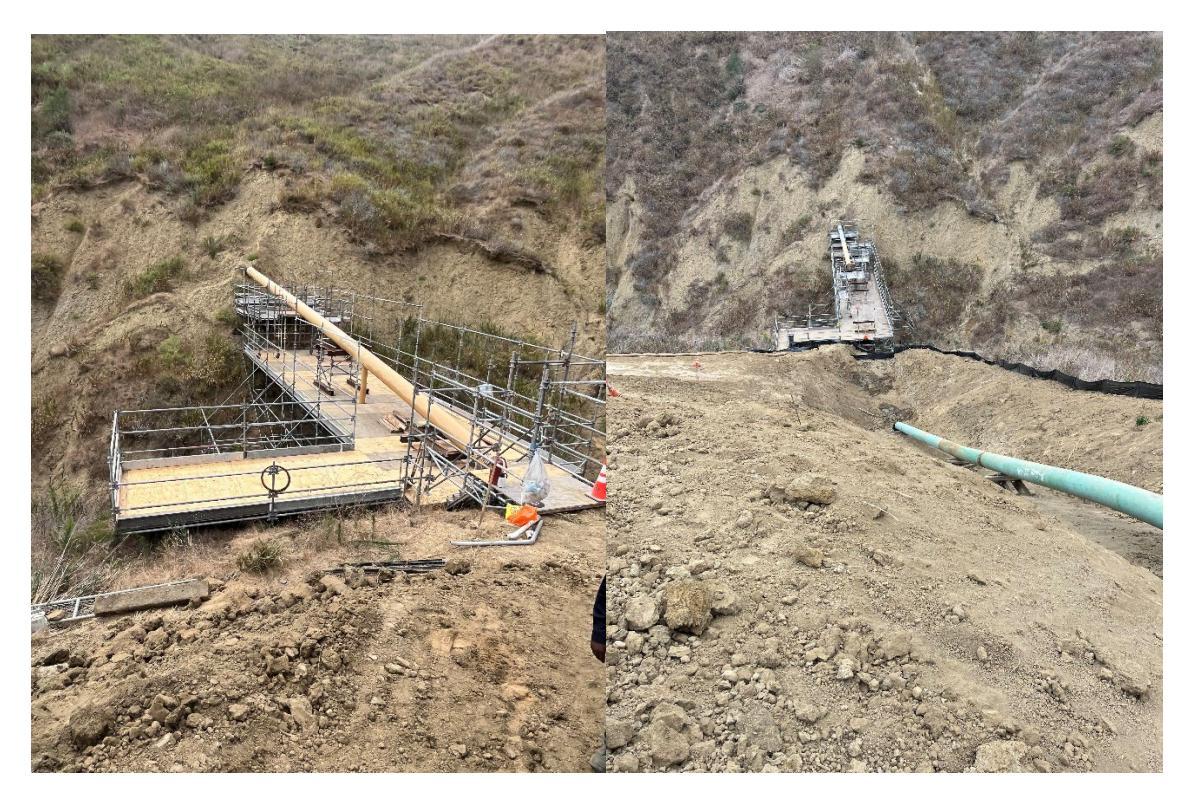
Figure 6. Support scaffolding at L-406 arroyo span and east slope repair segment

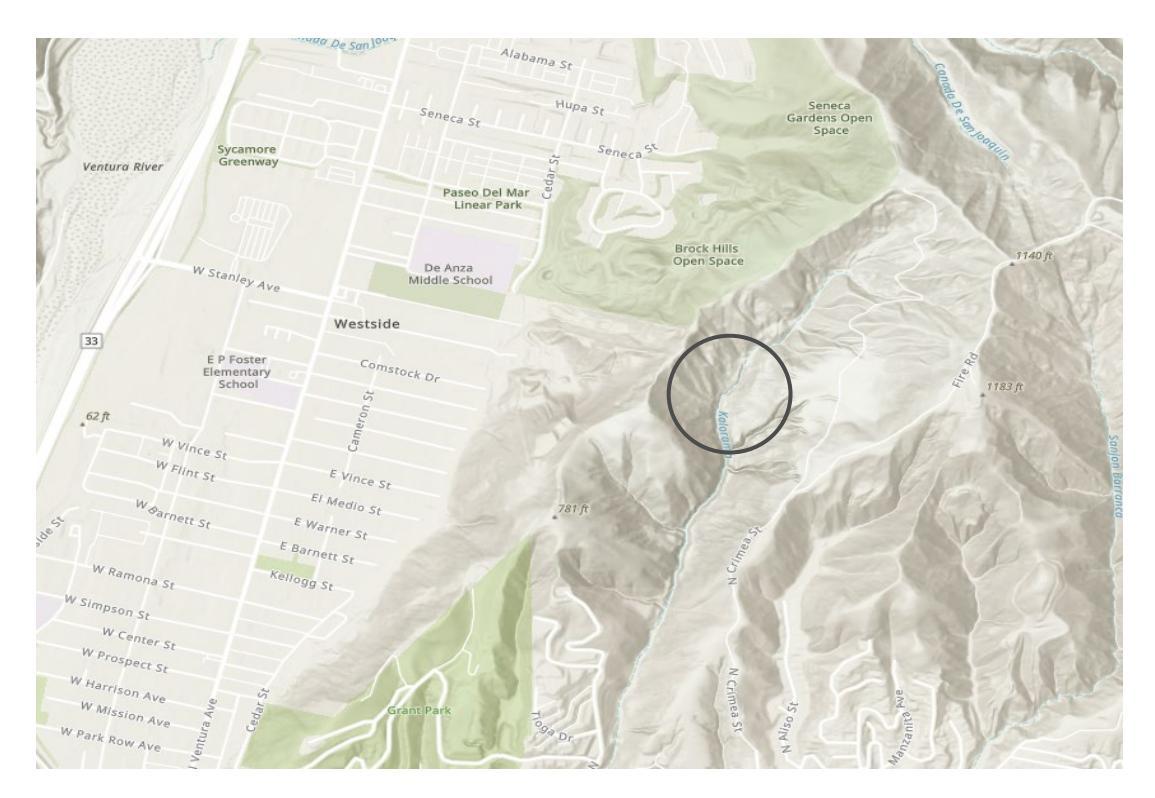
Figure 7. Kalorama Wash, California Department of Conservation, Historical Landslides [C4]

February 2024 precipitation reached more than 13 inches [C3], almost 400% more monthly precipitation than normal. Subsequent rains in February and March of 2024 exceeded 100% of area average annual rainfall [C.3], further saturating Ventura area foothill soils. A mudslides and washouts occurred and affected SoCalGas transmission pipeline span L406 crossing Kalorama Wash, an arroyo near Crimea Street Fire Road, near Ventura, Ventura County California.

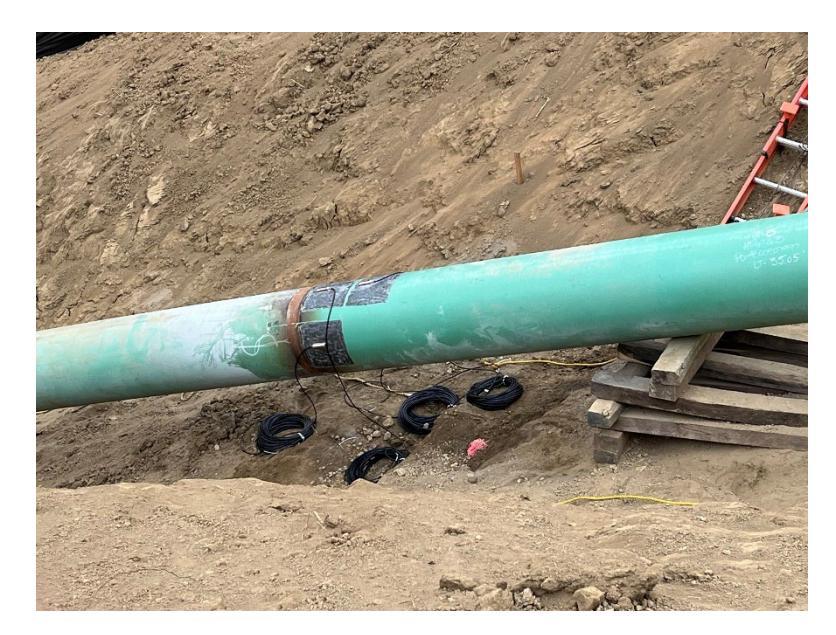
Figure 8. Kalorama Wash, California - steel strain sensors devices installed

SoCalGas' contractor Geosyntec installed stainless steel strain sensors devices on L-406 to monitor the scouring or movement of the soil surrounding the pipeline or movement of the pipeline and to take prompt remedial action to ensure the safe operation of L-406. Furthermore, SoCalGas will follow 49 CFR 192 § 192.613 – Continuing surveillance to conduct compliance inspection of its facilities following an extreme weather event or natural disaster that has the likelihood of damaging to SoCalGas' pipeline facilities and to mitigate the unsafe conditions in the pipeline right-of-way.

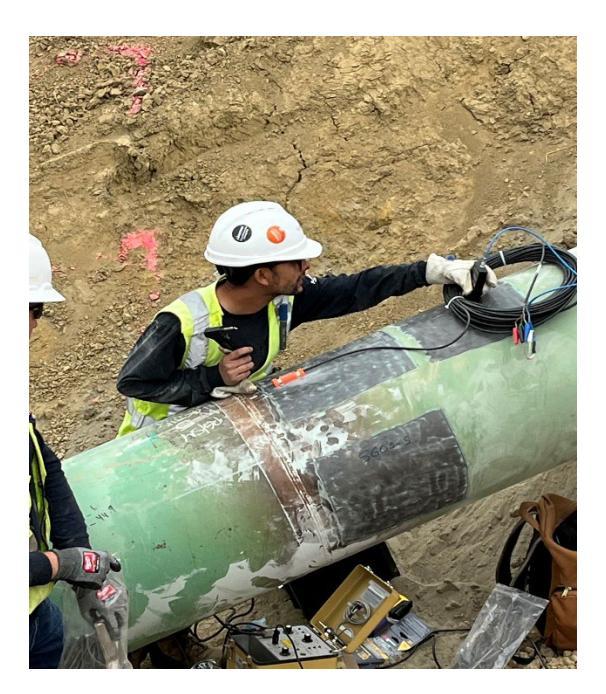
Figure 8. Kalorama Wash, California - steel strain sensors device soldering and testing

These sensing devices monitor longitudinal strain on the pipeline which is in the pathway of potentially high natural forces. These sensors are soldered to pipe joints and connected with communication cables.
