## CALIFORNIA PUBLIC UTILITIES COMMISSION Safety and Enforcement Division Wildfire Safety and Enforcement Branch

#### **Incident Investigation Report**

Incident Number: E20220622-01 (Edgewood Fire)

**Regulated Utility Involved:** Pacific Gas and Electric Company (PG&E)

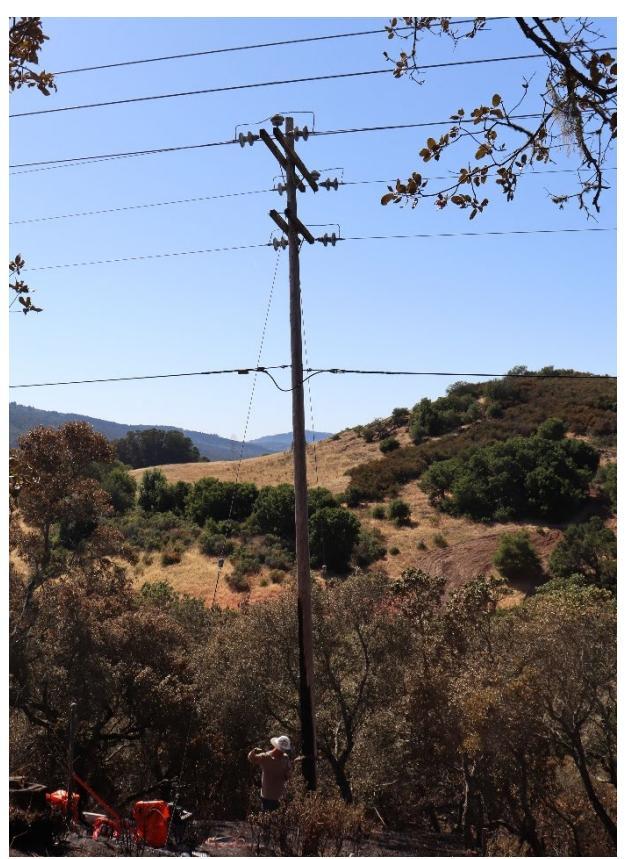
CAL FIRE led SED down the hill to the Incident Pole shown in Figure 2 below. Upon initial inspection of the Incident Pole, SED observed that the transmission line was hanging very low and appeared damaged directly above the high point of the distribution circuit on the Incident Pole (see Figure 3 below). The high point of the distribution line was a jumper cable supported by a vertical insulator on the south phase. SED observed that the jumper cable was broken at the point of the vertical insulator. In addition, visible flashing on the vertical insulator implied that the transmission conductor and distribution jumper cable likely came in close enough contact to cause an electrical arc.

Figure 2: Incident Pole supporting a distribution line with a transmission line visible above.

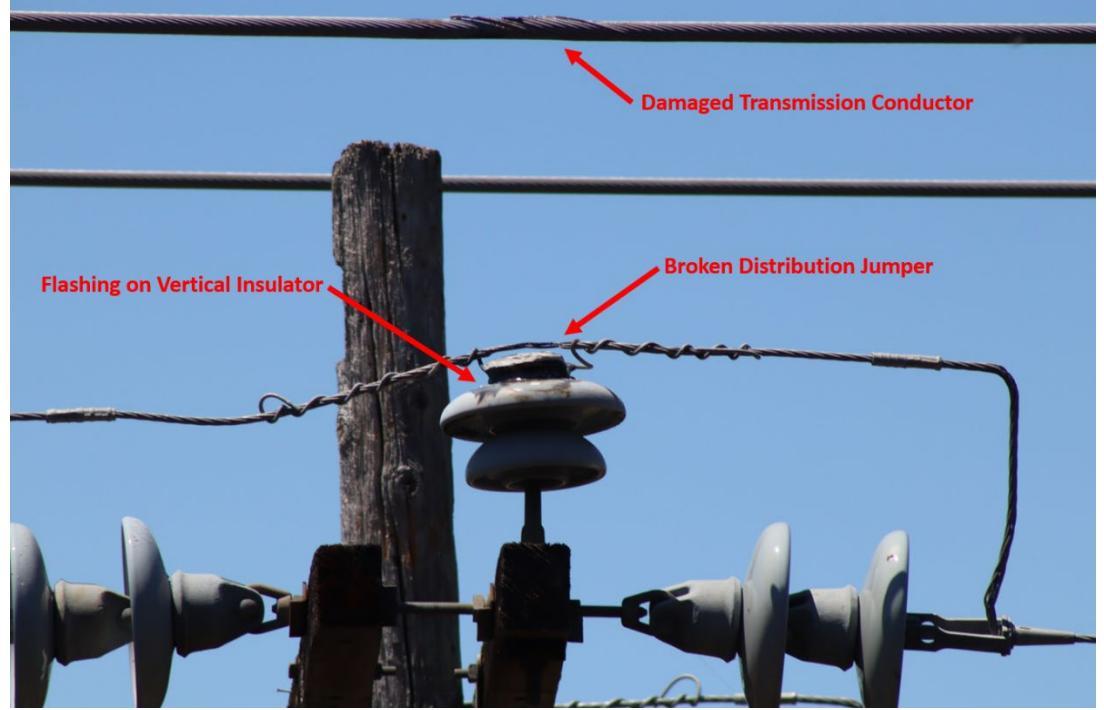
Figure 3: Top of the Incident Pole showing a damaged transmission conductor and a broken distribution jumper.

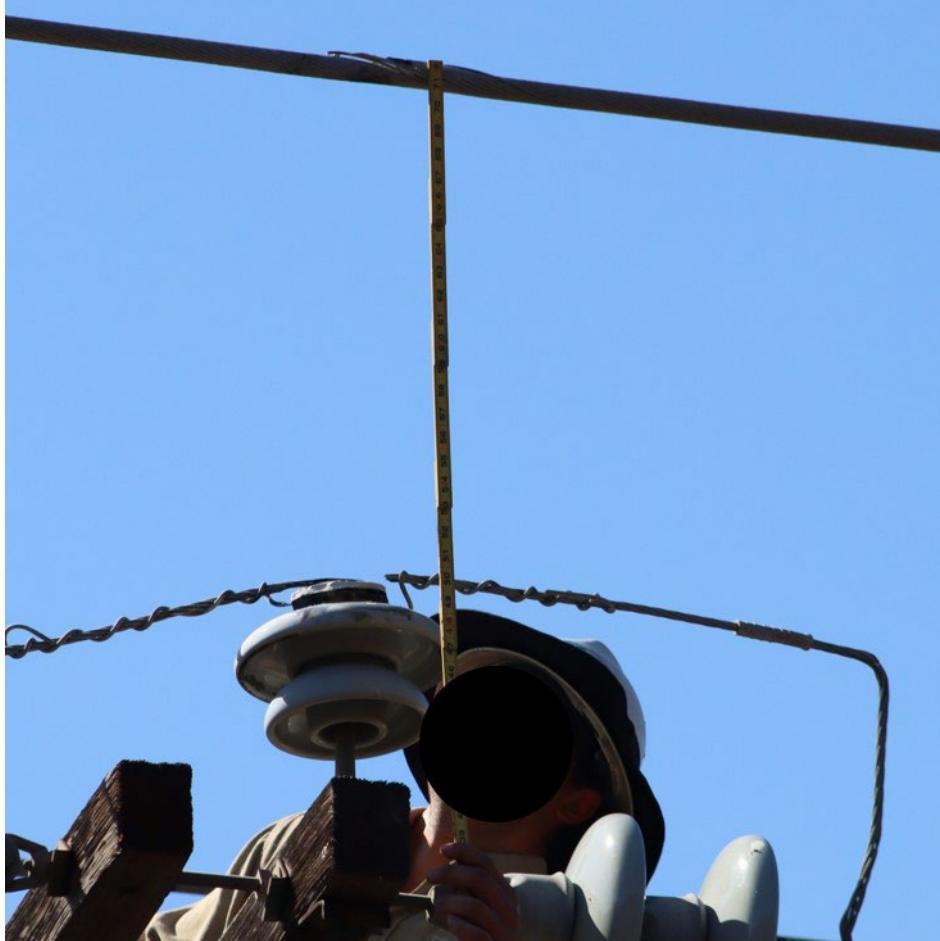
When PG&E joined CAL FIRE and SED, CAL FIRE informed the utility that they would be collecting evidence prior to the utility being able to repair and restore power. PG&E's priority for repair work was to repair the transmission line which served **Section 1**. Before removing the evidence for CAL FIRE, the utility took measurements of the conductors in place, shown in **Figure 4** below. The distance between the transmission line, and distribution line jumper on the south phase was 23.5 inches. The distance between the transmission line and distribution line jumper on the north phase was 36.5 inches. The PG&E Transmission Foreman acknowledged that GO 95, Rule 38 required a minimum distance of 96 inches between 60kV and 4.2kV power lines. The measurements taken were "in situ." To SED's knowledge, the measurements taken reflect the distances between the lines prior to the fire's ignition. PG&E also measured the distance from the ground to the south phase transmission line at 40 feet 0 inches, and the distance from the ground to the south phase distribution line at 36 feet 5 inches.

Figure 4: PG&E Lineman measuring the distance between a transmission line and a distribution jumper cable, which reportedly measured 23.5 inches.
