Re: Response to Notice of Gas Incident Probable Violations by Pacific Gas and Electric Company (PG&E) – Department of Transportation (DOT) Incident # 1314710

This letter is in response to the Safety and Enforcement Division's (SED) letter dated May 9, 2022 regarding a DOT reportable incident (#1314710) that occurred on August 25, 2021 at the intersection of Race St and Park Ave, San Jose.

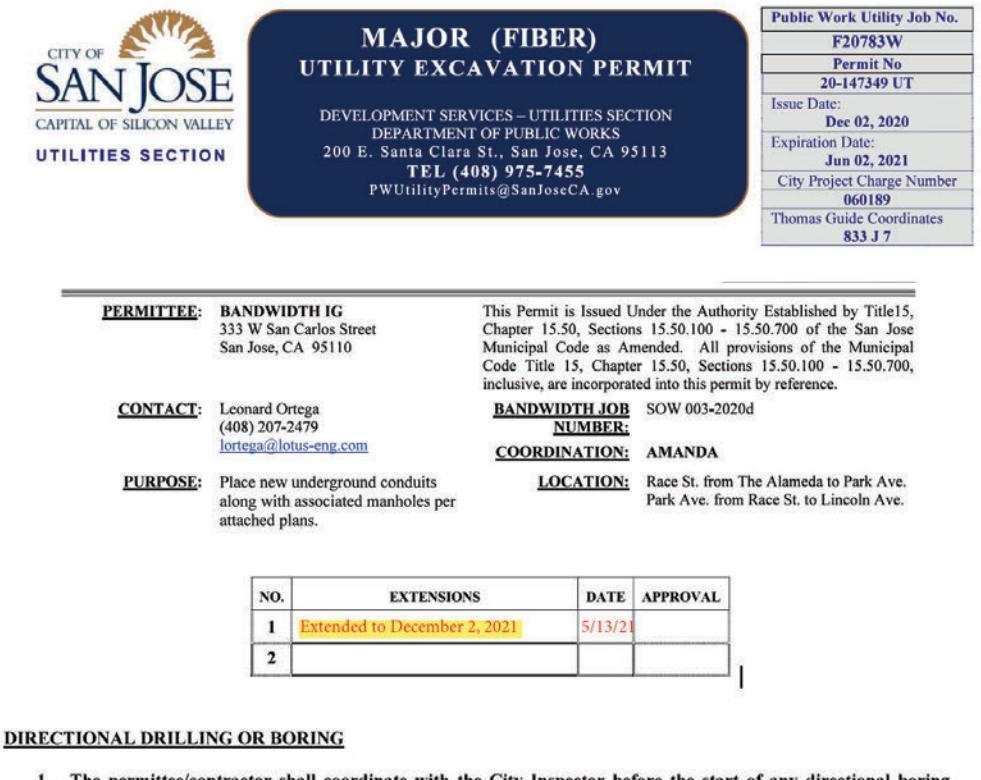
Figure 1. Excerpt of Excavation Permit from City of San Jose

As indicated in the dig-in investigation report that was previously provided, PG&E believes that this incident could have been avoided if the third-party excavator (Lightwave Construction) had exposed the gas facility with hand tools before using power-driven equipment as required by California Government Code 4216.4(a)(1). PG&E's investigation found that Lightwave Construction failed to pothole and visually locate PG&E's adjacent 8-inch main within its tolerance zone and at the location where the horizontal directional drilling (HDD) path crosses this pipeline. The requirement of exposing these pipeline crossings in the HDD path is also in the excavation permit issued by the City of San Jose (see Figure 1 below). Had Lightwave Construction taken this critical step, the subject 3-inch dead-end main may have been exposed along with the 8-inch main, helping to avoid this dig-in incident.

- The permittee/contractor shall coordinate with the City Inspector before the start of <u>anv</u> directional boring operation.
- If these methods are utilized, <u>all</u> utility crossings in the proposed bore alignment shall be potholed and exposed to verify depth prior to commencing with the boring operation. Potholes shall then remain open until the bore has passed the exposed utility to verify that no damage has occurred.
