2011 Audit of Ormond Beach Generating Station

August 2011

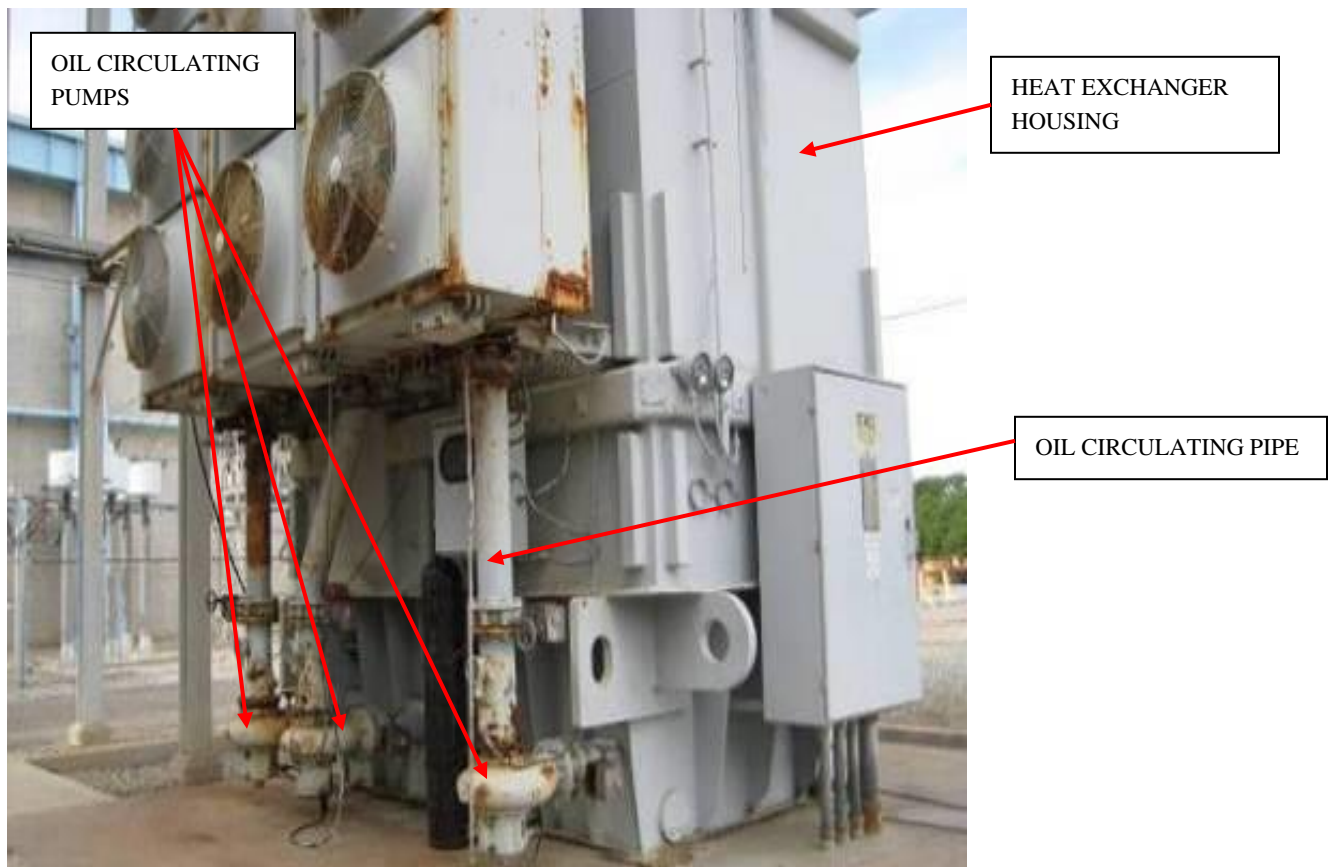
Photo 1: Typical Unit 2 Main Transformer (one for each phase).

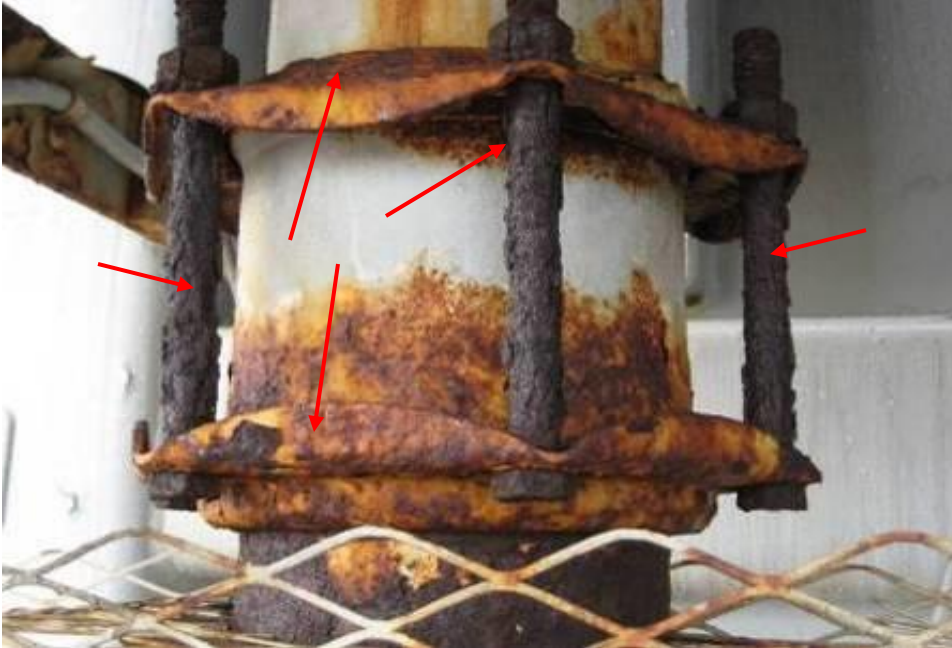
Photo 2: Severe corrosion of flange that connects bolts at lower housing.

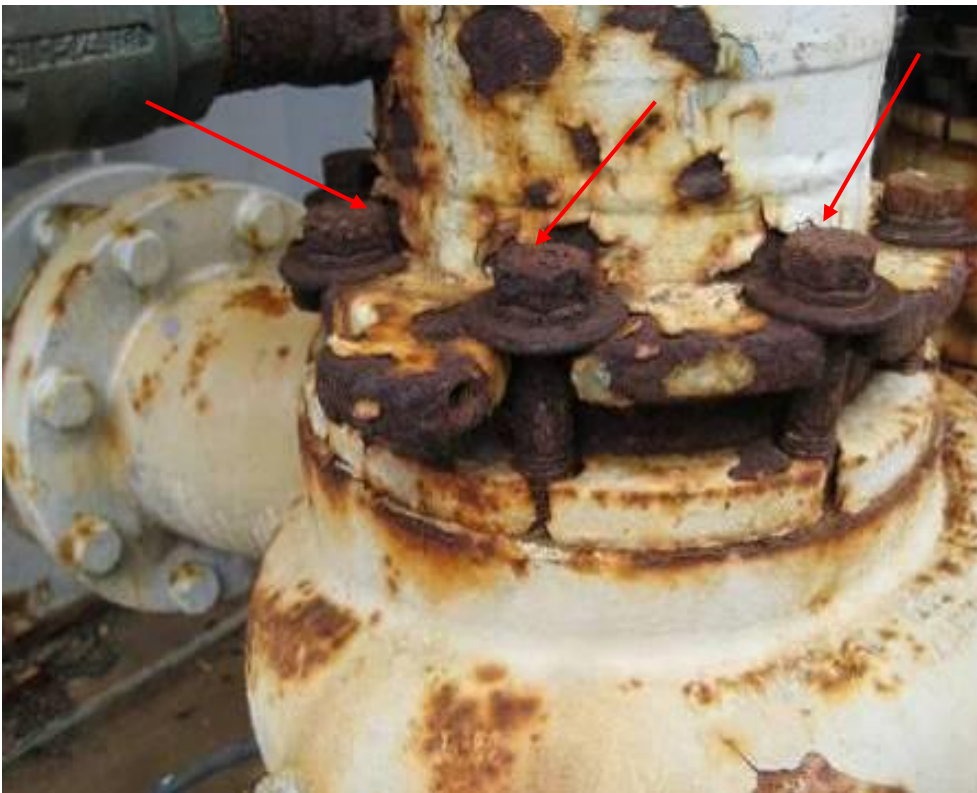
Photo 3: Severe corrosion at circulating oil pump flange bolts.

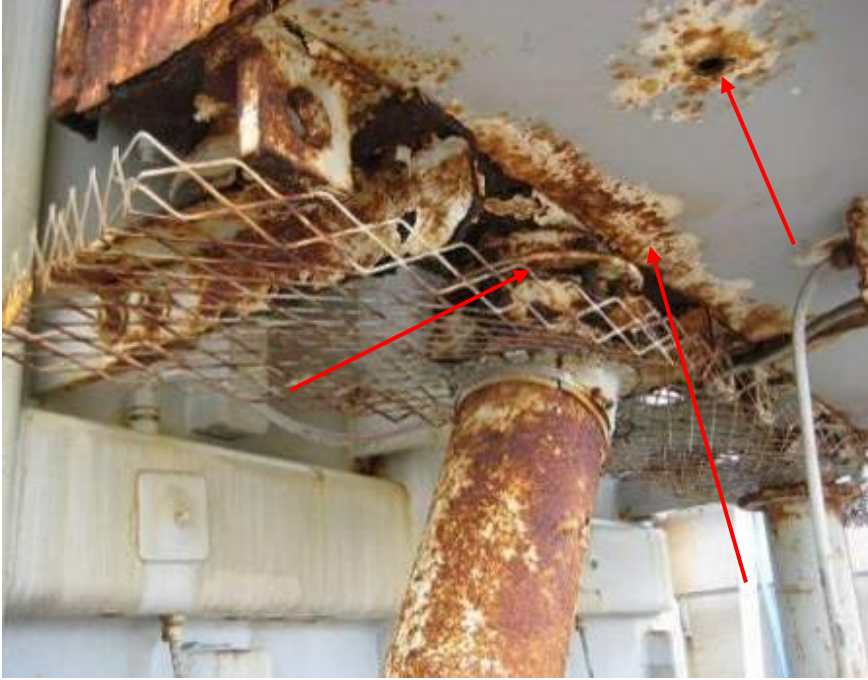
Photo 4: Severe corrosion at lower portion of heat exchanger housing.

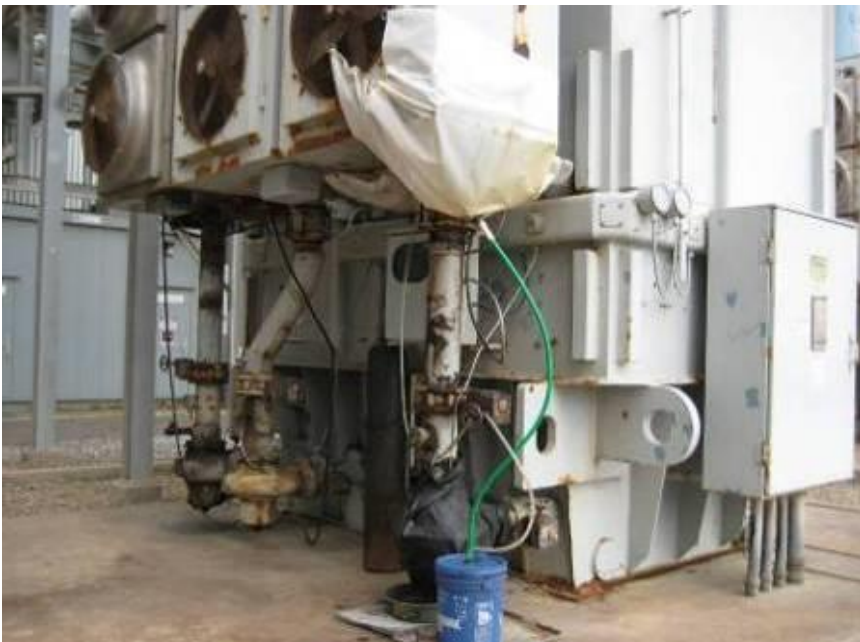
Photo 5: Completed containment mitigations, Unit 2 Phase C transformer.

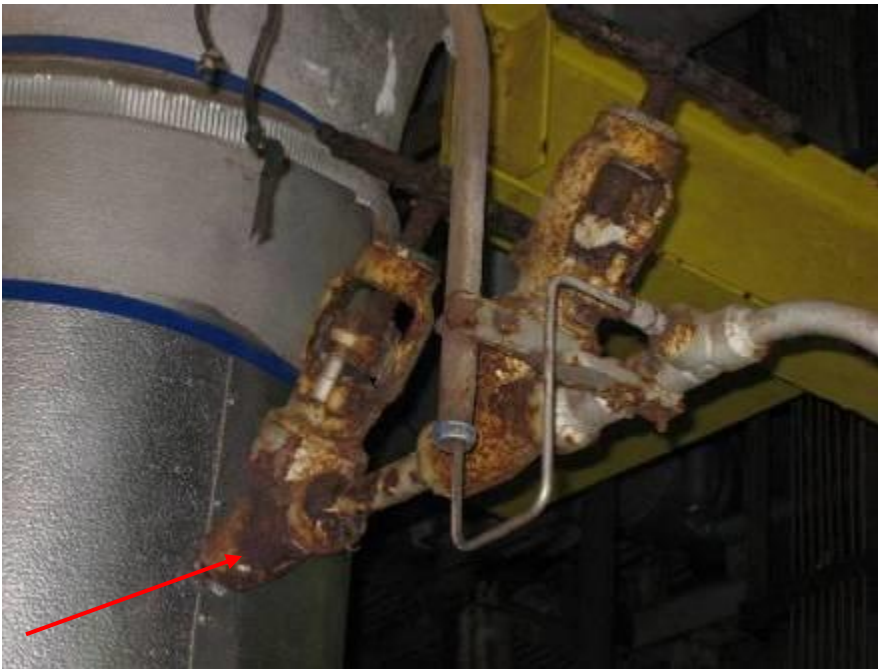
Photo 7: Severely corroded root valve.

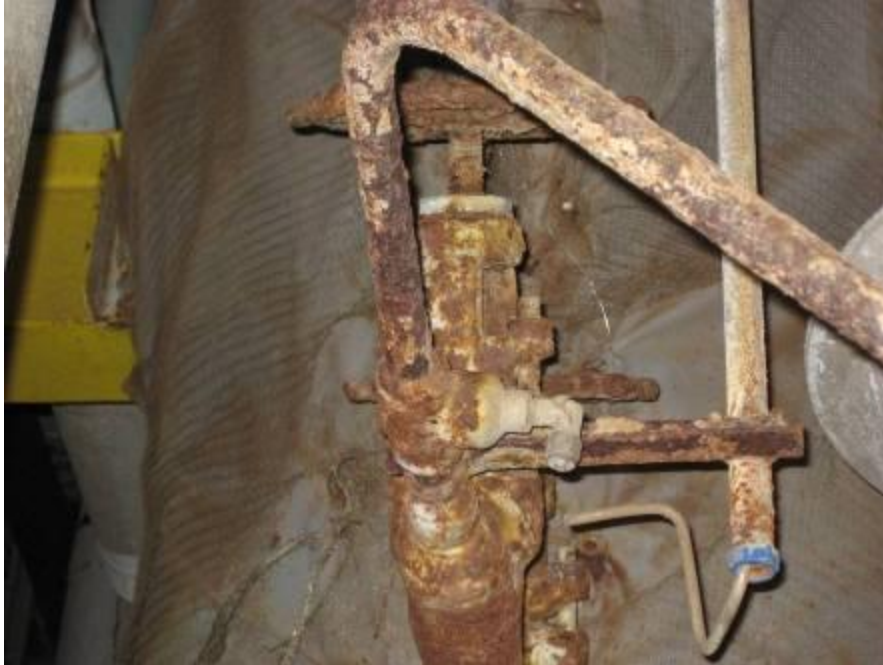
Photo 8: Corroded root valve and piping.

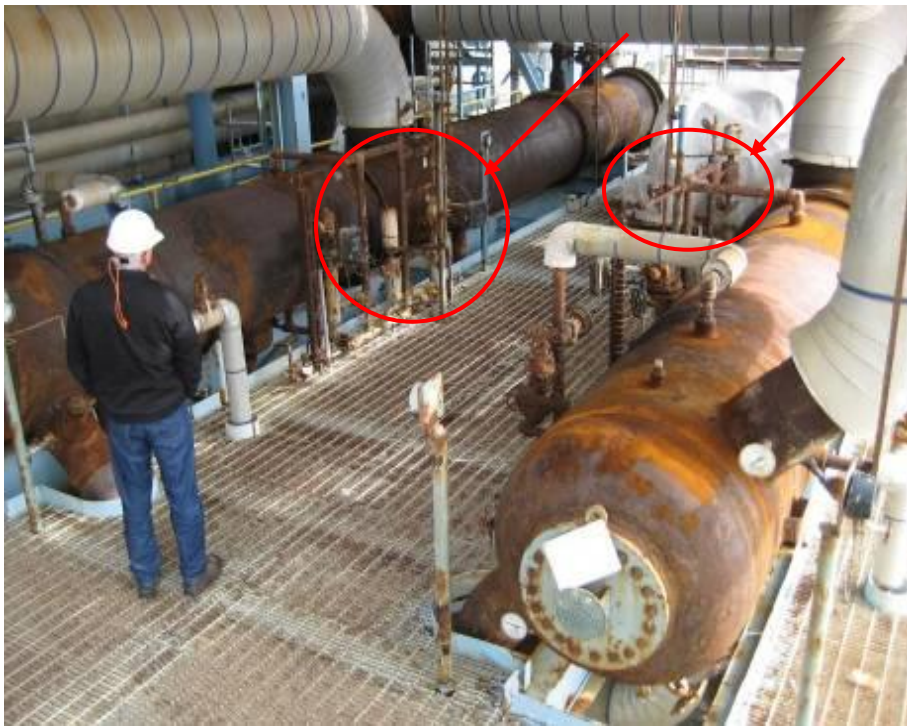
Photo 9: Corroded piping attached to two feedwater heaters

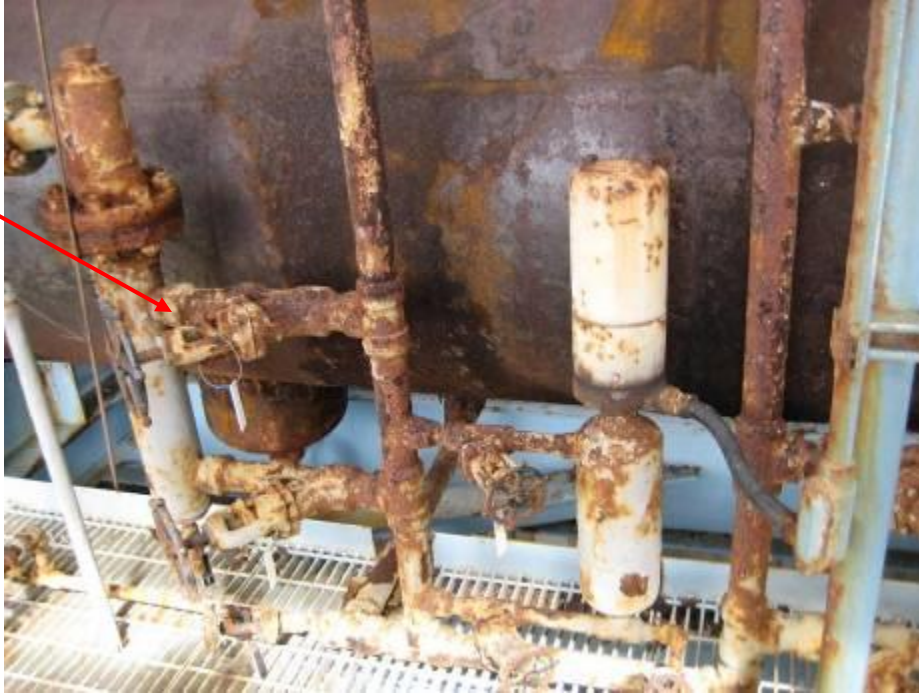
Photo 10: Corroded feedwater pipes.

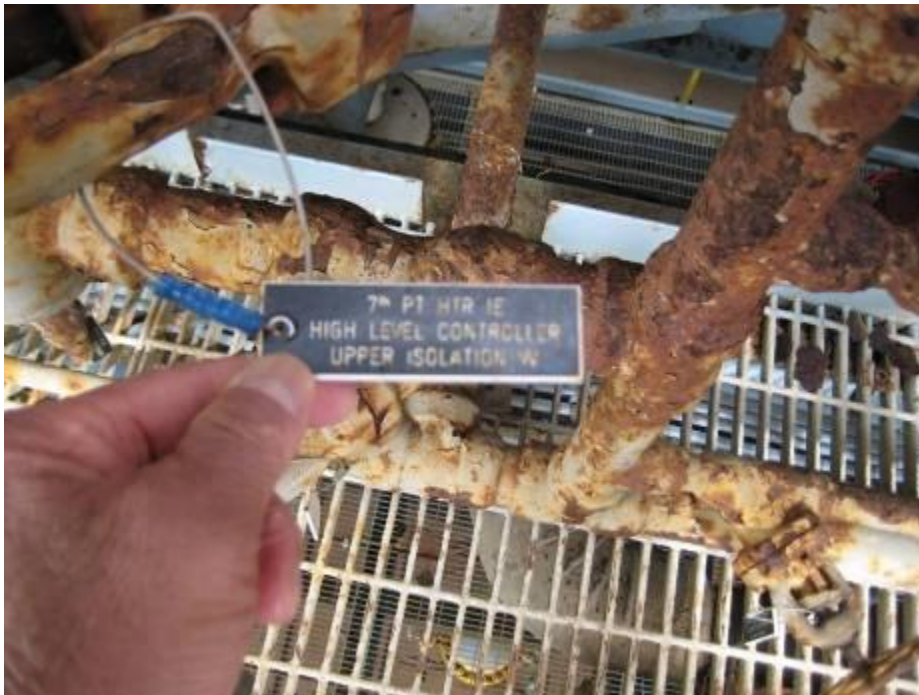
Photo 11: Close-up of corroded pipes.

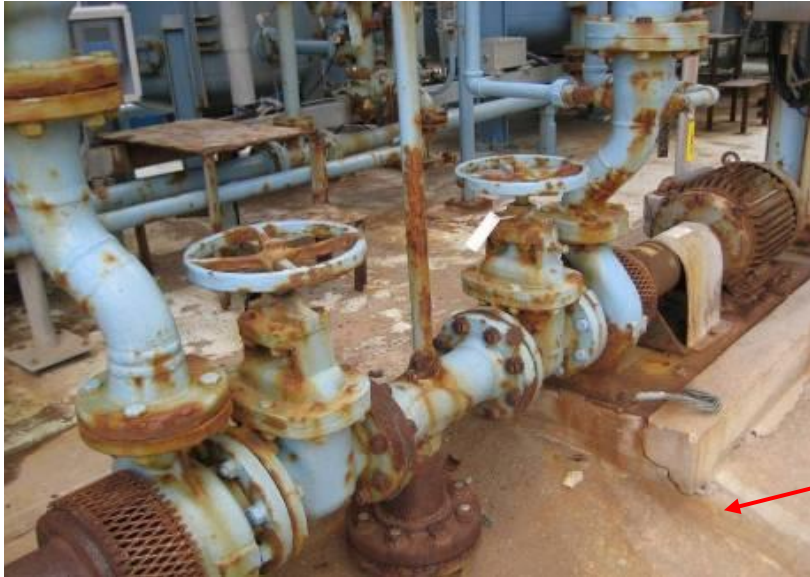
Photo 12: Cracked foundation beneath corroded pump and motor.

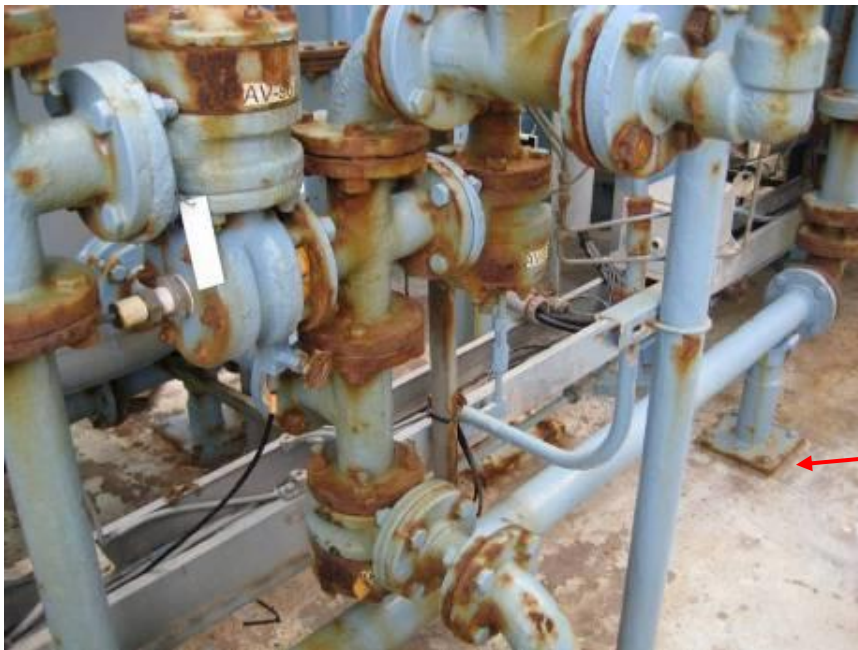
Photo 13: Piping support system; corrosion sheared bolt heads off stems.

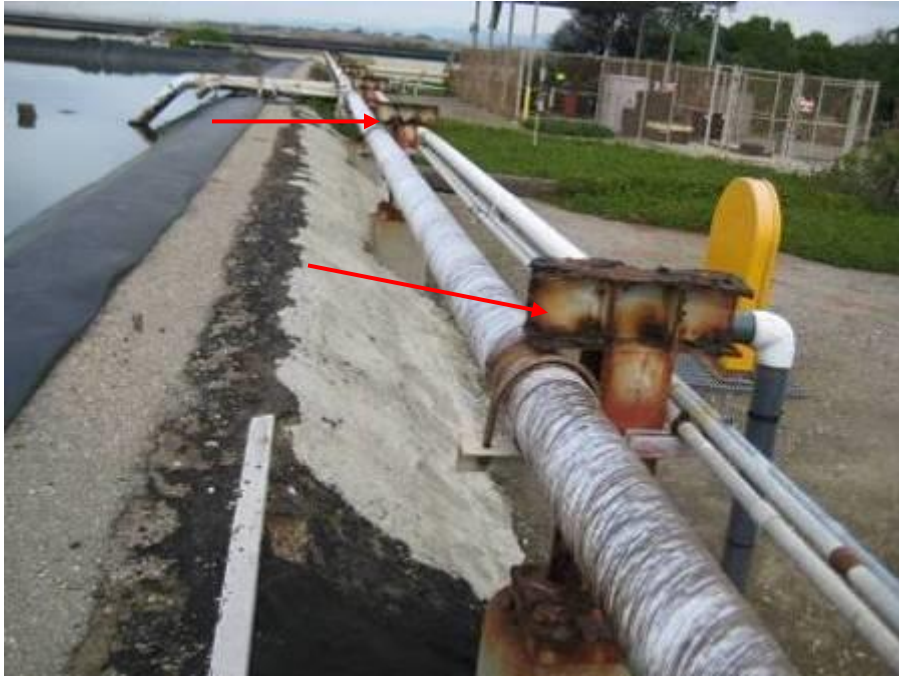
Photo 14: Corroded pipe supports and anchors along the RO discharge pipe.

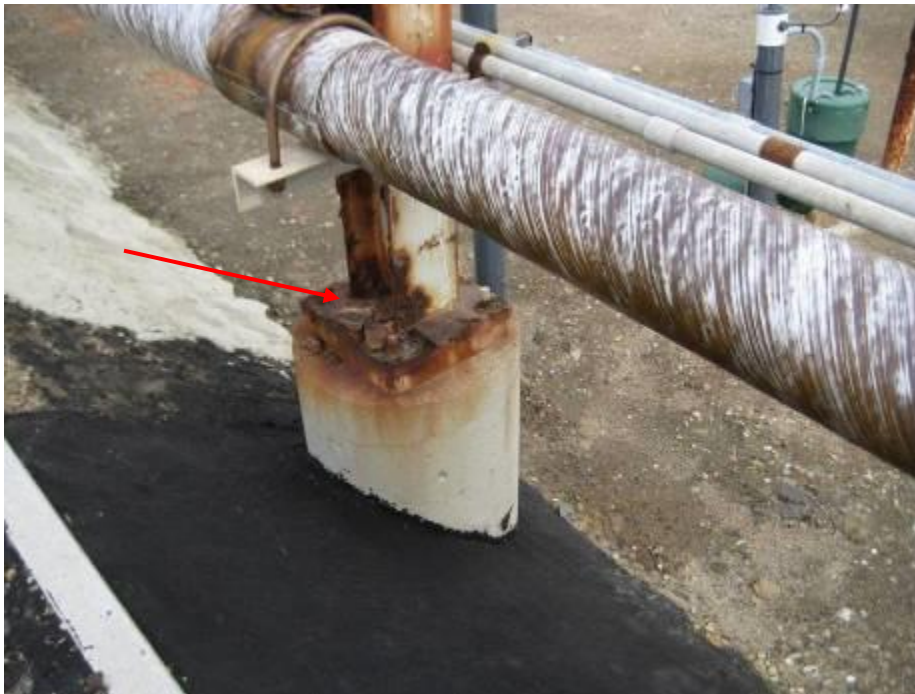
Photo 15: Corroded support and anchor

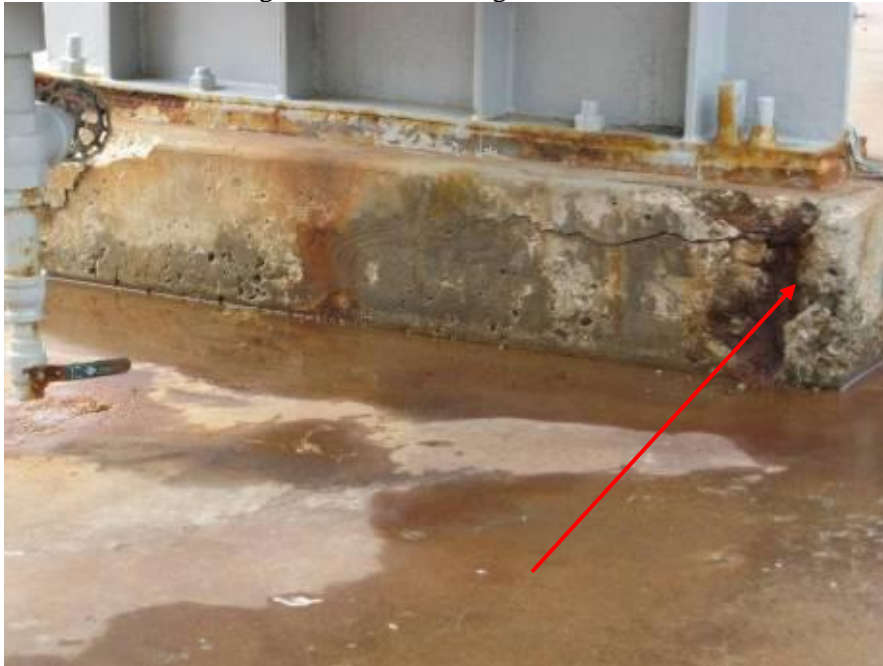
Photo 17: Cracked foundation exposes rusted rebar

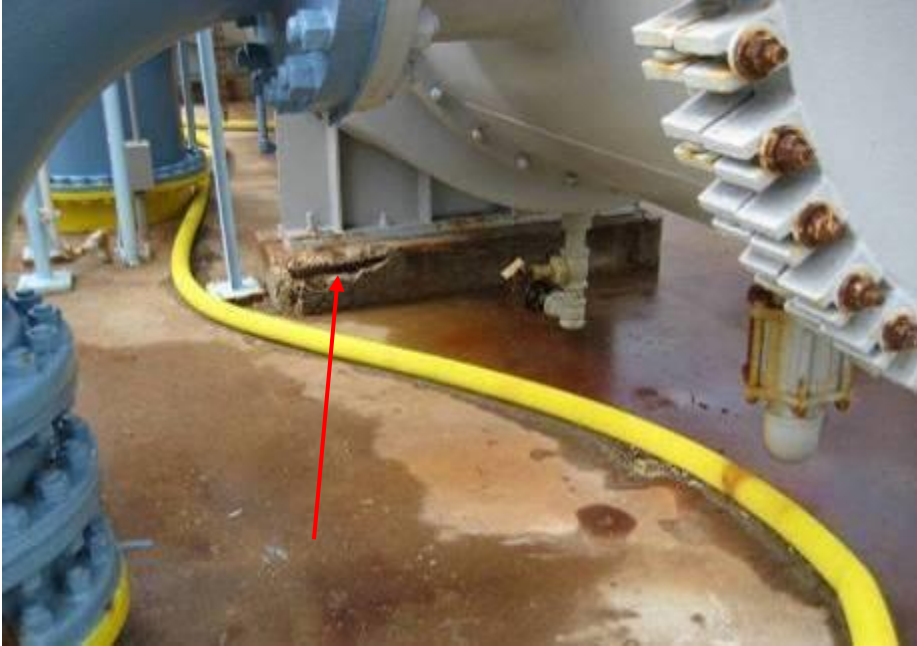
Photo 18: Cracked foundation.

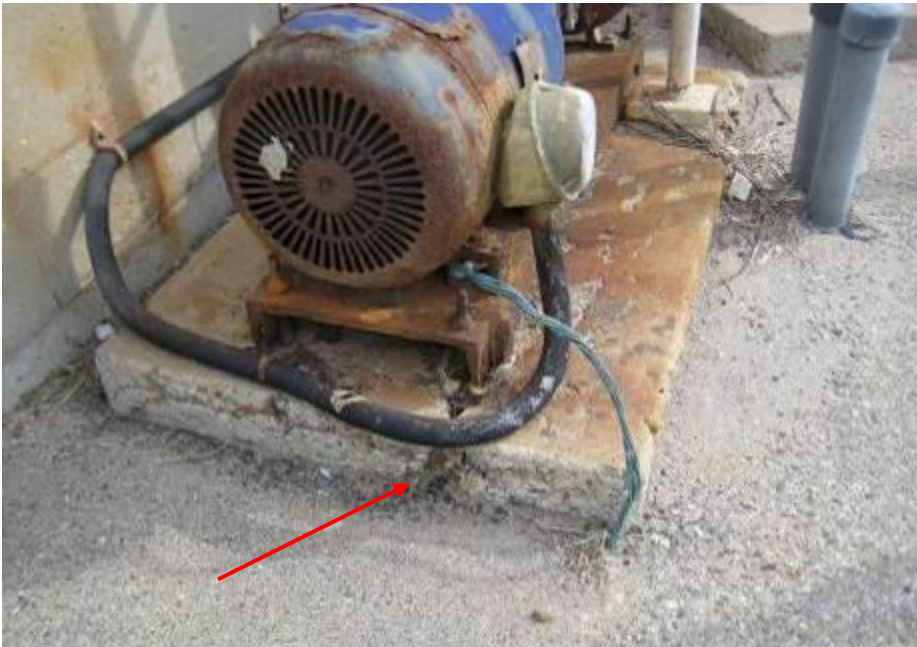
Photo 19: Cracked motor foundation.

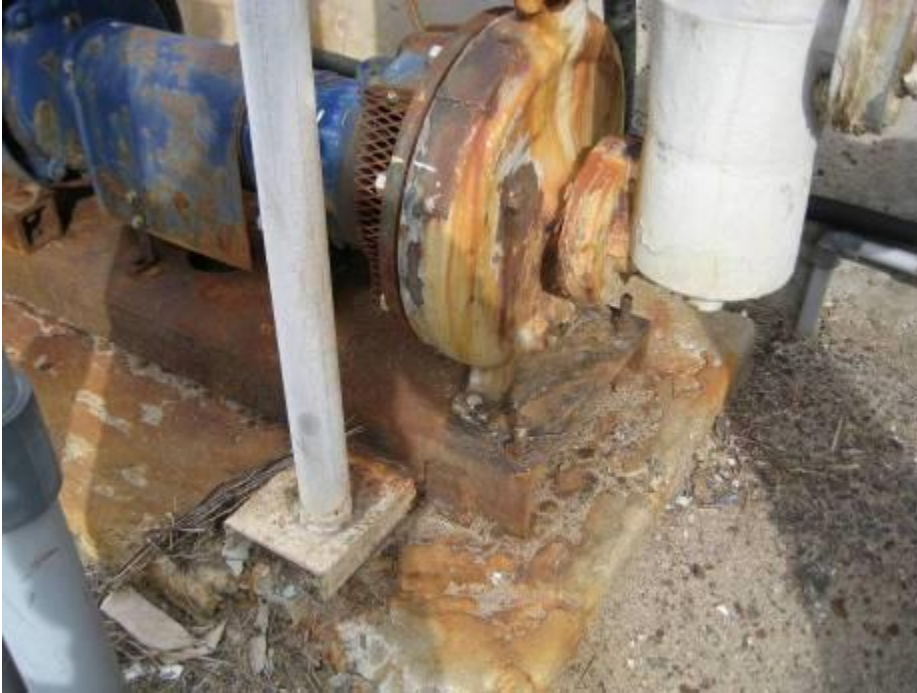
Photo 20: Crumbling pump foundation

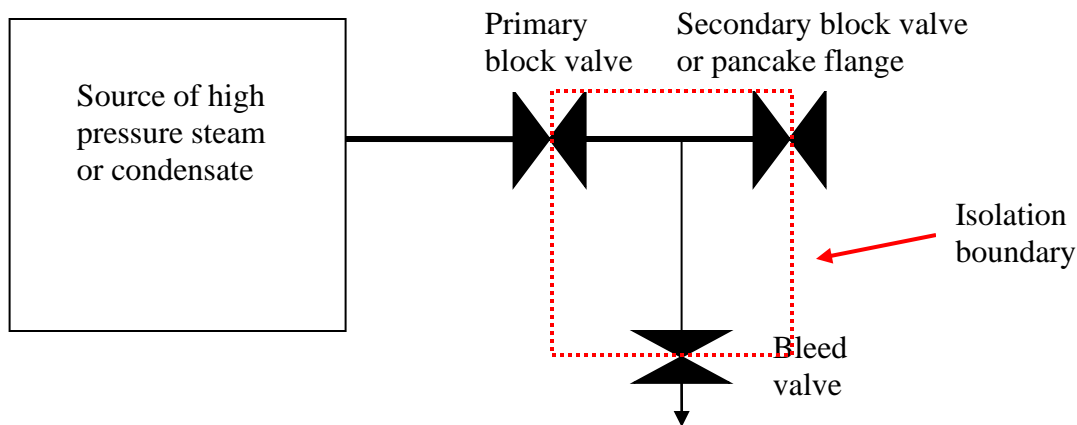
Diagram 1: Block and Bleed Valve Arrangement for Isolating High Pressure Energy

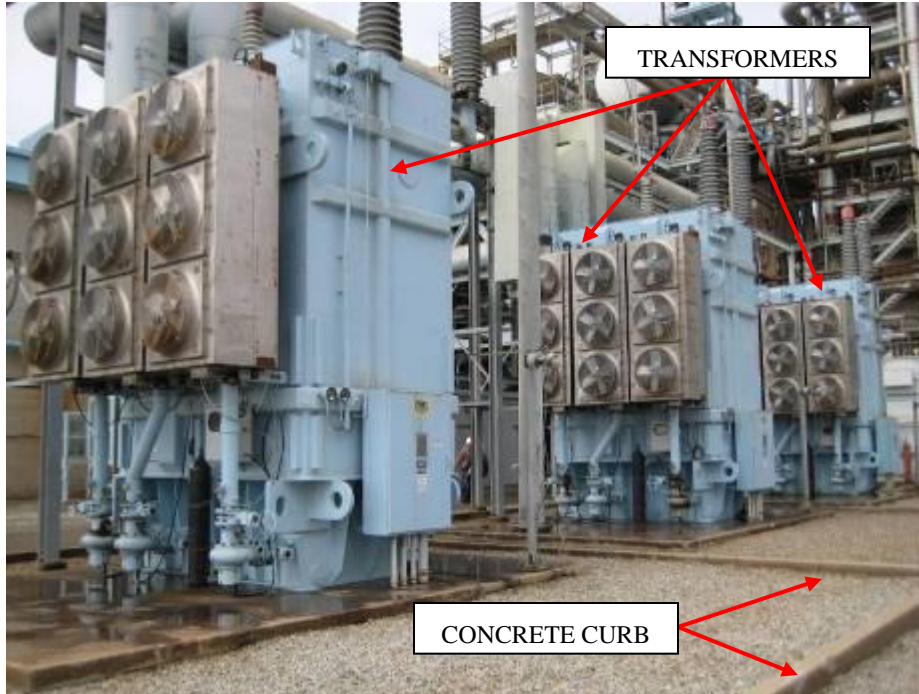
Photo 21: The plant's main transformers and concrete curb containment.

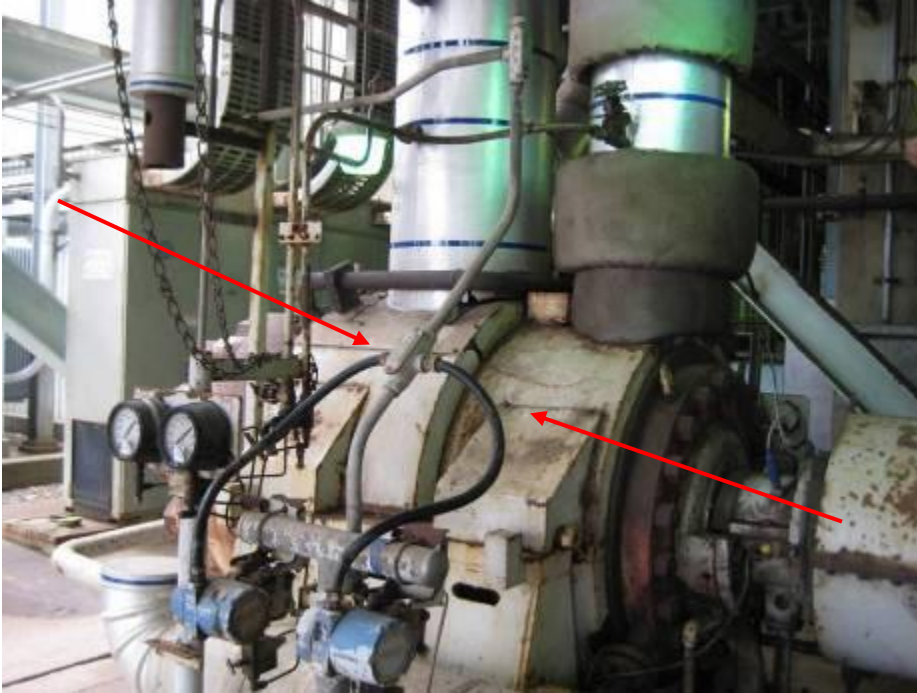
Photo 22: An uninsulated BFP casing.

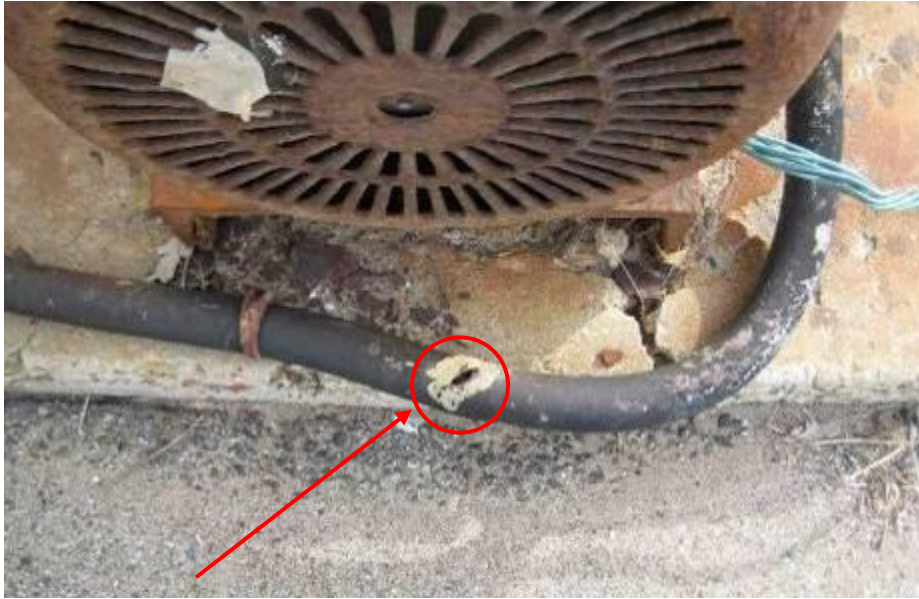
Photo 23: Damaged power cable exposes “hot” wiring.

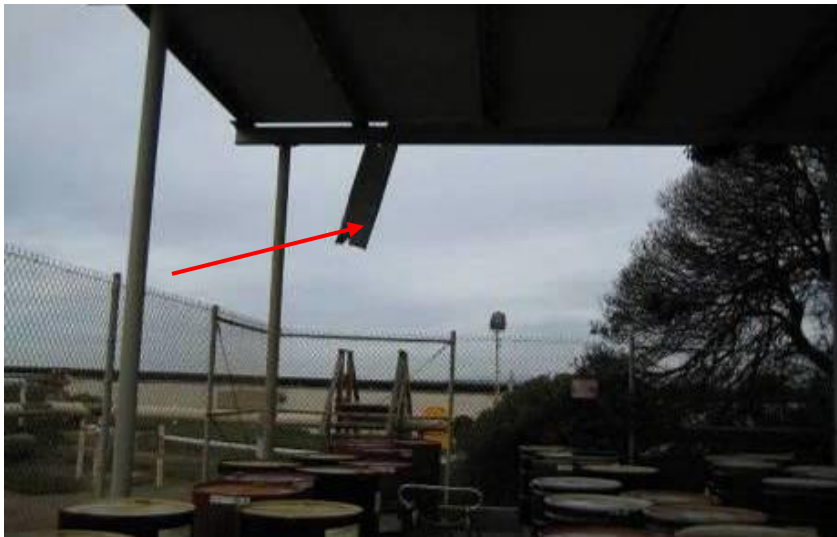
Photo 24: A loose roof panel hangs precariously over the storage area

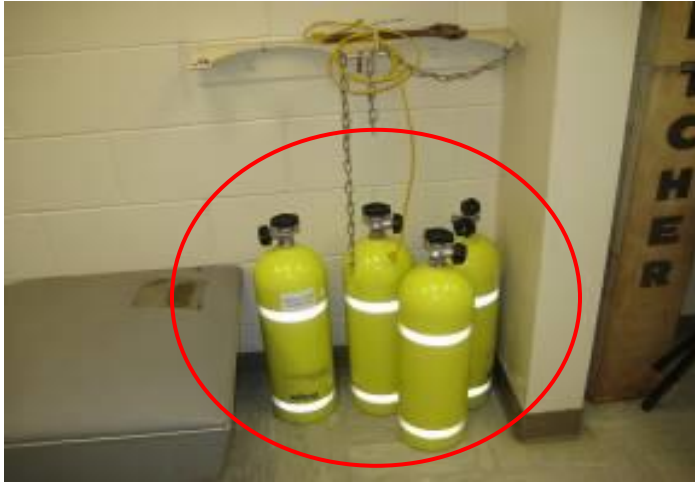
Photo 25: Unsecured, high pressure SCBA tanks in the First Aid room

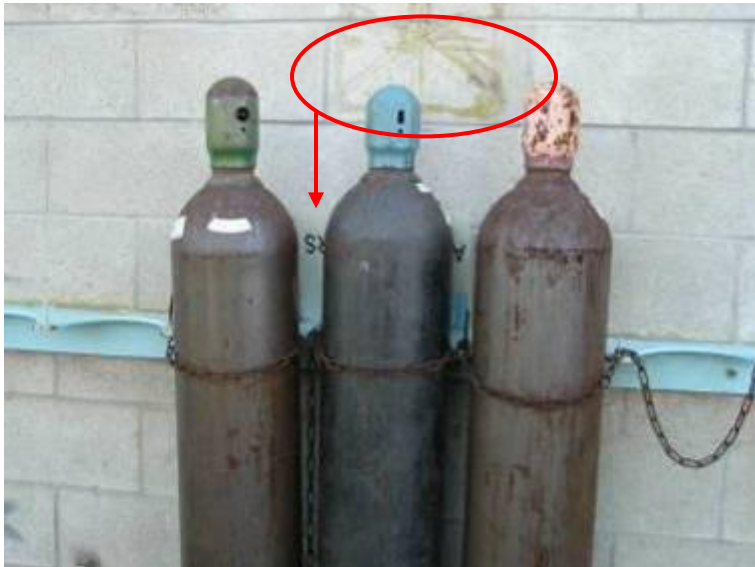
Photo 26: Identification sign not visible behind argon gas tanks.

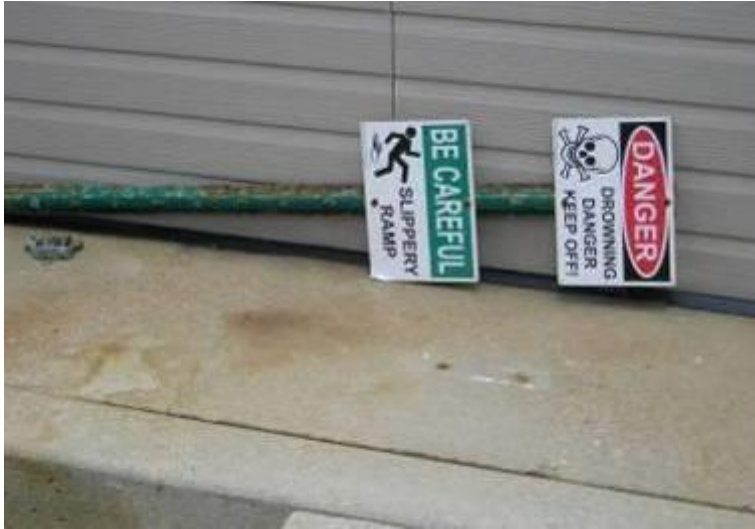
Photo 27: Broken sign post leans against a shed.

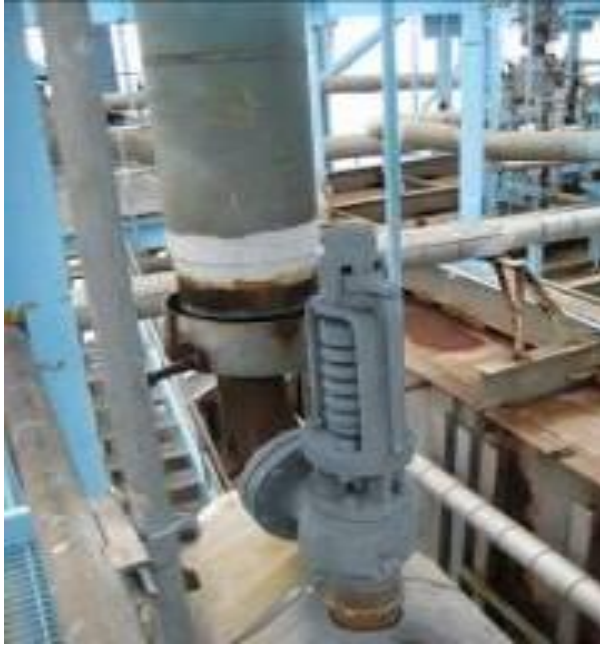
Photo 28: Safety valve number 02-PSV-3307 lacks identification tag

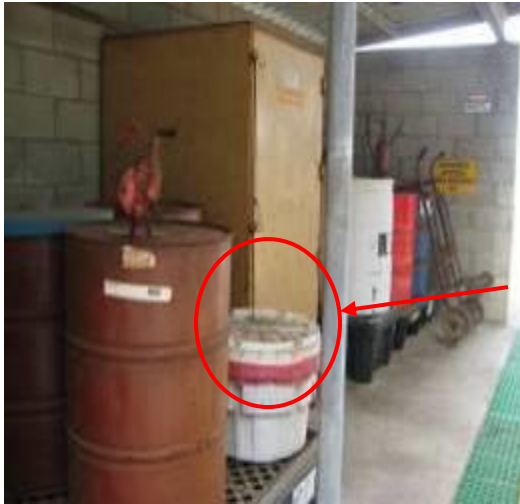
Photo 31: Spill kit in the Drum Lube Oil Storage area

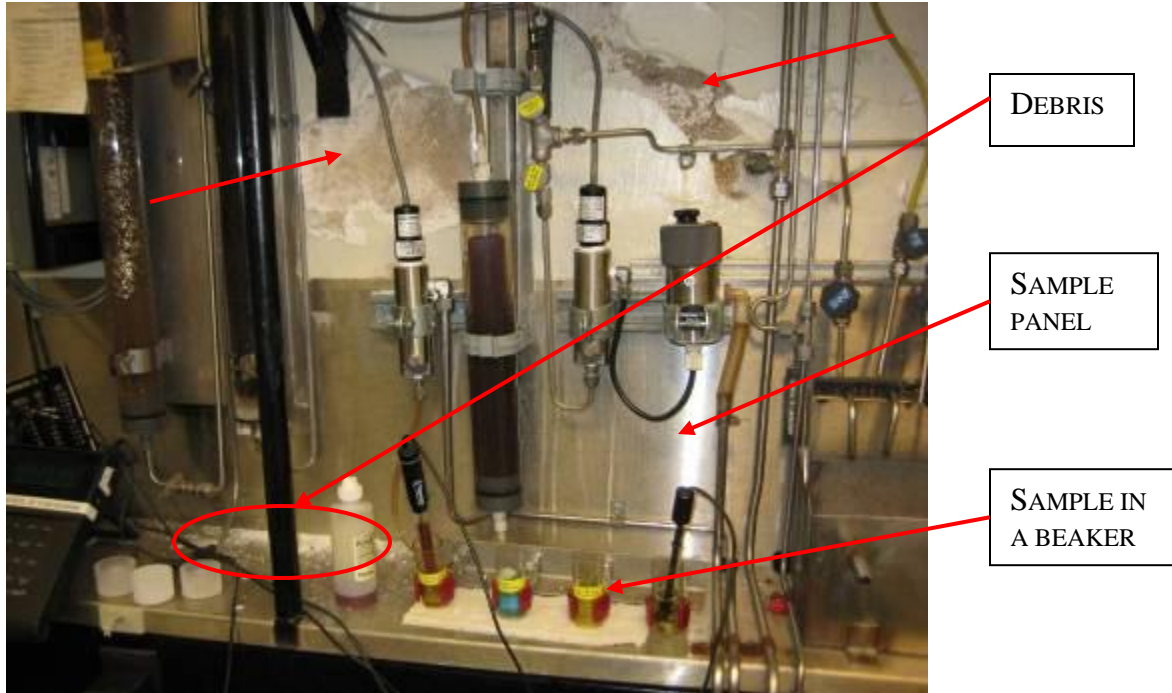
Photo 32: Deteriorated drywall flakes onto the lab bench.

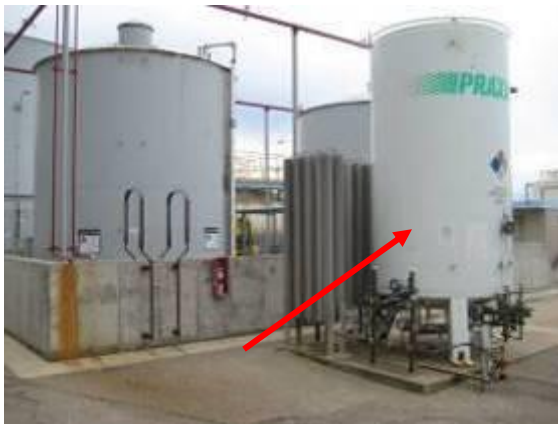
Photo 33: Bulk nitrogen storage tank is not recorded on plant schematic.

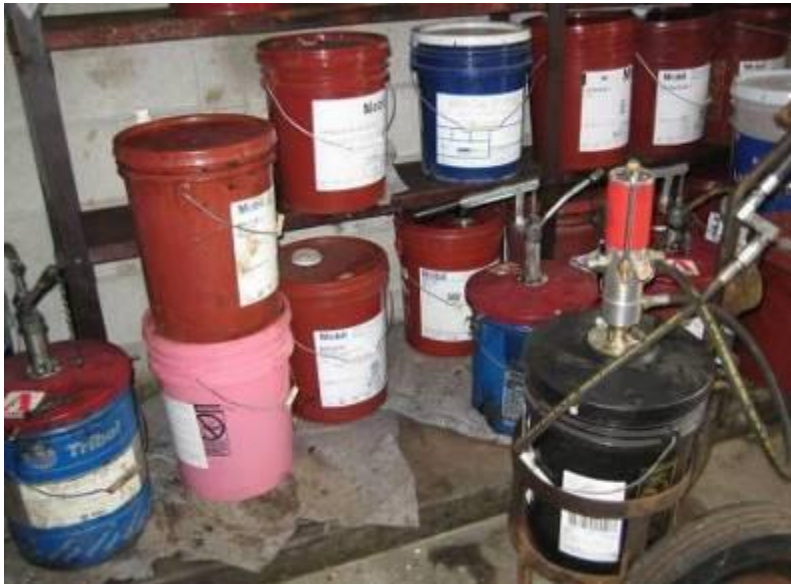
Photo 34: Sloppy storage of grease containers on racks and floor.

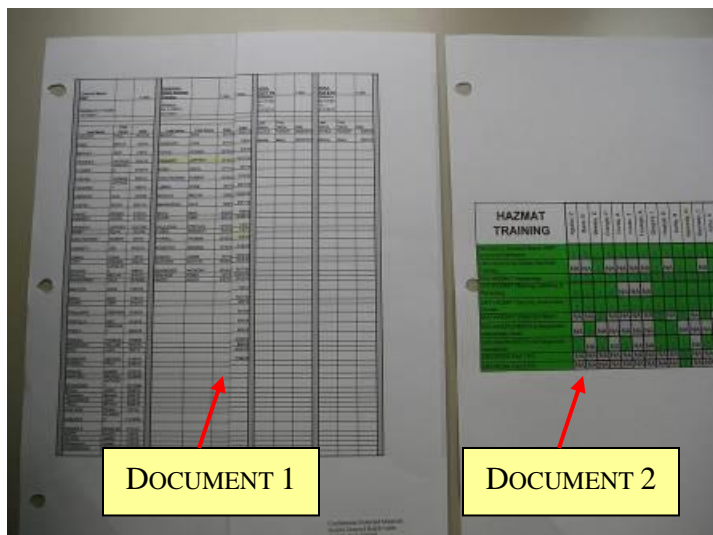
Photo 36: Hazmat training records provided to CPSD during the audit.
