PROJECT MEMORANDUM

ANTELOPE PARDEE PROJECT, SEGMENT 1

To: John Boccio, Project Manager, CPUC
Marian Kadota, Project Manager, ANF
From: Vida Strong, Aspen Project Manager
Date: May 30, 2008
Subject: Weekly Report #19, May 18-24, 2008

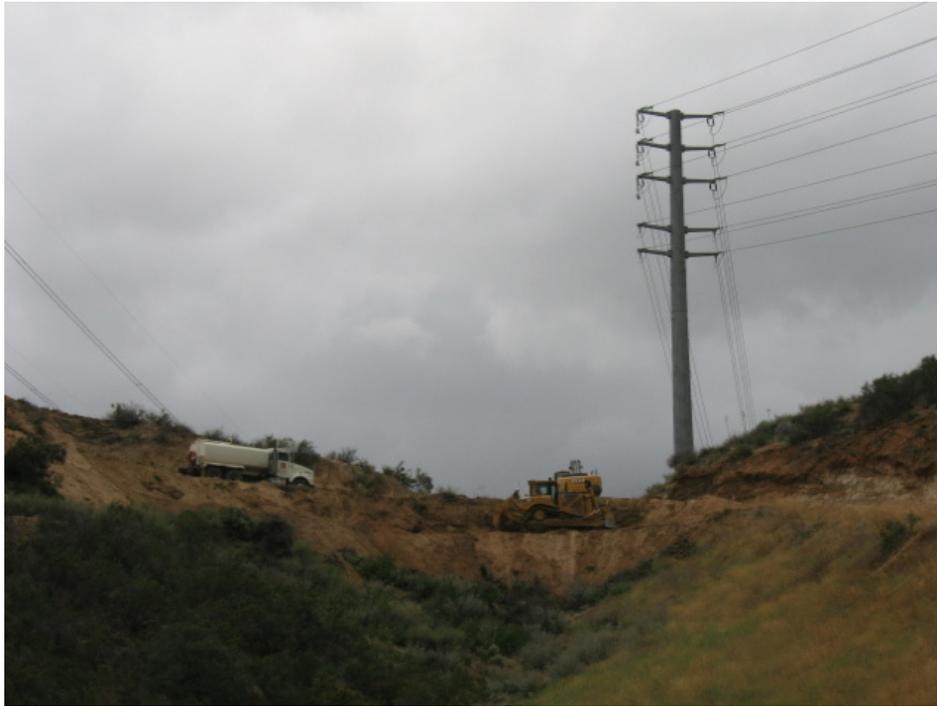
Figure 1: New crane pad construction at NC 9. Once the pad is constructed, the auger truck will be mobilized to drill the new tower foundations.

1. Road building and crane pad construction for access to new tower locations to support the Antelope Pardee 500 kV transmission continued. Roads were cut and/or improved to new tower construction sites (NC) 5, 6, 7 and 9, during the subject week (see Figure 1). PAR crews plan to conduct road construction from west to the east along the project alignment, followed by foundation drilling, concrete pouring, and tower assembly.
2. Tower foundation drilling took place after access to new tower locations had been constructed at NC 2-5. The four holes for the lattice tower foundations are up to 6-feet in diameter and up to 35-feet in depth.
3. Concrete pouring took place at NC 3 and 4 once the re-bar cages were placed into the foundation holes. Steel corners were anchored into the concrete in order to support the tower construction (see Figure 3).

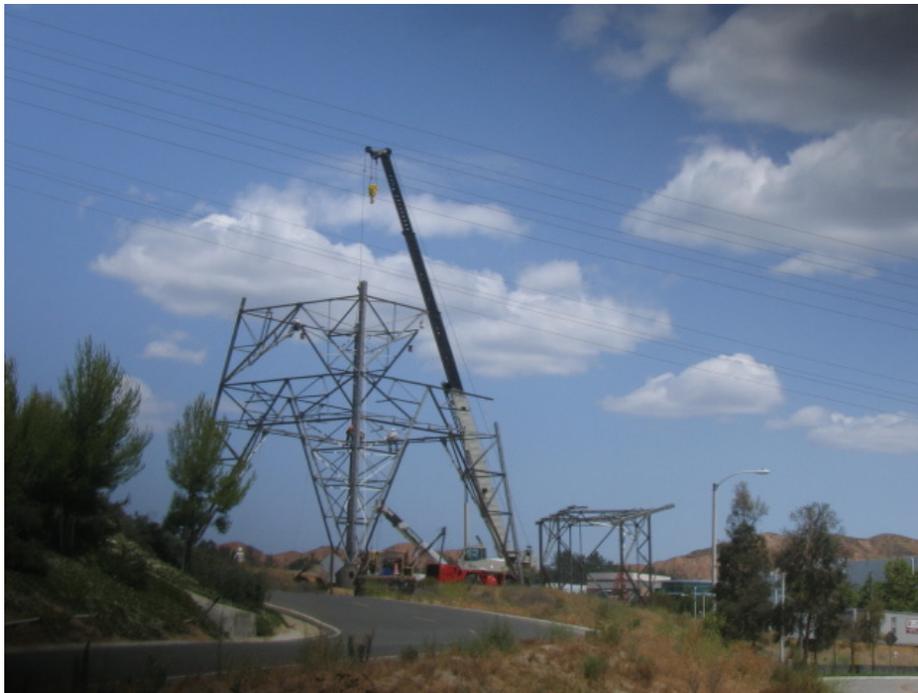
Figure 2: Assembly of 500 kV New Construct tower (NC) 2 outside of the Pardee Substation.

4. Tower assembly is occurring at NC 2, 3, and 4, which takes place once the concrete footings have cured (see Figure 2).
5. Along the Saugus–Del Sur 66 kV line, three towers were dismantled (5-1, 5-2, and 5-3). Crews accessed the tower sites along approved access roads and used crane trucks to remove the towers in pieces (see Figure 3). Several other 66 kV towers in Section 1 will be dismantled using helicopters in areas where no vehicle access exists. Sections of the dismantled towers will be flown to the Upper Pumpkin yard for further dismantling.
6. Biological monitoring and associated biological clearance surveys of Section 1 construction areas was conducted by Burns and McDonnell and BRC biologists during the subject weeks. Paleontological monitors were present to monitor ground disturbing construction activities.

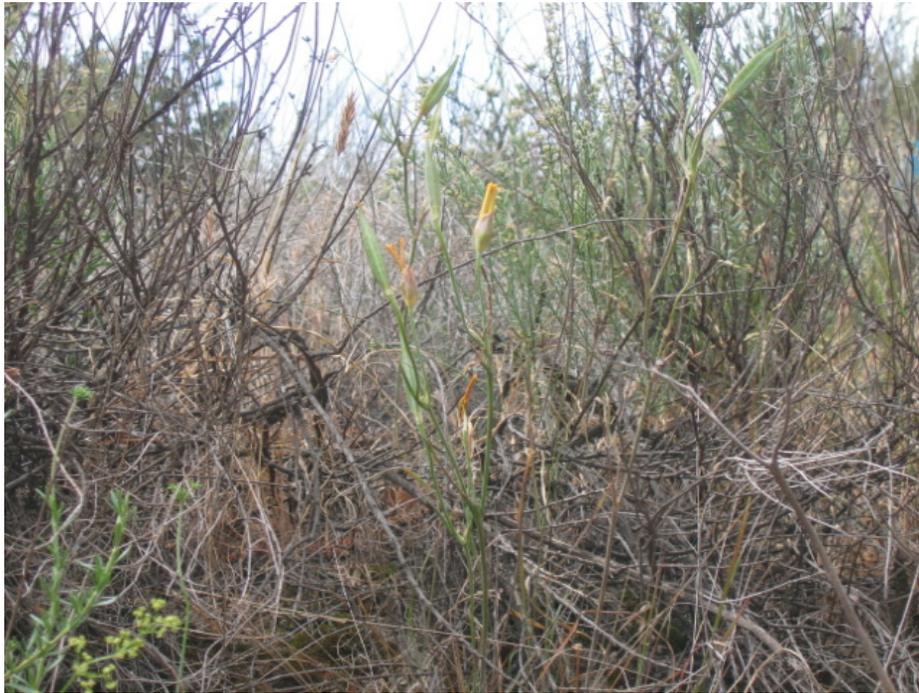
Figure 3: A population of mariposa lilies along the road to NC 9.

8. Sensitive plants are routinely observed within or adjacent to project areas. A mariposa lily was observed along the access road to NC 9 (see Figure 4).

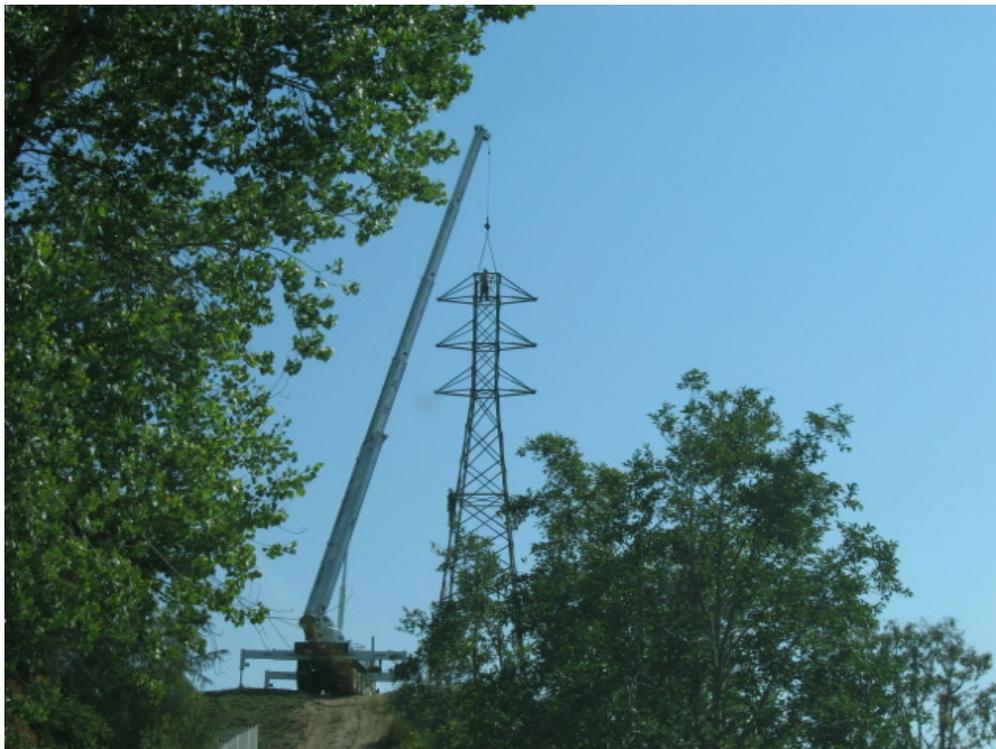
Figure 4: The removal of a 66 kV tower near Seco Canyon. A crane truck removed the tower in sections.

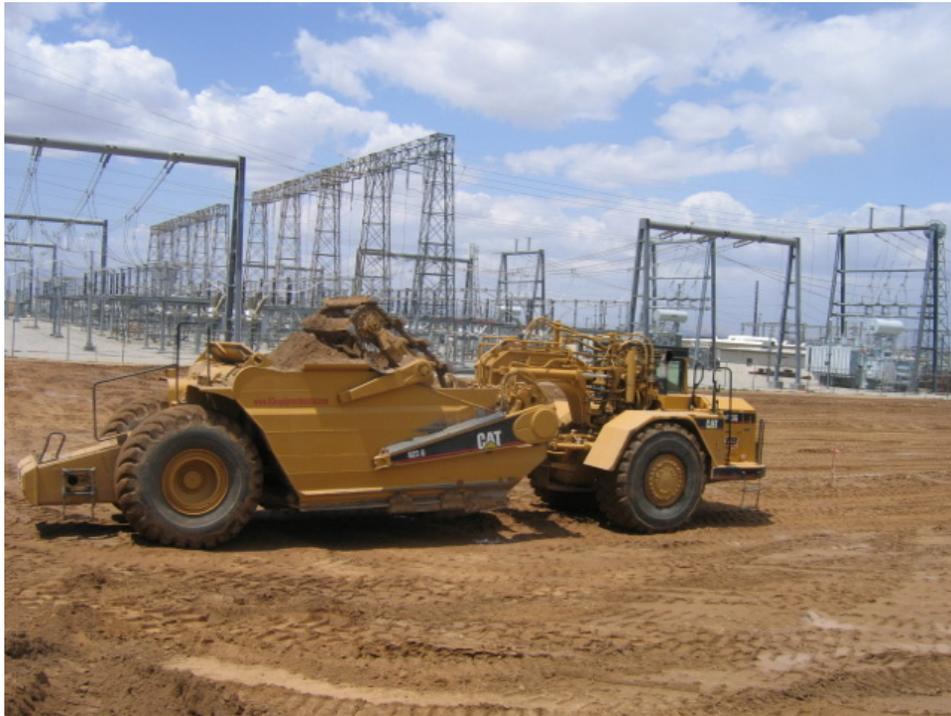
Figure 5: Grading and excavation of the Antelope Substation expansion area. Once the area matches the existing substation grade, rock placement will occur.

The grading of a small portion of the Antelope Substation expansion area is nearly completed (see Figure 5). Crews plan to place rock next week and place an earthen berm around the site for control of runoff.
