**PROJECT MEMORANDUM
SCE DPV2 TRANSMISSION PROJECT**

To: Billie Blanchard, Project Manager, CPUC
From: Vida Strong, Aspen Project Manager
Date: November 2, 2011
Subject: Weekly Report 13, October 10 to October 16, 2011

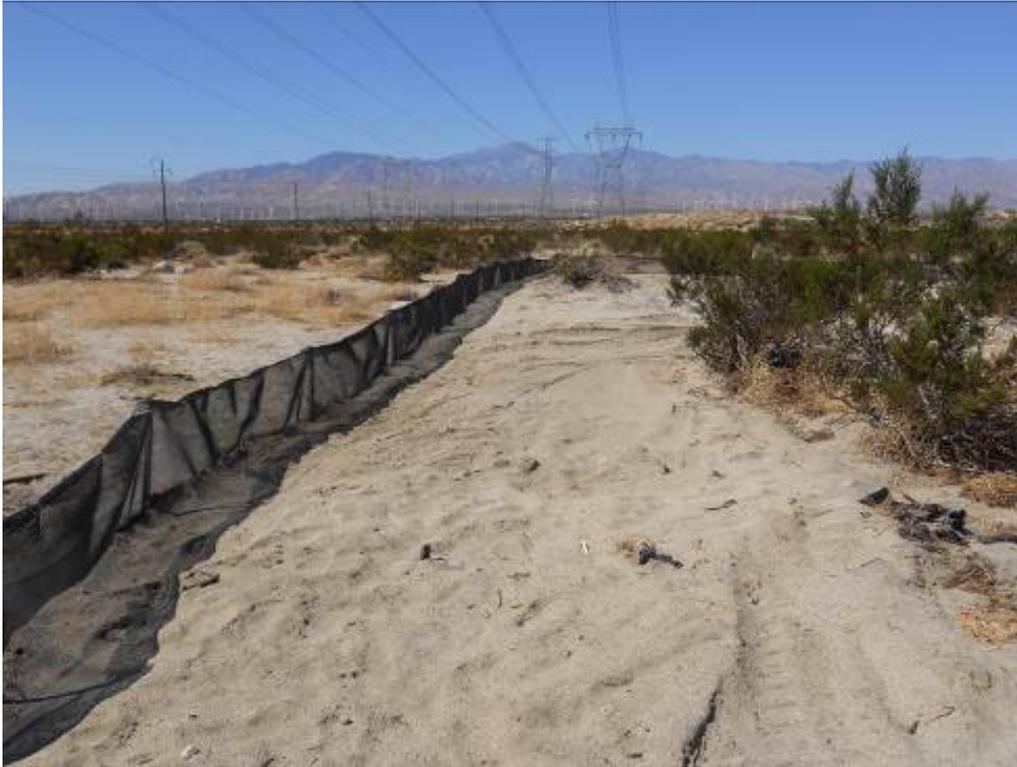
Figure 1: Completion of exclusionary fencing activities at one of the tower locations.

1. During the subject period, exclusionary fencing activities were completed at several locations, including Towers #2126 through #2137 and #2200. These activities included trenching and installation of fencing (see Figures 1 and 2).

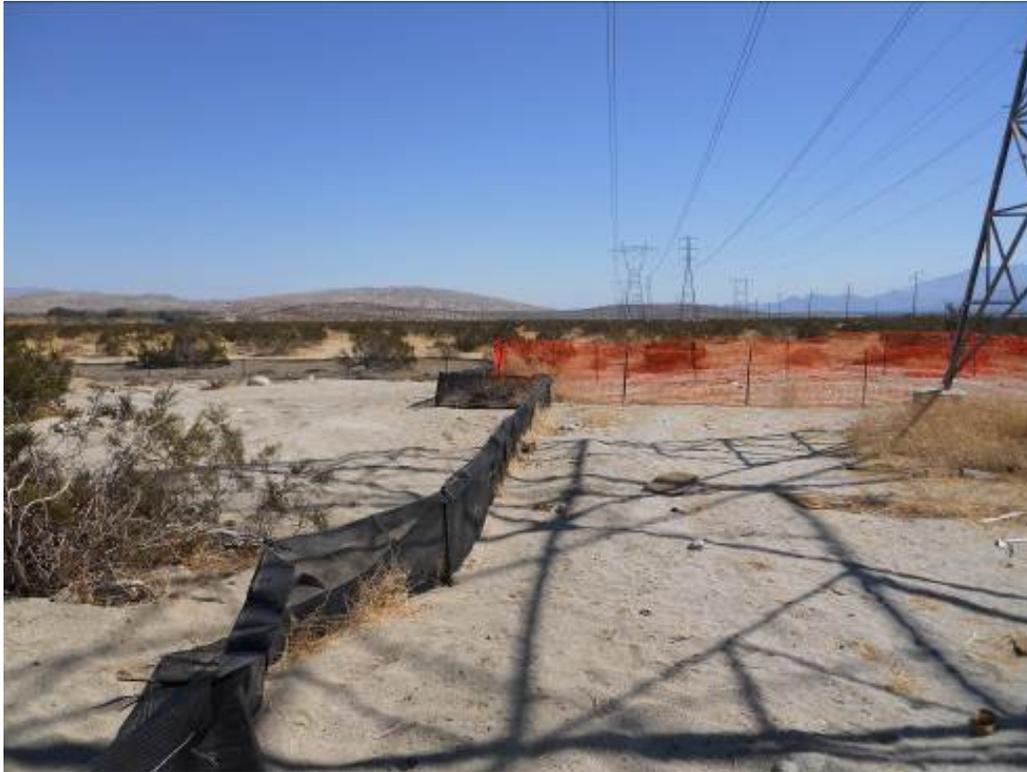
Figure 2: Exclusionary fencing has been installed at a tower location. Note avoidance of ESA (orange construction fencing).

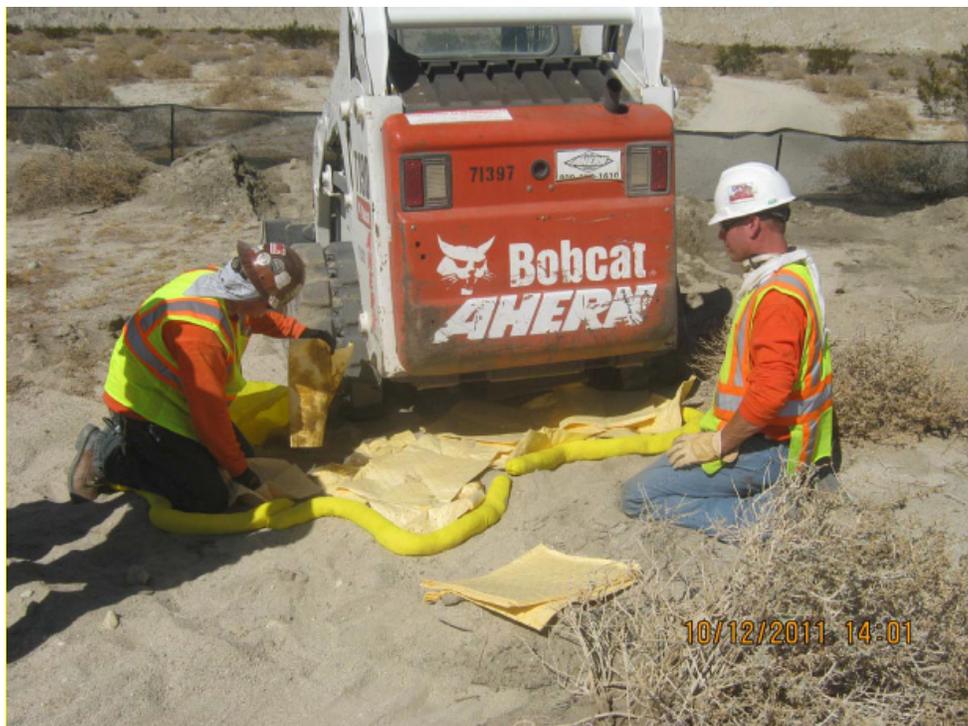
2. On October 12, a hydraulic leak from a rubber rack compact loader was observed by the SCE General Monitor. Operation of this piece of equipment was stopped immediately, and the spill was contained using onsite spill kit absorbent materials (see Figure 3). The contaminated soils were contained in plastic sheeting and, disposed of in drums, and removed offsite (see Figure 4). The CPUC EM was notified of the spill via phone call by SCE on October 13. It was determined during this discussion that any future spills would be reported directly to the CPUC EM only in the event that they exceed one gallon in volume. Otherwise, documentation of any lesser spills in daily reports is adequate. This is consistent with similar CPUC projects.

Figure 3: Small hydraulic fluid spill being contained during exclusionary fence installation at Tower #2132.

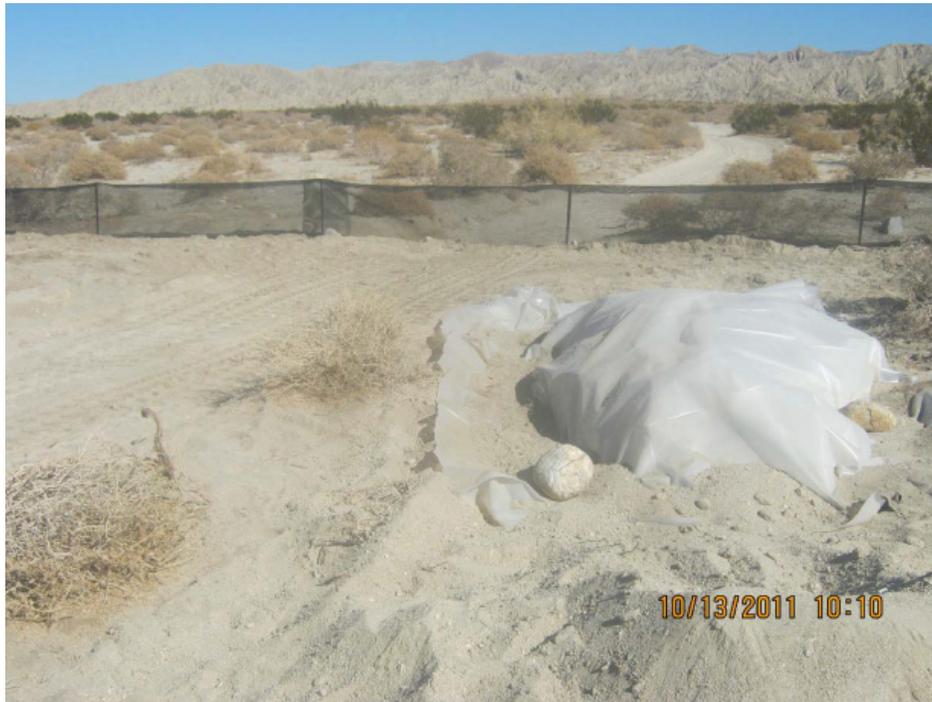
Figure 4: Contaminated soil from hydraulic fluid spill at Tower #2132 was isolated in plastic sheeting and removed from site the following day.

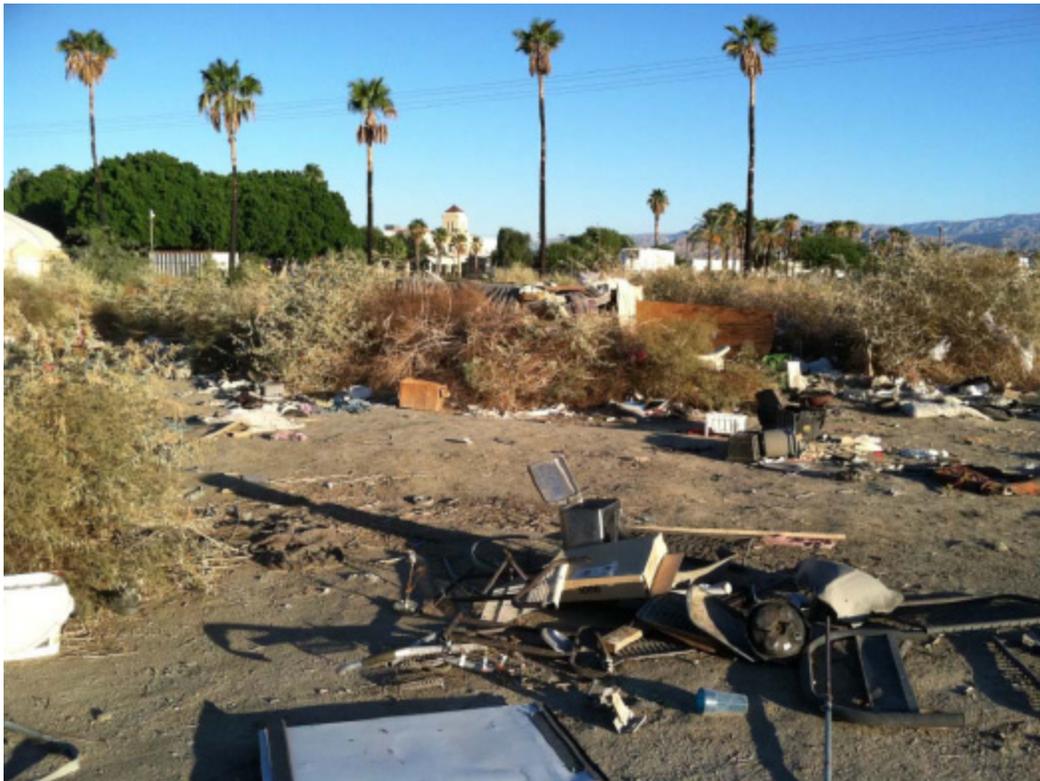
Figure 5: View of trash and debris at Indio Construction Yard site prior to construction. Note homeless encampment in background.

1. The SCE General and Biological Monitors reported that WEAP stickers were observed on all construction personnel hardhats. They also noted that dust suppression and BMP implementation were adequate and maintained throughout the subject period.
2. Project speed limit and dust reporting signs have been installed.
3. Due to the presence of several transient encampments, the Indio Police Department was called out to the site to provide final clearance prior to construction activities (see Figure 5).

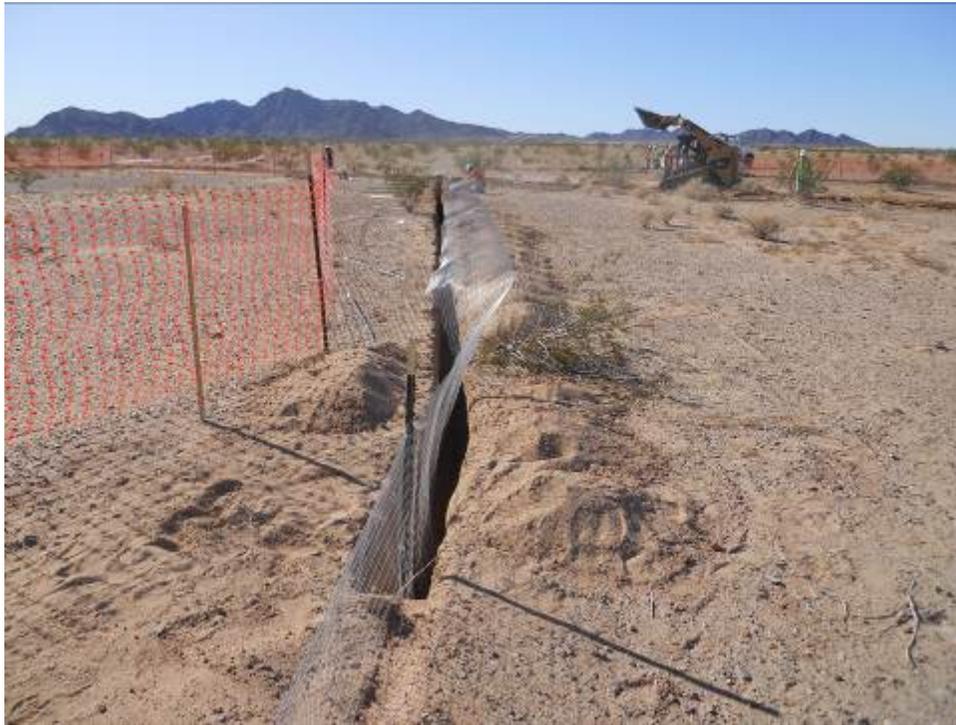
1. Major activities occurring at the Red Bluff Substation during the subject period included the trenching, installation, and backfilling of desert tortoise exclusionary fencing (see Figure 6). The installation of desert tortoise fencing was completed by October 14. Upon completion, a small crew conducted minor maintenance and repair activities by hand along the fence line. Minor blading associated with access road improvements was also performed.

Figure 6: Installation of desert tortoise exclusionary fencing at CRS site.

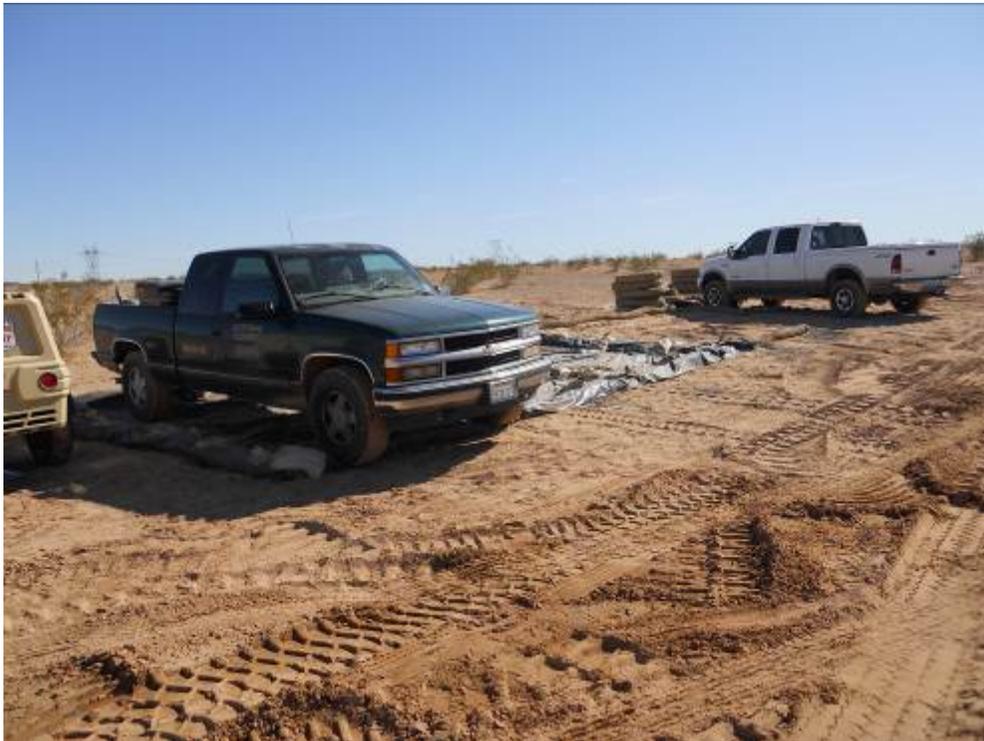
4. The CPUC EM confirmed that BMPs were in place and effective during an October 10 site visit (see Figure 7).

Figure 7: BMPs implemented, including contained parking areas, at the CRS site.

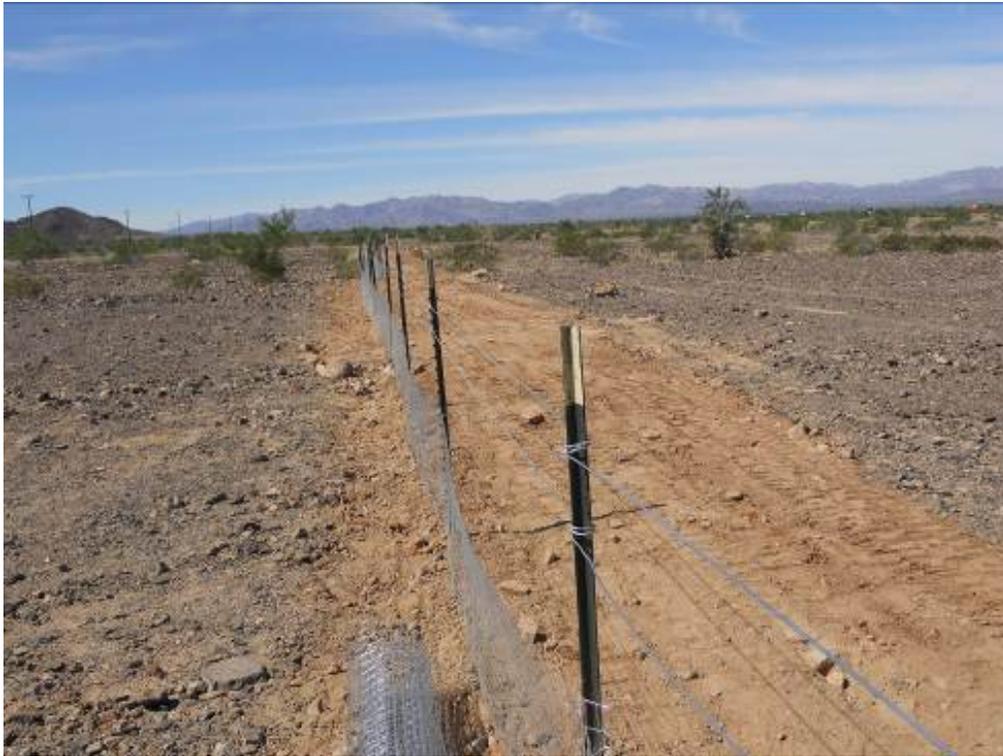
1. Installation of exclusionary fencing continued throughout the subject period and was limited to placing metal wiring to prohibit bighorn sheep entry (see Figure 8). The entire exclusionary fence was completed on October 10.
2. Civil surveyors began staking pothole locations to find the depth of a gas line that lies adjacent to the access road on October 12. Staking was completed by October 14.

Figure 8: Exclusionary fencing activities completed at the Red Bluff Substation site. Note top wire along fence to prohibit bighorn sheep entry.
