**PROJECT MEMORANDUM
SCE EL CASCO SYSTEM PROJECT**

To: Lynne Mosley, CPUC
From: Vida Strong, Aspen Project Manager
Date: May 18, 2010
Subject: Report 26: April 18 - May 8, 2010

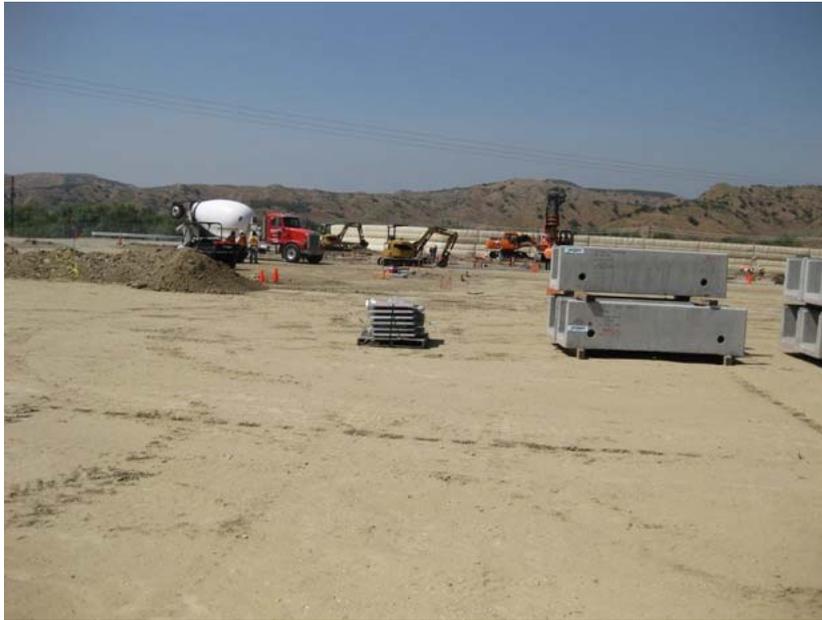
During the subject period, the contractor for the construction of the substation, Professional Construction, Inc., worked on trenching for ground wire placement, preparing trenches for conduit placement, and constructing foundations for structures (see Figure 1). The storage yard south of the site trailers continued to receive materials for the substation construction.

Figure 1: Work at the El Casco Substation site continued with trenching for ground wire placement, preparing trenches for conduit placement, and constructing foundations for structures. The photograph faces northeastward.

- Dust control, when necessary, was maintained by water trucks at the El Casco Substation and Zanja Substation work sites.
- Concrete truck wash-out basins have been established as necessary in areas where concrete placement occurs. Concrete placement occurred at El Casco Substation site during the subject period (see Figure 1).

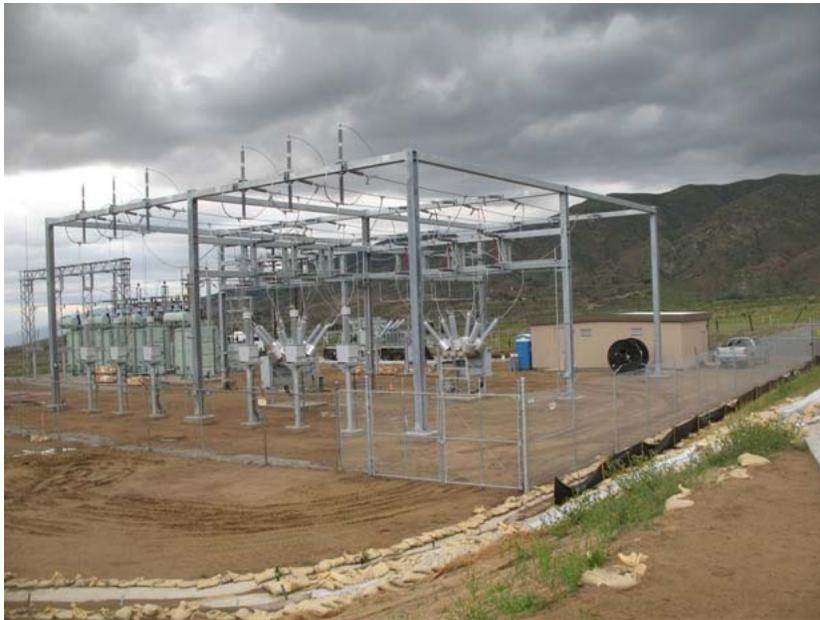
Construction activity at the substation has been mostly completed (see Figure 2). Work continued within the substation on the installation of the new electrical components.

Figure 2: Construction activity at the Zanja Substation has been mostly completed. Work continued within the substation on the installation of the new electrical components. The photograph faces northwestward.

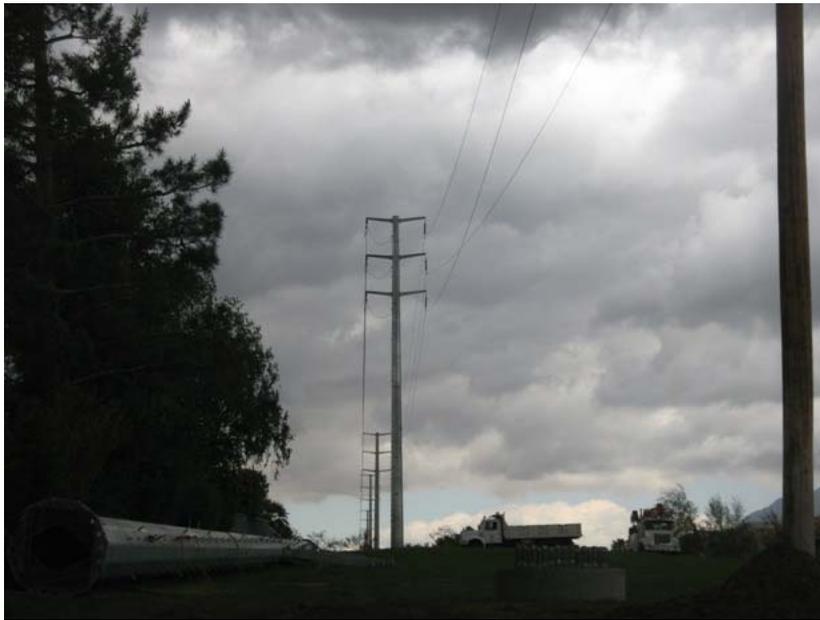
Work was completed on Segment 3 on during the subject period (see Figure 3).

Figure 3: Installation of Segment 3 of the 115 kV sub-transmission line within the Sun Lakes development in Banning has been completed.

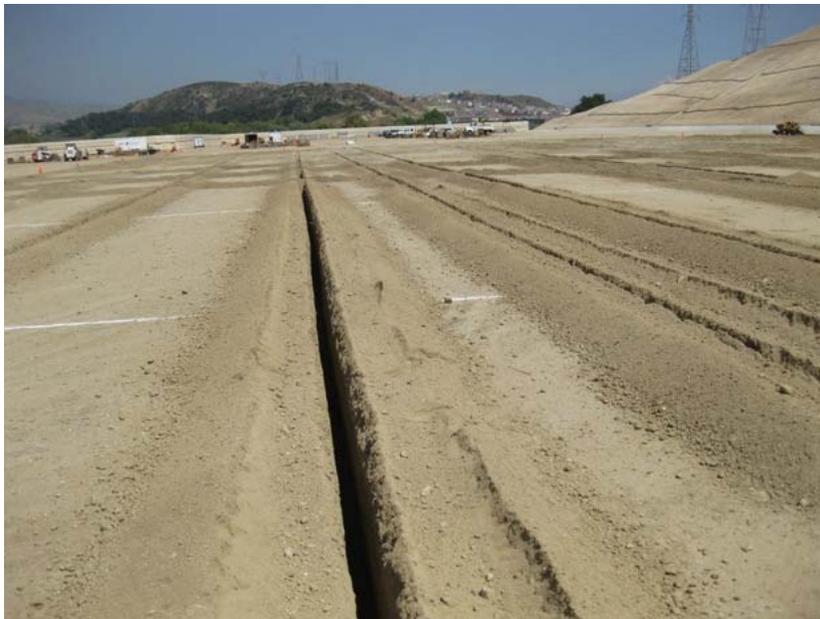
- It has been noted that temporary trenches are being dug on the pad at the El Casco Substation site that have the potential to trap animals (see Figure 4). NRC Biological Monitors are inspecting the trenches each morning, using flashlights when necessary, for trapped individuals. In addition, it has been noted that permanent V-ditches that have been constructed on the periphery of the substation site may have the potential for entrapment (see Figure 5). The issue is being investigated further by SCE.

Figure 4: Temporary trenches were being dug on the pad at the El Casco Substation site for the copper grounding wire grid. These trenches have the potential to trap animals. NRC Biological Monitors inspected the trenches each morning, using flashlights when necessary, for trapped individuals. The photograph faces northeastward.

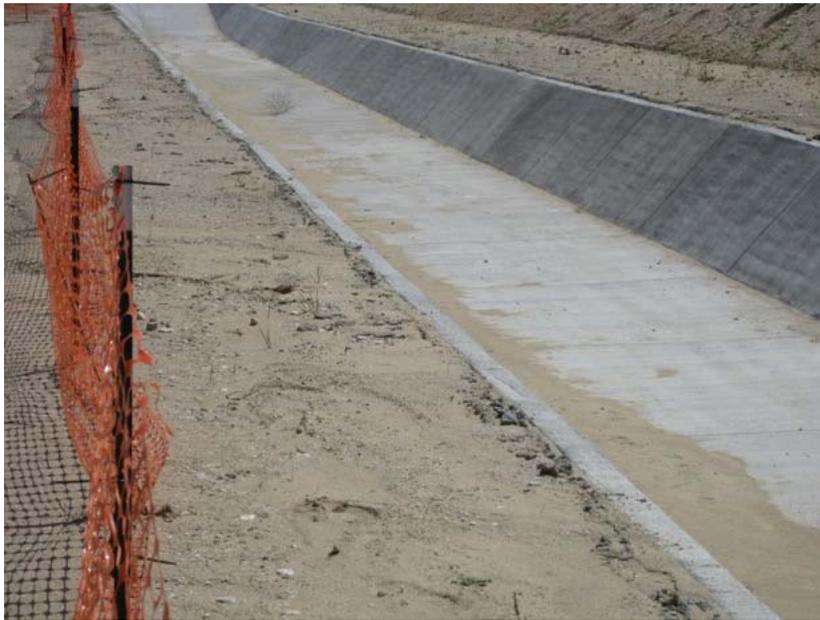
Figure 5: Permanent V-ditches that have been constructed on the periphery of the El Casco Substation site may have the potential for entrapment. The issue is being investigated further by SCE. The photograph was taken between the office trailers and the substation pad, and faces southward.
