**PROJECT MEMORANDUM  
SCE EL CASCO SYSTEM PROJECT**

**To:** Lynne Mosley, CPUC  
**From:** Vida Strong, Aspen Project Manager  
**Date:** July 14, 2010  
**Subject:** Report 31: June 28 – July 11, 2010

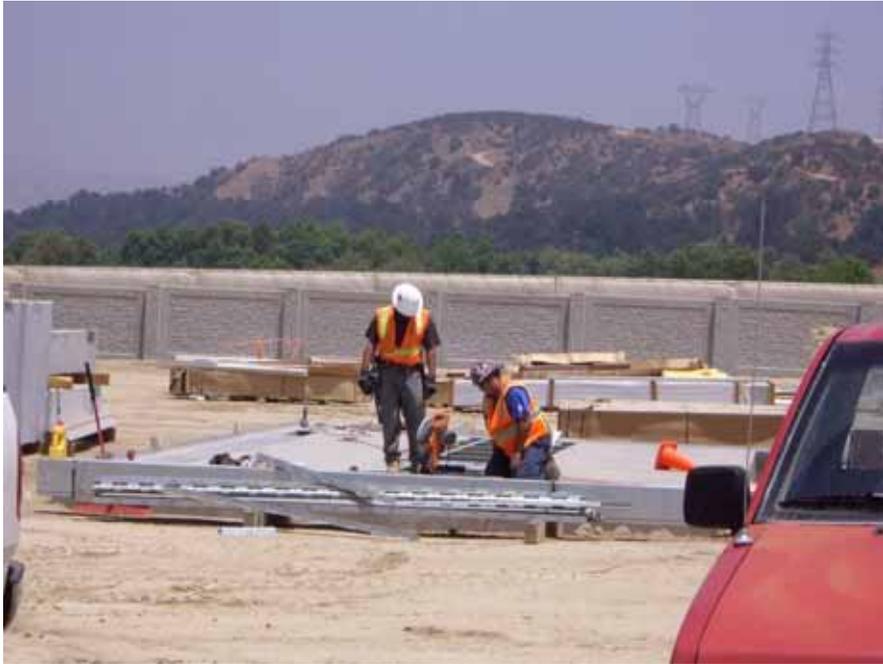
**Figure 1:** At the El Casco Substation site, crews worked on the concrete foundation for the 115 kV MEER building. This photograph is taken facing east.

During the subject period, the contractor for the construction of the substation, Professional Construction, Inc., continued preparing trenches for conduit placement, constructing foundations for structures, and placing the grounding grid system. Also, construction of steel structures for the 220 kV portion neared completion. Construction of the 220/115 kV MEER and construction of the foundation for the 12 kV MEER also continued during the subject period (see Figure 1).

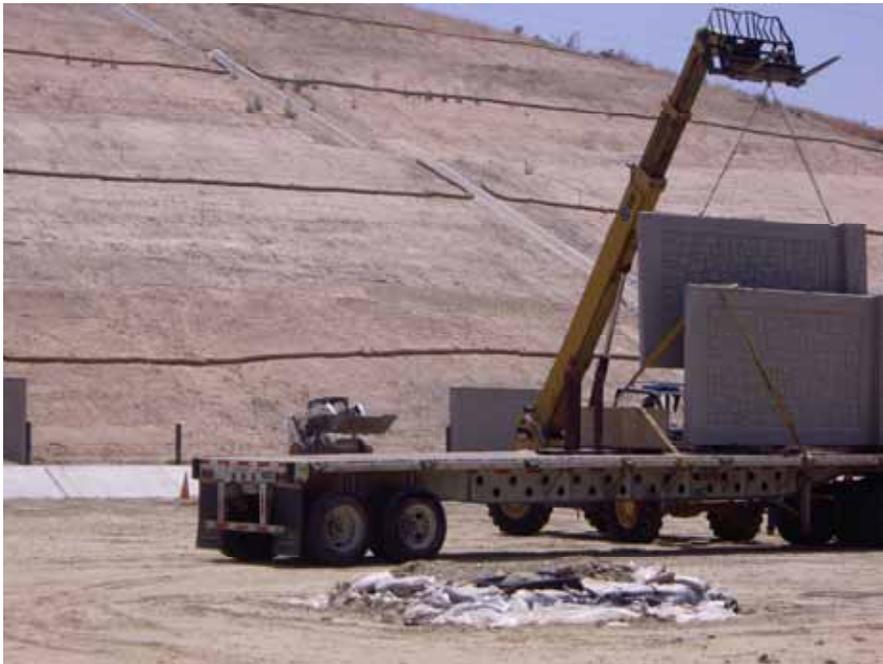
**Figure 2:** At the El Casco Substation site, a crane moved a perimeter wall panel. This photograph is taken facing south.

During the subject period, work continued on the perimeter wall, with a number of panels of the perimeter wall being placed in the last week (see Figure 2).

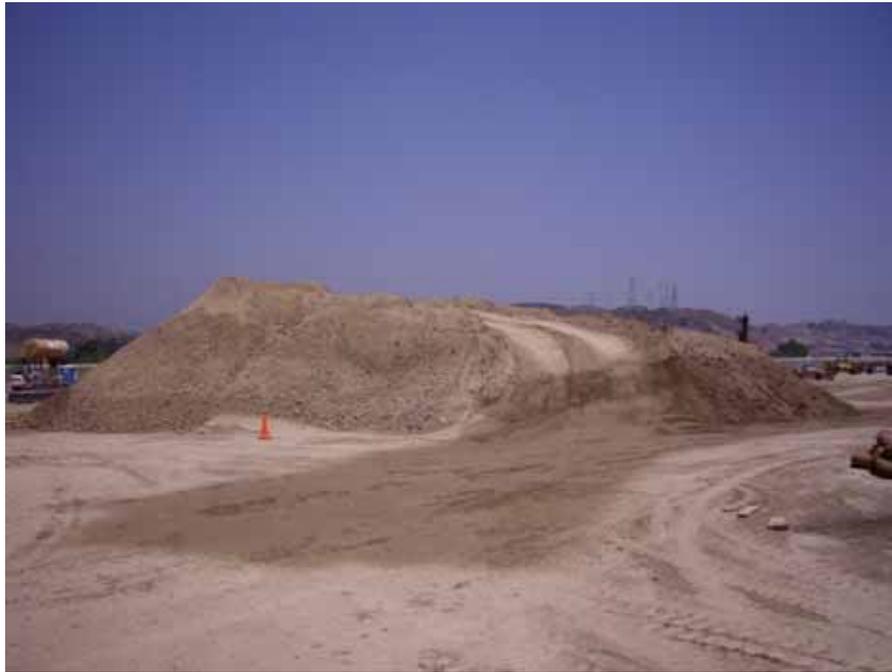
**Figure 3:** At the El Casco Substation site, a fill pile was generated from excavation for the perimeter wall. The photograph was taken when the pile had been recently watered.

- Dust control, when necessary, was maintained by water trucks at the El Casco Substation and Zanja Substation work sites. A large pile of fill, generated by trenching and leveling, has been watered continuously (see Figure 3). In general, the El Casco Substation was well-watered and dust free.

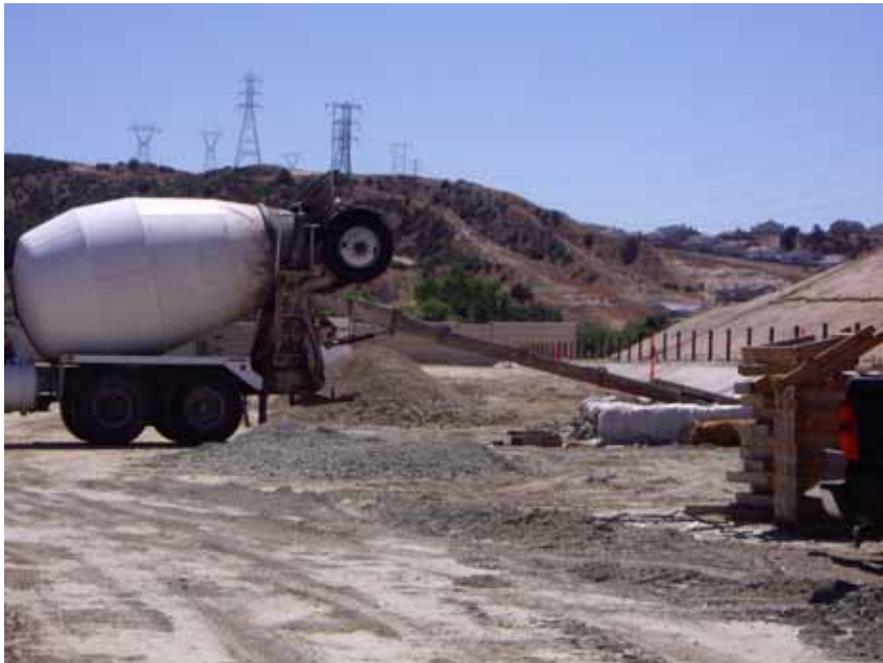
**Figure 4:** Cement truck using wash-out basin. This photograph is taken facing east.

- A concrete truck wash-out basin has been established and is in use at the El Casco Substation site (see Figure 4). The CPUC EM noticed a small, dried cement spill near the wash-out basin on July 2 and informed the Chambers monitor. The monitor spoke with the cement truck drivers and advised them to be more careful.
