**PROJECT MEMORANDUM
PG&E SEVENTH STANDARD SUBSTATION PROJECT**

To: Monisha Gangopadhyay, CEQA Project Manager, CPUC
From: Vida Strong, Aspen Project Manager
Date: March 22, 2010
Subject: Weekly Report #2: March 15, 2010 – March 20, 2010

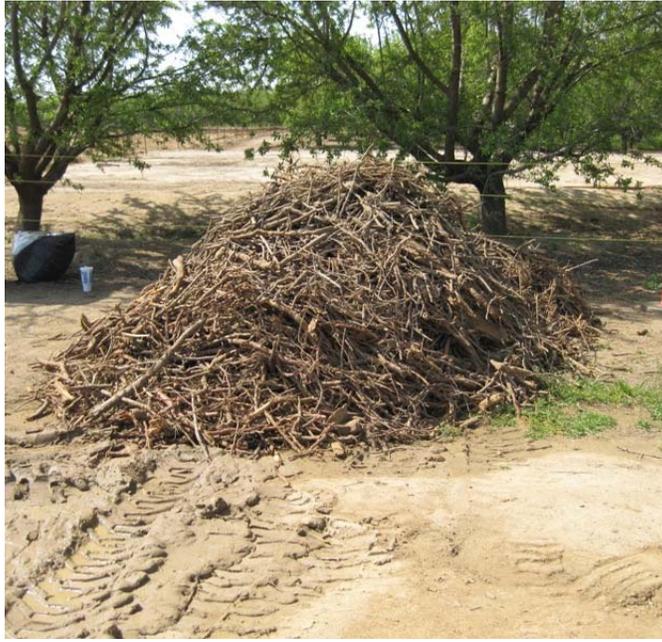
Figure 1: During soil preparation and grading, remaining roots from the earlier almond grove removal were hand collected and piled on site. They will be removed from the Project site. Protocol calls for removal of roots one-half inch in diameter and greater. Observation indicates that even smaller roots are being removed. The pile in the photograph represents approximately one and one-half acres of the five-acre site. The photograph was taken on the edge of the access road, and faces southwestward across the western portion of the substation site.

During the subject week, preparation and grading of the site continued. Material was shifted by excavators to rows. The material was then relocated, compacted, and graded. Roots from the earlier tree removal were removed during the operation (see Figure 1).
