**PROJECT MEMORANDUM
PG&E SEVENTH STANDARD SUBSTATION PROJECT**

To: Monisha Gangopadhyay, CEQA Project Manager, CPUC
From: Vida Strong, Aspen Project Manager
Date: August, 2010
Subject: Report #11: August 8, 2010 – August 21, 2010

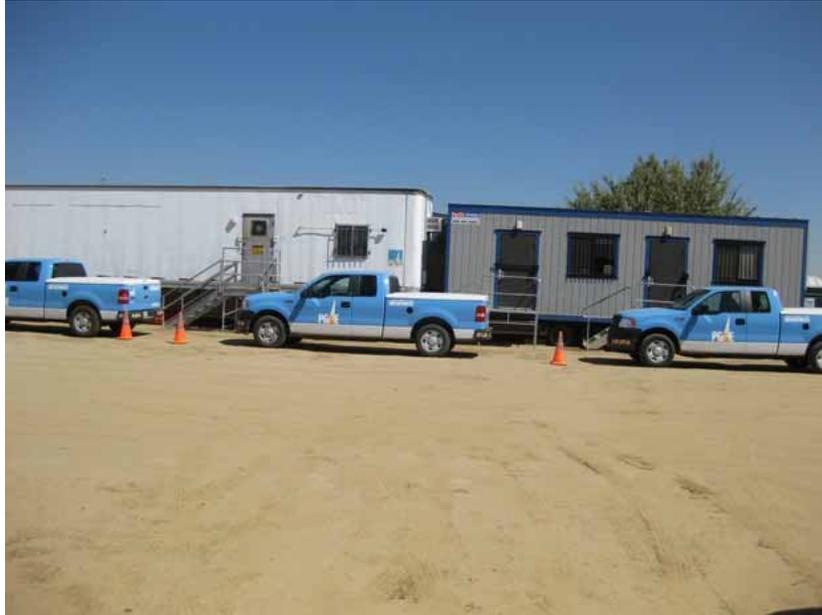
Figure 1: Electrical installation and testing crews from PG&E and a consultant continued to be on site. The photograph faces northward.

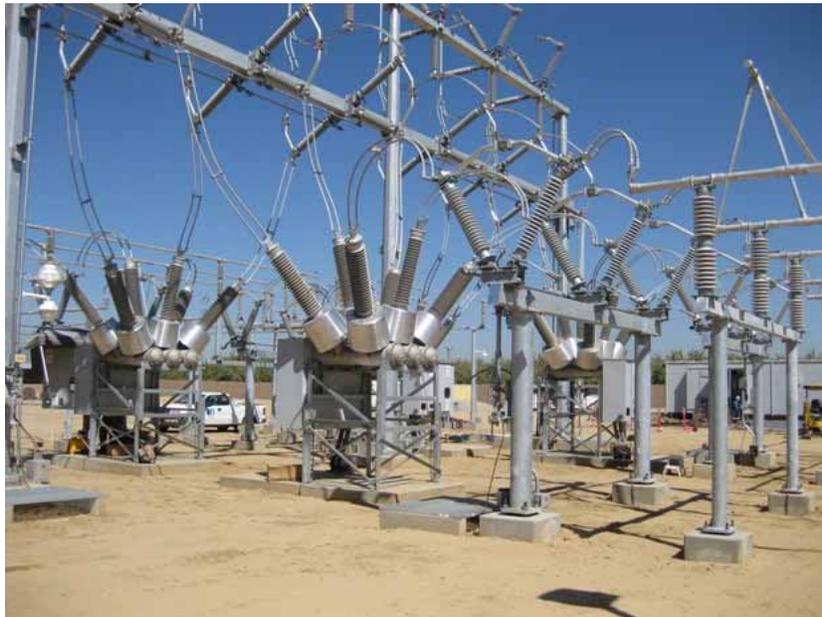
During the subject period, erection of structures continued (see Figure 2). Connections between the structures housing the buses, the transformer, and the electrical controls enclosure were mostly completed (see Figure 3).

Figure 2: The primary electrical contractor, TTR, continued erection of structures. The photograph faces southwestward.

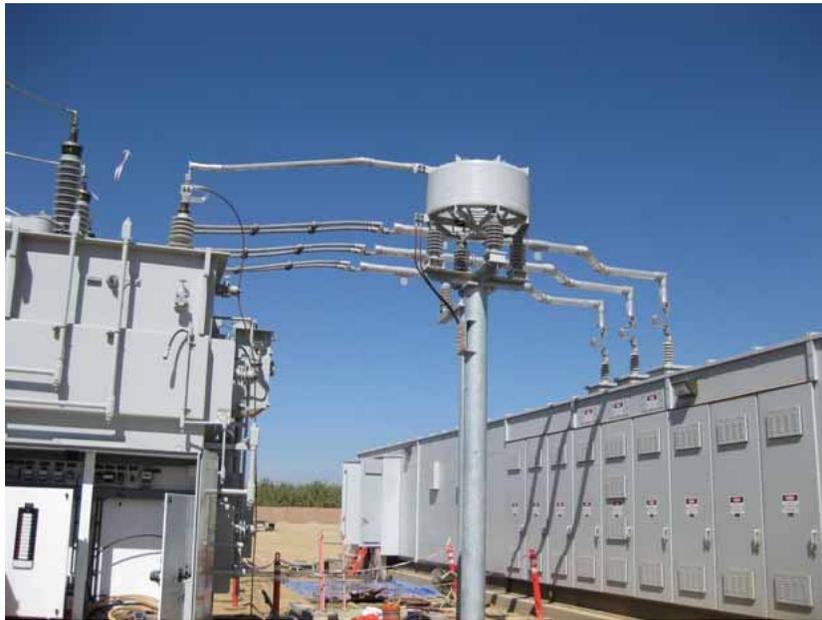
Figure 3: Connections between the structures housing the buses (to the left of the photograph), the transformer (on the left), and the electrical controls enclosure (on the right) were mostly completed during the subject period. The nine panels that will receive wiring from the transformer can be seen on the side of the enclosure. The photograph faces westward.

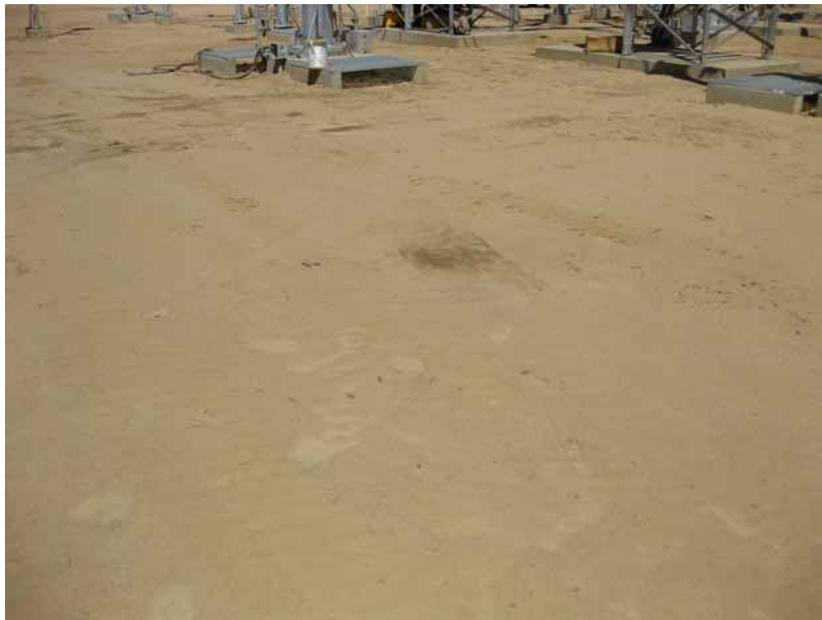
The contractor (TTR) continued to use water trucks for dust control. Watering occurred on dirt surfaces on the entire site as much as three times per day when necessary. At the end of each work day, the site surface consisted of either well-compacted dirt, or, in areas recently disturbed, the loosened soil had a fairly thick crust from watering (see Figure 4). Fugitive dust did not appear to be an issue during the subject period. Applicant Proposed Measures #6 and #7 continued to be enforced.

Figure 4: Water trucks continued to be used for dust control. Watering occurred on dirt surfaces on the entire site as much as three times per day when necessary. At the end of each work day, the site surface consisted of either well-compacted dirt, or, in areas recently disturbed, the loosened soil had a fairly thick crust from watering.
