PROJECT MEMORANDUM PG&E – TRI-VALLEY 2002 CAPACITY INCREASE PROJECT

To: Roosevelt Grant, CPUC
From: Vida Strong, Aspen Project Manager
Date: April 17, 2003
Subject: Weekly Report #30: April 7, 2003 – April 13, 2003
CPUC Environmental Monitor (EM): Anne Sweet

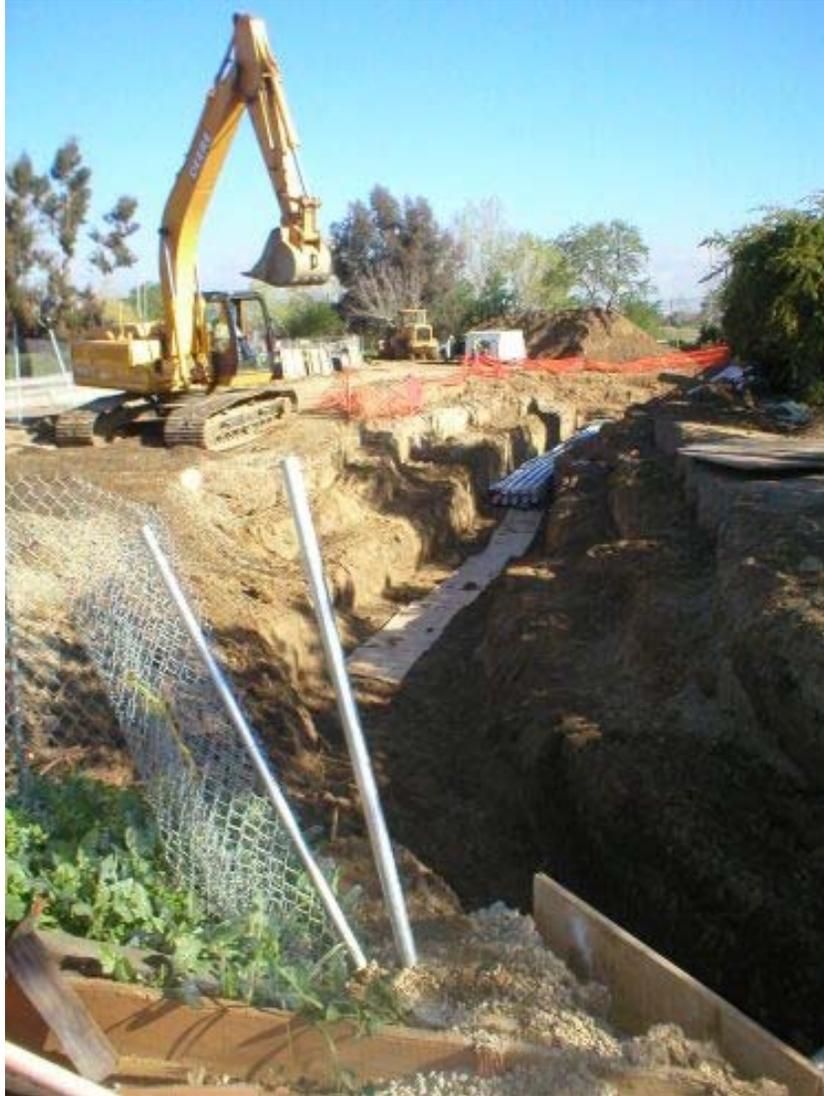
Figure 1
Trench tie-in south of the Arroyo bore.

For the area north of the Arroyo del Valle extending to the Vineyard Substation, vault installation and tie-ins had been completed and the area compacted and re-contoured. However, installed conduit proofing showed that a segment of conduit needed to be repaired. During the subject week, crews excavated an area north of the Arroyo del Valle, the concrete casing was broken apart and the line repaired. Short-term erosion controls were installed between the excavation and the north bank of the Arroyo del Valle. Crews set fresh concrete, backfilled and re-compacted the area, and have proofed the new conduit segment.

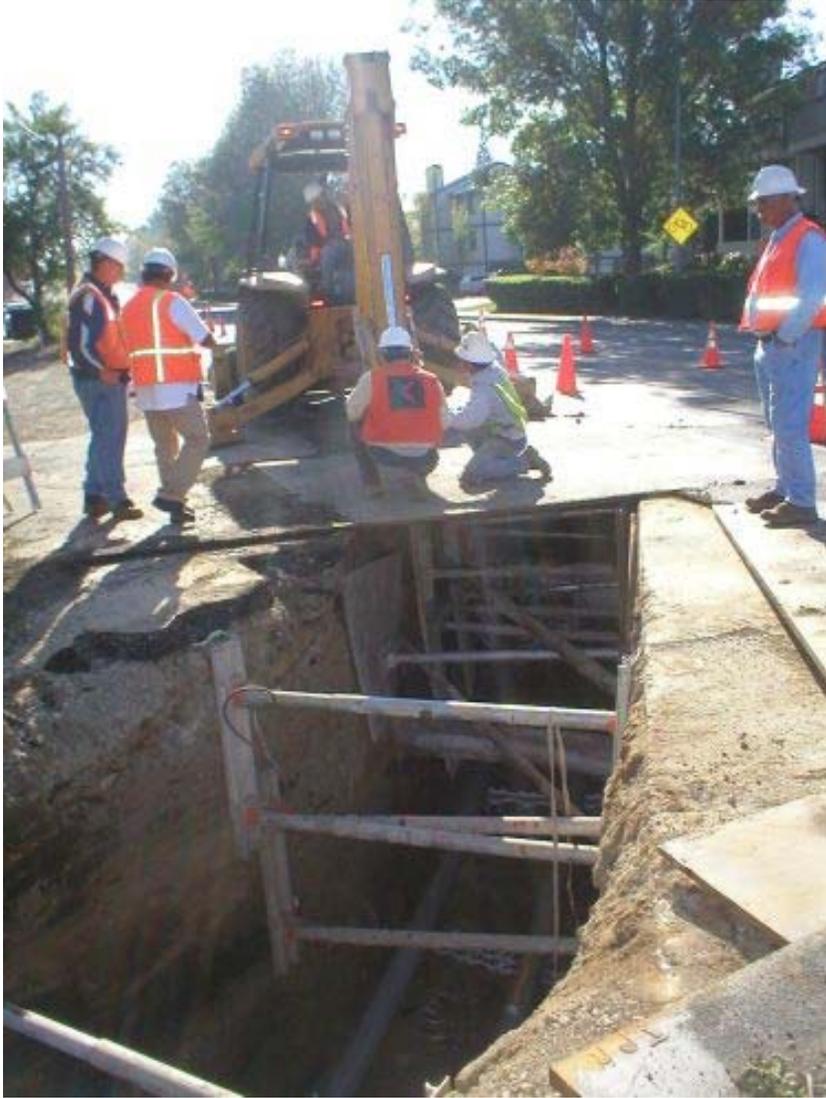
Figure 2
Steel plate cover removal of the trench within "Old" Vineyard Avenue.

Trenching and conduit installation was completed along New Vineyard Road westward from the Vault 14 location and across the intersection with “Old” Vineyard Avenue. Crews also completed trenching and installation within “Old” Vineyard Avenue from the Vault 15 location eastward toward the intersection. The areas were then backfilled and compacted. Crews have completed trenching and conduit installation from the Vault 16 location to the Vault 17 location, and from the Vault 17 location to south of the Arroyo del Valle with concrete being poured over the tie-in by the end of the subject week (see Figures 1 and 2). Crews were also on-site stringing conduit within “Old” Vineyard Avenue between Vaults 16 and Vaults 17 (see Figure 3). Crews were on-site splicing installed transmission line at Vaults 8 and 2. Throughout the “Old” Vineyard Avenue area, crews continued restoration along the right-of-way. Completed street trench areas were re-paved. At the end of each workday, all open trench was covered with steel plates and the areas swept clean. Traffic Control Plans were implemented.

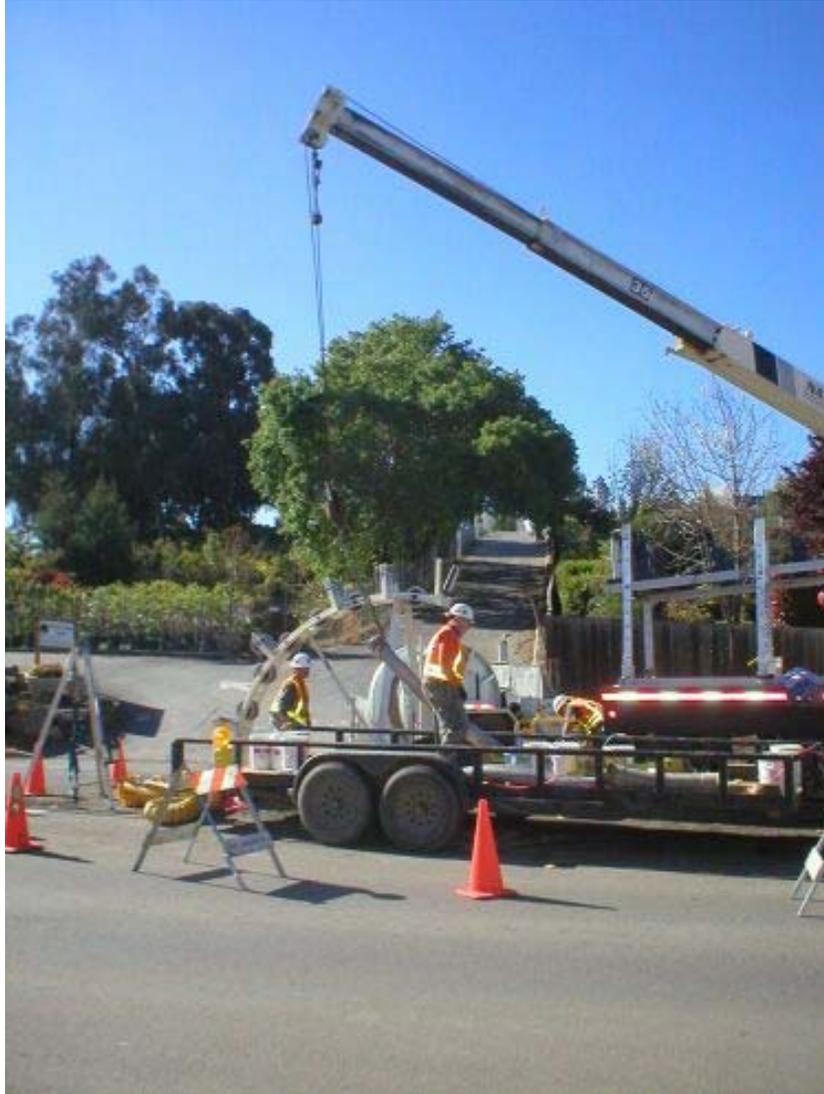
Figure 3
Preparations for transmission line stringing from the Vault 16 location to the Vault 17 location.

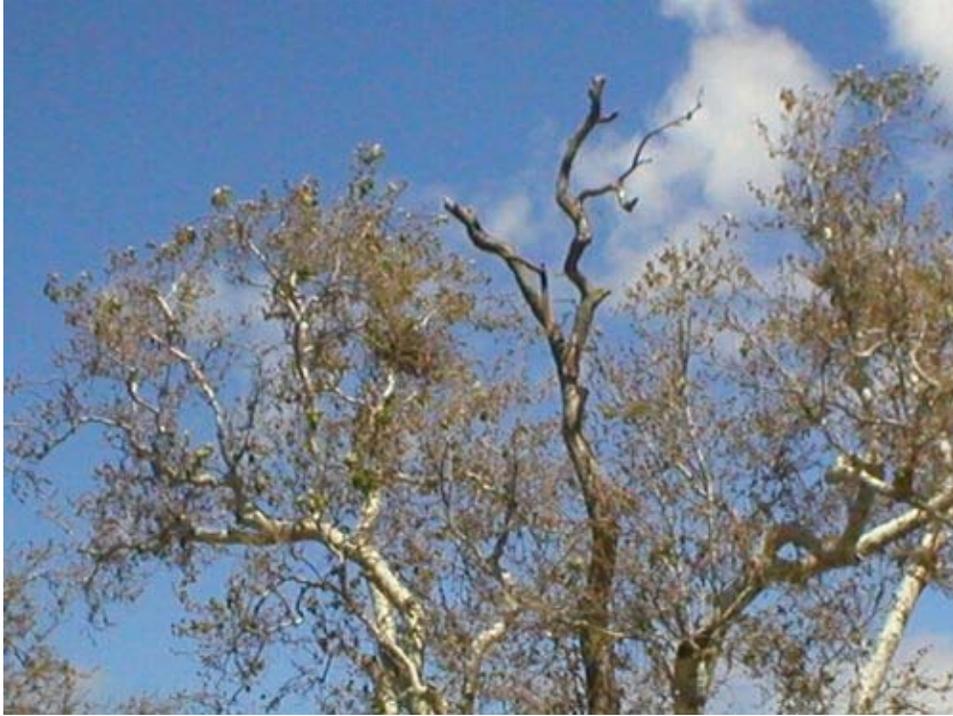
Figure 4
Red Tailed Hawk nest identified across from Station 61+00 (nest is mass located just left of center of the photograph).

The CPUC EM inspected the Red Tail Hawk's nest along the right-of-way near Vault 10. The PG&E biologist surveyed the nest area, as well as the entire Phase One project route. Survey findings showed that the Red Tail Hawk of concern is a juvenile and the observed nesting behavior is a practice exercise for future nesting. Therefore the nest is not active. Brandon Liddell removed the exclusion signs. However, during the project wide survey, an active Red Tail Hawk's nest was identified along the project right-of-way along the Zone 7 Access Road east of Highway 84 at Station 61+00 (see Figure 4). Exclusion signs were erected. Construction and some restoration activities have already been conducted through the area.

Within the area between Highway 84 and the Transition Station, restoration and grading work continued. Grapevines row extensions are being installed up to the underground installation. Crews were on-site stringing fiber optic through the installation. All work within the Red Tail Hawk nest exclusion area at Station 61+00 is being avoided.

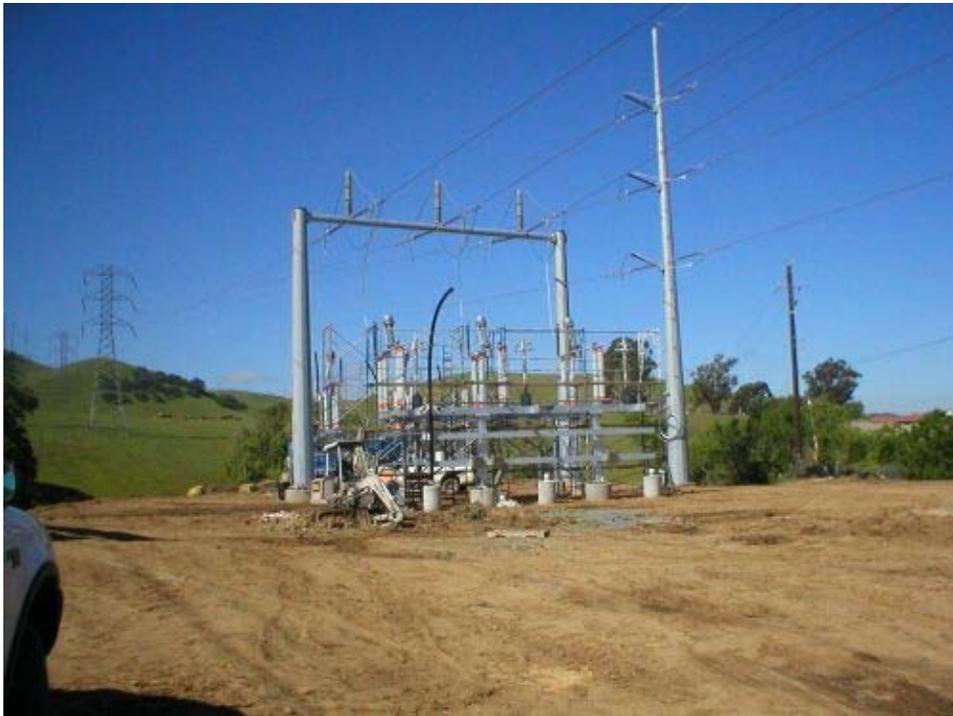
Figure 5
Continued work at the Transition Station.

At the Transition Station, connections to the existing Contra Costa-Newark transmission line, which overhangs the station area, have been made to the erected station poles. Crews completed installation of switching equipment and have finished conduit stringing from the underground installation up the pole supports (see Figure 5). On April 7, very deep holes were augured into the foundation pad and grounding wires were installed. The current grading at the site does not conform the engineering plans. Crews were on-site re-grading the foundation pad to a two percent slope. On April 11, crews started putting up fence poles around the station area. The CPUC EM checked erosion controls at the site, which appeared in good repair. Trucks and applicable equipment were being kept outside of exclusion boundaries at the Station site.
