## **PROJECT MEMORANDUM PG&E – TRI-VALLEY 2002 CAPACITY INCREASE PROJECT**

**To:** Roosevelt Grant, CPUC  
**From:** Vida Strong, Aspen Project Manager  
**Date:** August 20, 2003  
**Subject:** Weekly Report #48: August 11, 2003 – August 17, 2003  
**CPUC Environmental Monitor (EM):** Anne Sweet and Jenny Slaughter

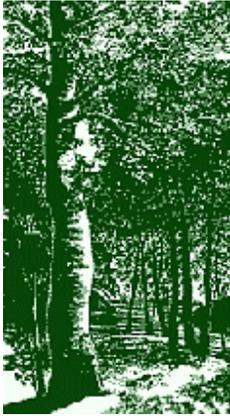
Vault installation occurred at locations CC-4 and DC-23, CC-5 and DC-24, CC-6 and DC-25 including the removal and replacement of a damaged vault (see Figure 2). At the end of each workday a ramp was installed in the pits to avoid animal entrapment. By the end of the subject week, the vault boxes were lowered into the pits. Crews backfilled the void between the vault boxes and pit excavations to avoid the possible entrapment of wildlife. Crews have also begun the excavation for Vault CC-5 and DC-24.

Figure 2 – Replacement of a damaged vault along May School Road, Phase Two.

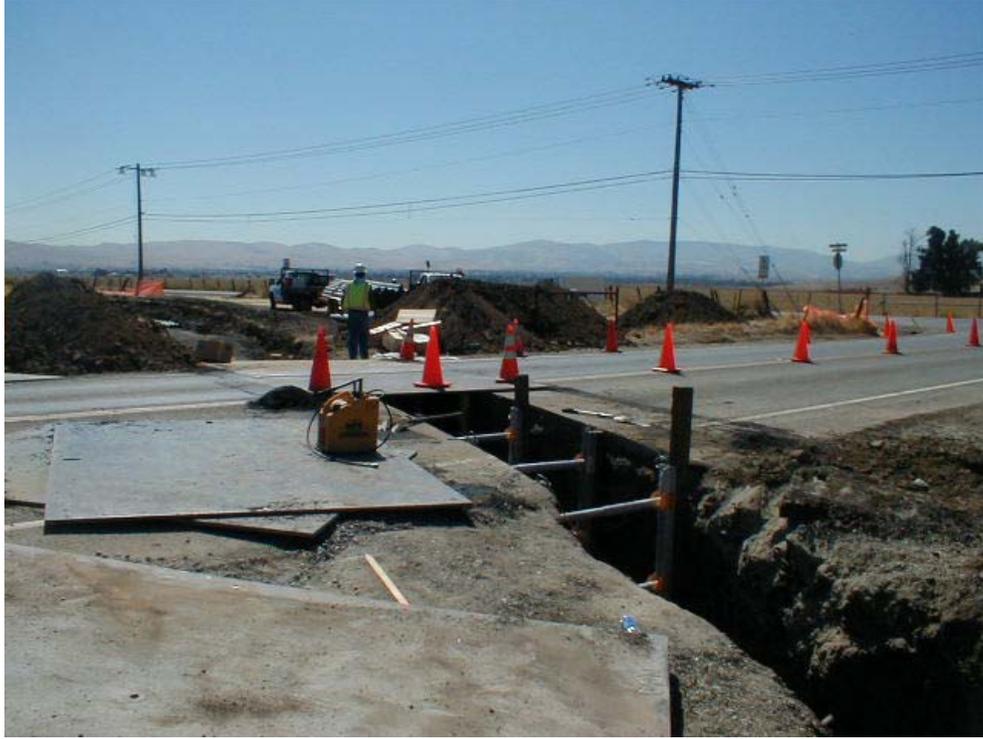
Crews completed trenching and conduit installation operations along May School Road and completed the road crossing of North Livermore Avenue during the subject week (see Figure 1). Concrete was poured over completed installations, and backfilled first with sub-soils up to base grade and then with the separated topsoils. Several locations along this segment have yet to be backfilled, which is expected to take place as the concrete cures. At the end of each workday, the contractor ramped the ends of the trench line and installed caps at the ends of each conduit.

Figure 1 – Trenching and conduit installation across North Livermore Avenue, Phase Two.

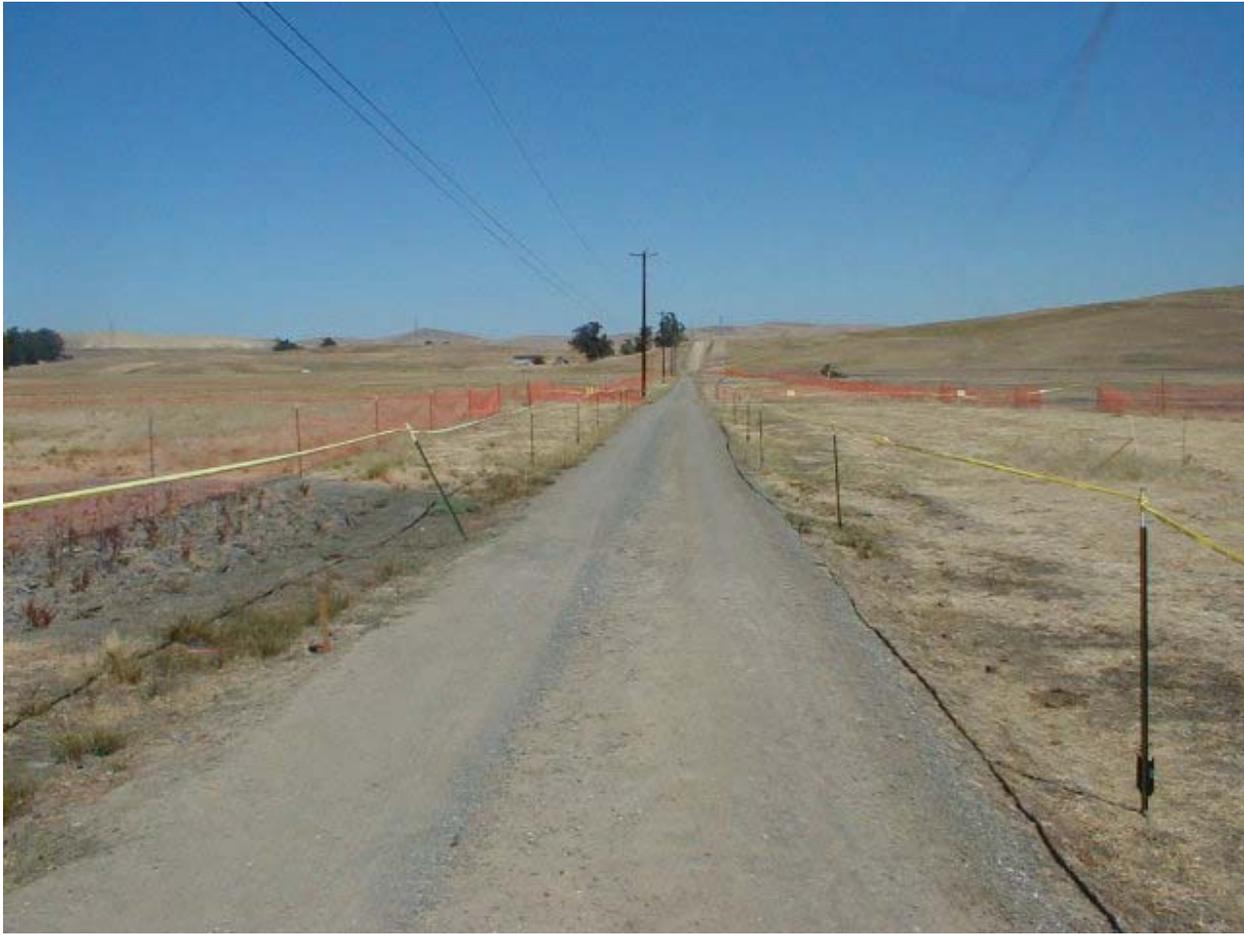
PG&E submitted documentation stating that the seasonal wetland east of Dagnino Road did not provide suitable habitat for sensitive species and therefore did not require a 100-foot buffer (see Figure 3). Further, the documentation demonstrated that the subject wetland is located within the mitigation site for the Dublin Ranch Development and as a result will soon be graded to establish the future wetland mitigation site. Documentation submitted included several biological survey reports, wetland delineations, excerpts from the Biological Opinion for this project and the Dublin Ranch Development, and maps. This information was submitted to Aspen/CPUC on Monday, August 18<sup>th</sup> for review. PG&E was notified on August 19 by the Aspen Project Manager that the 100 foot buffer could be reduced; however, exclusion fencing shall be installed to prevent any construction activity from entering the mitigation site and subject seasonal wetland.

Figure 3 – Buffer zone for potential aquatic invertebrate habitat along the North side of the access road between Dagnino Road and the Transition Station, Phase Two. PG&E trenchline is on the opposite side of the access road from the depression.
