PROJECT MEMORANDUM PG&E – TRI-VALLEY 2002 CAPACITY INCREASE PROJECT

To: Jensen Uchida, CPUC
From: Vida Strong, Aspen Project Manager
Date: November 2, 2005
Subject: Weekly Report #82: October 23, 2005 – October 29, 2005
CPUC Environmental Monitor (EM): Christopher Meyer

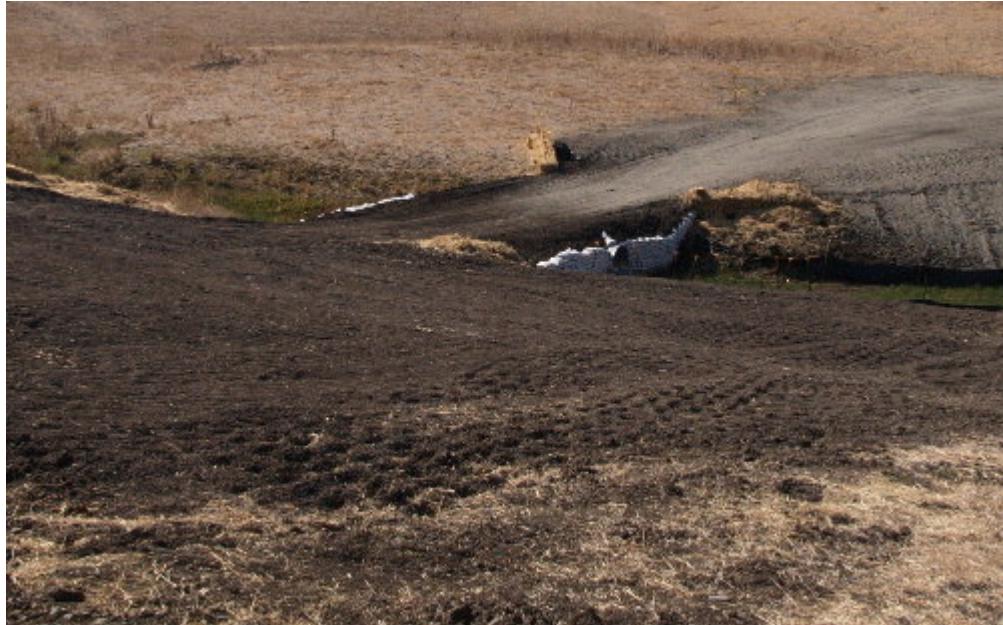
Figure 1 – Crossing of Cayetano Creek was in place on October 28th.

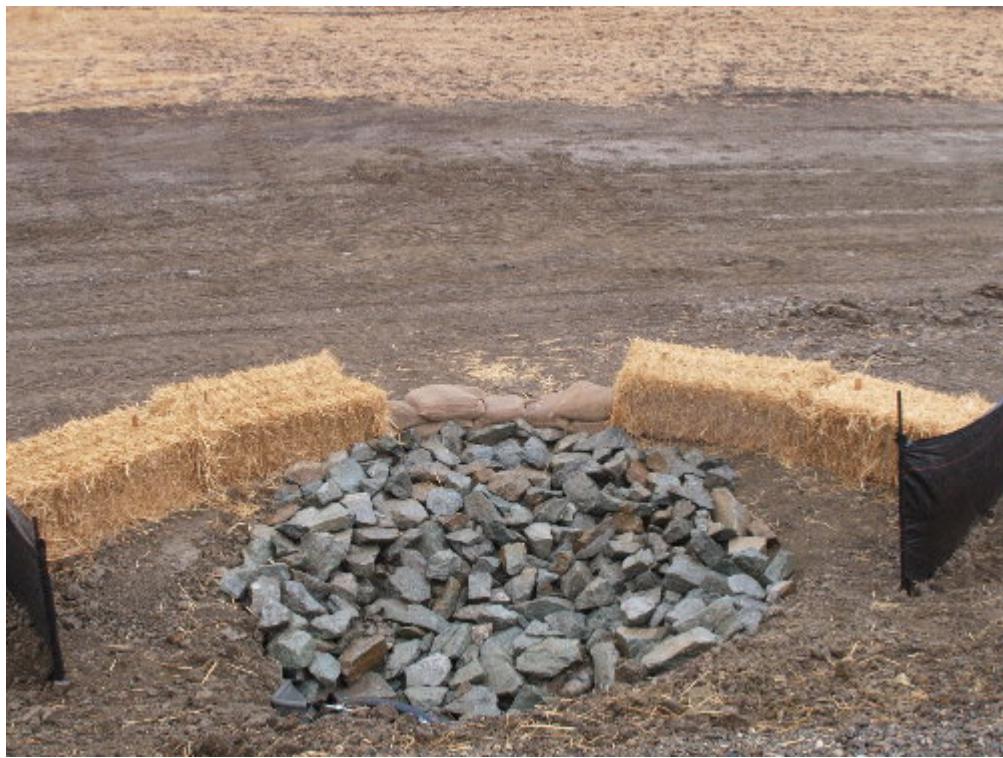
Sediment control devices were installed around the new culvert installations on Moller Road (see Figure 2). The CPUC Lead EM expressed concerns that problems such as the lack of proper installation of the straw bales could lead to failure of the devices and possibly lead to plugging the culverts. The concerns expressed by the CPUC EM previously that existing wetland areas adjacent to the roads could be impacted by the new drain features are being addressed by PG&E and the RWQCB. PG&E and a RWQCB hydrologist have a meeting scheduled for this week to address the issue.

Figure 2 – Straw bales upstream of culvert installation along Moller Ranch Road.

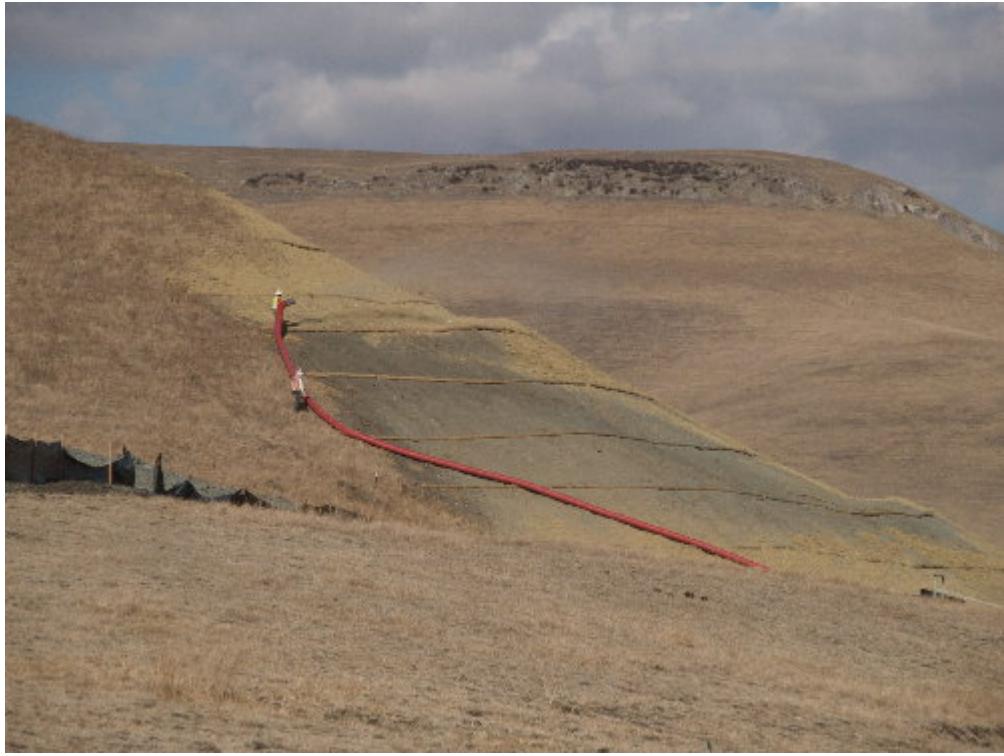
A crew hydroseeded and spread straw over the straw wattles on the slopes along Moller Ranch Road (see Figure 3). The crews used a hose to spread the straw on the upper sections of the slope and spread the straw directly from the unit on the lower portions of the slope. No installation of a bonding agent was noted during the site visit.

Figure 3 – Crew spreading straw over slopes after hydroseeding along Moller Ranch Road.

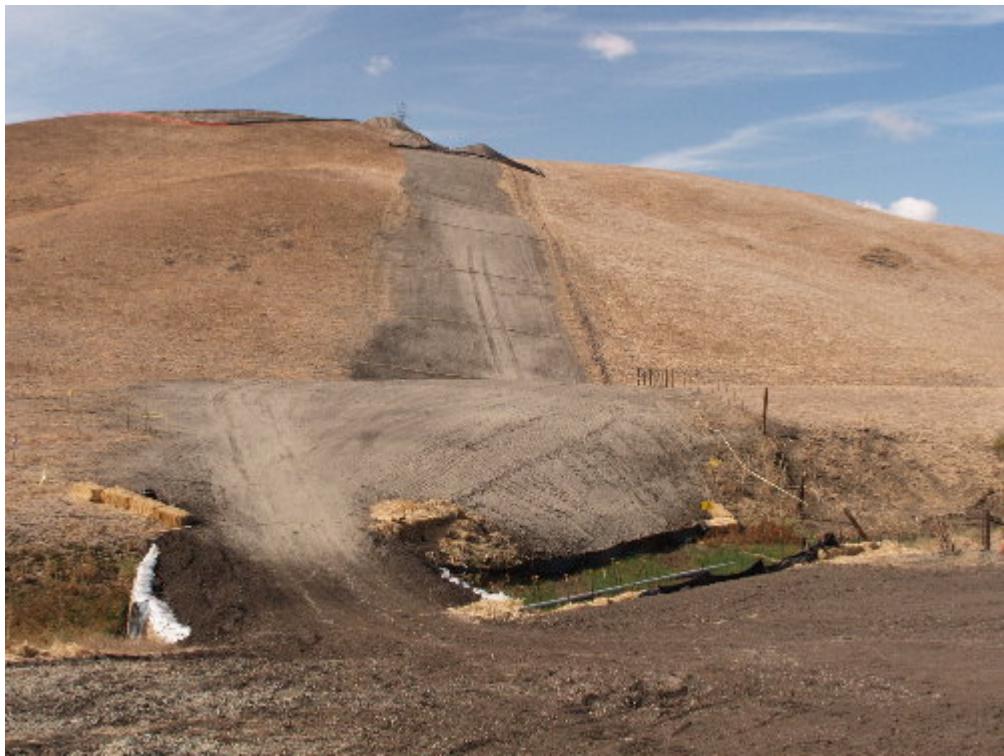
Figure 4 – Long slope over Cayetano Creek lacks adequate BMPs to address erosion prevention and sediment control.

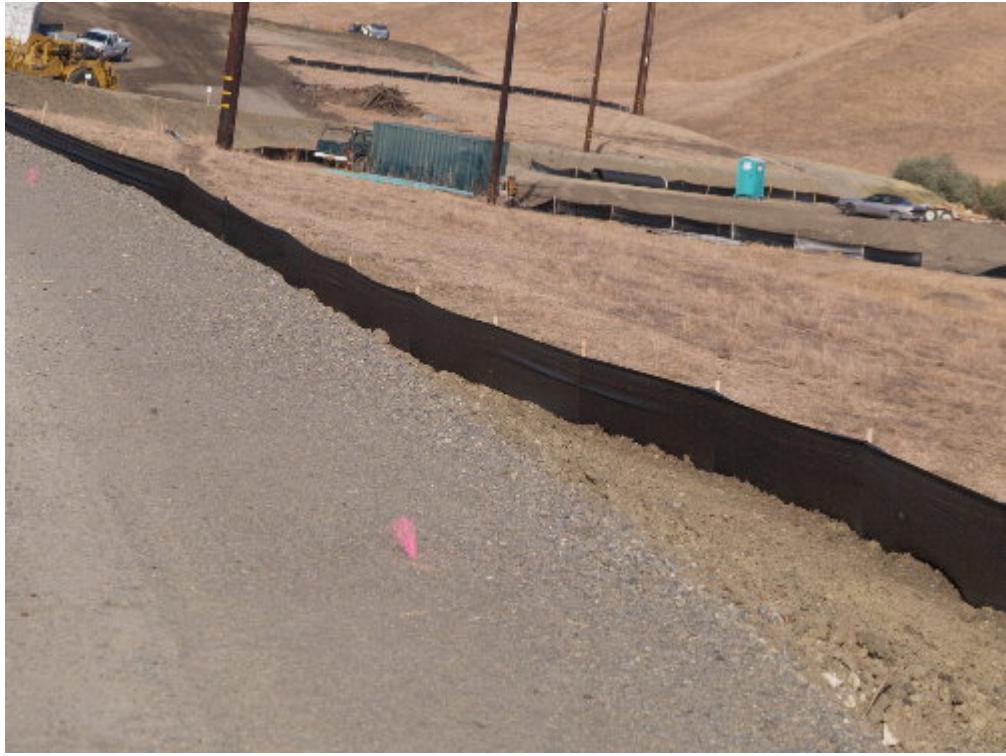
Figure 5 – The silt fencing in several locations was installed either too tightly or at an angle allowing water and sediment to flow along the silt fencing towards resources.

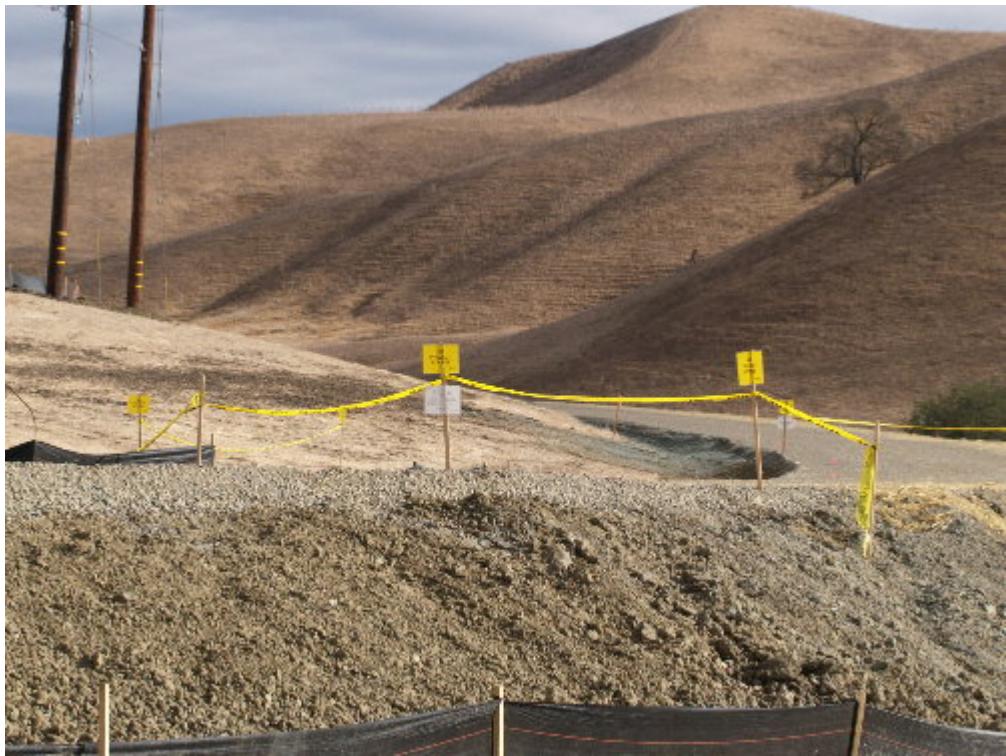
The PG&E EI at Moller Ranch observed a burrowing owl south of the Dublin Substation site and initiated the process of contacting the resource agencies. The burrow was identified and exclusion fencing and signs were placed on the access road and work space that were within 160 feet of the burrow (see Figure 6). PG&E is coordinating with representatives from the resource agencies on mitigation to allow work to continue in the area. The burrow appears to have been established after the current work started in the area.

Figure 6 – Exclusion tape and signs were placed on a section of Moller Ranch Road within 160 feet of the burrowing owl burrow discovered on October 27th.
