PROJECT MEMORANDUM

PG&E – TRI-VALLEY 2002 CAPACITY INCREASE PROJECT

Subject: Weekly Report #83: October 30, 2005 – November 5, 2005

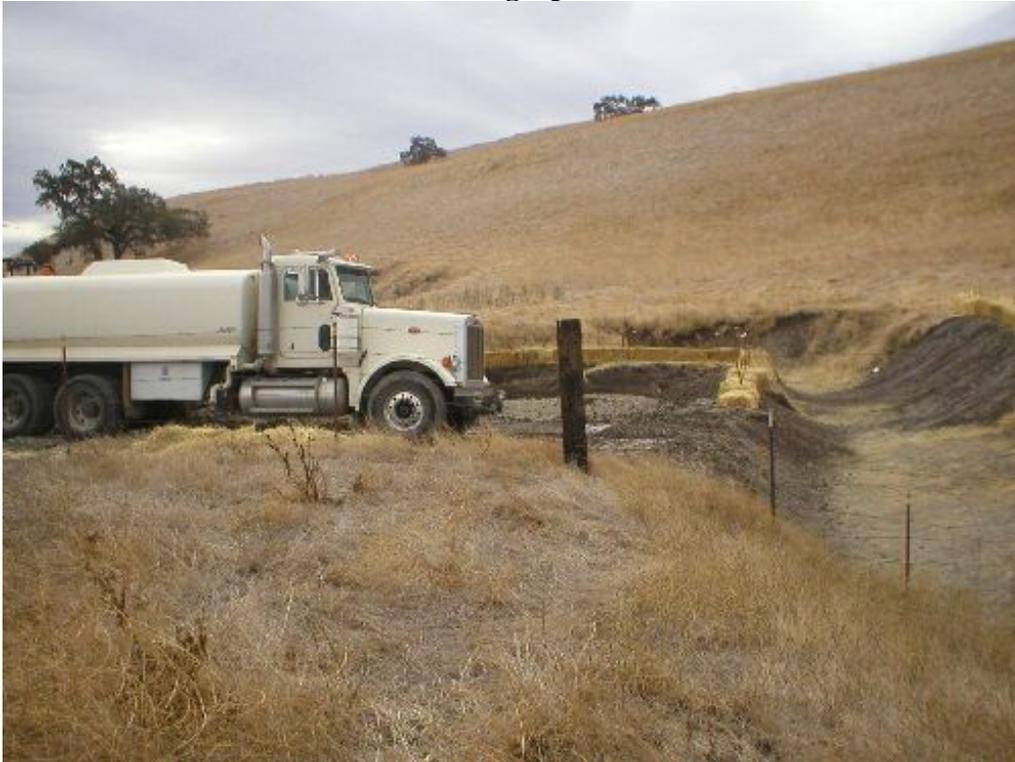
Figure 1 – On November 2nd, at the Cayetano Creek crossing, ground disturbing activity had occurred within the 30-foot buffer established around potential California red-legged frog and California tiger salamander habitat.

On November 2nd, ground disturbance activities occurred within the 30-foot buffer established around potential California red-legged frog and California tiger salamander habitat at Cayetano Creek. The conditions in the project Biological Opinion stipulate that work within this buffer is prohibited between November 1st and April 30th. The PG&E EI was forth right that he unintentionally overlooked the buffer requirement. Opus immediately notified the USFWS of the work within the potential habitat buffer and the issue was documented in the NCR issued by the CPUC EM on November 3rd.

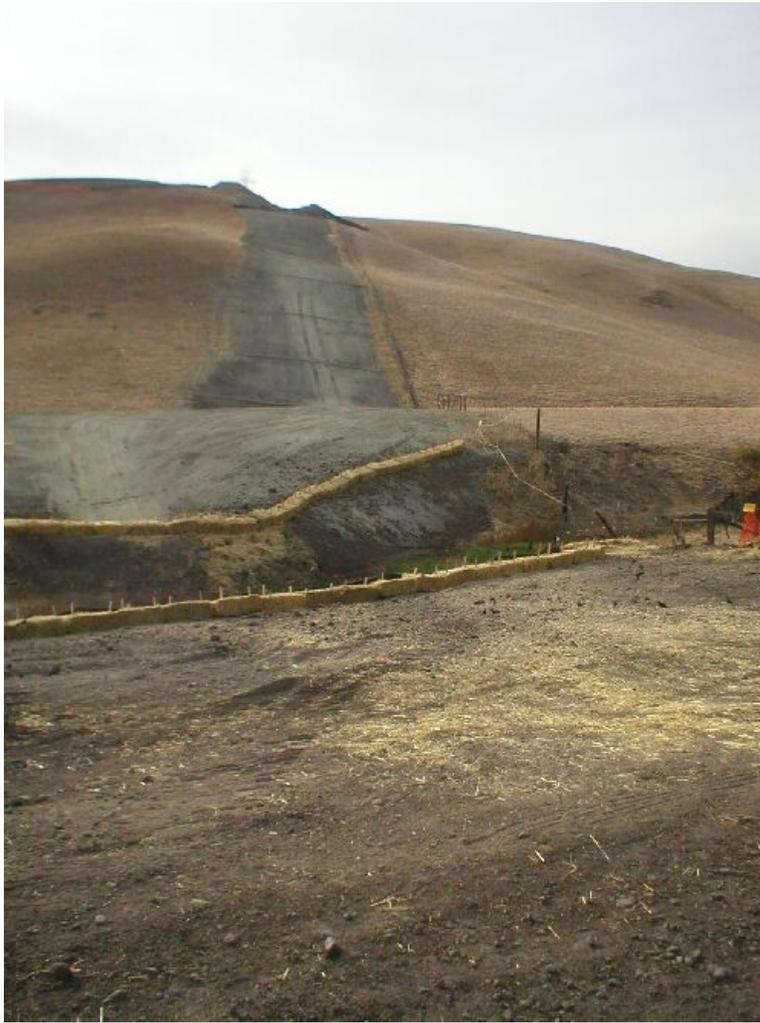
Figure 2 – Long slope over Cayetano Creek lacks adequate BMPs to address erosion prevention and sediment control – November 2nd.

On November 2nd, the CPUC EM noted the lack of adequate erosion controls where the Ranger Construction activities crossed Cayetano Creek just off of Road 5. This is a different area than where work occurred within the 30-foot buffer zone. Erosion controls were installed by November 4th.

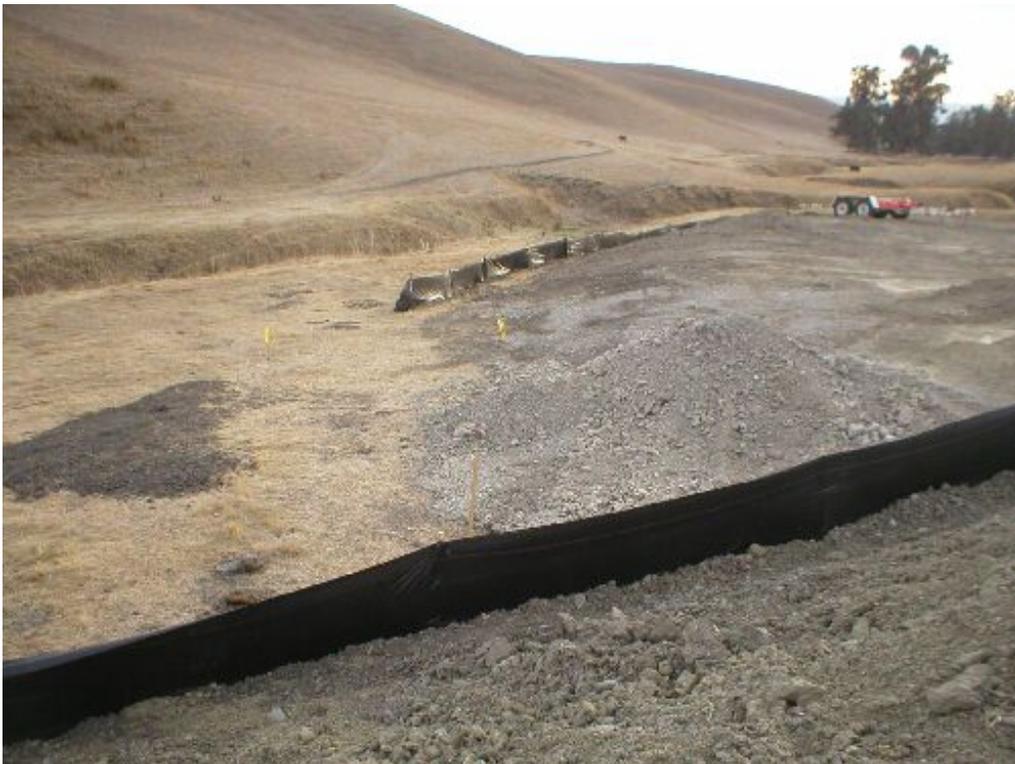
During the tour of Moller Road on November 1st, the CPUC EM noted that a spoil pile located in the staging yard across from the Substation site and adjacent to Tassajara Creek lacked adequate protection (see Figure 4). PG&E had previously been notified of the problem twice and the CPUC EM documented the issue in a Project Memorandum. During the tour on November 2nd, the CPUC EM documented that fiber rolls had been installed around the spoils pile and silt fencing had been extended to further protect the creek.

Figure 4 – Inadequate erosion controls around graded areas and a spoils pile located in a staging area adjacent to Tassajara Creek - November 1st.

During the tour of Moller Road on November 1st, the CPUC EM noted that a spoil pile located in the staging yard across from the Substation site and adjacent to Tassajara Creek lacked adequate protection. PG&E had previously been notified of the problem twice and the CPUC EM documented the issue in a

Project Memorandum. During the tour on November 2nd, the CPUC EM documented that fiber rolls had been installed around the spoils pile and silt fencing had been extended to further protect the Creek.

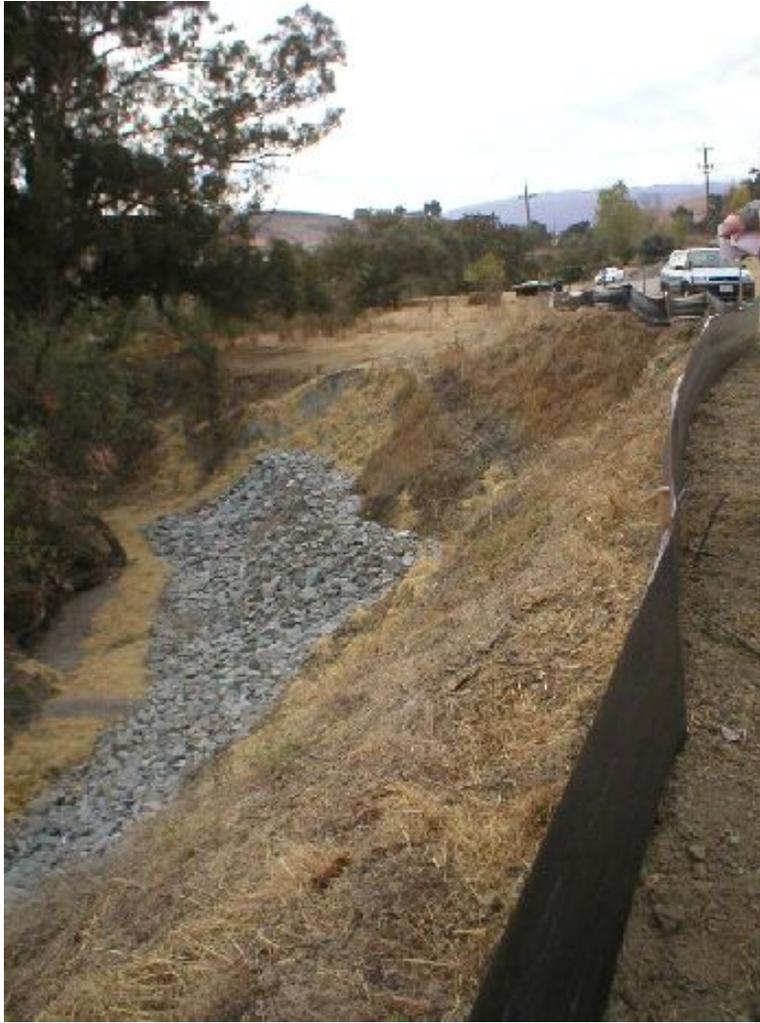
On November 2nd, the CPUC EM toured the site with CH2MHill and the PG&E EI. The CPUC EM noted that at the Tassajara Creek bank stabilization area riprap has been installed by Granite Construction; however, the upslope erosion cloth installation as outlined in the USFWS BO has not yet occurred (see Figure 5). October 31st is the deadline for the bank stabilization work in both the USFWS BO and the CDFG Streambed Alteration Agreement. PG&E had been repeatedly informed of the necessary erosion protection requirements, as well as work deadlines. Opus Environmental notified CDFG that the installation had not met the required deadline. The issue was documented in the November 3rd NCR. During the follow up tour on November 4th, erosion cloth installation, as outlined in the USFWS Biological Opinion (BO), had occurred at the Tassajara Creek bank stabilization area (see Figure 6).

Figure 5 – Bank stabilization work in Tassajara Creek - November 2nd.
Note the incomplete erosion controls.

At the Tassajara Creek bank stabilization area, the upslope erosion cloth installation as outlined in the USFWS BO had not occurred by October 31st, the deadline for the bank stabilization work in both the USFWS BO and the CDFG Streambed Alteration Agreement. PG&E had been repeatedly informed of the necessary erosion protection requirements, as well as work deadlines. Opus Environmental notified CDFG that the installation had not met the required deadline. The installation was completed by November 4th.

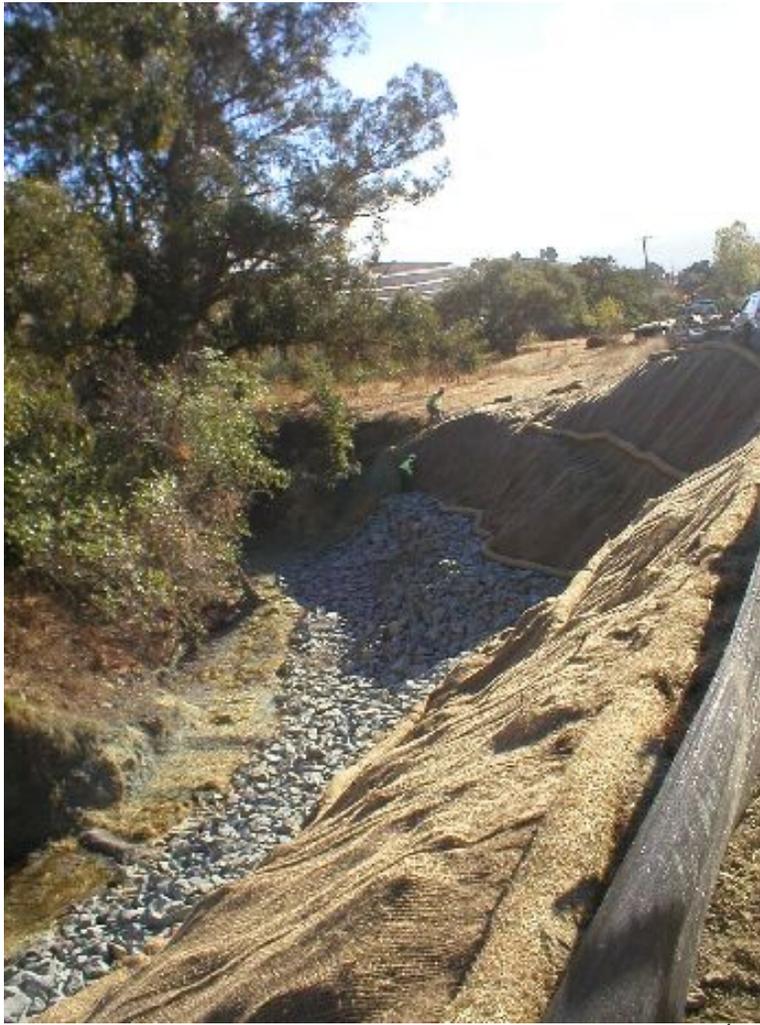
Figure 6 – Bank stabilization work in Tassajara Creek - November 4th. Note the complete erosion controls.

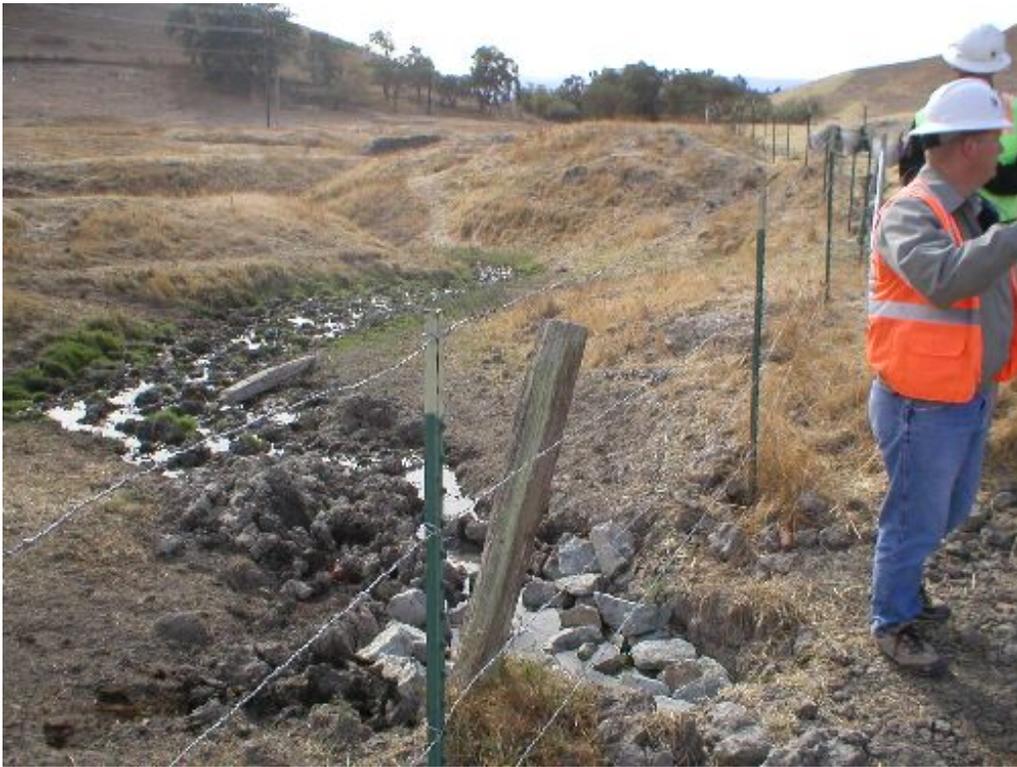
The CPUC EM had previously expressed concerns that existing wetland areas adjacent to the roads could be impacted by the new drain features. These concerns were again reiterated (see Figure 7). CH2MHill responded that their hydrologist has analyzed the site and a report will be submitted to PG&E. The CPUC EM requested that the CPUC and the RWQCB be given copies of the report.

Figure 7 – French Drain installation resulting in diverted flow down a drainage channel from a nearby wetland area - November 2nd.

During the subject week, Aspen/CPUC responded to comments supplied by Brian Wines/RWQCB concerning information supplied in the Project Weekly Report #82. After discussions with PG&E, the CPUC EM had reported that PG&E had a meeting with a RWQCB hydrologist. This turned out to be incorrect. A CH2MHill hydrologist had visited the site and will be supplying a report regarding two sub drains placed in Moller Road to PG&E and RWQCB.
