PROJECT MEMORANDUM PG&E – TRI-VALLEY 2002 CAPACITY INCREASE PROJECT

To: Jensen Uchida, CPUC
From: Vida Strong, Aspen Project Manager
Date: January 4, 2006
Subject: Weekly Report #91: December 25, 2005 – December 31, 2005
CPUC Environmental Monitor (EM): Anne Sweet

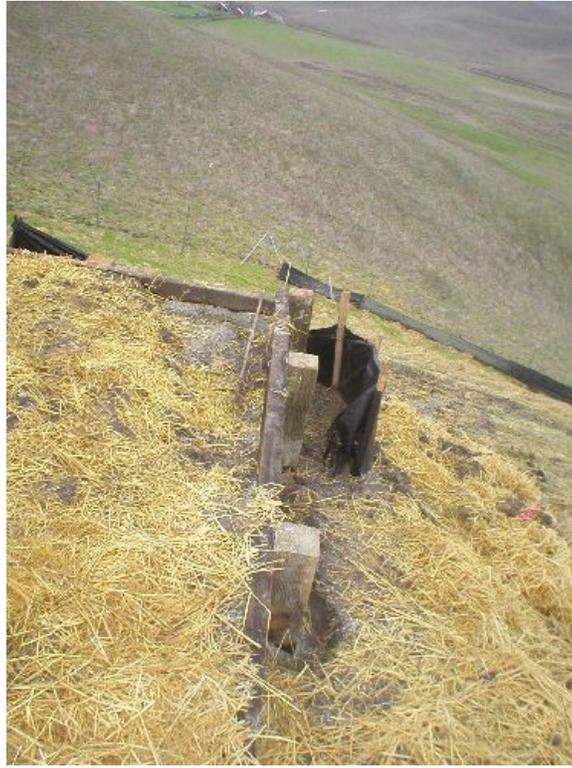
At the Transition Station, the pad has showed signs of erosion at the northeast corner of the bulkhead. Granite filled the corner with concrete and installed sediment fence below the area on December 22nd; however, erosion continues and additional maintenance will be required (see Figure 1).

Figure 1 – Erosion at the transition station bulkhead,
December 29, 2005.

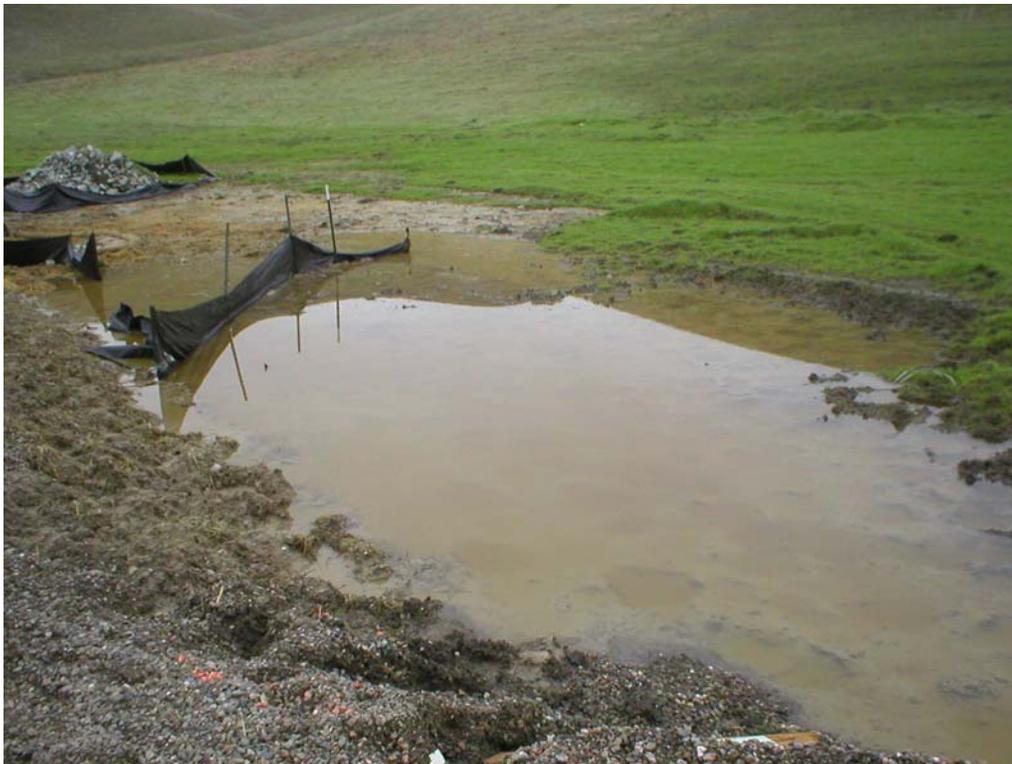
An on-foot tour was conducted by the CPUC EM and PG&E EI on December 29th to review the site prior to a large storm event forecast over the weekend. Along Moller Road and the mitigation site access road, several areas along the new roadbed including some culvert inlet areas continue to show signs of ponding (see Figure 2). Some erosion has occurred in v-ditches along the side of Moller Road (see Figure 3). In most areas, the controls including those repaired recently are working well and areas that have been hydroseeded are showing good grass growth (see Figure 4), except areas trampled by cattle grazing. Additional seeding may need to occur in those areas. North Valley Construction remained on-call to handle erosion controls maintenance needs.

Figure 2 – Ponded area located along Moller Road, near the substation,
December 29, 2005.

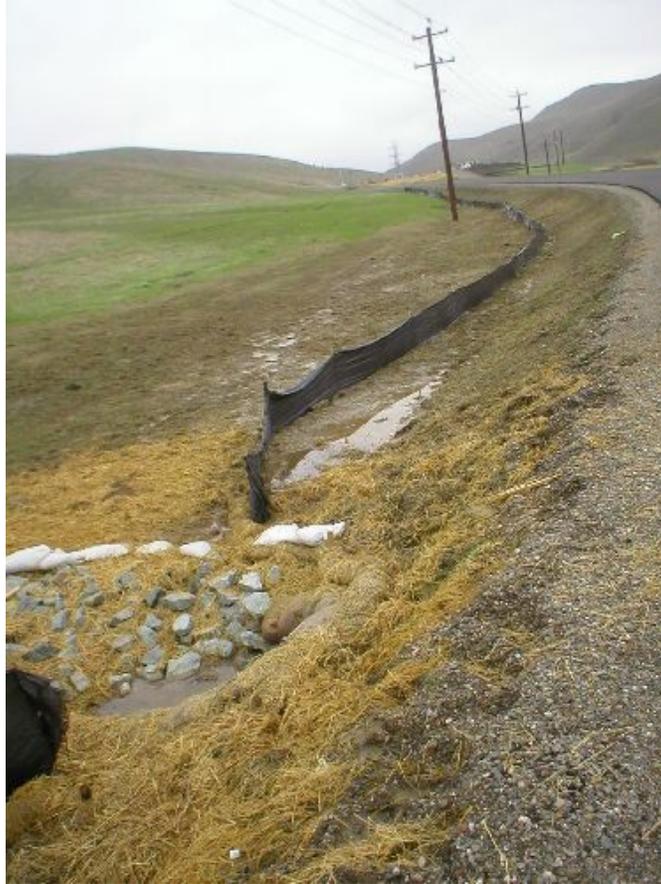
Figure 3 – V-ditch erosion near a culvert along Moller Road, December 29, 2005.

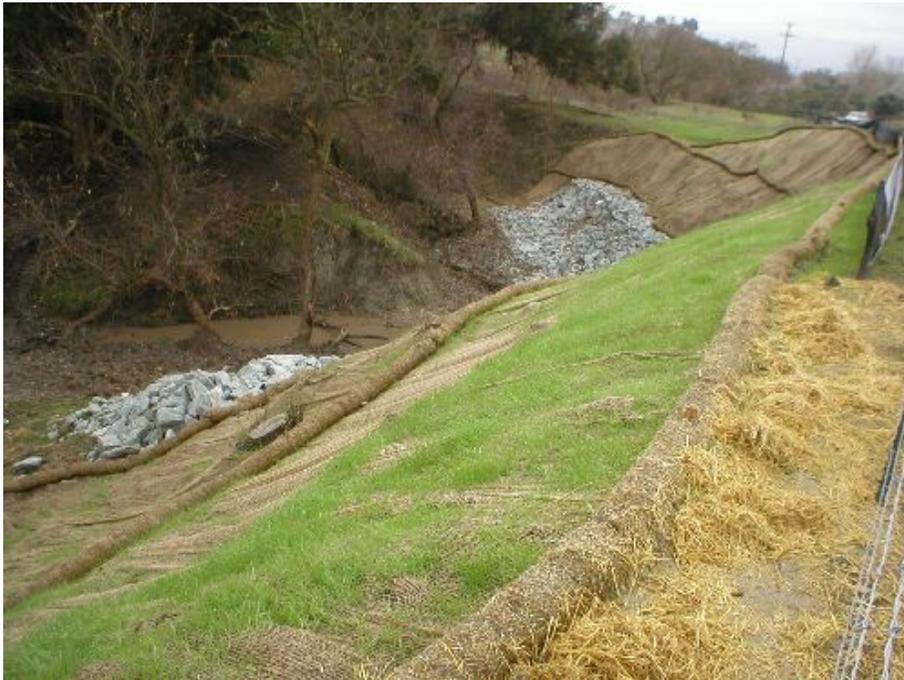
Figure 4 – Good grass growth above the bank stabilization area along Moller Road, December 29, 2005.
