# PACIFIC GAS AND ELECTRIC COMPANY'S APPLICATION TO CONSTRUCT LAKEVILLE-SONOMA 115 kV TRANSMISSION LINE PROJECT CPUC A.04-11-011 Draft Mitigated Negative Declaration

Prepared for:  
California Public Utilities Commission

December 2005

# APPENDIX A – Route Comparison Report<sup>1</sup>

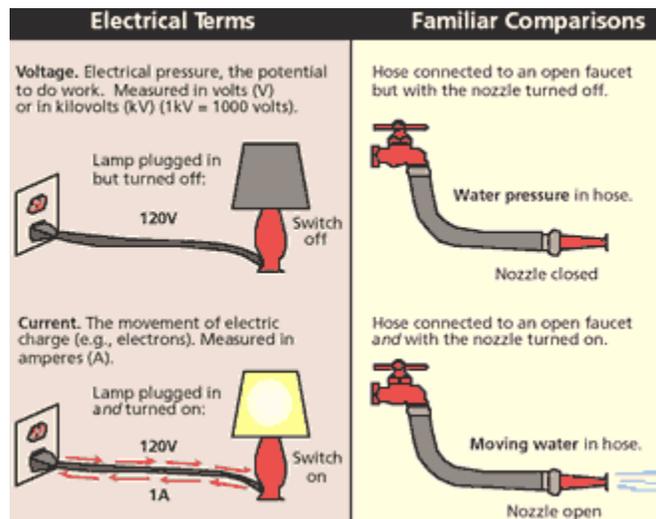
FIGURE B-1  
VOLTAGE VS. CURRENT

Figure B-1 below illustrates the electrical *voltage* and *current* concepts:

As explained by the National Institutes of Health, “...electric fields are produced by voltage and increase in strength as the voltage increases. The electric field strength is measured in units of volts per meter (V/m). Magnetic fields result from the flow of current through wires or electrical devices and increase in strength as the current increases. Magnetic fields are measured in units of gauss (G) or tesla (T).”<sup>2</sup>

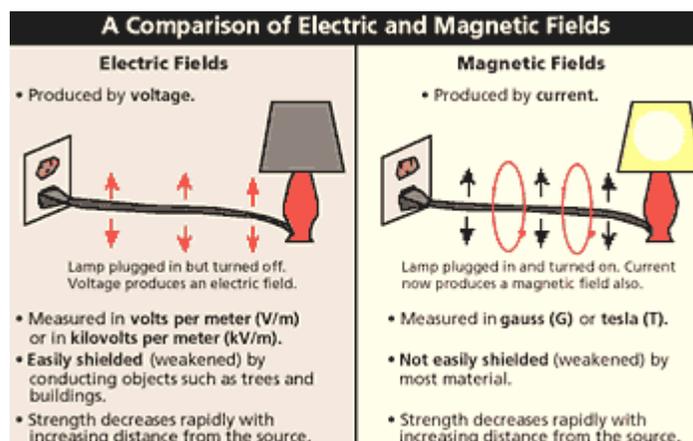
**FIGURE B-2**  
**ELECTRIC VS. MAGNETIC FIELDS**

At low frequencies (such as those associated with EMF from transmission lines), the electric and magnetic fields are separable. By contrast, at high and super high frequencies, the fields are inseparable.<sup>3</sup>

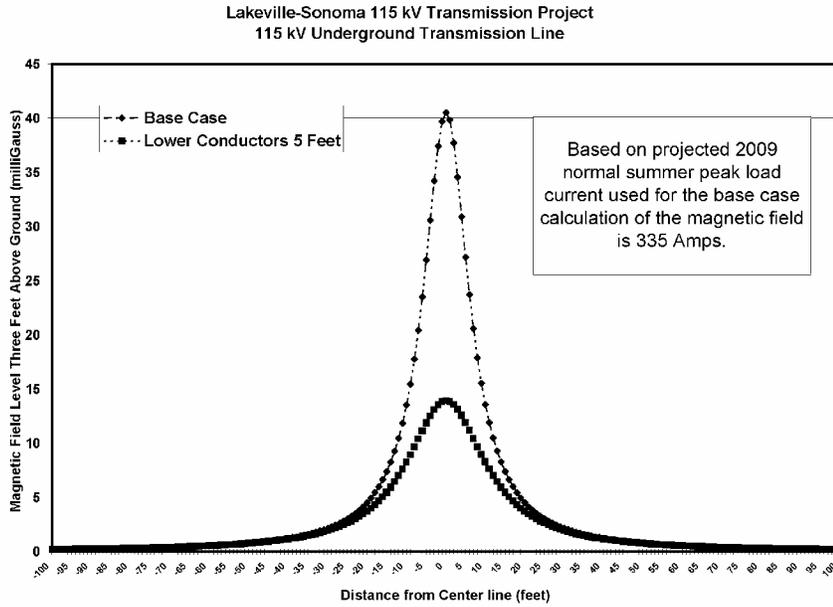
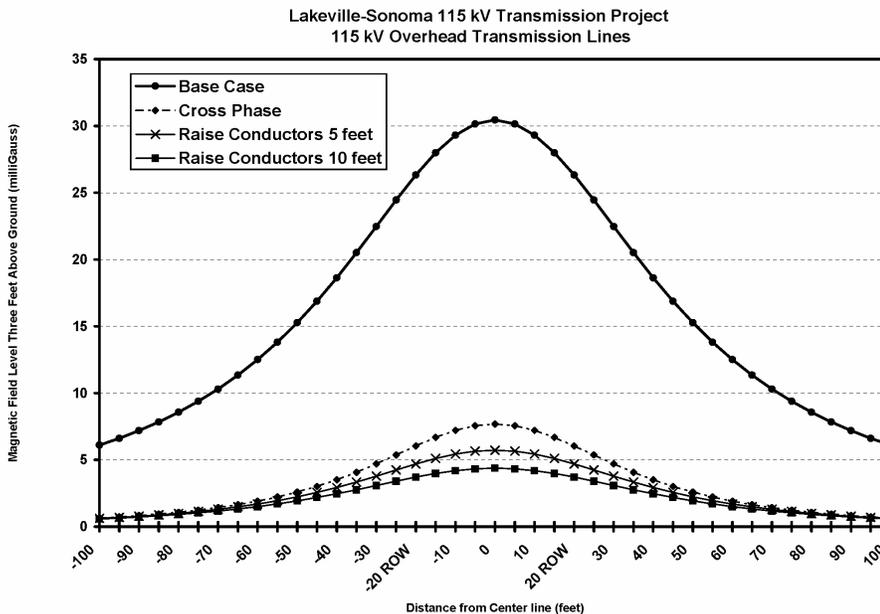
**FIGURE B-4**  
**PG&E ESTIMATED EMF LEVELS WITH AND WITHOUT REDUCTION MEASURES**

- Lakeville-Sonoma Circuit #1 is arranged ABC (Top, Middle, Bottom)
- Lakeville-Sonoma Circuit #2 is arranged CBA (Bottom, Middle, Top)

Based on the calculations provided, the revised maximum magnetic field strength using the cross phasing reduction measure varies from approximately 7.7 mG directly beneath the conductors, to 6.0 mG at the edge of the 40 foot wide right of way. This represents a 77.2 percent reduction in EMF levels at the edge of the right of way relative to the Base Case condition described above. This is considered a “no-cost” field reduction measure that PG&E has indicated will be incorporated into the Proposed Project. PG&E’s graphic representation of EMF levels for both overhead and underground portions of the line with and without EMF reduction measures are

shown on **Figure B-4**.

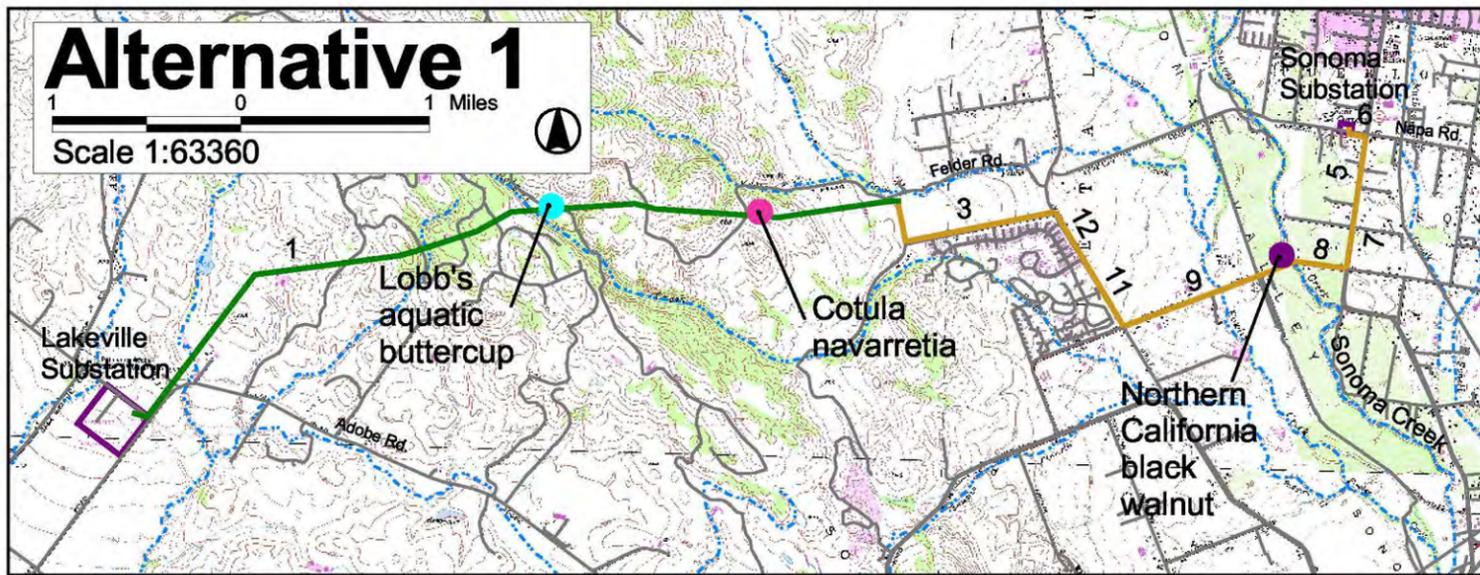
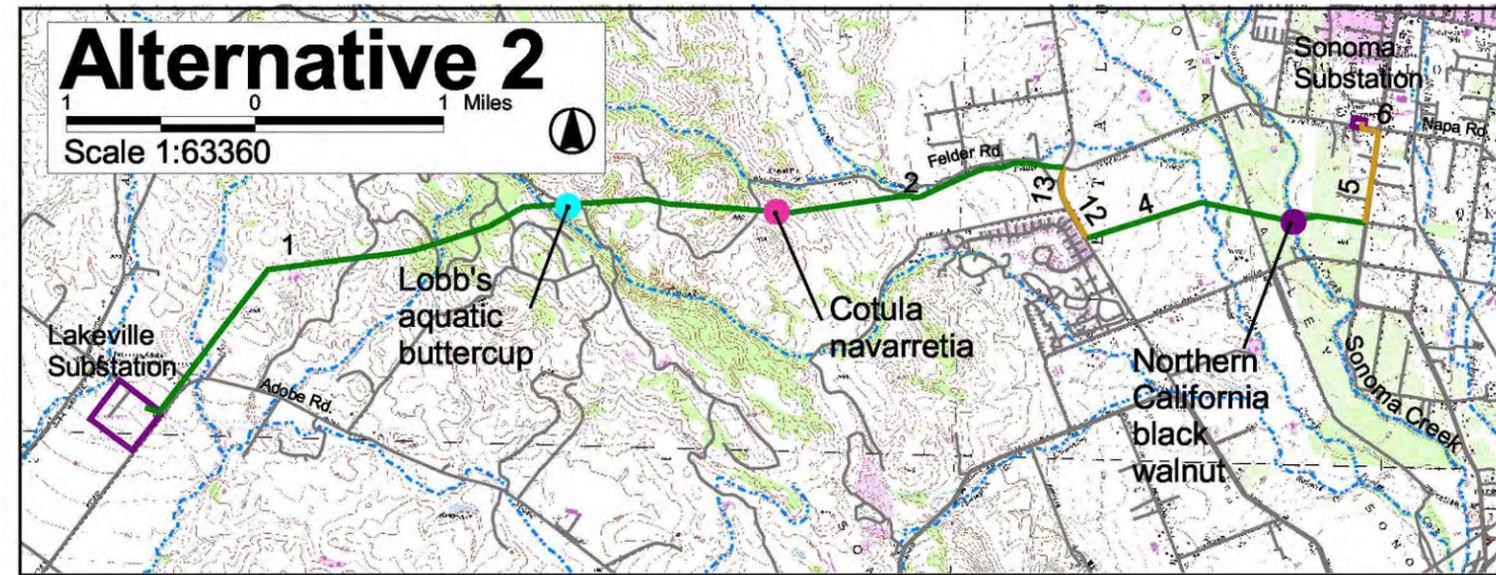
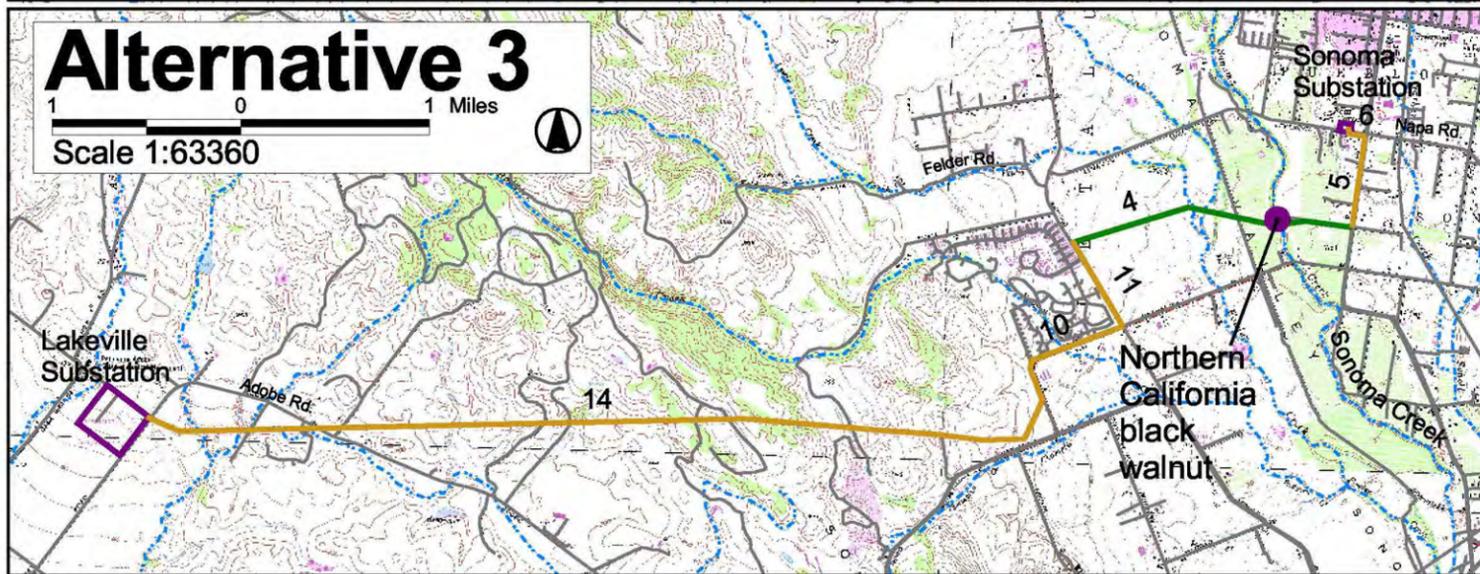
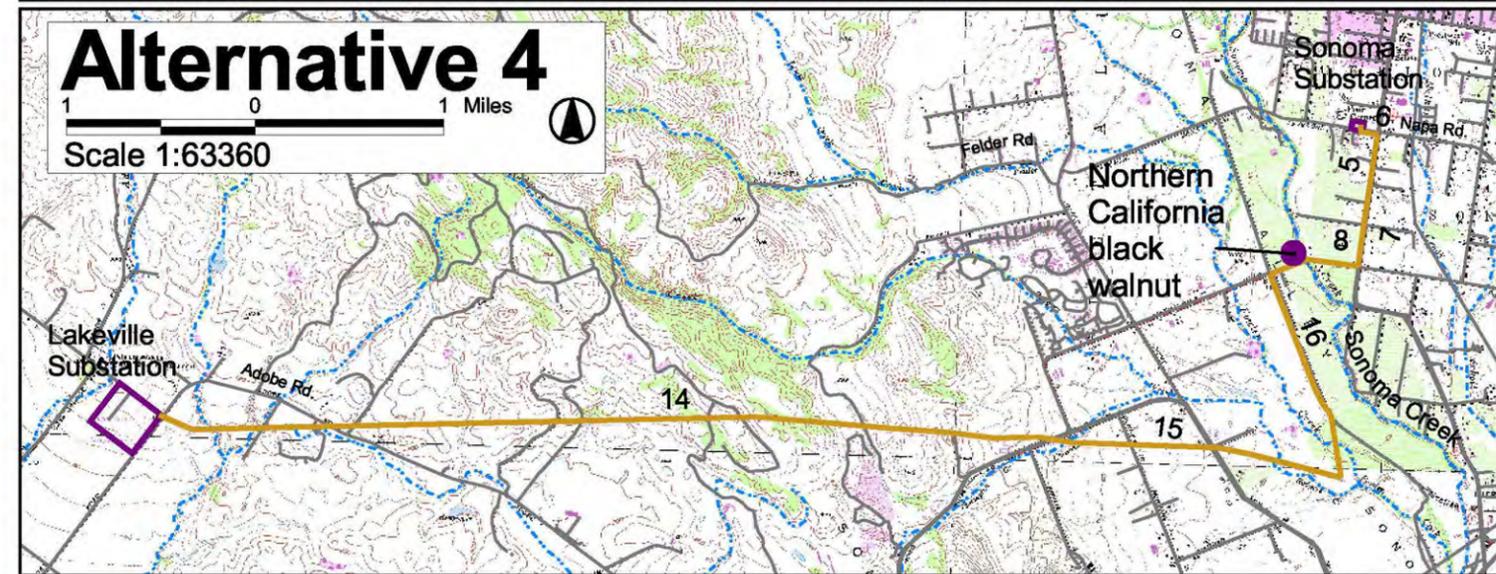
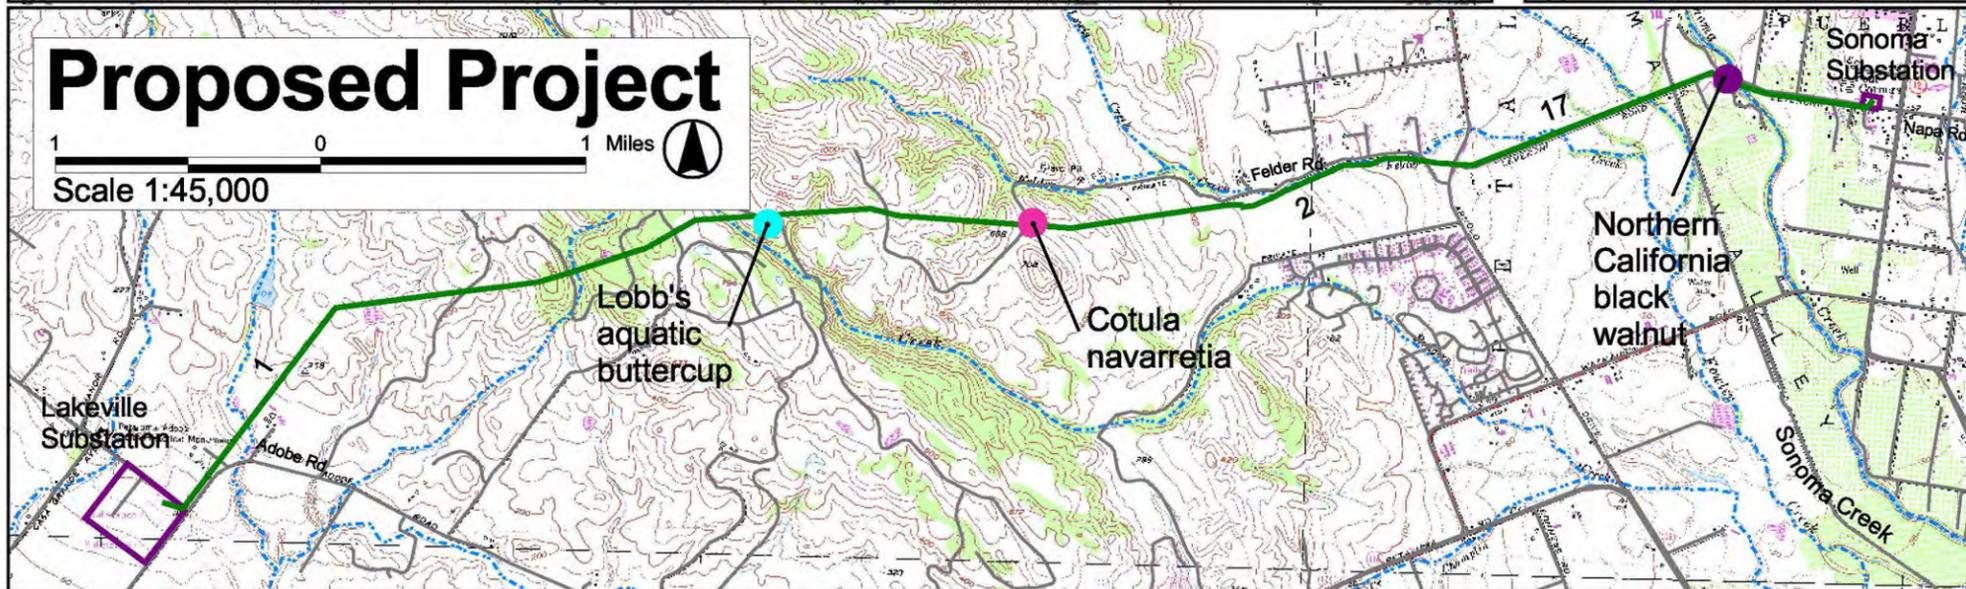
Figure 1.  
Study area and results of special-status plant surveys.  
Lakeville-Sonoma 115kV Transmission Line Project  
October 2004

The proposed project route is approximately seven miles long and includes segments 1, 2 and 17. (See Figure 1) From PG&E's Lakeville substation at the northwest corner of Adobe and Frates roads, segment 1 crosses Adobe Road and extends east across the southern part of Sonoma Mountain, terminating at the eastern base of Sonoma Mountain, near the upstream crossing of Felder Creek by Felder Road. Segment 2 continues east, running parallel to and just south of Felder Creek, and terminating at the intersection of Arnold Drive and Leveroni Road. Segment 17 follows Leveroni Road east to the Sonoma substation, near the intersection of Leveroni Road and State Highway 12, in the City of Sonoma. The terrain crossed by the proposed route includes level ground in the valley bottoms, shallow depressions containing seasonal wetlands, gradual to steep slopes on Sonoma Mountain, and several steep-sided, deeply incised stream canyons (Rodgers

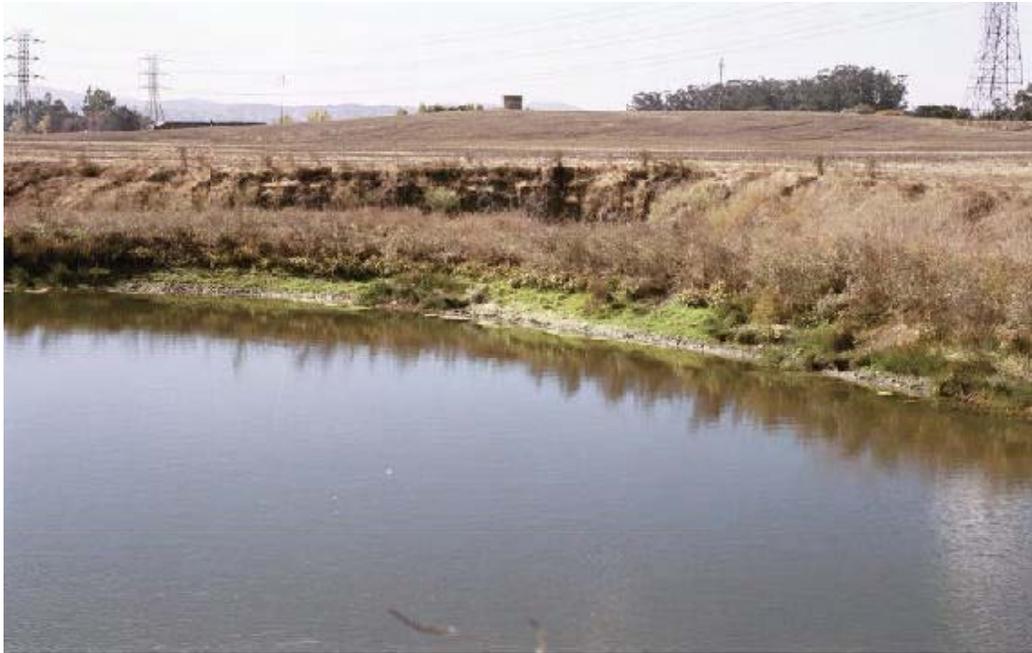
**Photo 1.** Suitable habitat for California red-legged frog, site 1a (segment 1).

Seventeen ponds (site nos. 1a, 1b, 1d, 2a, 2b, 2c, 3a, 3b, 3c, 4a, 4b, 4c, 4d, 4e, 4f, 6 and 7) provide potential breeding habitats for California red-legged frog in the assessment area along segment 1 (Table 1 and Figures 1a and 1b). Of the seventeen ponds, ten (sites 1a, 1b, 2a, 2b, 2c, 3b, 3c, 4a, 4b, and 4c) are located where potential impact to California red-legged frogs or their habitat could occur during project activities, absent avoidance and minimization measures. These ponds are all permanent, artificial stock ponds, except for 3a. Ponds 1a (Photo 1) and 1b are small ponds; Pond 2a (Photo 2) is a larger water body. They are used to provide surface storage water for vineyards. Ponds 2b and 2c are large artificial ponds with shallow and deep water. They are mostly bordered by emergent vegetation providing suitable basking and refuge sites for California red-legged frog. Ponds 3b (Photo 3), 3c (Photo 4), 4a, 4b, and 4c are located near the middle of segment 1. These ponds provide suitable habitat characteristics for California red-legged frog. Their banks offer potential basking sites (areas with full sun or mixed sun and

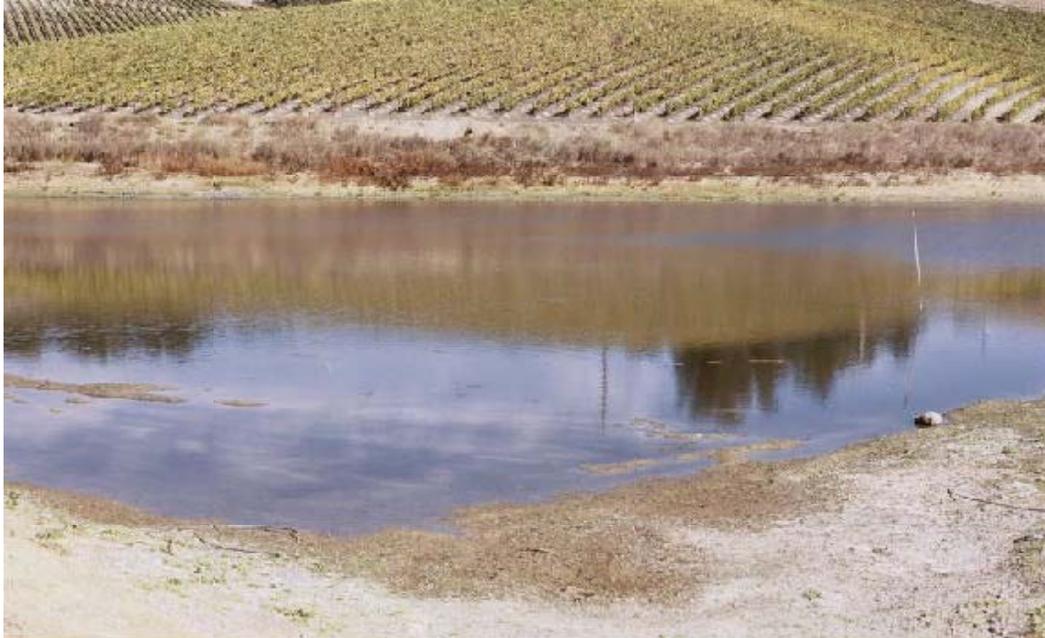
**Photo 2.** Suitable habitat for California red-legged frog, site 2a (segment 1).

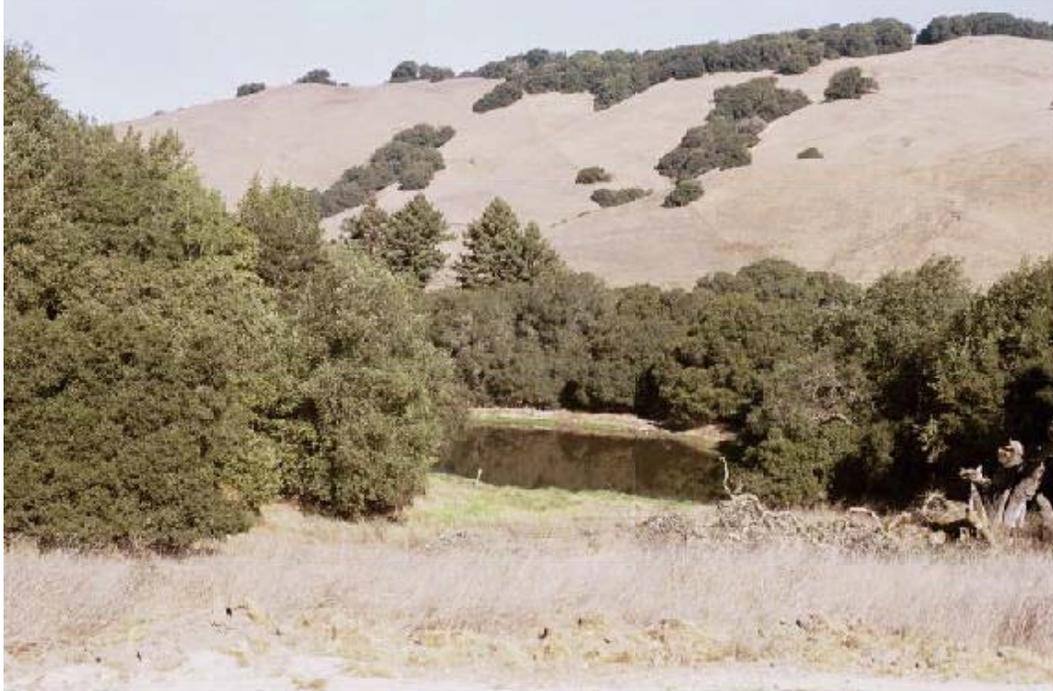
**Photo 3.** Suitable habitat for California red-legged frog, site 3b (segment 1).

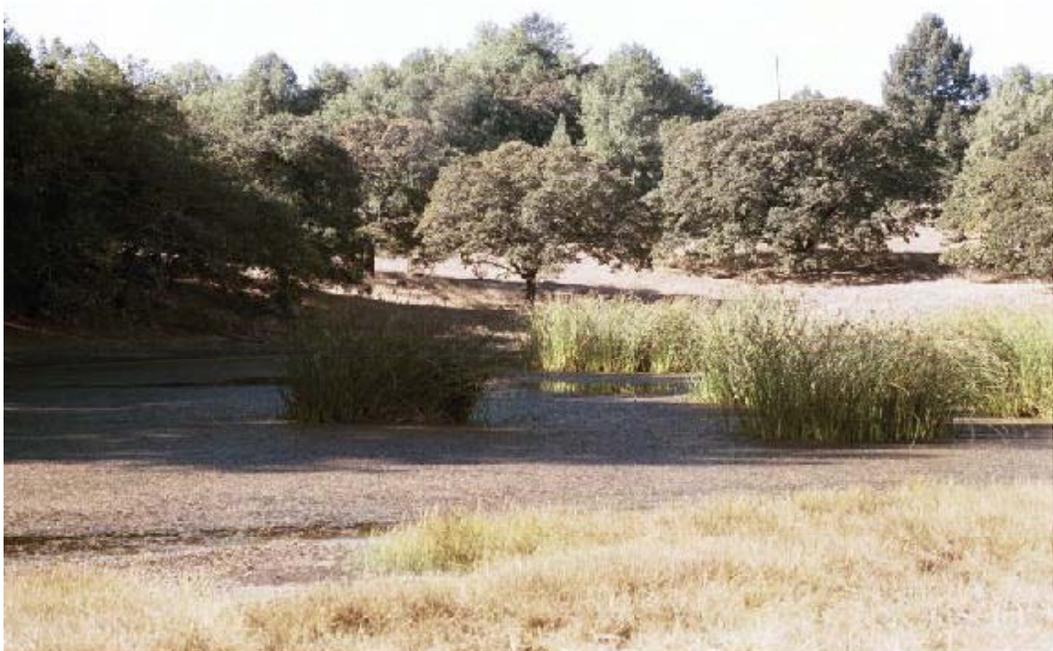
**Photo 4.** Suitable habitat for California red-legged frog, site 3c (segment 1).

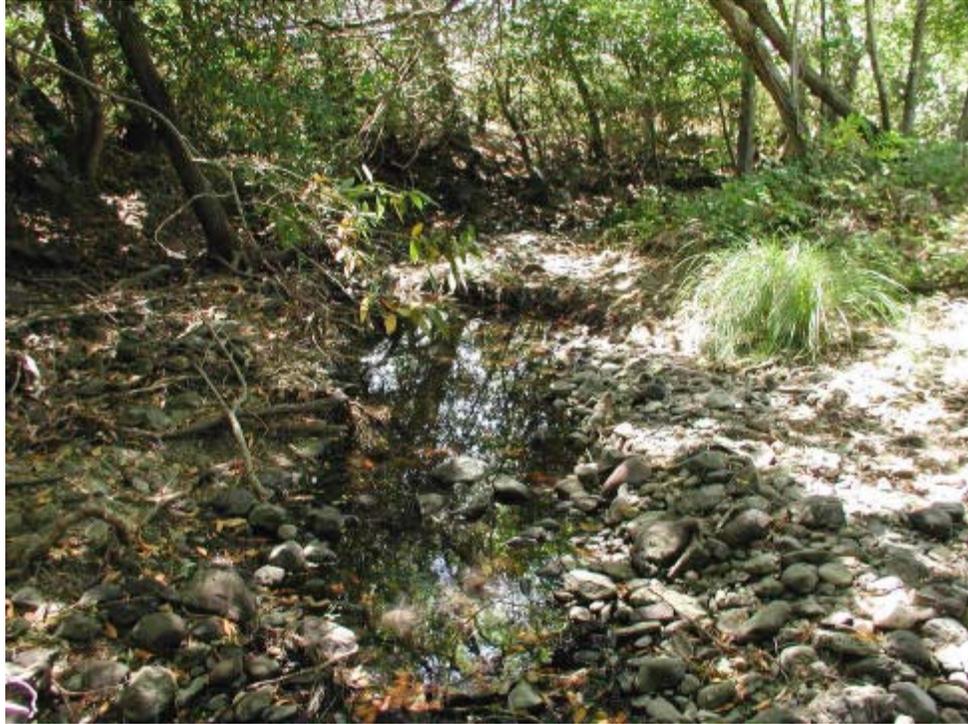
**Photo 5.** Suitable habitat for California red-legged frog along Felder Creek, site 14b (segment 2).

Potential habitat for California red-legged frog is located within Felder Creek along the western portion of segment 2 (site 14b). The creek in this area is an intermittent, low gradient stream which is well shaded by dense riparian vegetation (Photo 5). The creek is bordered by vineyards and rural-residences and a paved road runs along the north side of the creek. The substrate is composed of silt, gravel, and cobble. Water flow ceases in this reach by late summer; however, a few deep pools that could be used by California red-legged frogs appear to persist through the summer and into early fall. The banks generally lack aquatic vegetation and contain semi-submerged root balls and woody debris. The presence of fish and bullfrogs could limit frog breeding success in this section of the creek, possibly making it unsuitable for tadpoles and metamorphs. Farther downstream in the eastern portion of segment 2, Felder Creek becomes totally dry by mid summer and is not suitable habitat.

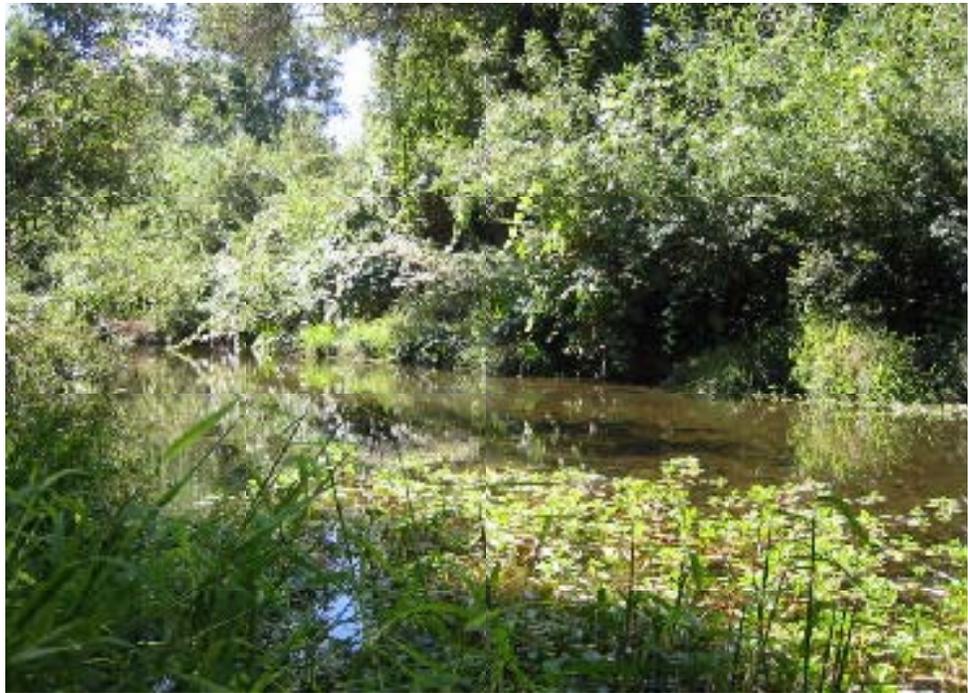
**Photo 6.** Suitable habitat for California red-legged frog along Sonoma Creek, site 18 (segment 17).

Sonoma Creek (Site 18) is a major permanent creek with dense riparian vegetation along the shoreline (Photo 6). The creek is characterized by deep pools (> 1 m or 3 ft) with riffles. The substrate is mainly composed of gravel, cobble, and boulder. In general, the creek supports a wide range of habitat characteristics suitable for California red-legged frogs: suitable breeding sites (deep and shallow pools with few backwaters protected from fish predation); basking sites (e.g., rocks, gravel, logs); and refuge retreats (e.g., dense riparian vegetation, deep pools, and woody debris).

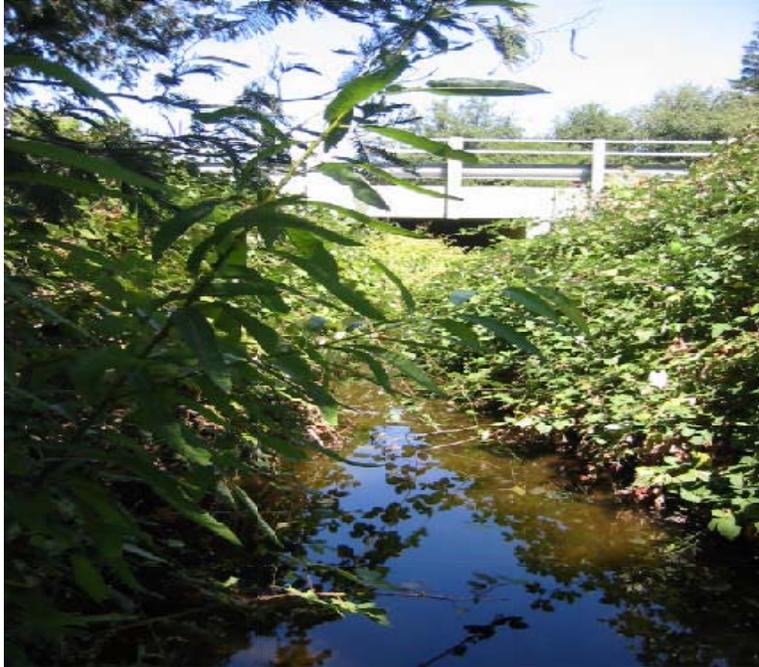
**Photo 7.** Suitable habitat for California red-legged frog along Fryer Creek, site 19 (segment 17).

Fryer Creek (site 19) is characterized by shallow pools with silt, clay, and gravel substrate. The tributary section within the project area has permanent water all year providing suitable breeding sites for California red-legged frogs (Photo 7). The banks are mostly covered by dense riparian vegetation. Semi-submerged root balls are found along the banks. In general, the creek offers suitable habitat characteristics for California red-legged frog: breeding sites (e.g., large pools), basking sites (e.g., banks with sun exposure), and refuge retreats (e.g., riparian vegetation, woody debris or root balls).

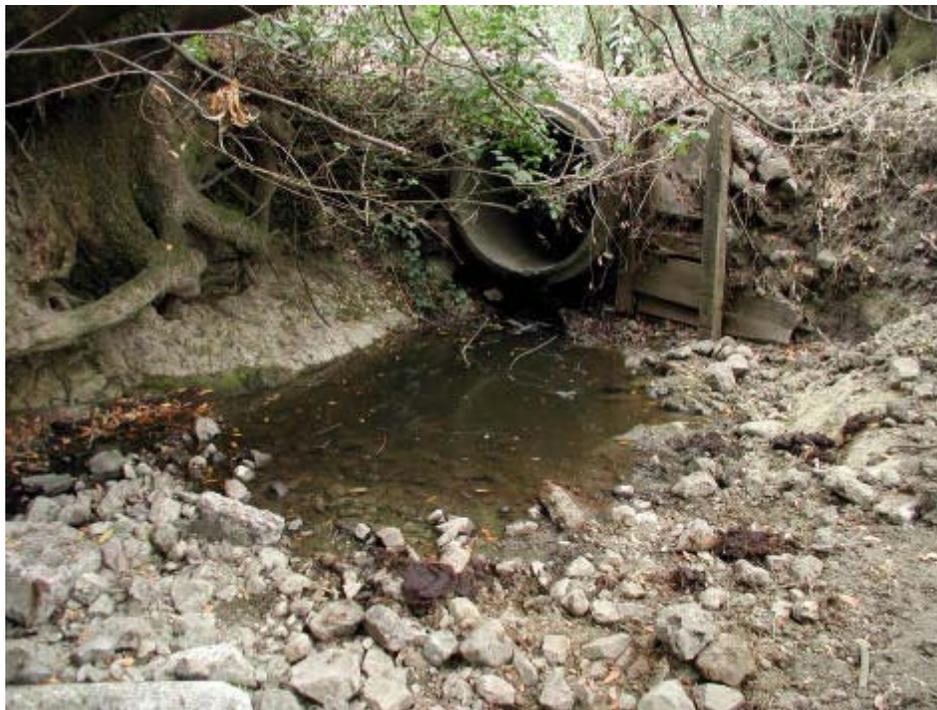
**Photo 8.** Culvert at upper Felder Creek where California red-legged frogs were found in June 2004 (site 14c, segment 1).

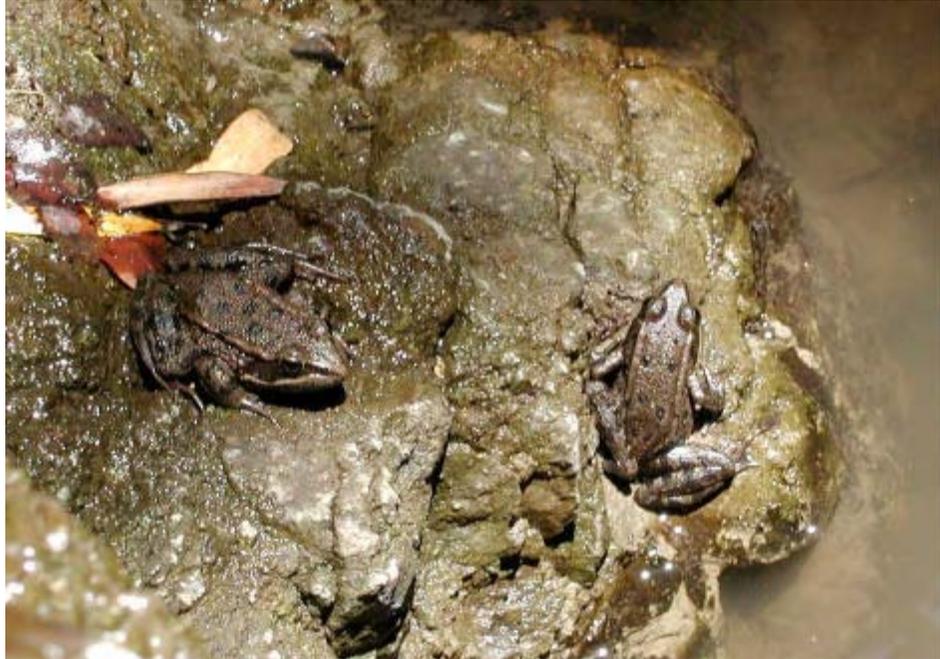
**Photo 9.** California red-legged frog adults at an unnamed tributary to Felder Creek, June 2004 (site 14c, segment 1).

California red-legged frogs were present at one site along the eastern portion of segment 1. This site (14c) includes the upper branch of Felder Creek and its adjoining tributary (Figure 1a). Six adult frogs were observed here on June 17, 2004. Two of them were found at the downstream end of a concrete culvert where a private dirt road crosses Felder Creek (Photo 8). As noted above, this location showed impacts from livestock that use this area of the creek for drinking. Three of the frogs were located adjacent to a small pool in the tributary (Photo 9) approximately 90 m (300 ft) north of where the transmission line spans over the tributary. One frog was found in a pool in the main branch of Felder Creek, approximately 60 m (200 ft) upstream of the tributary confluence (Photo 10). California red-legged frogs were not observed at any of the other protocol survey sites visited during any of the daytime or nighttime surveys, including sites farther downstream in Felder Creek adjacent to the transmission line route.

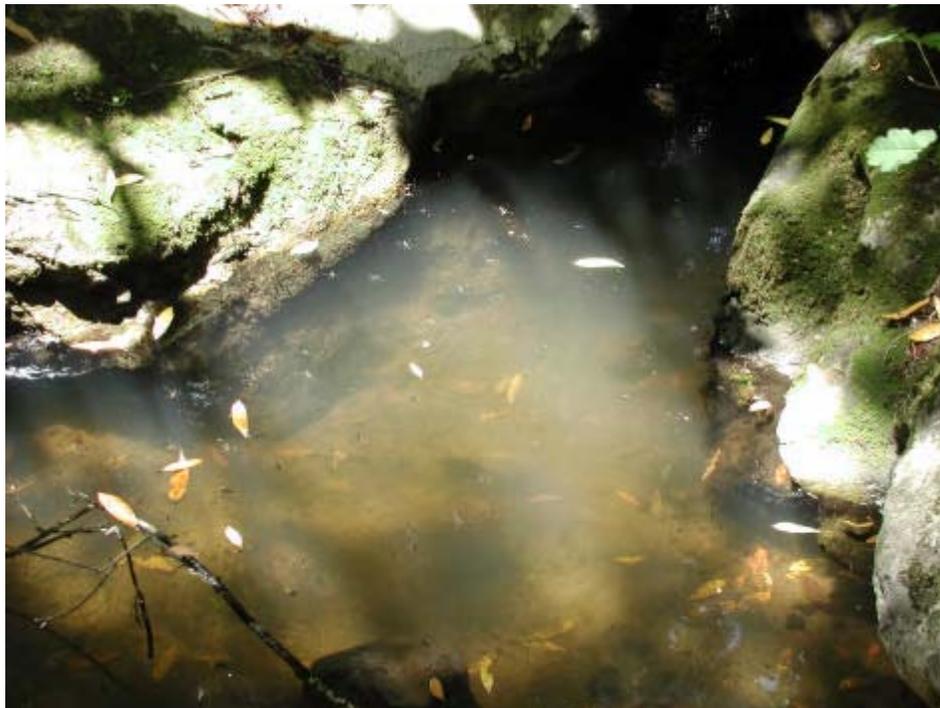
**Photo 10.** Pool in upper Felder Creek where California red-legged frog was found (site 14c, segment 1).

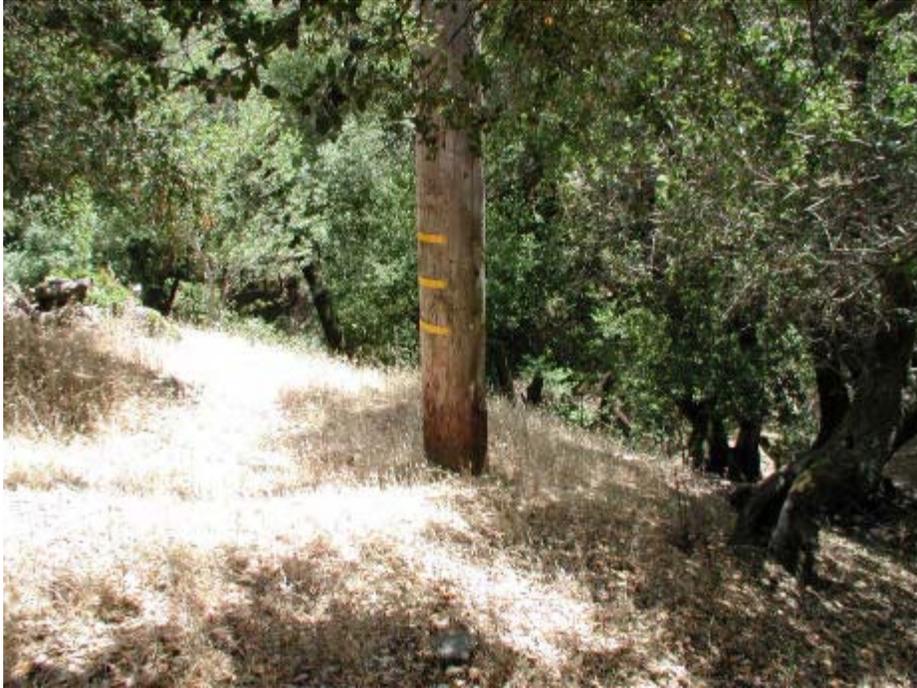
**Photo 11.** Pole 54, located in oak woodland upslope of tributary to Felder Creek near where California red-legged frogs were found.

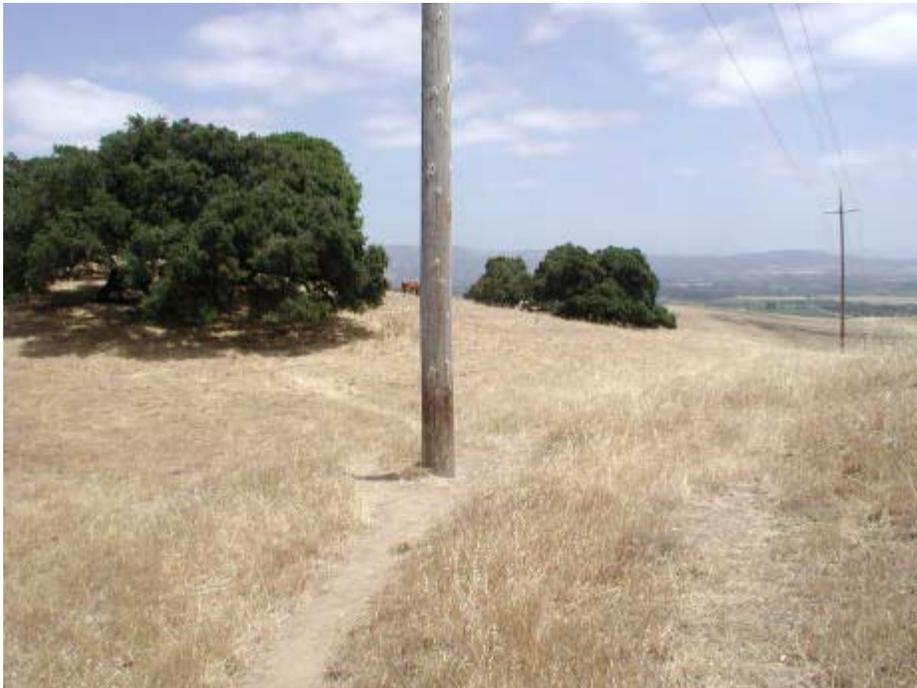
**Photo 12.** Pole 55, located upslope and east of tributary to Felder Creek near where California red-legged frogs were found.

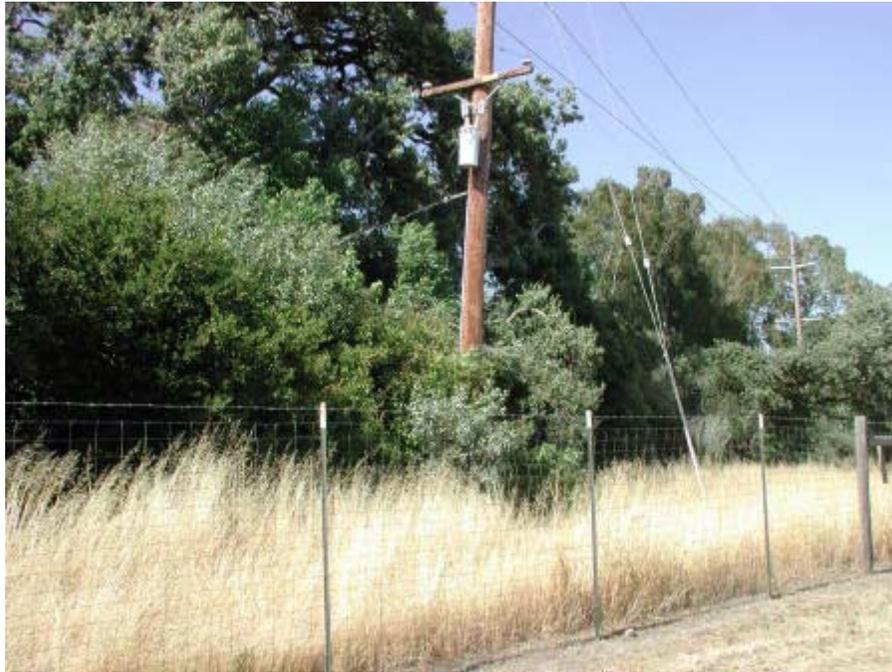
**Photo 13.** Transmission line along the edge of riparian vegetation of Felder Creek approximately 1.5 miles downstream from California red-legged frog location.
