*Southern California Edison*  
**San Joaquin Cross Valley Loop Project A.08-05-039**

**DATA REQUEST SET SJXVL CPUC-ED-03**

Subject: **LETTER OF TRANSMITTAL**  
**Report of Geologic Consultation**  
**Proposed Cross Valley Tower Alternate Location, Stokes Mountain**  
**East of Dinuba, Tulare County, California**  
**MACTEC Project No. 4953-07-2011**

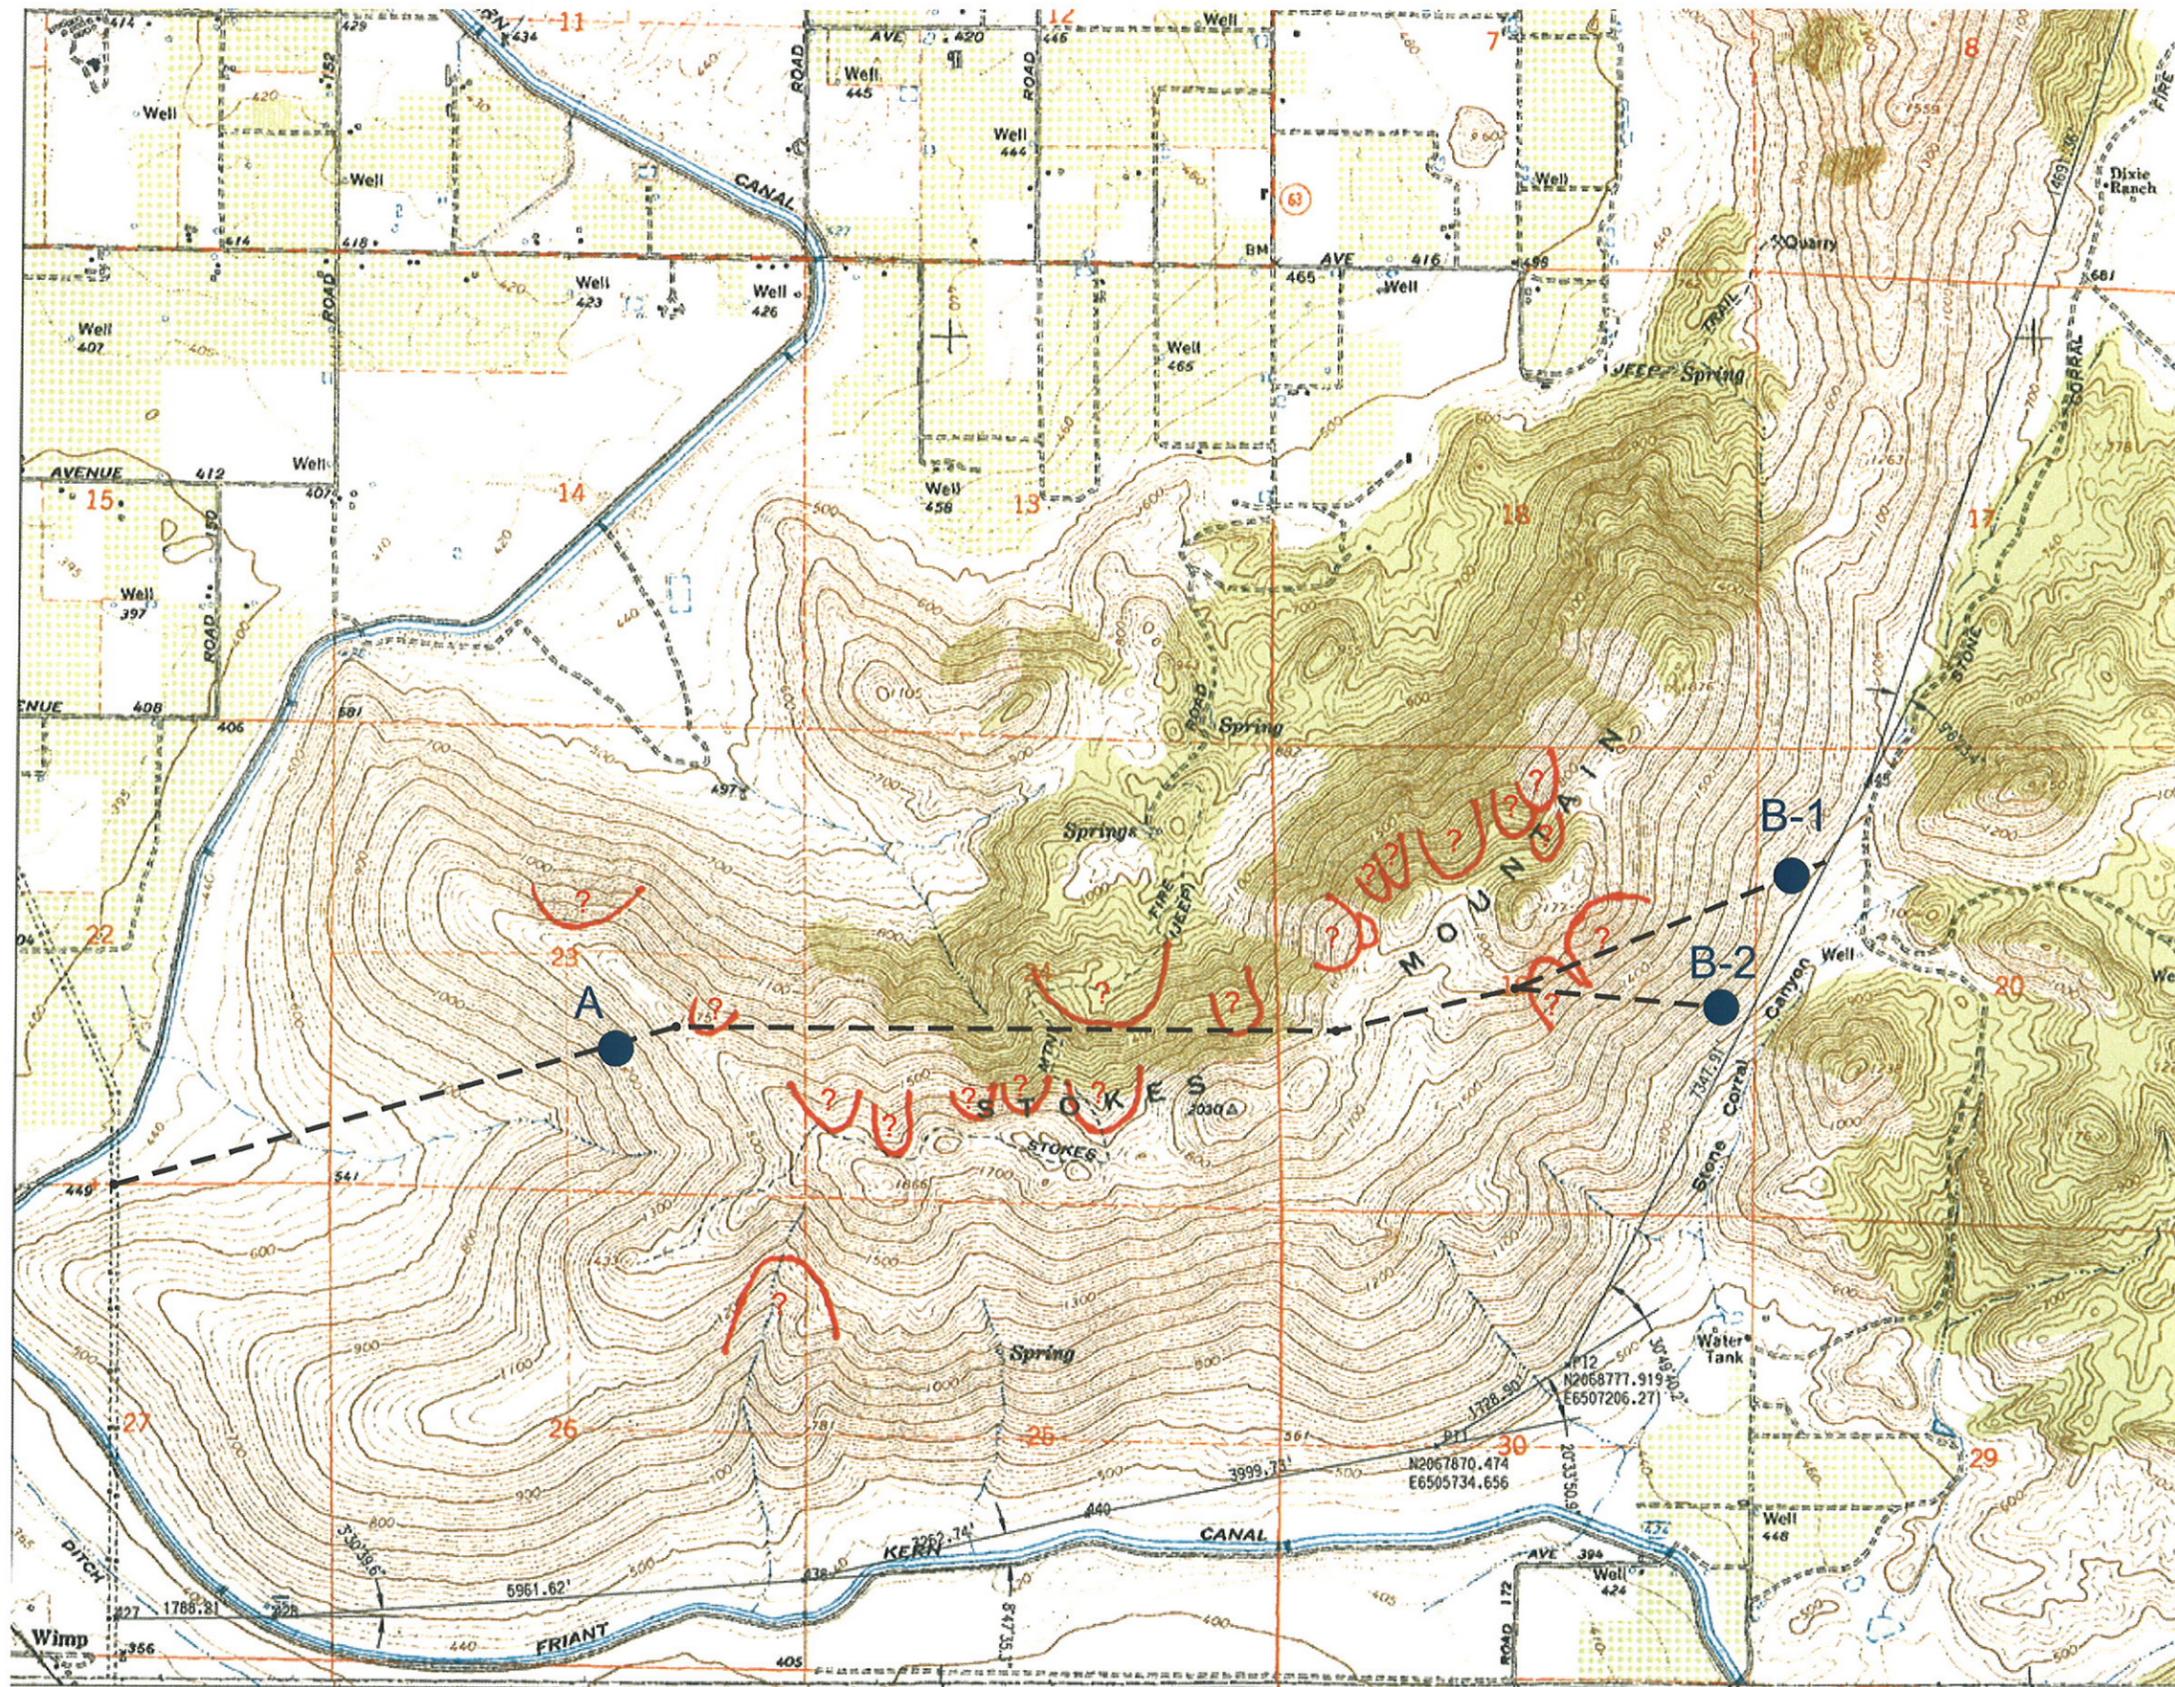
Figure 3. Locations of Possible Shallow Failures Stokes Mountain Cross Valley Tower Alternate Near Dinuba, Tulare County, California			
JOB NO.:	4953-07-2011	REVISIONS:	
DATE:	10/19/07		
SCALE:			
DRAWN BY:	RM		
CHECKED BY:

Possible Shallow Failure

Alternate Option

United States Geological Survey, "Stokes Mtn. 7.5 Minute Quadrangle."

It is likely that shallow failures have occurred and could occur in the future on the slopes below the ridgeline. Some of the possible locations are shown on Figure 3. The potential for shallow failures should be considered in determining tower locations and foundation depths.

It is likely that shallow failures have occurred and could occur in the future on the slopes below the ridgeline. We recommend that during the field investigation, one boring be drilled for each proposed tower location between points A and B shown on Figure 3, estimated to be 4 to 5 per mile. We recommend that borings on the ridge top be between 50 and 70 feet in depth. We recommend that borings on the slopes in the vicinity of areas indicated on Figure 3 be drilled to approximately 100 feet in depth. The borings should be logged and reviewed by a qualified geologist.
