## **PROJECT MEMORANDUM PG&E ATLANTIC-DEL MAR REINFORCEMENT PROJECT**

**To:** Jensen Uchida, CPUC  
**From:** Vida Strong, Aspen Project Manager  
**Date:** March 31, 2006  
**Subject:** Weekly Report #49: March 19, 2006 – March 25, 2006  
**CPUC Environmental Monitor (EM):** Heather Stiles

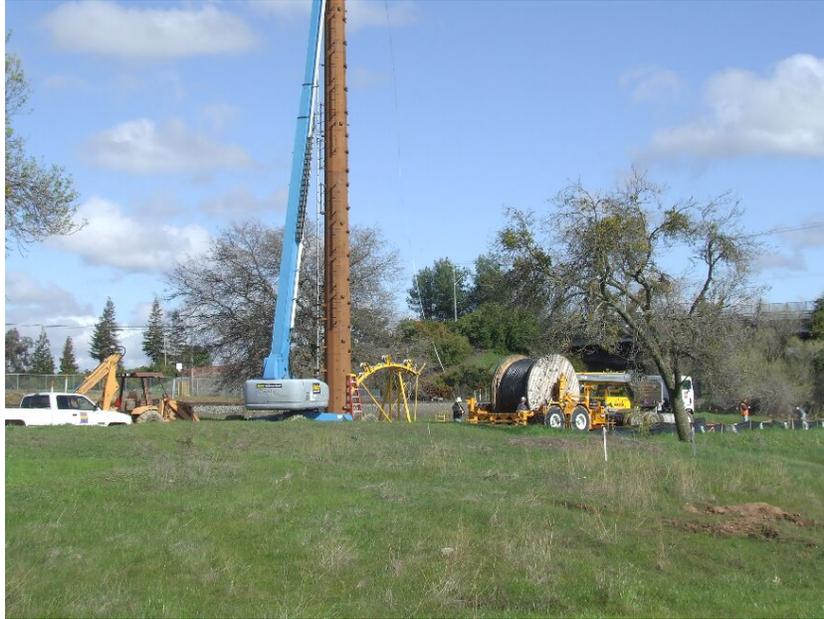
**Figure 1** – Cable stringing near Vault #4, March 24, 2006.

During the subject week, Wilson and their subcontractors completed pulling cable between Vaults 4 and 3, and between Vaults 1 and 2 (see Figure 1).

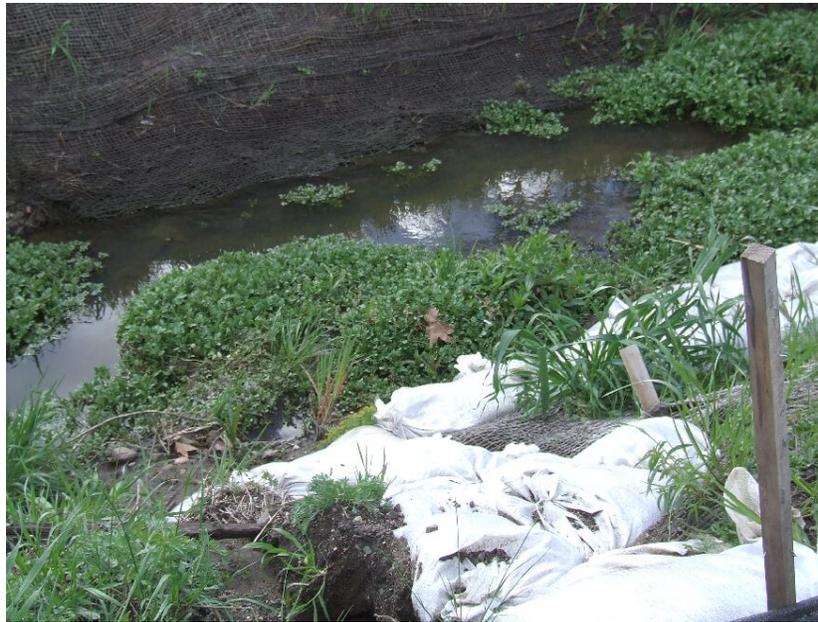
A section of silt fence at Drainage #30 was undercut by water flow during a storm event during the previous week. This section was previously breached in December, which caused erosion on the bank of the drainage. After the initial problem, Wilson's crews had installed sandbags on the bank to prevent further erosion. This remedy had been working until Tuesday of the previous week, when the water undercut the fence in nearly the same location (slope of the terrain directs water to this location). The water flow cut parallel to the original erosion and caused additional damage to the bank. Further damage was observed during the tour on March 21 (see Figure 2). Wilson crews installed additional erosion control devices to repair the undercut section and to attempt to direct water flow away from this location. Repairs included re-burying the undercut section of fence, placing sandbags along the area that had been undercut, and installing a new section of silt fence to direct water flow away from this location. Again, the CPUC EM reminded the PG&E EI of the sensitive nature of Drainage # 30 and the importance of finding a solution that would prevent degradation to the resource. The CDFG was notified via email on Thursday, March 23.

**Figure 2** – Bank of Drainage #30, March 21, 2006.
