## **PROJECT MEMORANDUM SDG&E – MIGUEL-MISSION 230 kV #2 PROJECT**

**To:** Jensen Uchida, CPUC  
**From:** Vida Strong, Aspen Project Manager  
**Date:** December 22, 2004  
**Subject:** Weekly Report #20: December 12, 2004 – December 18, 2004  
**CPUC ENVIRONMENTAL MONITOR (EM):** Christopher Meyer

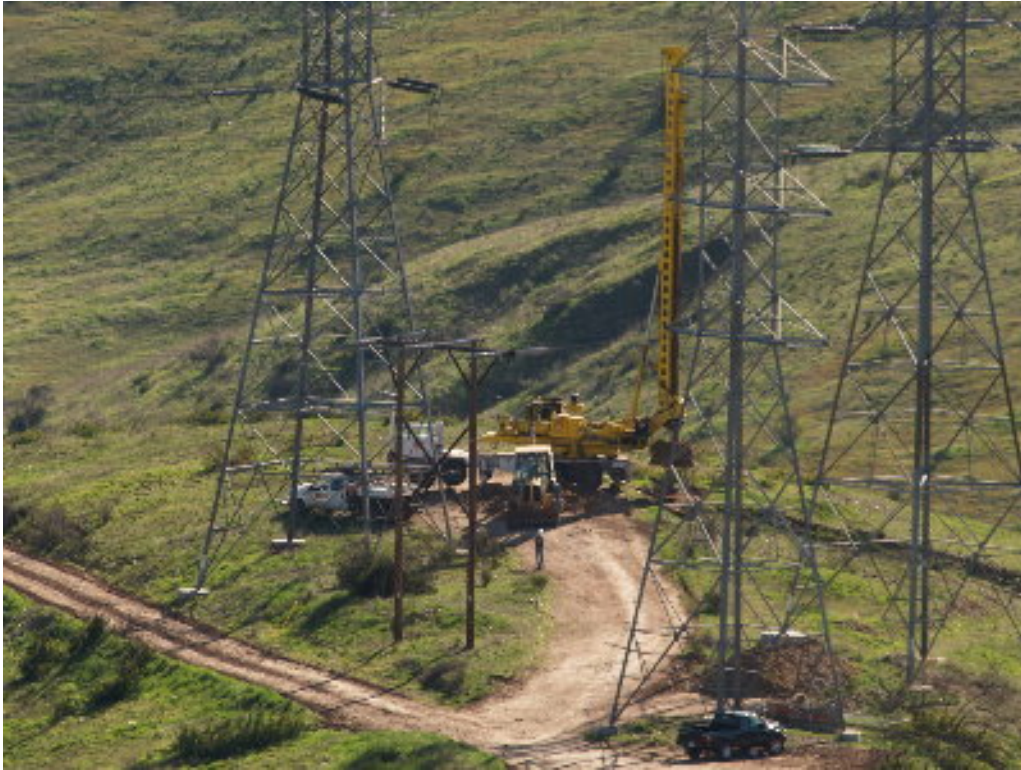
The grading of the pads for the 230 kV towers at Fanita Junction, on Miramar, was completed during the subject week. Crews worked on drilling during the CPUC site visit (see Figure 1). The grading issues related to the access road to the Fanita Junction locations have been addressed by SDG&E and the Essex Environmental Inspector (EI). The loose material has been removed and the road cuts seeded.

**Figure 1** – The PAR crew worked on the drilling covered under NTP #3, on Miramar Naval Air Station, during the subject week.

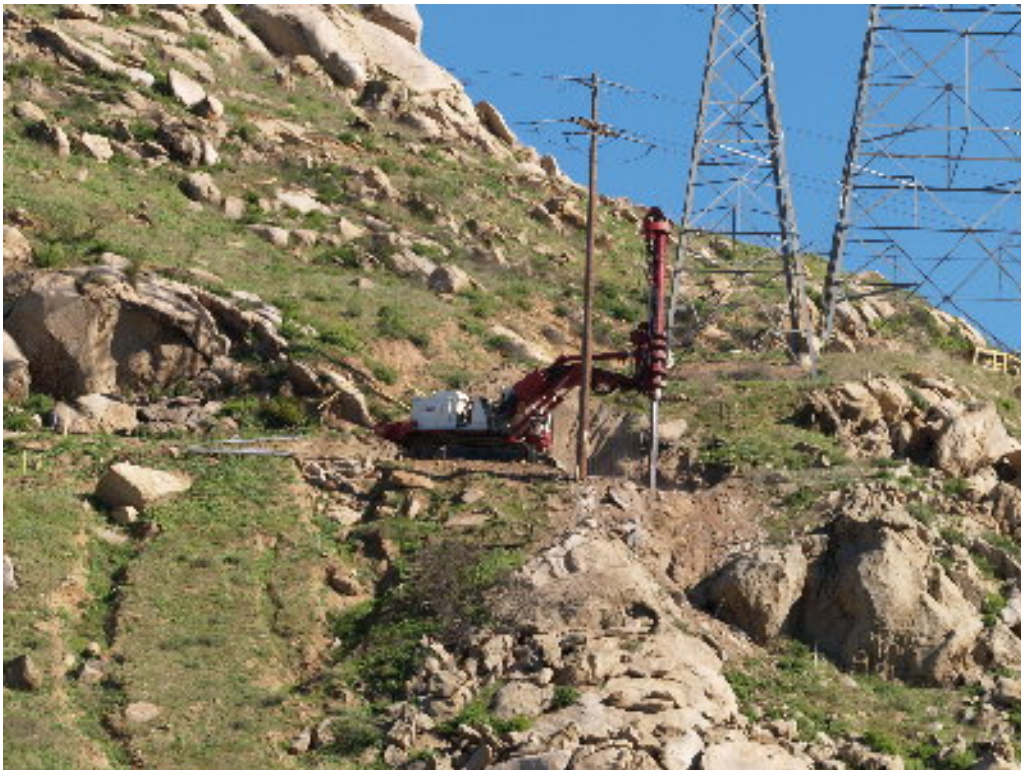
The Low Drill drilling machine continued work at Tower Site 1160 during the site visit. Loose material was visible moving down the slope at the drill site and needs to be contained (see Figure 2). The contractor is reviewing plans to change the drilling method at the site due to safety concerns related to blasting.

**Figure 2** – The Low Drill continued work at Tower Site 1160. Note material moving down hillside under the drill.

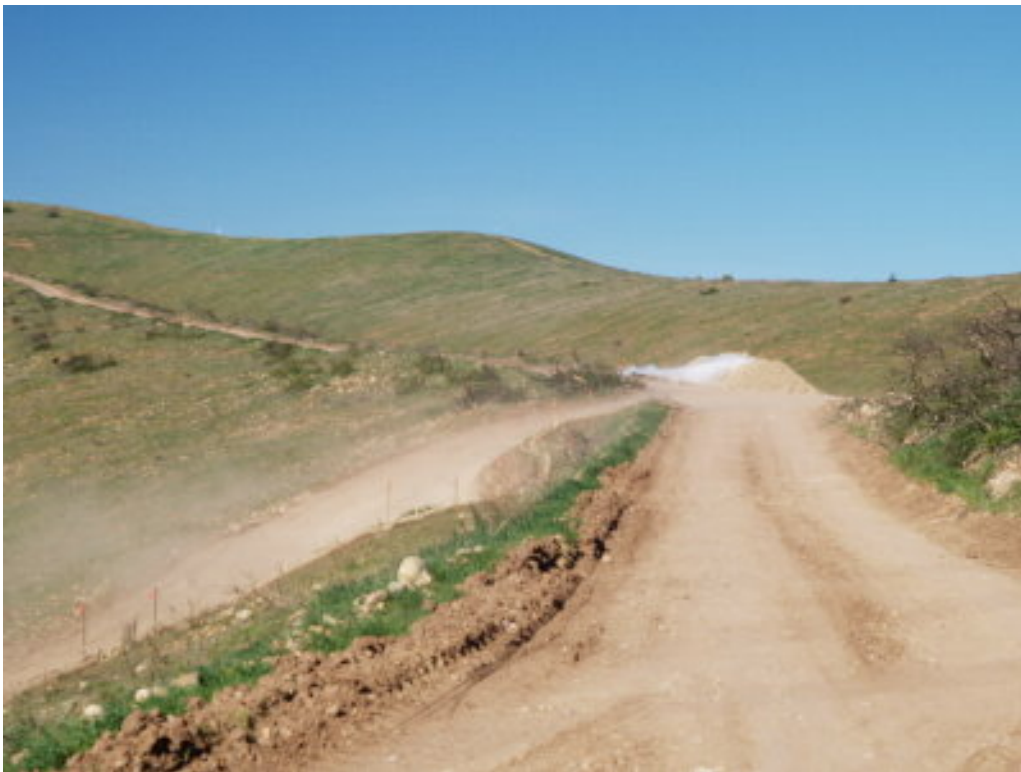
Fugitive dust was observed leaving the right-of-way at Fanita Junction during the site visit (see Figure 4). The spoil piles and access roads had not been watered and the plastic covering on the spoil piles had blown off in the high winds. Some of the rice waddles placed around the pad site are nearly vertical on the slope and do not conform to the design of the BMP (see Figure 5). The Essex EI was notified of both issues.

**Figure 4** – Fugitive dust was observed leaving the right-of-way at Tower Site 601 during the site visit. The roads and spoil piles had not been watered recently.

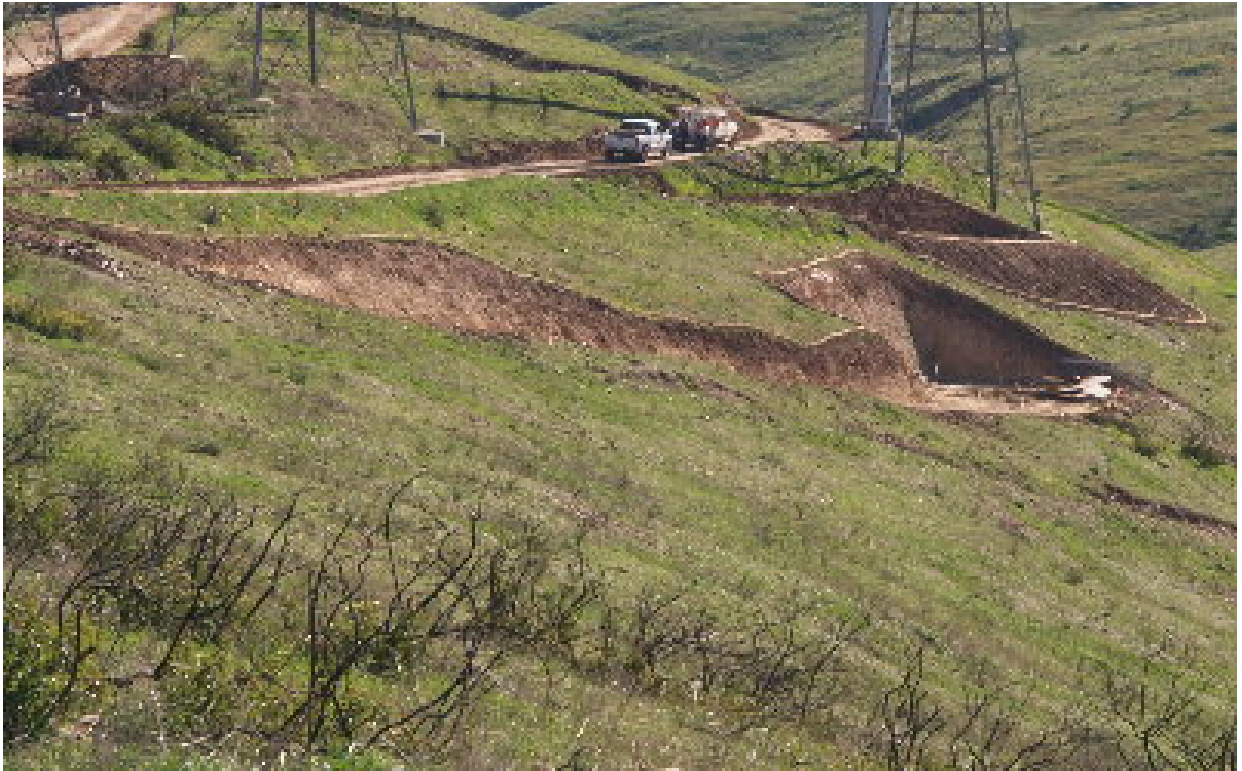
**Figure 5** – Several of the straw waddles placed at Tower Site 601 cannot contain the material above or are installed at very steep angles.

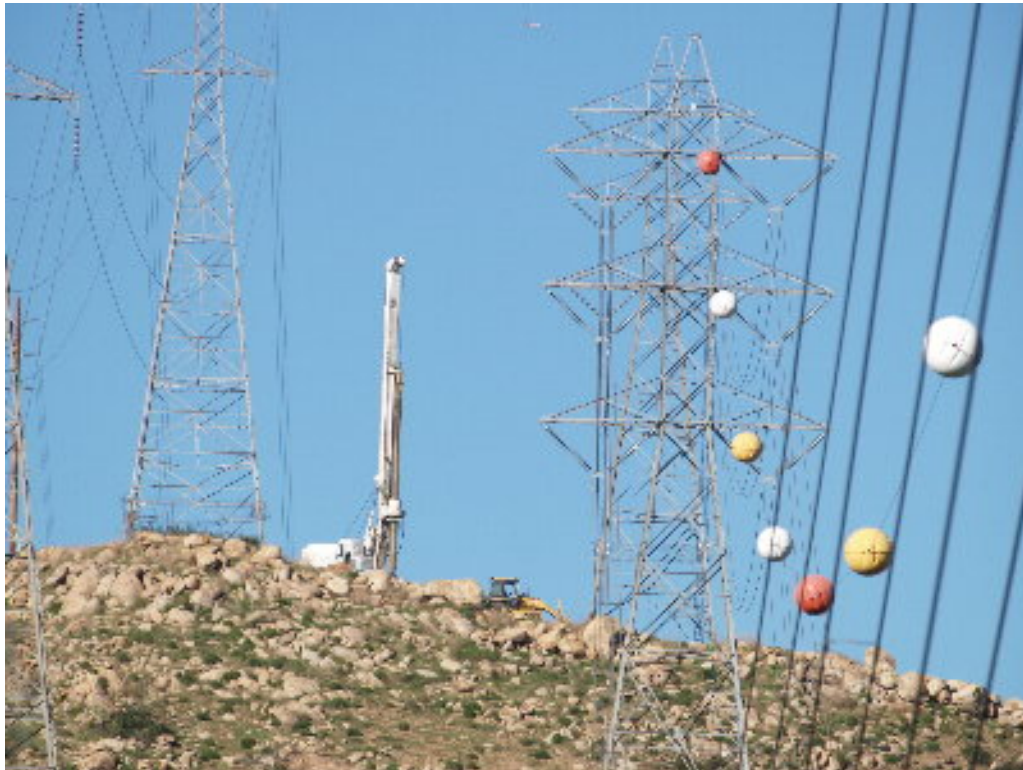
The drilling crew completed work at Tower Site 881 and broke down the machine for travel (see Figure 6). The concrete crew was on-site to prepare the foundation for pouring. The drilling machine continued working south of Highway 8 during the site visit (see Figure 7).

**Figure 6** – The drilling at Tower Site 881 was completed during the week.

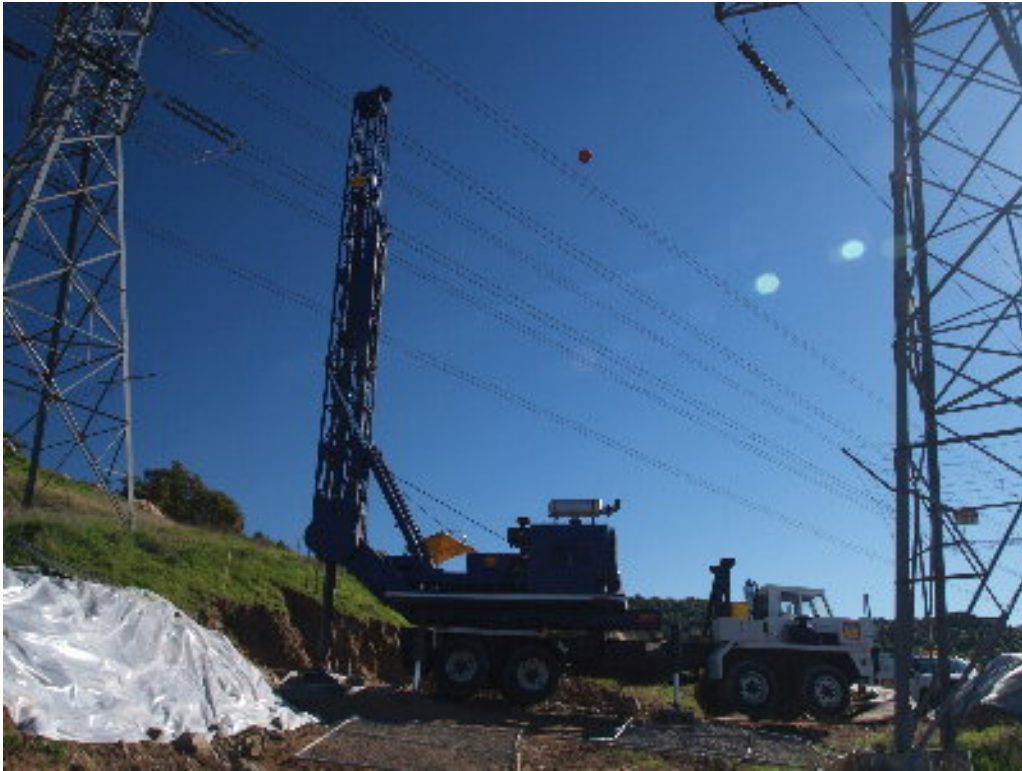
**Figure 7** – The drilling continued south of Highway 8.

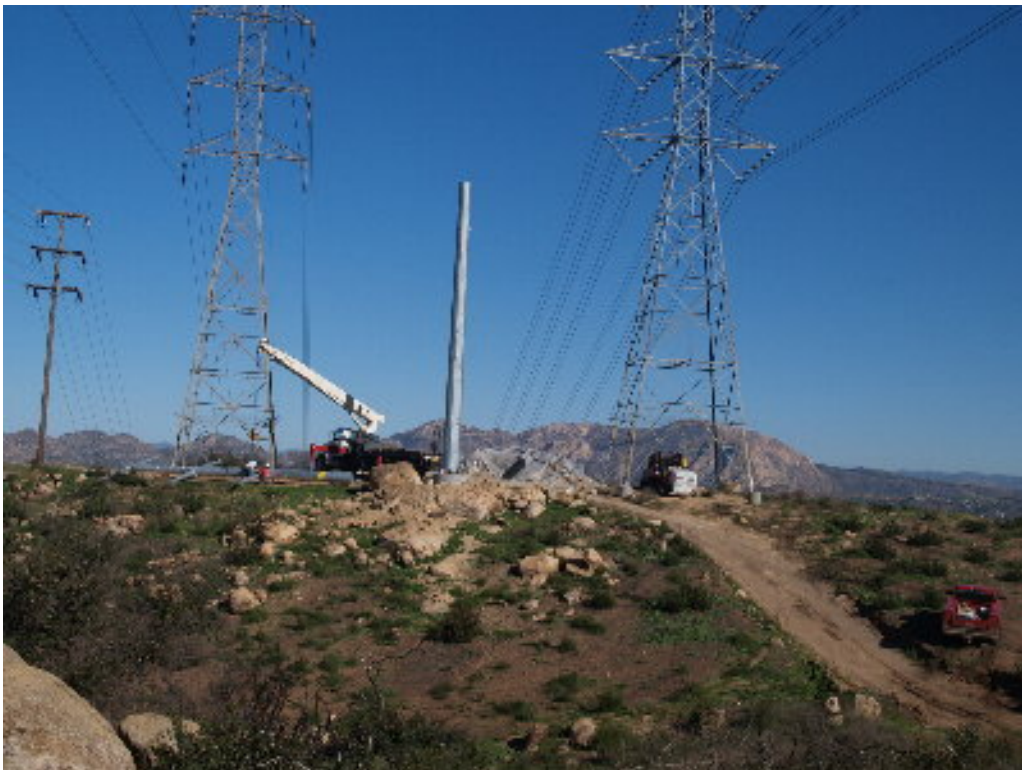
A small PAR crew worked to attach the arms to the upper sections of the steel poles between Tower Site 925 and Tower Site 881 (see Figure 8).

The PAR crew assembling the upper sections pulled a vehicle off the right-of-way. The truck did not damage any native vegetation due to the recent fire damage in the area and was moved back onto the access road. The Essex EI will address access road and parking issues with the crews.

**Figure 8** – The PAR crew attached the arms to the upper section of the steel pole.  
Note the red truck parked off the access road, in the habitat.
