**PROJECT MEMORANDUM
SDG&E'S SUNRISE POWERLINK PROJECT**

To: Billie Blanchard, Project Manager, CPUC
From: Vida Strong, Aspen Project Manager
Date: June 23, 2011
Subject: Weekly Report 38 – June 5 to June 11, 2011

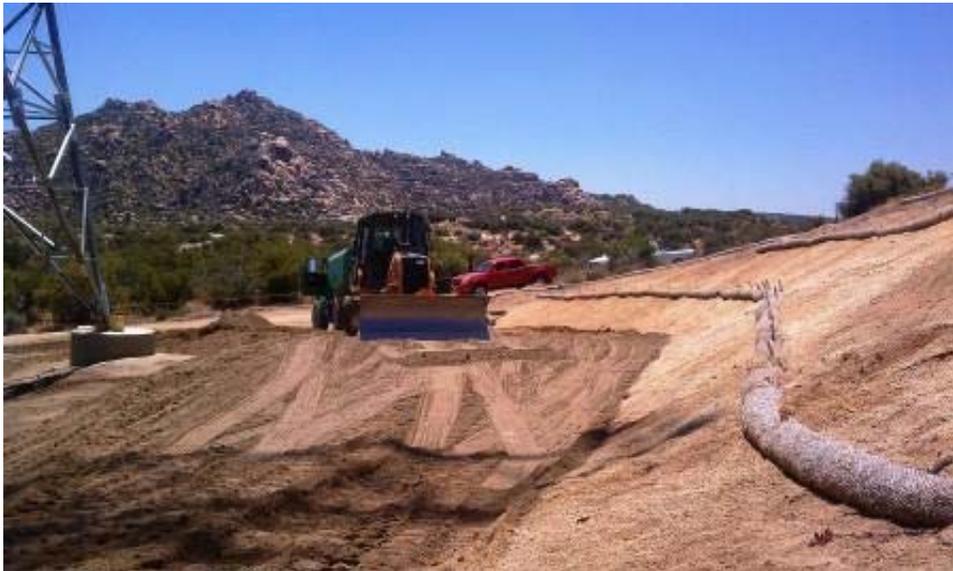
- Ground resistance testing was conducted at Tower EP214, EP215, EP217, EP218, EP219, EP220-1, and EP243.
- Grading took place at the EP220-1 tower site and spur road (see Figure 1).
- Micropile drilling and grouting occurred at EP223-1.
- Tower assembly was conducted at EP219-1 and EP244.
- Insulators were installed at EP244.
- Final grade of pad site to original contour took place at EP220.
- QC inspections were performed at EP208, EP209, and EP210.
- Grout equipment removal occurred at EP223-1.

Figure 1: Tower site restoration, EP 220-1, Link 1.

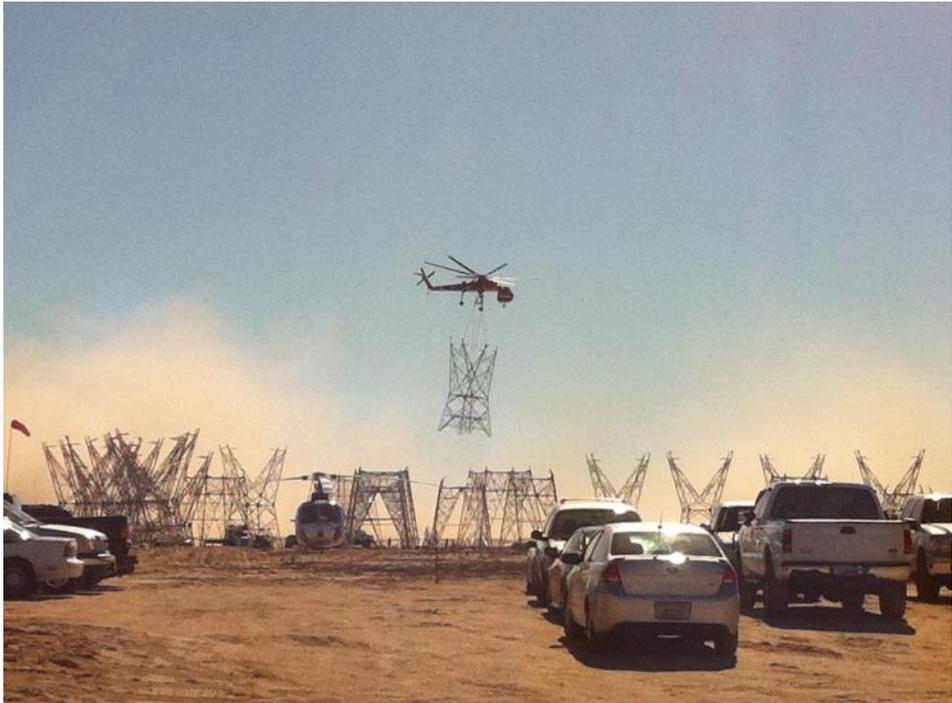
Figure 2: Tower lift from Plaster City Construction Yard, Link 1.

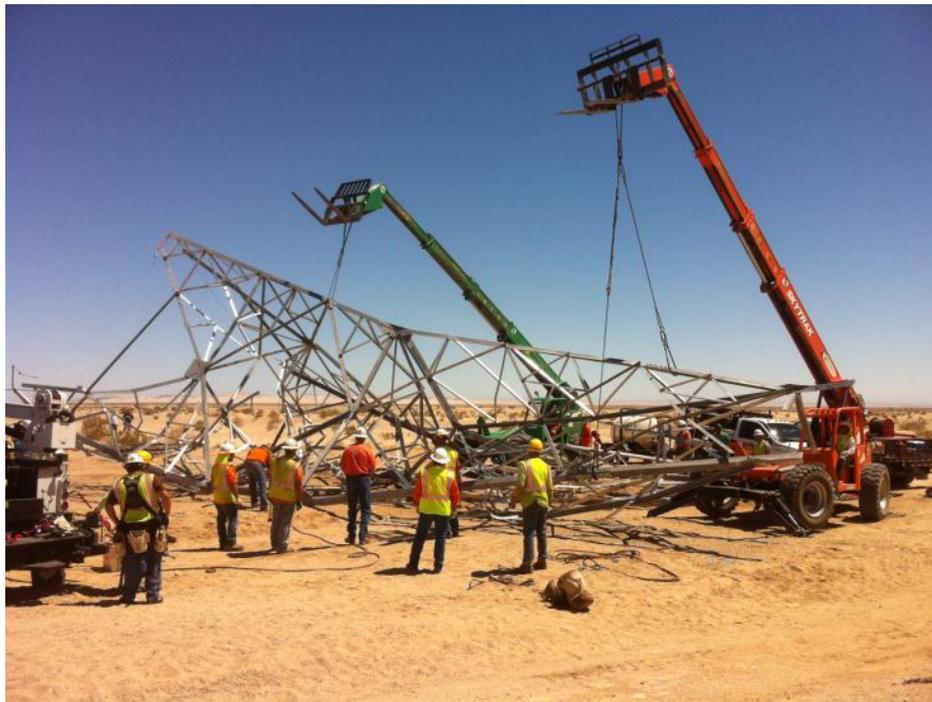
1. Biological, Cultural, and Native American monitors were present as applicable during all transmission line construction activities.
2. On the morning of June 7 and June 10, 2011, two separate incidents occurred in the Imperial Valley involving SDG&E's "Sun Bird" S-64 air crane helicopter. The first incident involved a section of transmission tower that was being carried by the air crane. It fell approximately 150 feet to the ground approximately 200 feet from the Plaster City Construction Yard and approximately 20 feet from Evan Hewes Highway (see Figures 2 and 3). The tower piece fell as a result of an unplanned release of the hooks that were lifting it. The second incident on June 10, 2011 also involved three of the four hooks releasing without command. The helicopter and stricker were quickly lowered to the ground. The structure was nearly upright (on two legs) when the last hook released and the tower section fell on its side (see Figure 4). In both incidents, the tower fell off of the right-of-way and the appropriate monitors were brought onsite to assess the impacts. No injuries or property damages (beside the tower sections) occurred.

Incident	05/17/11	Link 1	BMP crew drove off the road between EP345 and EP346 and park within the ESA boundary.
Incident	06/07/11	Link 1	During the aerial delivery of a structure body to EP339, approximately 200ft outside of Plaster City Yard, the piece fell from the Aircrane. No injuries have been reported.

Figure 3: Tower section that fell on June 7, 2011, Link 1.

SDG&E grounded the air crane and conducted an investigation of the first incident with Erickson, the manufacturer of the air crane. During troubleshooting, a problem was found and repaired. Test flights were conducted prior to resuming tower lifts for construction. After the second incident, the FAA grounded the "Sun Bird" and an investigation was launched to determine the cause of that incident and to ensure it would not happen again. The helicopter was flown back to Erickson's helicopter manufacturing facility in Oregon to conduct a more thorough investigation. Both incidents were reported to the California Public Utilities Commission (CPUC) and the Federal Aviation Administration (FAA). The SDG&E owned "Sunbird" air crane will not participate in any construction activities pending the results of the investigation. CPUC issued an initial Incident Report and investigation of the air crane incidents by CPUC is ongoing. (Link1)

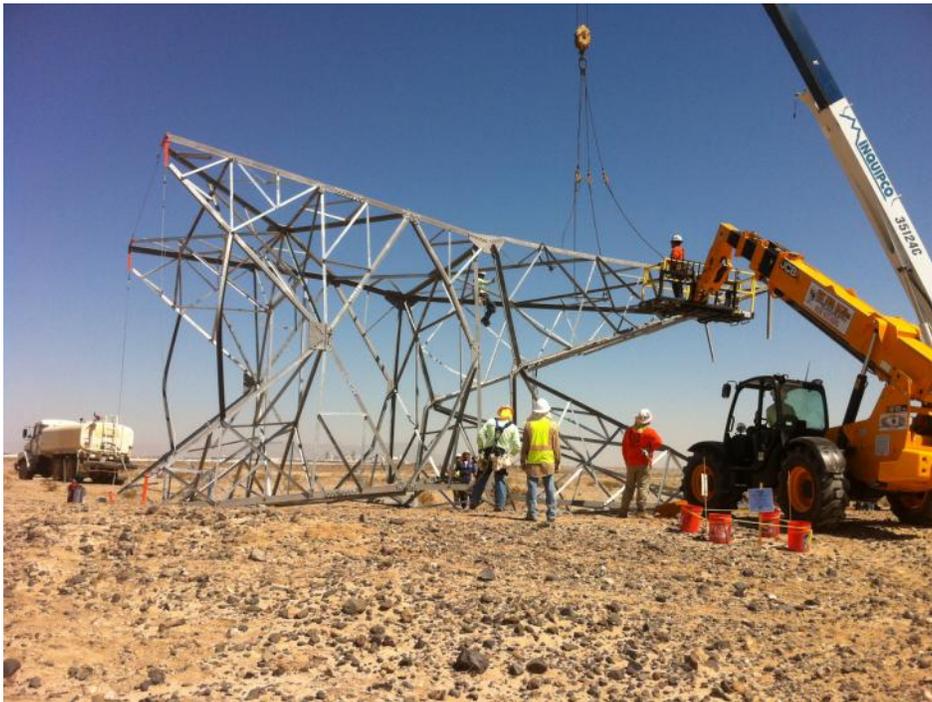
Type	Date	Location	Description
Incident	06/10/11	Link 1	During the aerial delivery of a structure layback to EP 339, at the EP 339 construction site, 3 of the 4 hooks released and caused an emergency placement of the steel at the site. While in the process of placing on the ground, the 4 th hook released and the tower fell to the ground. No injuries have been reported.

Figure 4: Tower section that fell on June 10, 2011, Link 1.

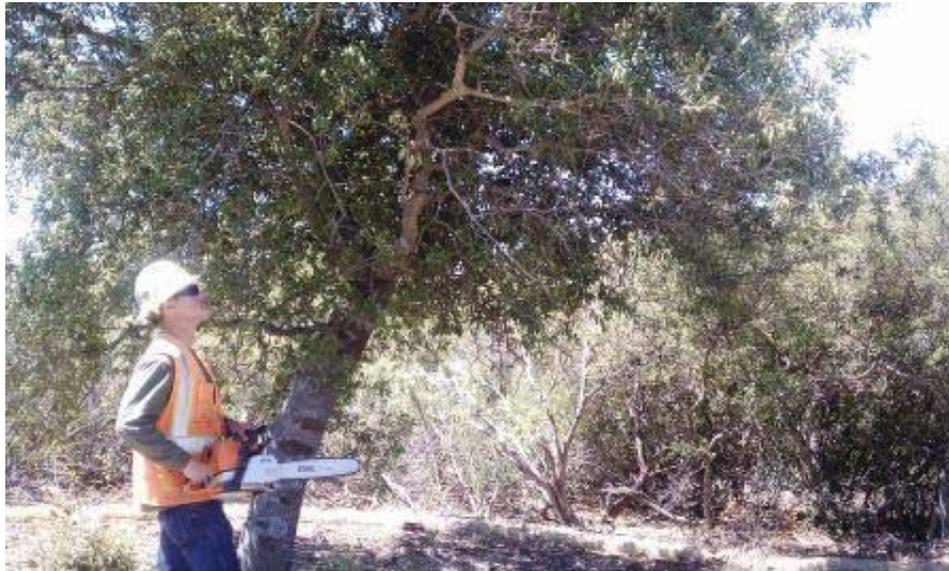
6. A tree branch was trimmed at EP 85-2 (see Figure 5) to maintain compliance with fire codes during micropile drilling. (Link 2)
7. One rosy boa (*Lichanura trivirgata*) found on El Monte Road in Alpine was relocated. (Link 4)

Figure 5: Trimming a tree branch at EP 85-2 to maintain compliance with fire codes during micropile drilling, Link 2.

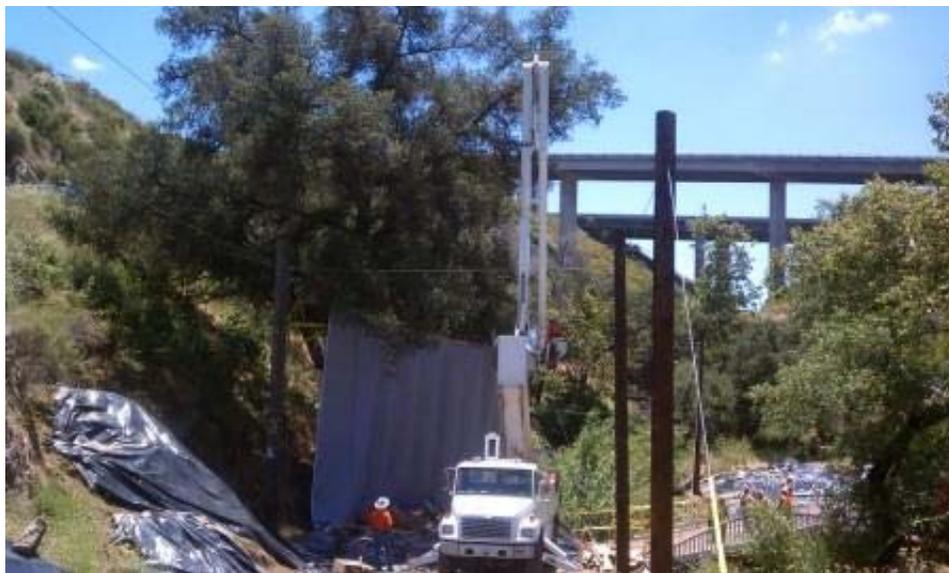
9. Acoustic blankets at Bauer Bridge were originally delivered and installed the week of 5/29/11, but because of problems were re-installed on 6/7/11 (see Figures 6,7, and 8). They were installed to protect nesting birds from construction noise and visual disturbance while construction occurs on Bauer Bridge. (Link 4)

Figure 6: Installation of acoustic blankets at Bauer Bridge from eastern side, Link 4.

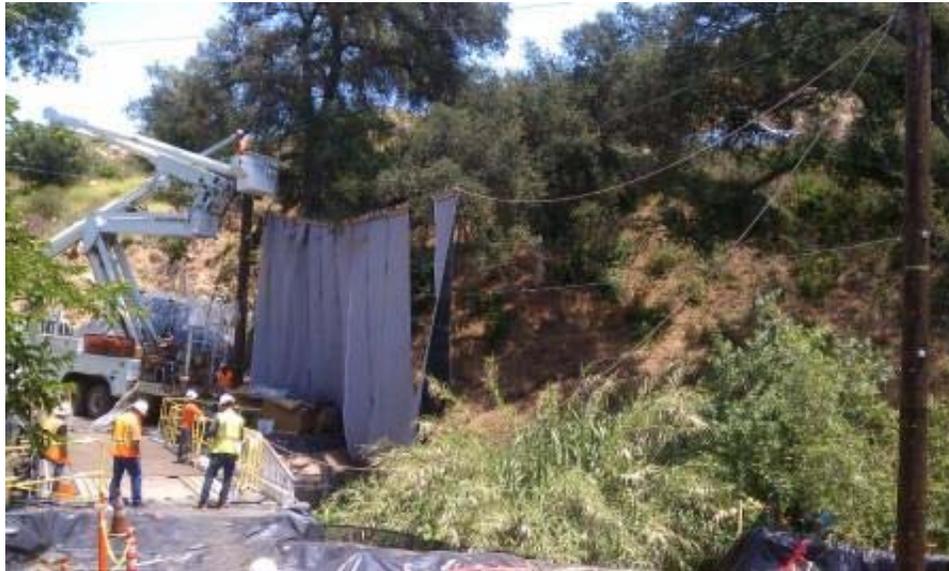
Figure 7: Installation of acoustic blankets at Bauer Bridge from western side, Link 4.

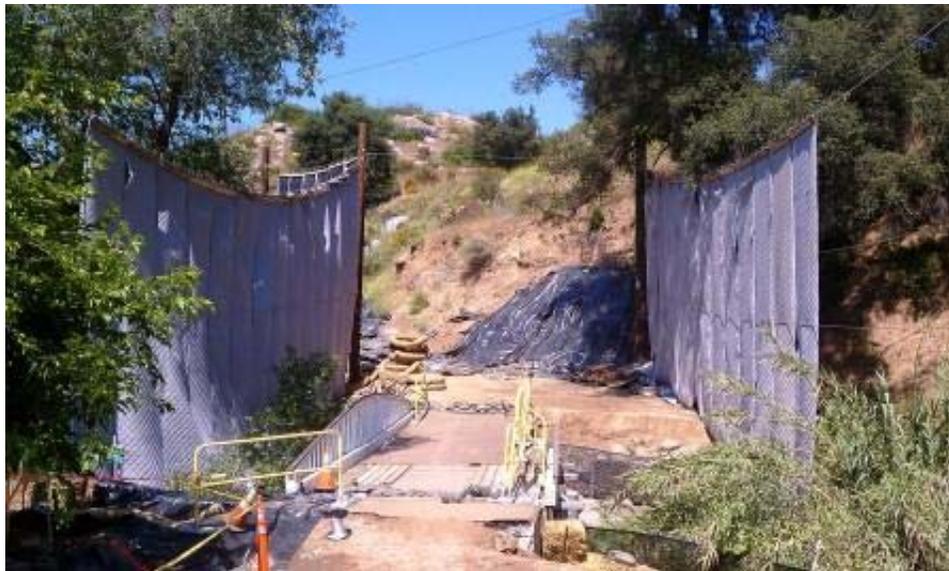
Figure 8: Acoustic blankets installed at Bauer Bridge from western side, Link 4

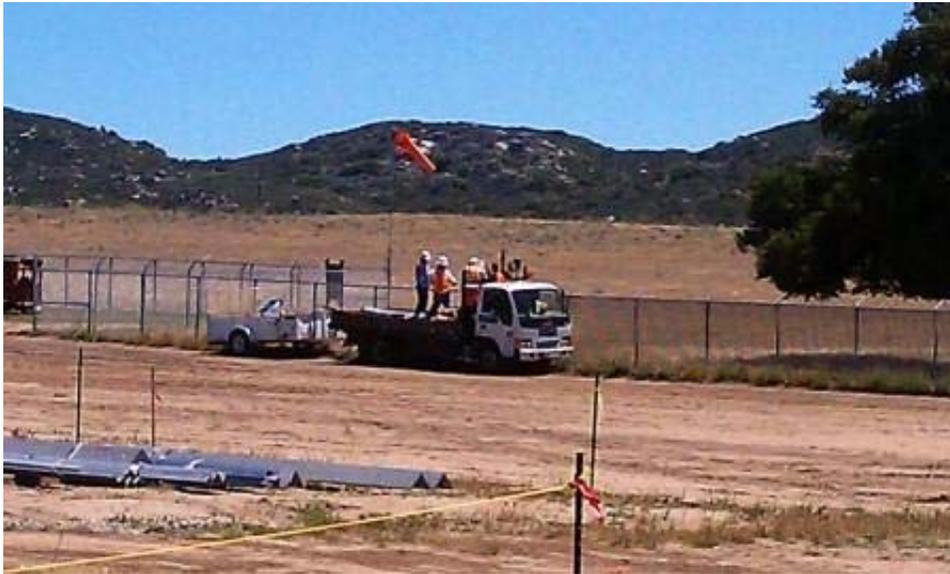
3. Bartlett-Hauser Yard – Tower assembly and helicopter operations occurred. Slats were removed from the perimeter fence (see Figure 9) and sliding curtains will be installed to provide a visual barrier.

Figure 9: Crews removing fence slats at Bartlett-Hauser Construction Yard, Link 2.

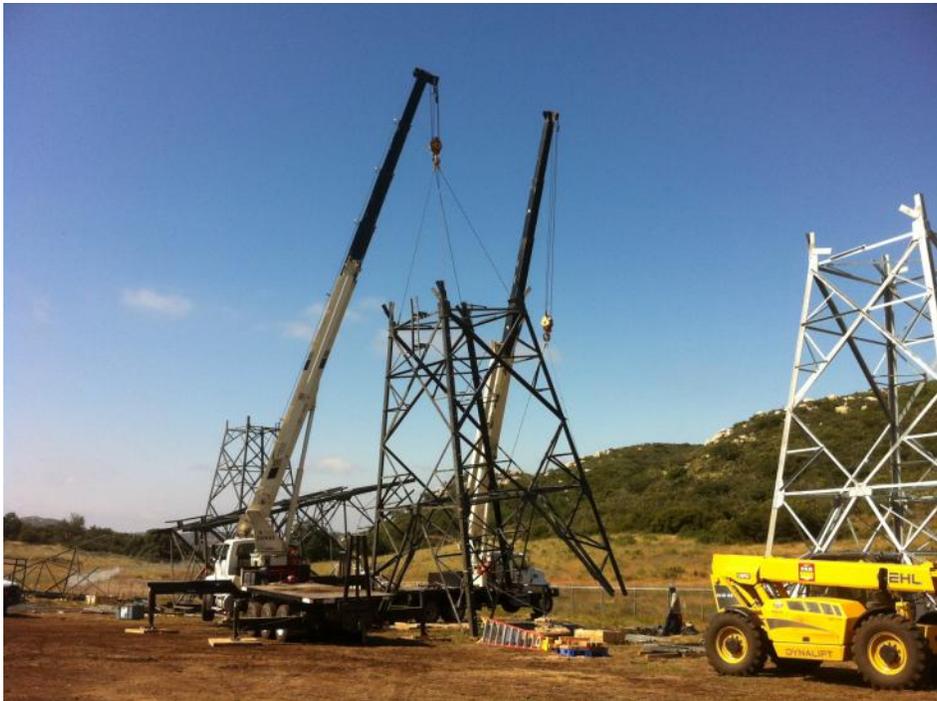
11. Thomas Yard – No work occurred at this location during this reporting period.
12. Wilson Yard – Tower assembly continued and QC occurred (see Figure 10).

Figure 10: Tower assembly at Wilson Yard, Link 3.
