SCE Viejo System Project Mitigation Monitoring Program Final Report

Viejo System Project

Mitigation Monitoring Program Final Report

Prepared for:
California Public Utilities Commission

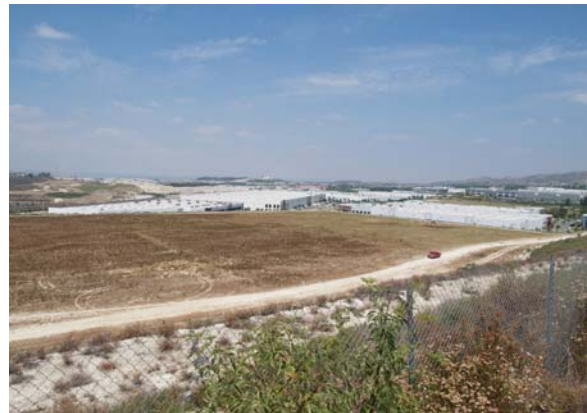
Figure 2-1. Viejo Substation site prior to vegetation removal and grading activities

The Viejo Substation site was previously graded and vacant, including disturbed habitat consisting of white clover, star thistle, and telegraph weed (see Figure 2-1). Mulefat, coyote bush, common tarweed, and buckwheat occurred in small populations scattered intermittently across the site. The area is surrounded by existing office and technology parks and undeveloped lands characterized by scrub vegetation and the nearby Edison Trail to the east. This portion of the trail is above the elevational grade of the substation site and passes through undeveloped lands dominated by low-growing vegetation. Biological resources located in this area are typical of species common to the peninsular ranges of southern California and are adapted to a Mediterranean climate with cool wet winters and hot dry summers. Sage scrub communities occur in the area adjacent to the Viejo Substation and were once the dominant community in the project area. Urban development has encroached into the surrounding foothills removing much of the previous habitat.

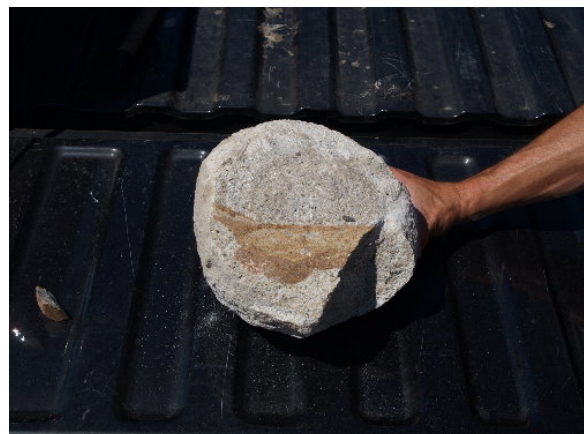
Figure 2-2. Fossil fish discovered on the Viejo Substation site by the LSA paleontological monitor, August 10, 2004

The paleontological inspector was on-site to monitor grading activities at the substation site. Several fossils were discovered during grading activities including a fish fossil and a fragment of sea cow bone (see Figure 2-2). The pad for the site has been severely disturbed and it is likely that some of the fossils have been moved from their original location prior to the start of project construction. Nonetheless, some of the fossils discovered during vertical boring for foundation structures are likely to have been discovered *in situ*.

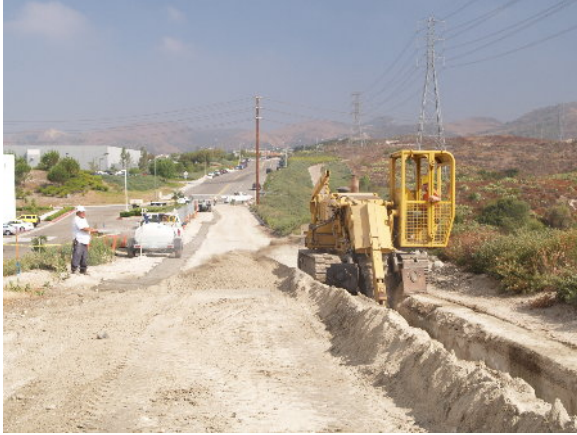
Figure 2-3. Three Kings Construction excavates trench along main access road for fiber optic and 12 kV distribution lines, August 4, 2004

The first excavation on the project was started the week of August 1, 2004, for the electrical conduit between the Viejo Substation site and main gate (see Figure 2-3). This conduit was damaged during the backfill operation and sections were re-excavated later in the project for repair. Following the initial

The pulling of both fiber optic and 12 kV conductor was delayed due to damage to the conduit originally installed by Three Kings Construction. This damage was not identified until later in the project and a section of the access road near the front gate was excavated to replace sections of the PVC conduit.

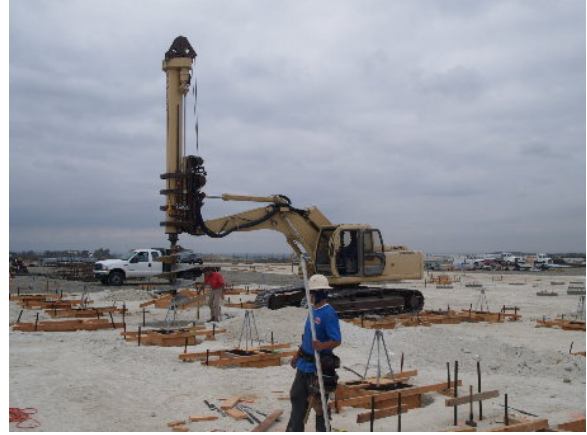
Figure 2-4. Boring machine excavating foundations for supports in the Viejo Substation, September 30, 2004

After the completion of the grounding grid, a vertical drilling machine was used to bore the numerous foundations that were required for the poles and other structures at the facility (see Figure 2-4). The drilling progressed slowly due to the hardness of the native material. Foundations were excavated, formed and concrete placed for the transformer pads, MEER #1 and MEER #2, as well as for other smaller concrete pads.

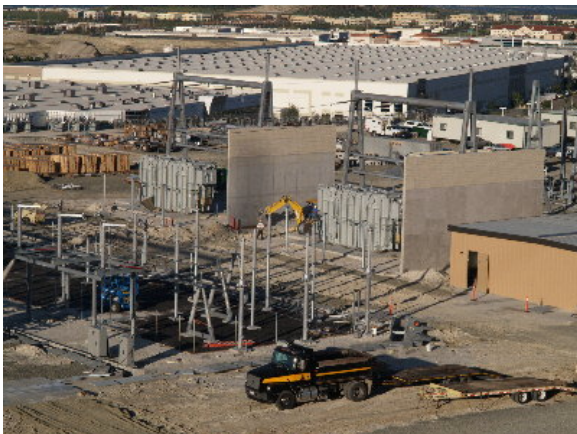
Figure 2-5. Firewalls constructed between the two A-bank transformers and between the transformers and MEER #1, January 11, 2005

The construction of the two firewalls, one between the first A-bank (220 kV to 66 kV) transformer and MEER #1 and the other between the two A-bank transformers, were completed by October 15, 2004 (see Figure 2-5). These firewalls both protect workers in MEER #1 in the case of a transformer fire, but also help prevent a fire from spreading between the two A-bank transformers.

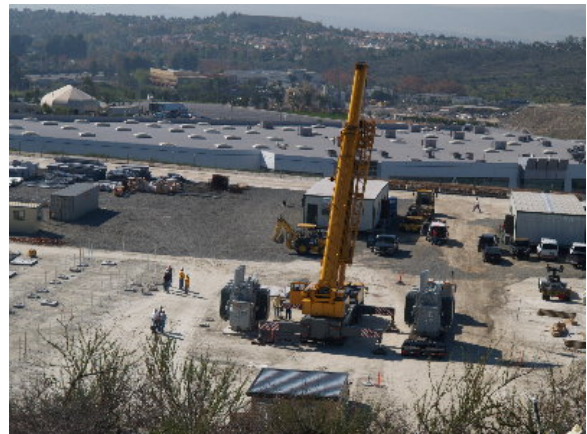
Figure 2-6. Large crane brought to Viejo Substation to set B-bank transformers onto completed concrete pads, November 18, 2004

On November 18, 2004, a crew worked with a 300-ton crane to set the B-bank (66 kV to 12 kV) transformers on their foundations (see Figure 2-6). The crane arrived on-site without counterweights and was not able to extend the boom more than a few degrees away from center. This problem required the

crew to move the transformers in two steps, with the crane located as close as possible to the foundations. The two A-bank transformers were delivered to the substation site by special trucks the week of December 19, 2004. Much of the substation equipment had been delivered and placed on the poured foundations by this time.

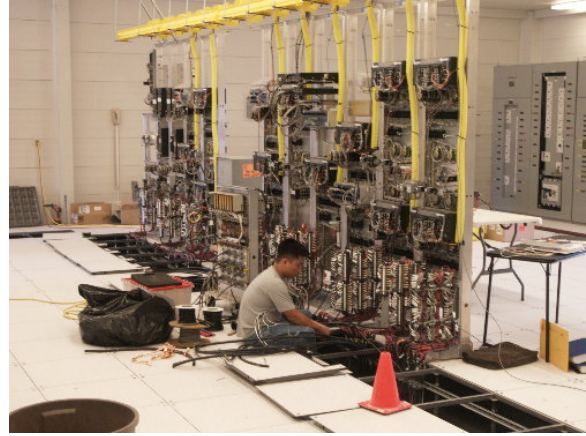
Figure 2-7. Crews worked inside MEER #1 on communication and control systems for the Viejo Substation, March 20, 2005

During 2005, work within the substation site focused on conditioning the transformers, constructing the interior components of the MEER #1 and MEER #2, and building the switching equipment (see Figure 2-7). Work on the installing the switching equipment, stringing conductor, and testing the facility components also occurred at this time.

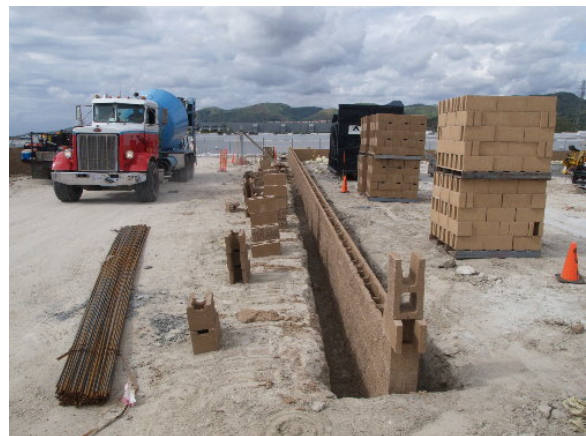
Figure 2-8. Reycon Construction crews built the containment walls and the block wall surrounding the Viejo Substation after the foundations were placed by Union Construction, March 22, 2005

In March of 2005, Union Construction completed the excavation and placement of the concrete foundation for the block wall that shielded three sides of the substation site. SCE increased the width of the foundation for increased stability in the wall. A specialized crew set the concrete blocks for both the exterior wall and the smaller spill containment wall in March and April of 2005 (see Figure 2-8). The smaller spill containment wall was specially coated to prevent the spreading of any petroleum spills and direct any spilled material into a special containment area for proper disposal. The wall was grouted to approximately 3 feet in elevation, when work was delayed briefly while waiting for an inspection by the city building department.

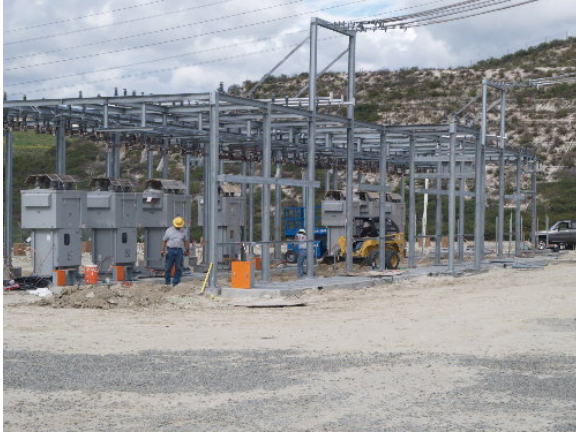
Figure 2-9. The substation electrical contractor, NRG, worked on the 12 kV switching system, March 22, 2005

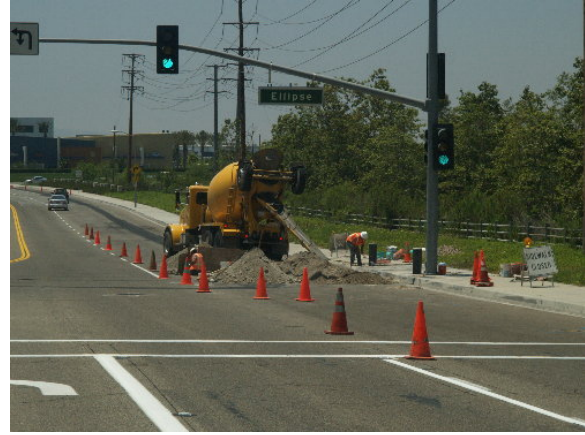
Figure 2-10. Arizona Pipeline installed the 12 kV distribution system and the fiber optic communication lines between the Viejo Substation and the local system, May 24, 2005

well as conduit for the 12 kV distribution lines (see Figure 2-10). Minor concerns over traffic control were addressed early in the construction of the 12 kV and fiber optic underground portion of the project.

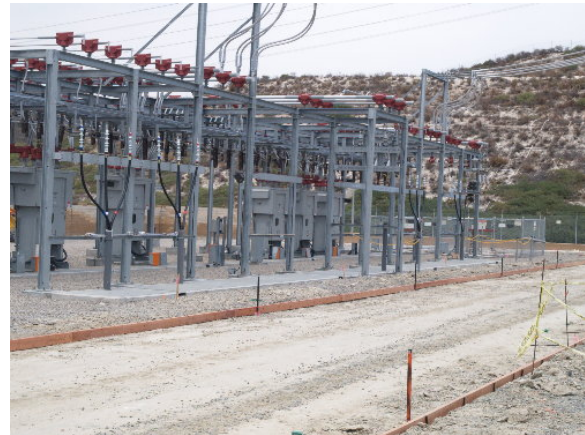
Figure 2-11. The 12 kV underground distribution conductor was connected to the switching system at the Viejo Substation, July 20, 2005

The electrical subcontractor, Hampton Tedder, pulled conductor from the 12 kV vault on Portola Parkway to the racks within the distribution section of the Viejo Substation. The vault connects the 12 kV from the substation to the local distribution system. Hampton Tedder connected the four sets of three 12 kV underground conductors to the racks in the substation, energizing the 12 kV section of the substation in July of 2005 (see Figure 2-11).

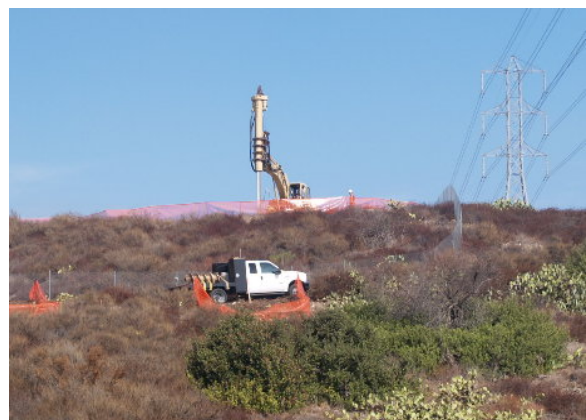
Figure 3-1. The drilling machine started the excavation of foundations for the 220 kV portion of the project, October 5, 2004

A drilling machine started working on the pole foundations starting on October 4, 2004 (see Figure 3-1). The drilling machine spent the entire first week working on one foundation bore due to the hardness of the rock. The spoils from the drilling operation were trucked back to the substation site for removal. Iron workers worked concurrently with the drilling to prepare the rebar cages for the 220 kV transmission line foundations on-site at each LST location.

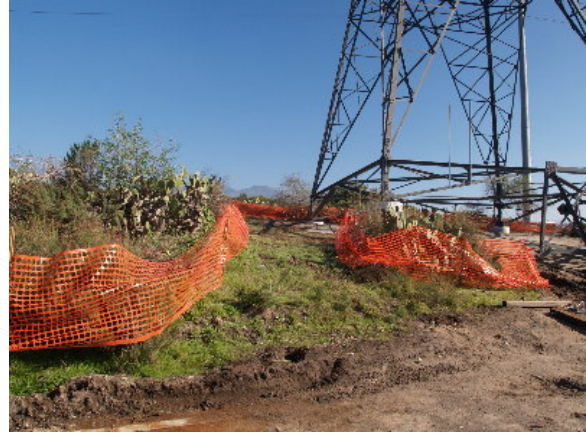
Figure 3-2. Higher value native habitat was marked off to allow the crane and man-lifts to set up on the southern 220 kV tower, December 9, 2004

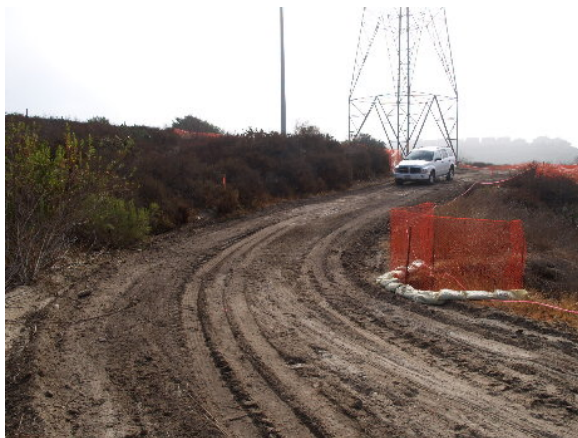
Figure 3-3. The access road between the southern 220 kV tower and the Viejo Substation was eroding due to natural drainage. Steel plates, and later rock, were placed to allow safe passage, October 5, 2004

A grader operator worked to improve the access road to the drilling pads and correct drainage issues before the first rains of the season. The CPUC EM reviewed the access road at the southern portion of the 220 kV section. The condition of the access road had been degraded by erosion from several years of rain runoff along the road. The road had continued to move upstream into the habitat as the downstream side eroded. The contractor needed additional space to move a large crane over the degraded section of the access road. Due to California Department of Fish and Game (CDFG) restrictions, the erosion to the access road cannot be repaired without a permit. SCE placed a steel plate over the eroded section of the road to allow safe passage of large equipment. Furthermore, the access roads in the 220 kV section of the project were rocked to address erosion and all-weather access concerns that arose early in the project (see Figure 3-3). This addition of rock on the access roads greatly reduced erosion and sediment transport from vehicles and restricted sediment transport from disturbed LST pads. SCE stated that it will look into getting CDFG and U.S. Army Corps of Engineers permits to permanently repair the access road in the future.

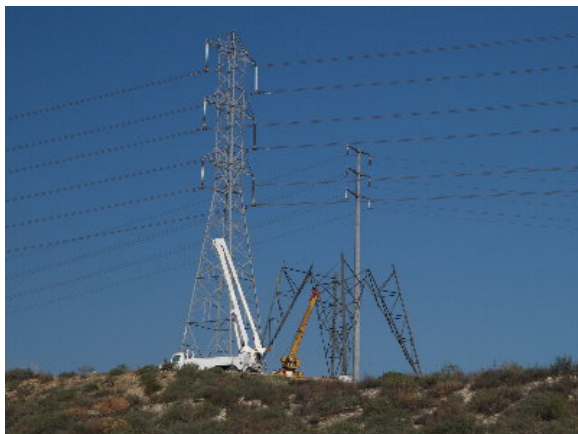
Figure 3-4. Crews used small cranes and man-lifts to raise the section of the new 220 kV towers above the Viejo Substation, November 18, 2004

Construction of the 220 kV portion of the project was simplified by the suitability of the existing access roads and tower pads. Four foundations were drilled and poured for each LST. Anchors set into these foundations provided the attachment points for the lattice structure. Much of the lattice structures were constructed on the ground and then raised into place by a large mobile crane for attachment by transmission line crews (see Figure 3-4). After the

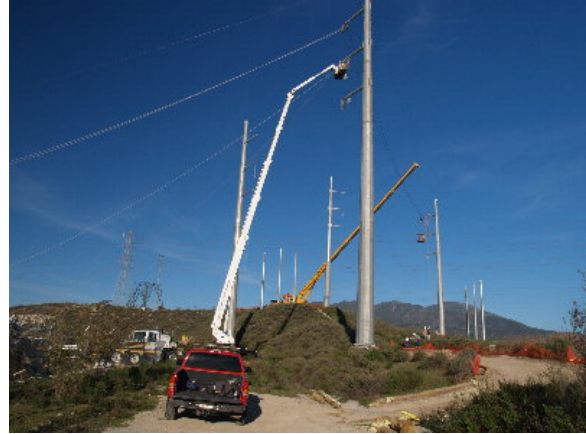
Figure 3-5. Crews used man-lifts and crane-supported baskets during stringing activities on the 220 kV section, December 17, 2004

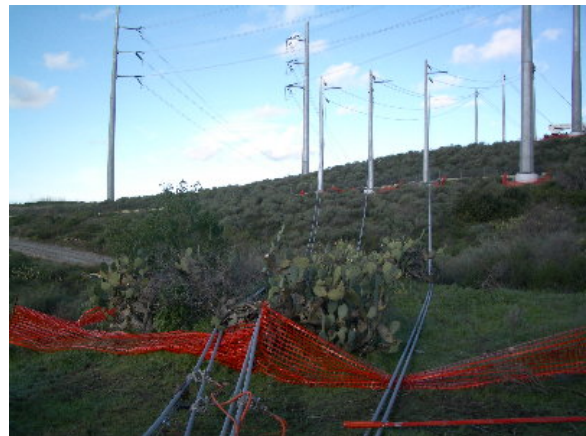
Figure 3-6. Conductor dropped during the stringing of the 220 kV transmission line. SCE worked with the project biologist to remove the conductor with minimal environmental impact, December 30, 2004

In December of 2004, the SCE transmission line crews used a large mobile Hill Crane in stringing cable between the substation site and the 220 kV transmission line corridor. The crews worked in both a basket held by the Hill Crane and mobile man-lifts to connect the insulators and cables on the steel pole portion of the transmission work (see Figure 3-5). The Bronto man-lift was set up on the level area between the southern staging area and the transmission line right-of-way. The SCE biologist helped the crew set up the Bronto in the non-native vegetation. No clearing or grading was required to set up the man-lift. These two man-lifts worked on the south side of the substation staging area to lift workers to the poles. Stringing work on the 220 kV transmission line corridor could be completed only under an ISO outage and these usually were granted early on a weekend morning. The stringing across the 241 Toll Road was also coordinated with Caltrans due to the temporary closure of the road for safety reasons. Stringing across the toll road was completed with no safety issues. The conductor did drop into the native vegetation between the toll road and the Viejo Substation, but the crews worked with the SCE biologist to remove the conduit with minimal impacts to the vegetation (see Figure 3-6). The impacts could not be easily seen during the final walkthrough a year after the incident.

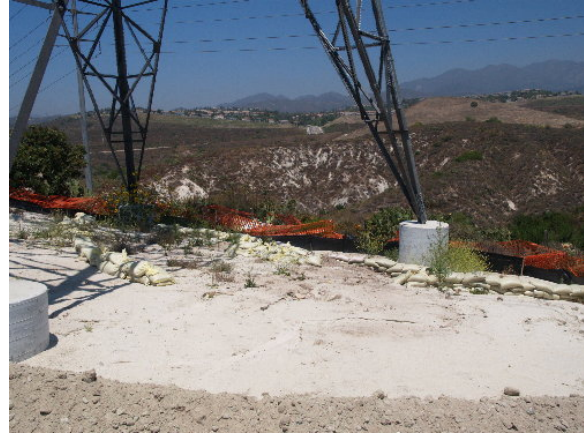
Figure 3-7. Non-native ruderal species emerged in the areas disturbed by the 220 kV transmission line construction and were removed by hand, July 5, 2005

Only minimal revegetation was required on the 220 kV portion of the project due to the previously disturbed nature of the site. Revegetation was limited to reseeding or replacement of native seed bank on slopes disturbed during the construction of the tower pads. Due to the time lapse between the completion of pad construction and the final clean-up and restoration, invasive species were growing on several disturbed slopes and under the new towers (see Figure 3-7). The CPUC EM notified SCE of the concern since the area adjacent to the project is dominated by native species and is part of a habitat conservation area. In August of 2005, the invasive plant species in the recontoured area of the 220 kV right-of-way, adjacent to the native plant communities, were carefully removed by SCE without disturbing the reemerging native species.

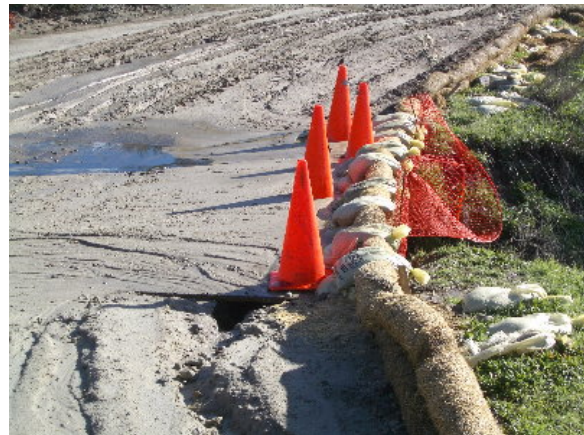
Figure 3-8. Heavy rains and the use of inappropriate erosion prevention and sediment control devices led to sediment transport on the 220 kV transmission line right-of-way, December 30, 2004

Minor erosion and sediment control issues were reported to SCE early in the project after the near record rainfall in the winter of 2004/2005. Inadequate erosion prevention and sediment control devices or lack of regular maintenance led to the transportation of sediment off the project right-of-way (see Figure 3-8). SCE corrected these issues by improved maintenance and the installation of additional erosion control devices and the placement of rock on the access roads. As these issues were presented verbally by the CPUC Lead EM, resulted in no resource damage, and were promptly corrected by SCE, no written Project Memoranda or Non-Compliance Reports were necessary.

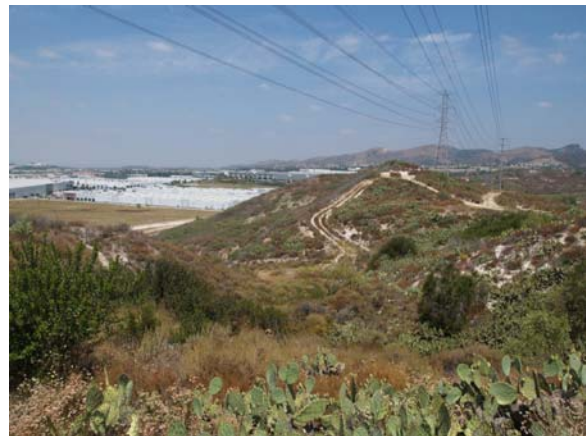
Figure 4-1. Native vegetation on 66 kV right-of-way prior to construction, May 2005

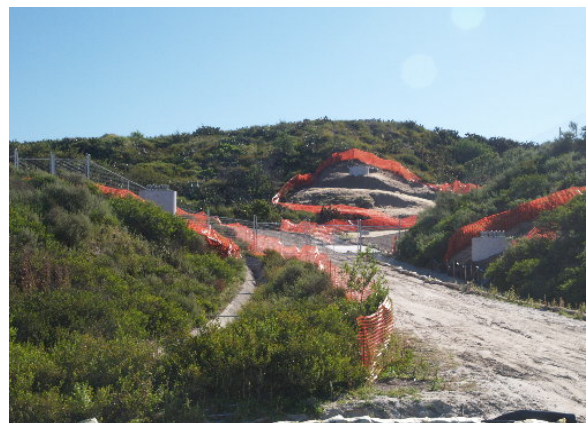
Figure 4-2. New access roads and pads were required for the steel poles connecting the 66 kV right-of-way and the Viejo Substation, April 1, 2005

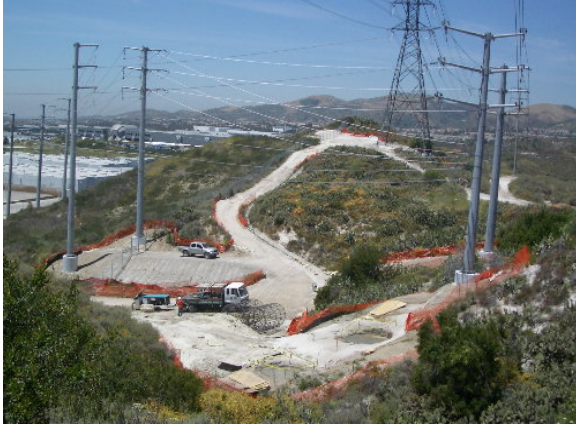
Figure 4-3. The two excavations for H-Frame Structure 13 in the foreground were backfilled with slurry after improper placement, May 20, 2005. Note the contrast compared to Figure 4-1.

tion. The foundations excavated for H-Frame Structure 13 (closest to the Viejo Substation) were slightly misaligned and were backfilled with cement slurry in May of 2005, and then re-excavated once the slurry had set (see Figure 4-3).

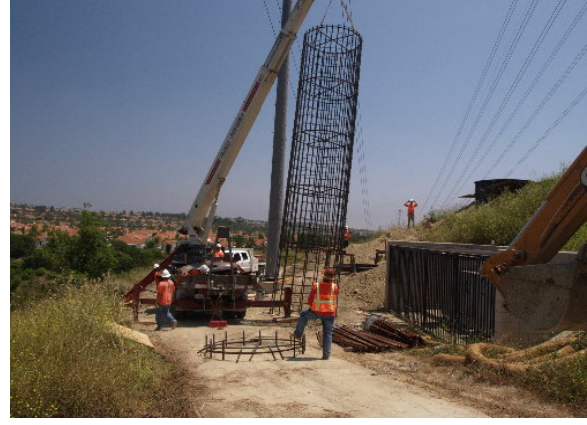
Figure 4-4. Crews prepared to lower the rebar re-enforcing cage and anchor bolts into the foundation for H-Frame Structure 9 prior to concrete placement, June 14, 2005

Upon the completion of excavation of the foundation holes, the contractor placed a rebar cage and anchor bolts in the excavation prior to the placement of concrete (see Figure 4-4). The rebar adds strength to the foundation and the anchor bolts protrude far enough from the concrete foundation to provide a secure attachment for the steel poles. The H-frame structures were raised in steps once the concrete in the foundations had cured sufficiently to handle the load. Cranes were used to raise the lower steel pole sections, and once these were securely bolted to the foundation, crews scaled the poles to attach the upper section of the H-frame structure while it was held in place by the crane (see Figure 4-5). The two steel poles of the H-frame structure were connected by cross braces and then arms were connected to the outside of the structures (see Figure 4-6). H-Frame Structure 13 was complete in June of 2005 and the final H-frame structure adjacent to the Chiquita Substation was completed and ready for conductor in November of 2005 (see Figure 4-7). Minor delays struck the crews raising the steel poles in July of 2005 due to the loss of ISO outages due to high energy loads with the summer heat. The ISO outages were necessary for work at many of the structures due to the proximity of energized lines.

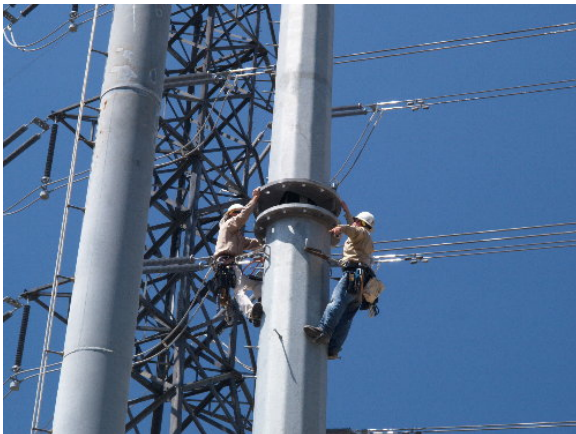
Figure 4-5. A crew scaled H-Frame Structure 12 to guide the upper section into place and bolt it to the lower section, June 7, 2005

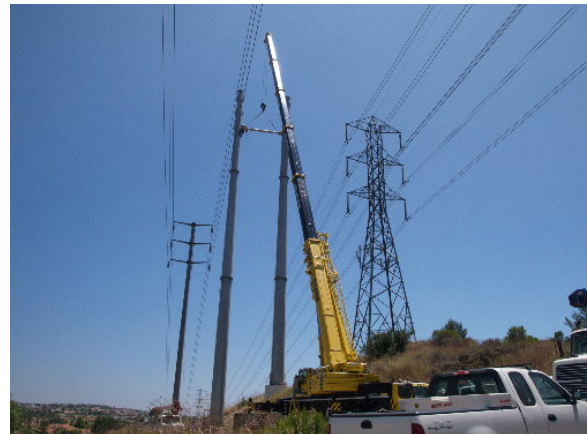
Figure 4-6. Crews worked with a crane and man-lifts to attach the cross members to H-Frame Structure 9, June 29, 2005

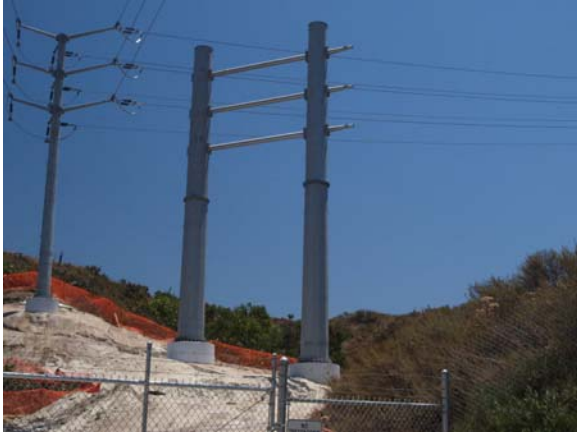
Figure 4-7. H-Frame Structure 13 completed with cross members and west set of arms, June 22, 2005

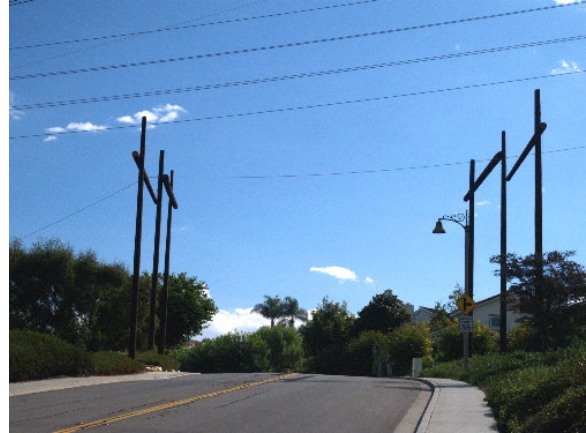
Figure 4-8. Guard structures placed across residential road to prevent pulling rope from sagging onto road, September 26, 2005

Prior to the pulling of any conductor over sensitive habitat, foreign utilities, or roads, the crews installed guard structures to protect these resources from being damaged by the weight of the conductor. The guard structures were constructed of two wood poles placed into excavated holes with a third pole lashed to the tops (see Figure 4-8). A pair of these structures can support any conductor or pulling line that sags between the towers due to either a malfunction with the puller or a break in the conductor. The guard structures were removed once the final conductor was pulled over the resource and the ground restored. The majority of guard structure on the 66 kV transmission line were placed in the ornamental landscaping adjacent to public roads.

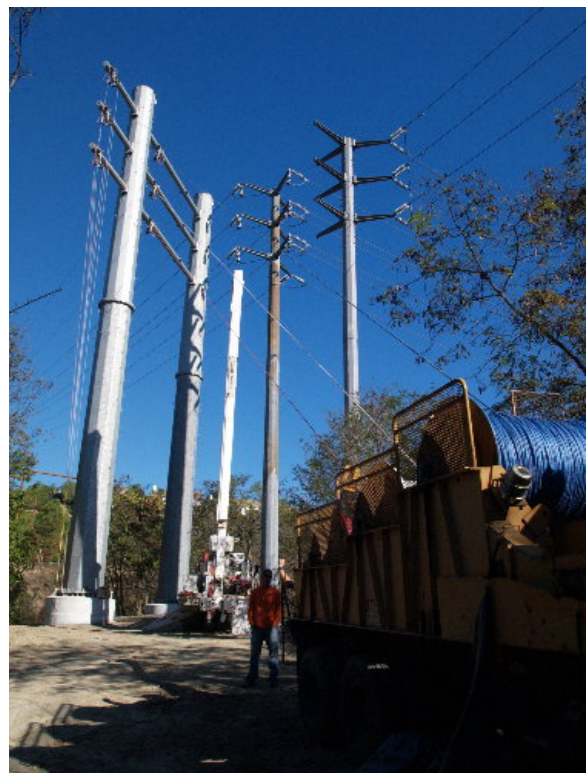
Figure 4-9. The pulling crew set up adjacent to the Chiquita Substation to pull the center circuit of the 66 kV transmission line, April 1, 2005

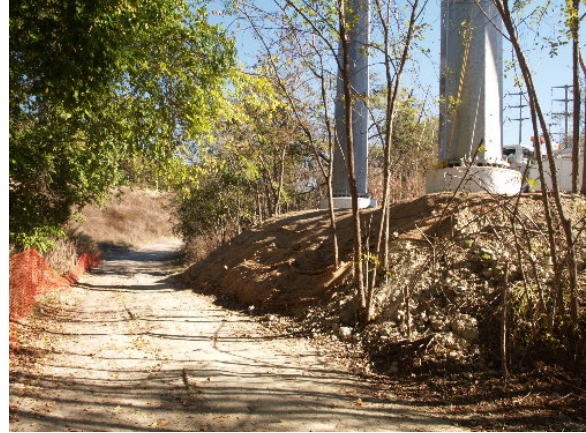
Figure 4-10. No recruitment of native (or ruderal) vegetation has been observed on the disturbed slope below H-Frame Structure 1, October 31, 2005

Since the 66 kV transmission line was constructed in the existing disturbed right-of-way and most of the vegetation disturbed was ornamental landscaping, very little restoration was necessary. The small area disturbed on the slope below H-Frame Structure 1 was stabilized with jute netting, but has shown no signs of revegetation in the past year (see Figure 4-10). The slopes of the new pads adjacent to the Viejo Substation, which are located in the Viejo Conservation Bank, were stabilized and allowed to revegetate naturally.
