PROJECT MEMORANDUM
SDG&E VINE 69/12-KV SUBSTATION PROJECT

To: Eric Chiang, Project Manager, CPUC
From: Vida Strong, Aspen Project Manager
Date: August 15, 2016
Subject: Monitoring Report #2: July 30 to August 12, 2016

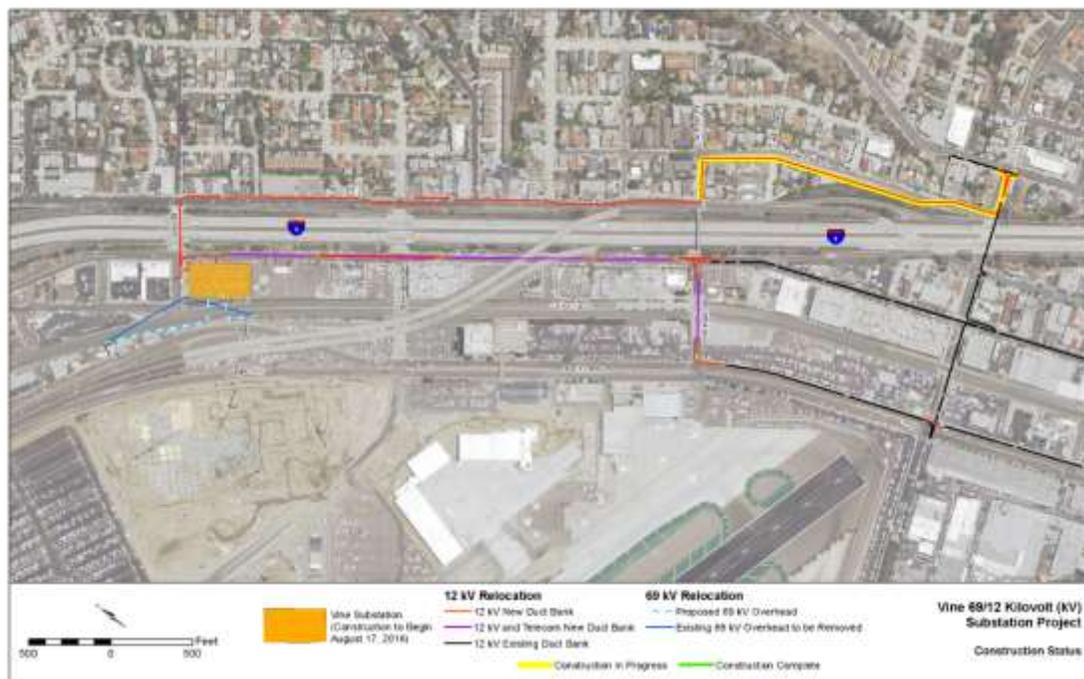
Exhibit A – Construction Status

Summary of Activity: Please see Exhibit A

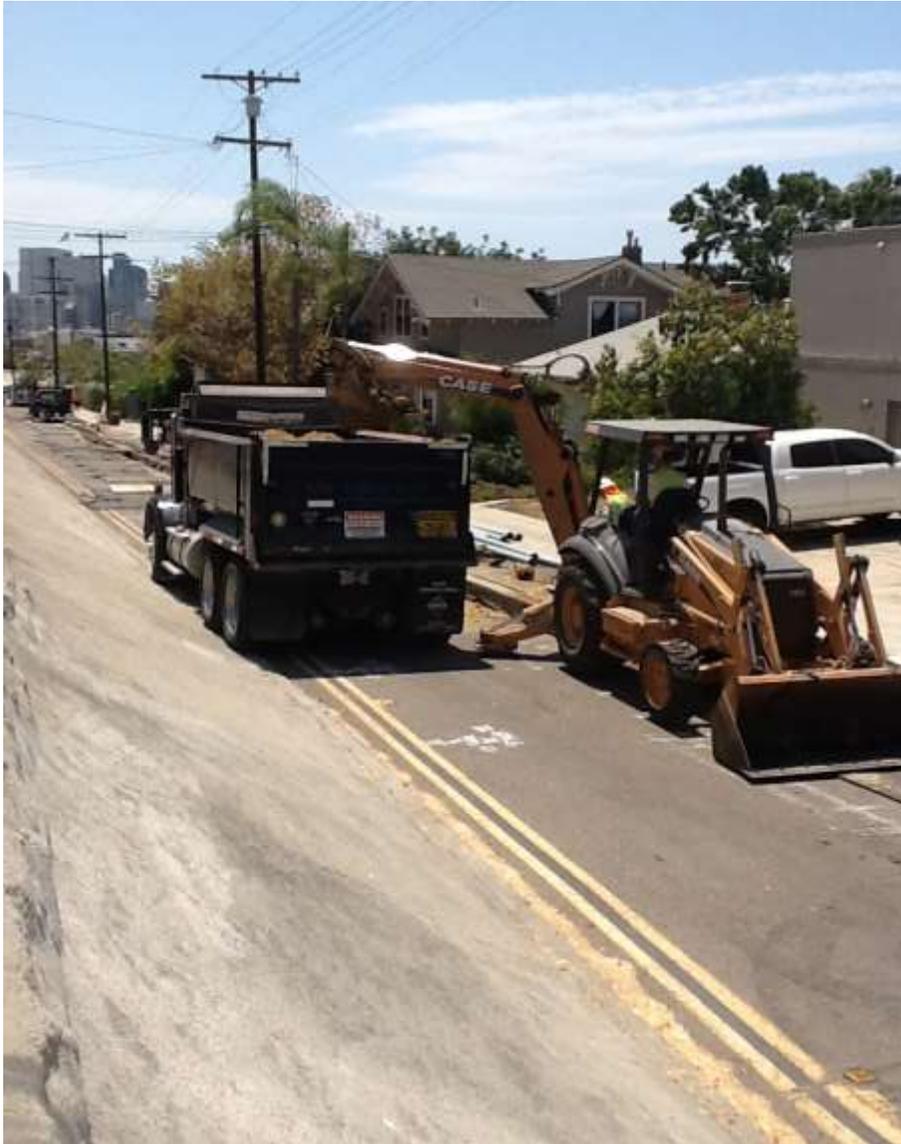
1. Utility potholing, saw-cutting of asphalt, and excavation of trenches took place along W. Laurel and Columbia Streets (see Figure 1). Excavated soils were hauled offsite. Excavations were covered at the end of the work day using steel plates (see Figure 2). NPL is the contractor conducting the 12-kV relocation.

Figure 1 – Trenching continued along Columbia Street. Excavated materials are being hauled offsite.

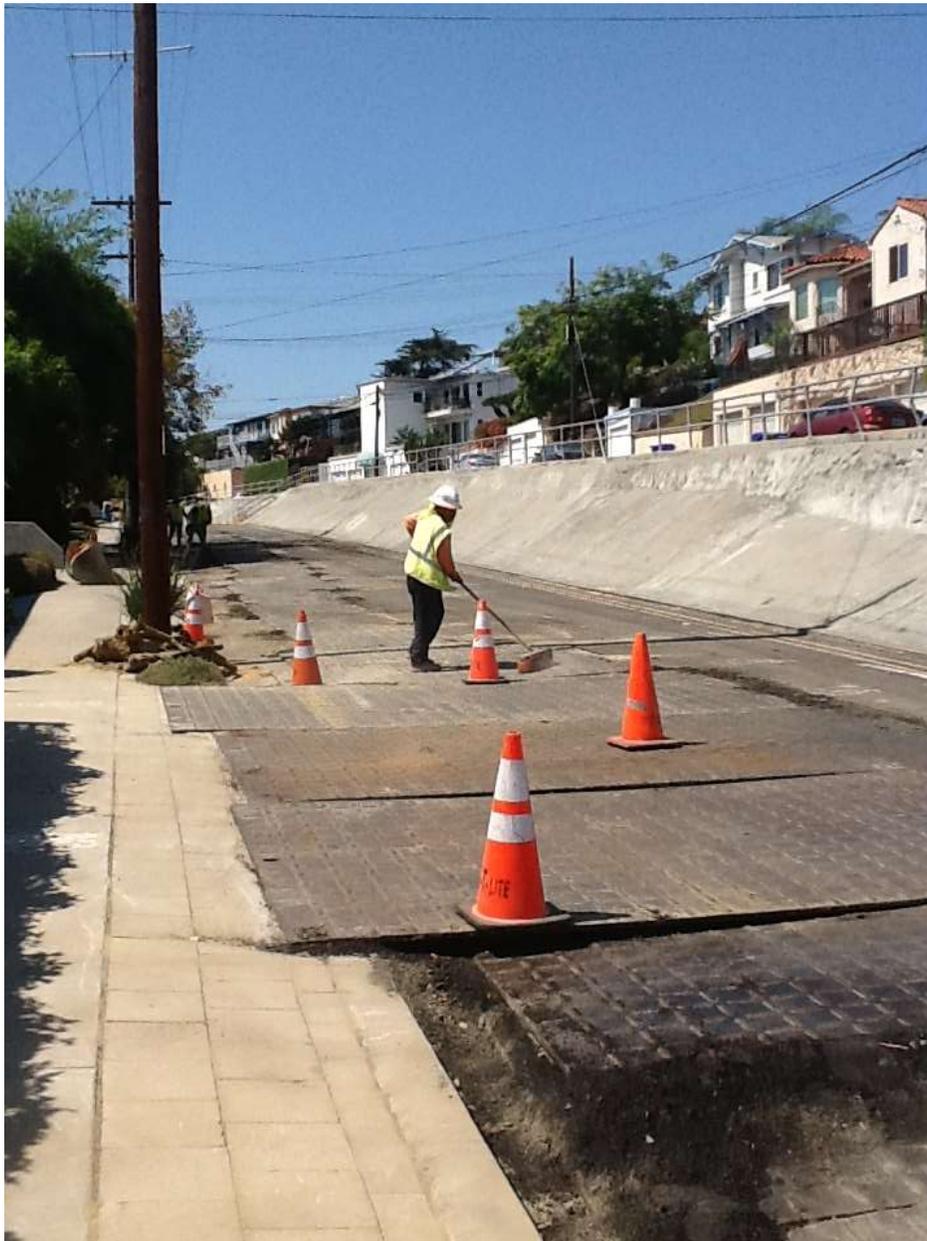
Figure 2 – Steel plate placement over the trenchline at the end of the day along Columbia Street.

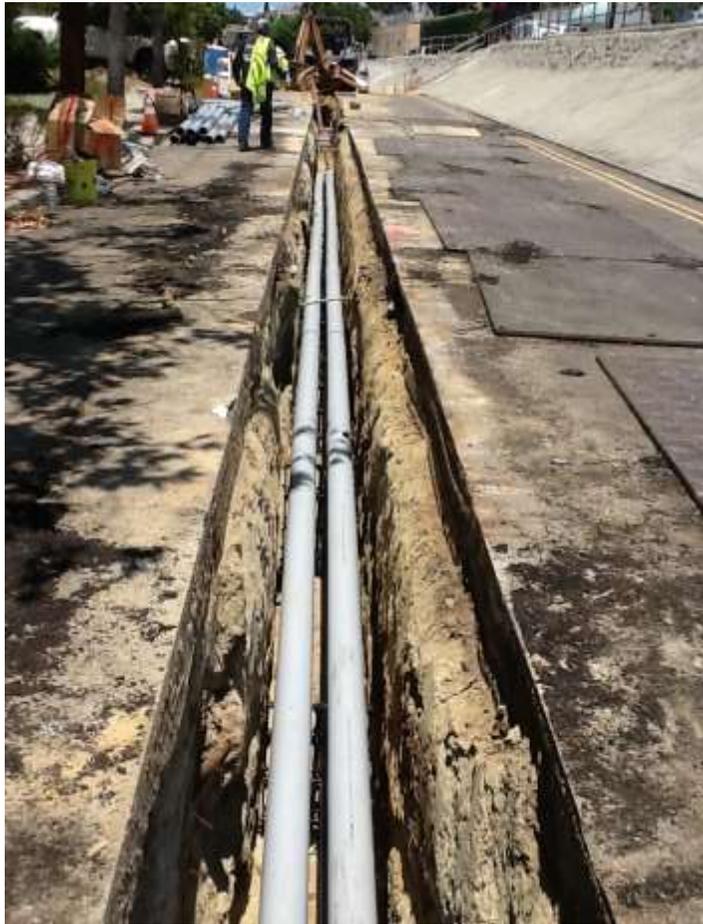
4. Conduit installation occurred between vaults and concrete was used to backfill the trenches (see Figures 3 and 4).

Figure 3 – Conduit installation in the trench along Columbia Street.

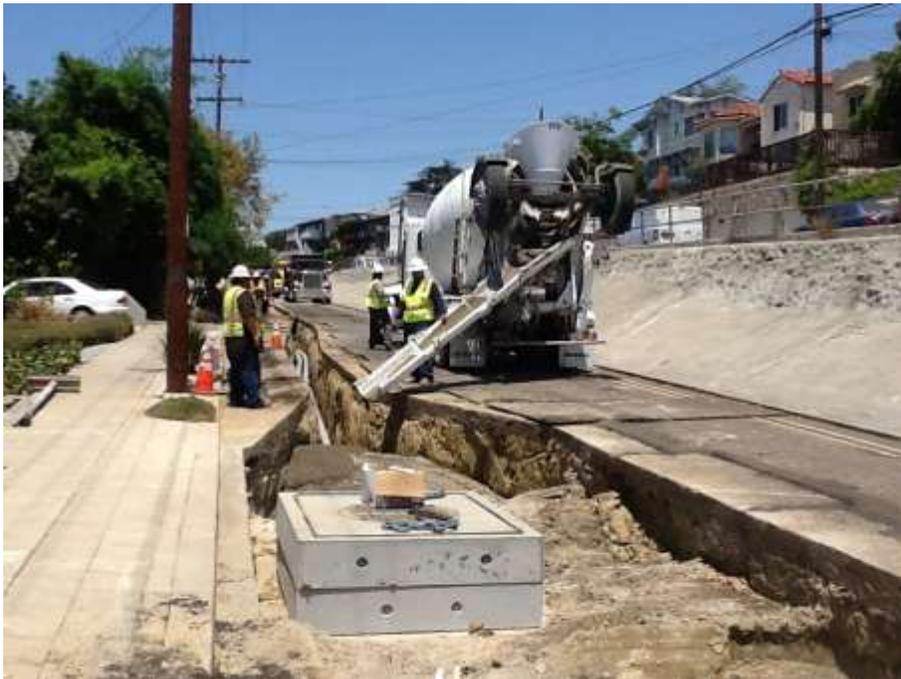
Figure 4 – Concrete backfilling of the trench after conduit installation along Columbia Street.

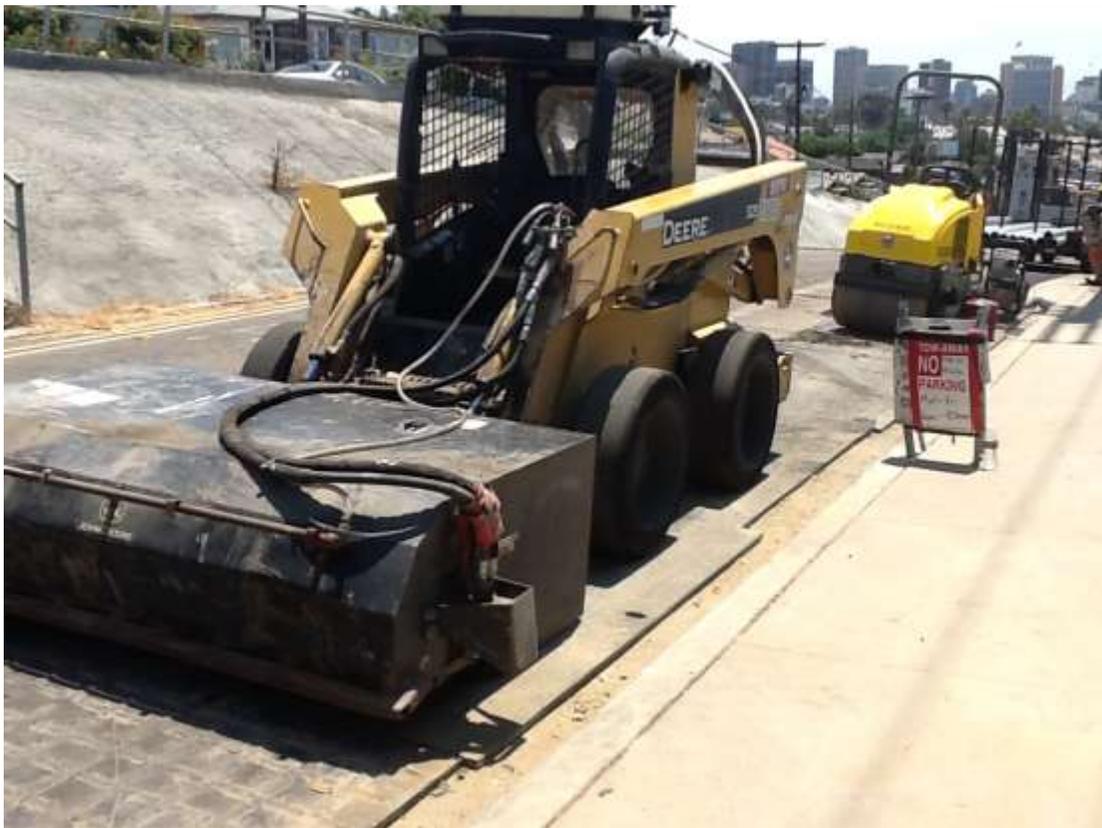
1. **Air Quality** - On August 2, the CPUC EM observed that the NPL contractors were using a street sweeping attachment which was not in compliance with local air quality rules (see Figure 5). This information was communicated to the SDG&E Environmental Inspector (EI). The CPUC EM provided the applicable rule information to SDG&E. SDG&E reported that NPL had obtained a certified street sweeper consistent with the local air quality rules.
2. **Air Quality** - NPL has two pieces of Tier 2 equipment in use on the Project. In accordance with Mitigation Measure AQ-1, both were used for less than 10 days and were removed from the Project on August 5.

Figure 5 – NPL’s street sweeper was not on the SCAPCD approved list of sweepers.

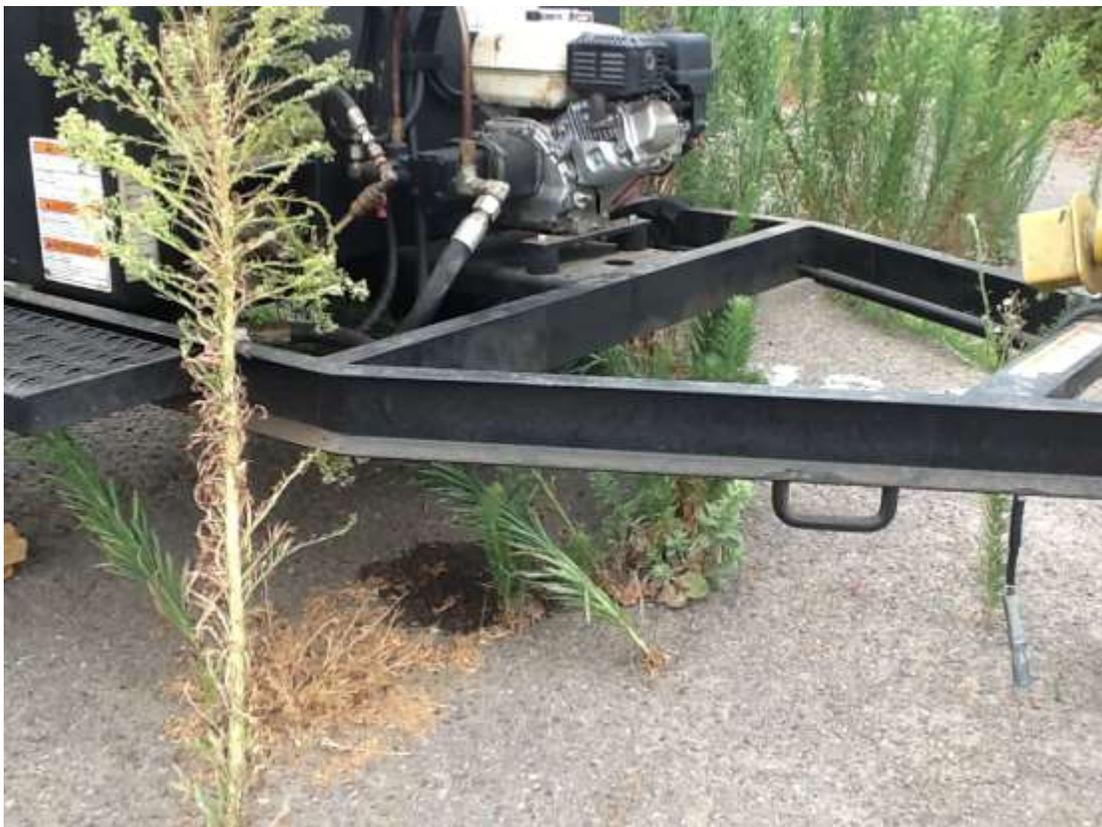
3. **Hazardous Materials** - On August 2, the CPUC EM toured the Vine Substation area where NPL’s materials and equipment were staged. A motorized trailer was observed to be leaking onto the pavement and no drip pan had been placed underneath the motor (see Figure 6). This was reported to SDG&E’s EI. Absorbent material was used to remove as much material as possible and a drip pan was placed under the engine.
4. **SWPPP** - The CPUC EM observed uncontained construction waste being stored at the Vine Substation site. No dumpsters were located at the site. According to SDG&E, NPL planned to dispose of all of the material offsite.

Figure 6 – Leaking equipment at the Vine Substation yard without secondary containment.
