KOP 12
Morongo Community Center
Existing View

SCE West of Devers Upgrade Project
Visual Resources
Figure D.18-19A

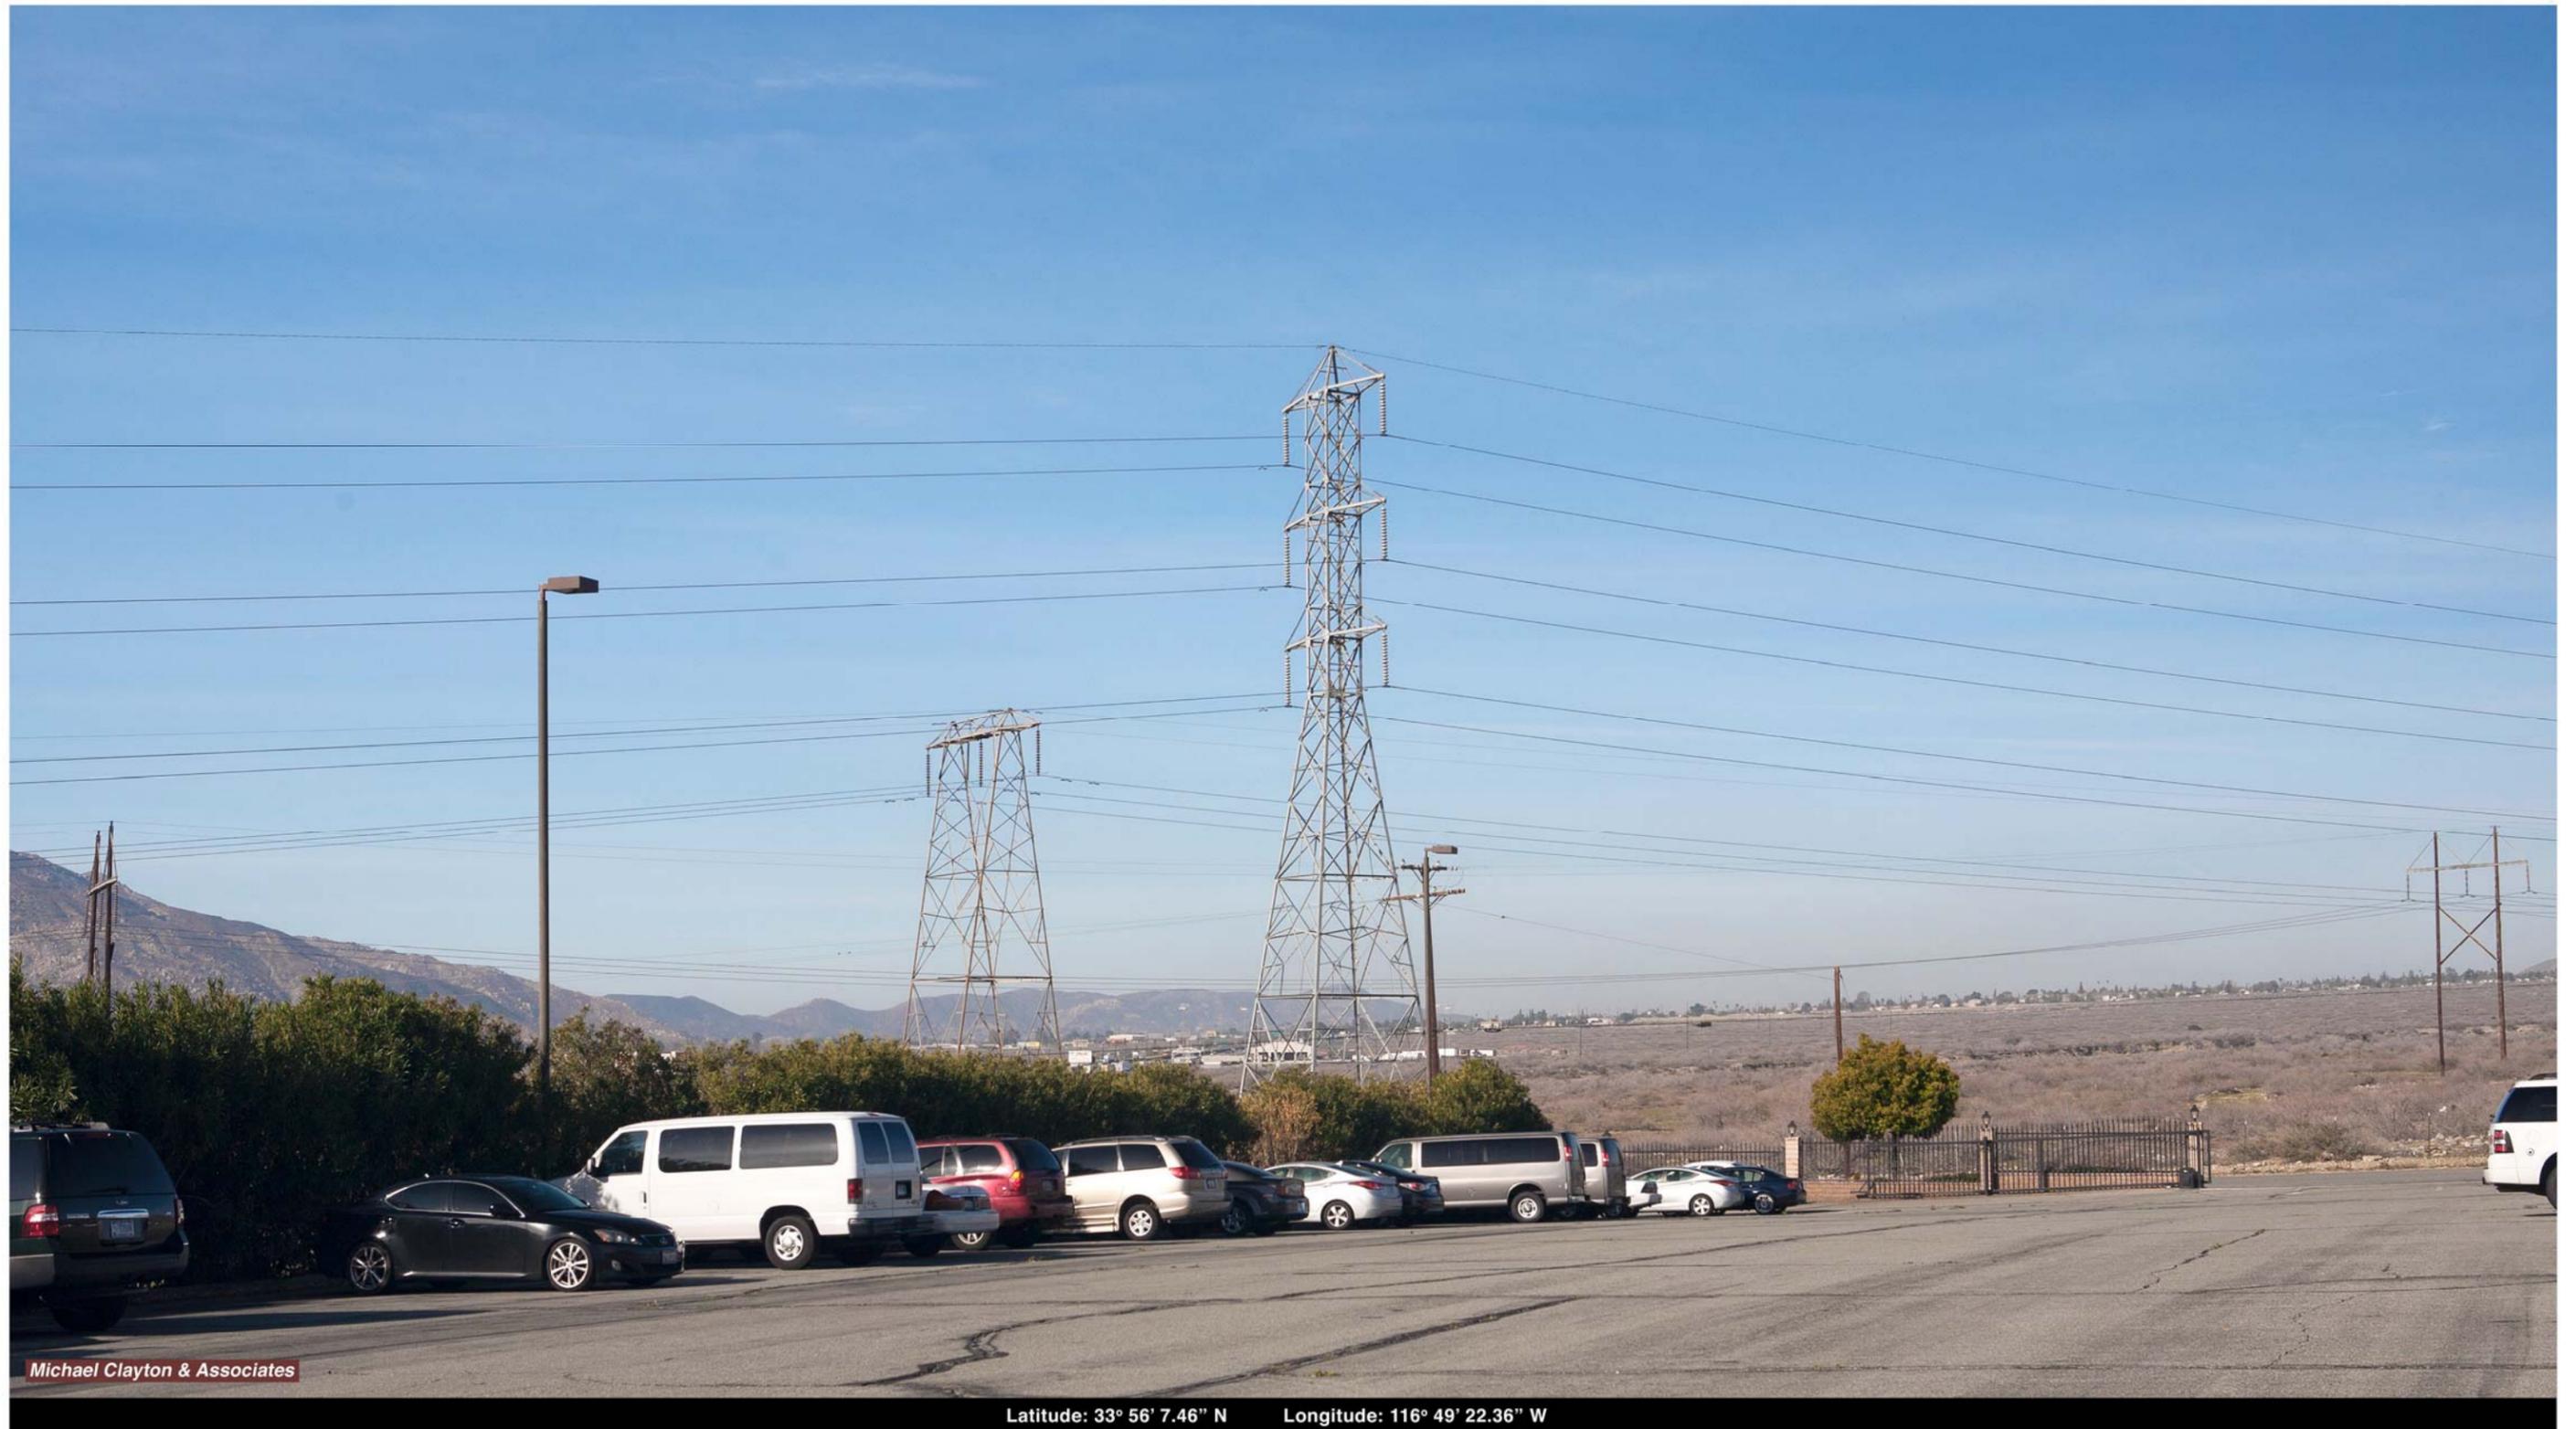
This image presents the **Existing View** to the southwest from **KOP 12**, at the **Morongo Community Center**. The view encompasses a portion of the Community Center parking lot and the ROW as it passes between the Community Center and I-10. The ROW contains three transmission lines, two consisting of lattice steel structures, and one wood-pole H-frame line.
