PROJECT MEMORANDUM PG&E WINDSOR SUBSTATION PROJECT

To:Eric Chiang, Project Manager, CPUCFrom:Vida Strong, Aspen Project ManagerDate:August 30, 2017Subject:Monitoring Report #30 – August 21, 2017 to August 27, 2017

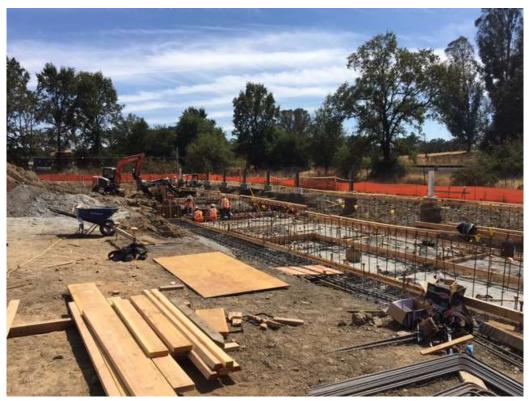
Construction of the SPCC pond along the western side of the site continued with excavating and the installation of rebar for footings. Excavated soil was hauled off site.

Figure 1 – Tying rebar in the SPCC ponds on west side of site – view southwest, August 24, 2017.

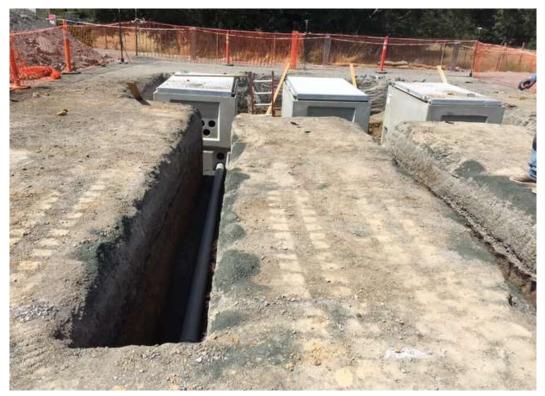
Conduit trenches for the distribution line were excavated, conduit installed to pull boxes, and the trenches backfilled.

Figure 2 – Installing conduit to pull boxes set on northern perimeter – view north, August 24, 2017.

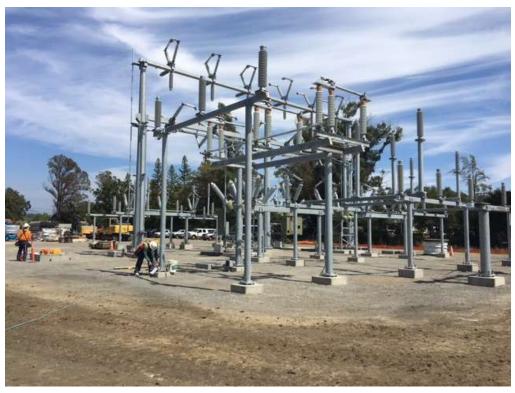
On the southwest side of the site, installation of transmission switches and insulators on dead-end structures occurred. Operator platforms were also installed.

Figure 3 – Installation of switches and insulators on dead-end structures – view southeast, August 24, 2017.

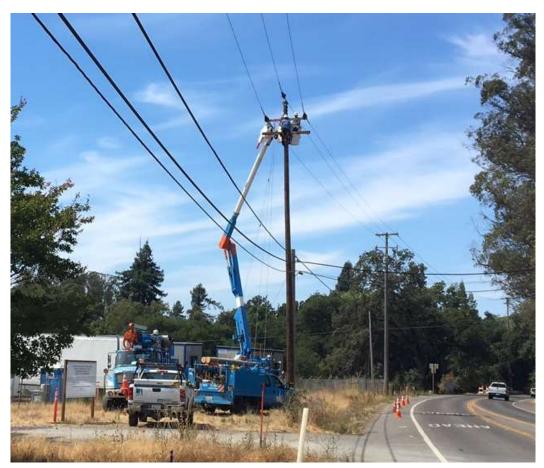
The new pole outside the substation was set. Replacement poles have been staged at the remaining pole locations along Old Redwood Highway, and the crew will continue to work south.

At the time of the CPUC EM site visit on August 24, crews were using a bucket truck to work on the line at the new pole location (see Figure 4).

Figure 4 – Pole installation outside of substation – view north, August 24, 2017.
