PROJECT MEMORANDUM PG&E WINDSOR SUBSTATION PROJECT

To: Eric Chiang, Project Manager, CPUC
From: Vida Strong, Aspen Project Manager
Date: November 2, 2017
Subject: Monitoring Report #38 – October 23, 2017 to October 29, 2017

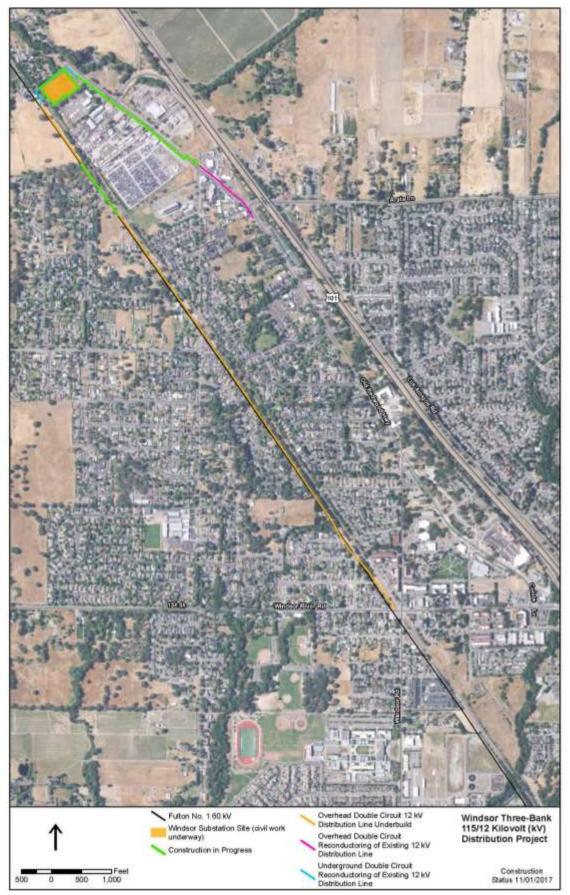
EXHIBIT A – CONSTRUCTION STATUS

This report provides a summary of the construction and compliance activities associated with the PG&E Windsor Substation Project which includes the construction of the Windsor Substation, as well as 12 kV distribution line underbuild and reconductoring work (see Exhibit A).

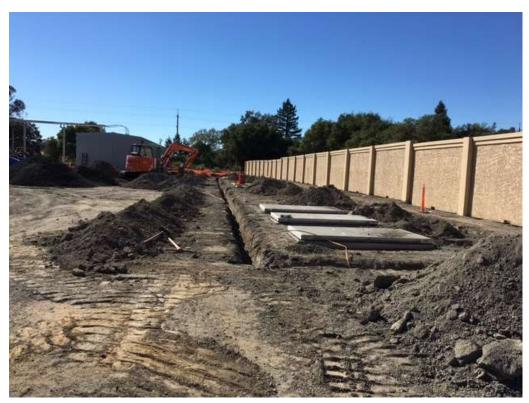
Conduit trenches for the distribution line were excavated, conduit installed to pull boxes, and the trenches backfilled on the northern side of the switchgear building (see Figure 1).

Figure 1 – Conduit trenching on north side of switchgear building – view west, October 27, 2017.

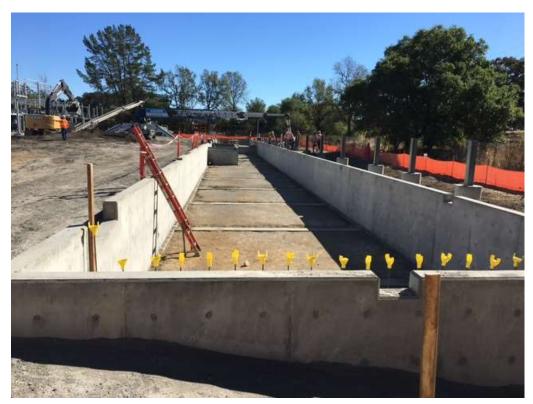
Crews poured concrete for the SPCC pond and continued to backfill and compact engineered fill around the pond (see Figures 2 and 3).

Figure 2 – Backfilling and compacting around SPCC pond – view south, October 27, 2017.

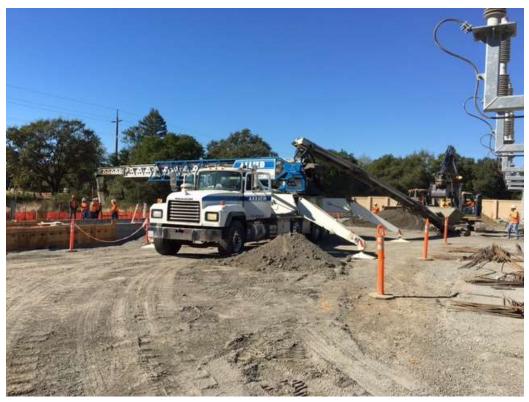
Figure 3 – Equipment moving backfill to west side of SPCC pond – view northwest, October 27, 2017.

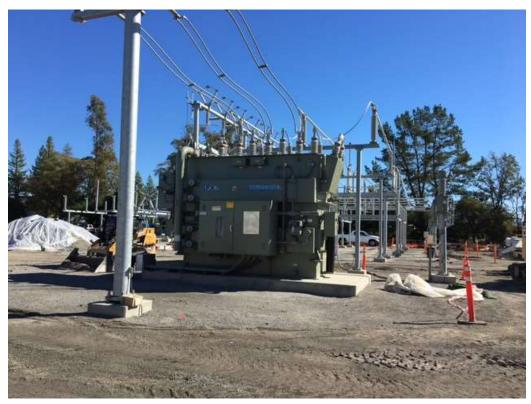
The transformer and some of the dead-end structures were painted green (see Figure 4).

Figure 4 – Transformer painted green – view south, October 27, 2017.
