<p>California Public Utilities Commission <i>Mitigation Monitoring, Compliance, and Reporting Program</i></p>
	<p>East County (ECO) Substation Project</p> <p>Compliance Status Report: 022</p> <p>February 2, 2014</p>

SUMMARY

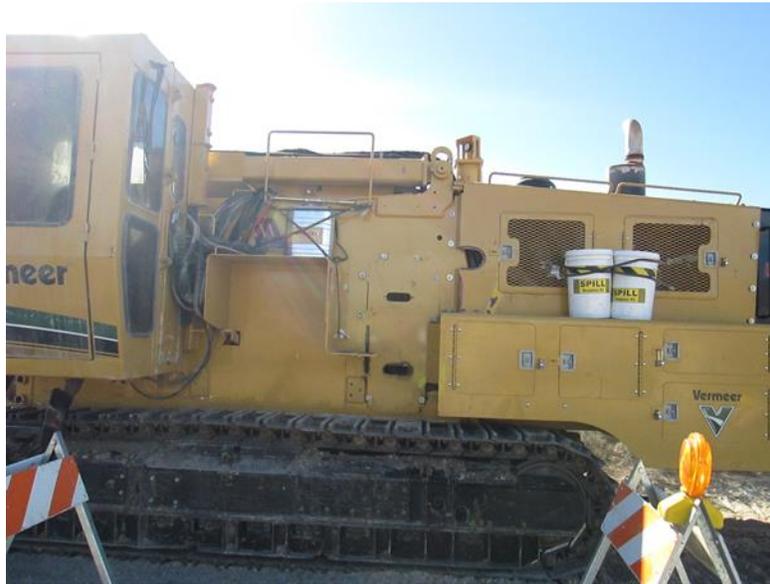
Photo 1: Spill kits attached to construction equipment to ensure materials are readily accessible for clean-up of small spills in accordance with MM HAZ1-a.

In accordance with MM-HAZ-1a, spill kits were observed on site and securely attached to construction equipment (see Attachment A - Photo 1) to ensure materials are readily accessible for clean-up of small spills. Staged equipment and portable restroom facilities were also observed to have containment bins (see Attachment A - Photo 2).

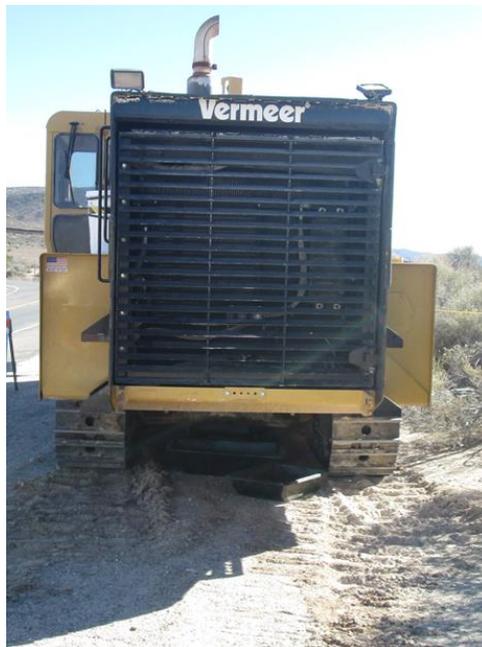
Photo 2: Containment bins were observed beneath staged equipment in accordance with MM-HAZ1-a.

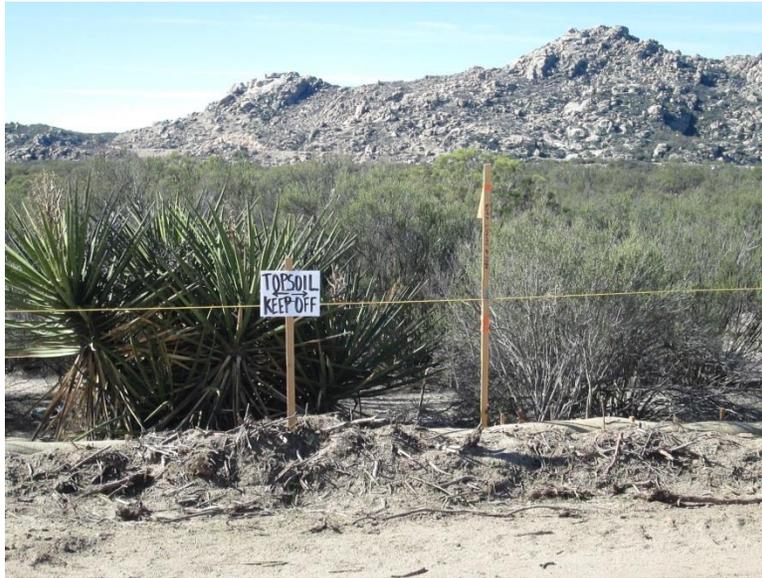
Photo 3: Topsoil is stockpiled along the edges of the work limits for use in restoration activities in accordance with the Habitat Restoration Plan and MM BIO-1d.

Topsoil was observed stockpiled along the edges of the work limits in accordance with the Habitat Restoration Plan and MM-BIO-1d (see Attachment A - Photo 3).

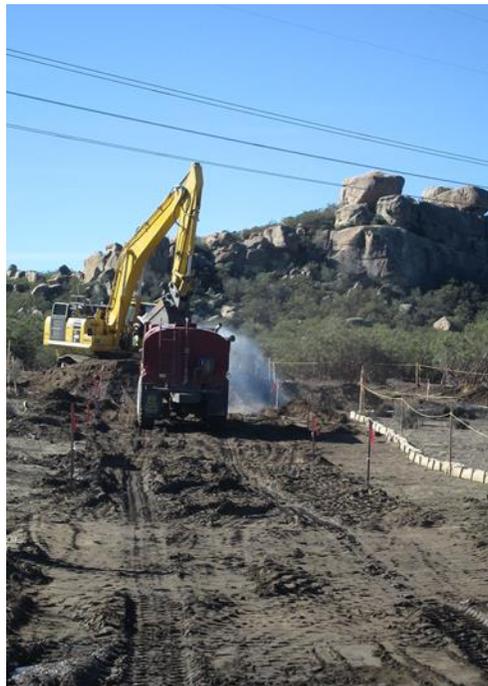
Photo 4: In accordance with MM BIO-4a and MM AQ-1, water trucks were observed suppressing fugitive dust emissions in areas of active construction.

In accordance with MM-BIO-4a and MM-AQ-1, water trucks were observed suppressing fugitive dust emissions in areas of active construction and along unpaved roads (see Attachment A - Photo 4). Trucks transporting bulk materials during spoil removal were observed to be covered per MM-AQ-1.

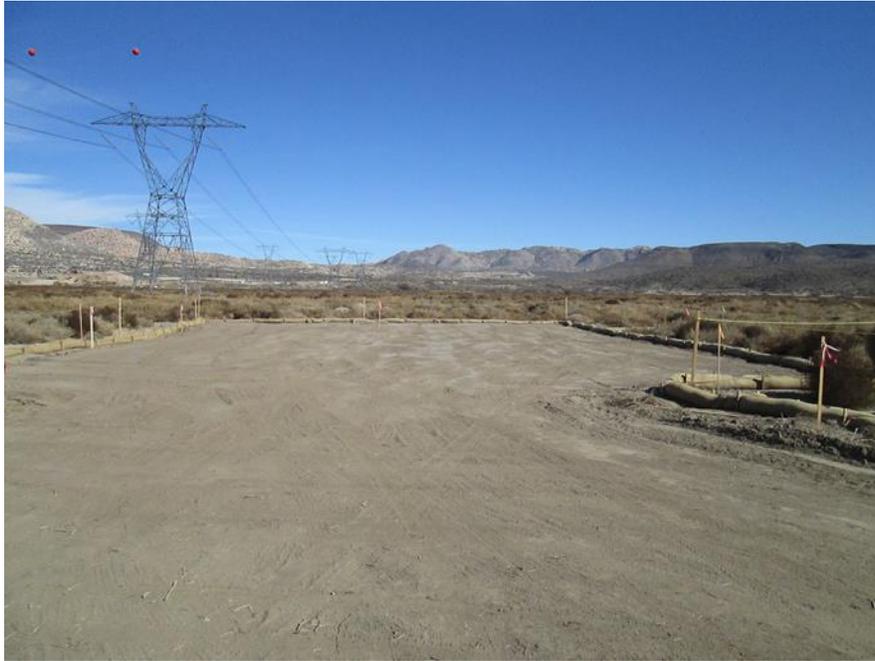
Photo 5: Silt fencing and straw wattles are installed along the perimeter of steel pole pad sites for erosion and sedimentation control in accordance with the SWPPP and MM HYD-1.

Silt fencing and straw wattles were installed at steel pole pad sites and along spur roads for erosion control purposes in accordance with MM-HYD-1 (see Attachment A - Photo 5).

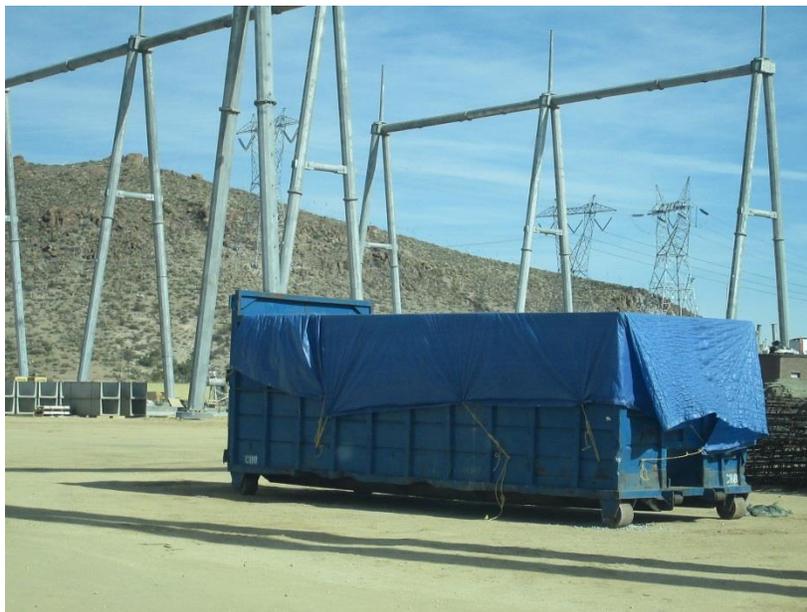
Photo 6: In accordance with MM HAZ-1c, trash storage bins were covered and removed from site when at capacity.

In accordance with MM-BIO-7d, waste was contained in covered waste-management receptacles or inside construction vehicles. In accordance with MM-HAZ-1c, trash storage bins were covered and removed from site when at capacity (see Attachment A - Photo 6).

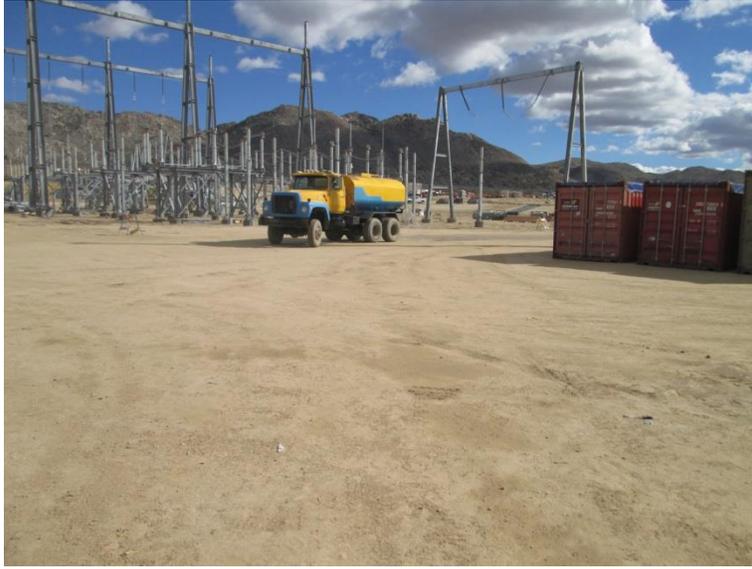
Photo 7: Water trucks were observed being utilized throughout construction activities at the ECO substation to suppress dust per MM BIO4-a and MM AQ-1.

Water trucks and water buffalos with hose attachments were used throughout the substation to suppress dust along access roads and active spoil piles as specified in the project dust control plan and per MM-BIO4-a and MM-AQ-1 (see Attachment A - Photo 7).

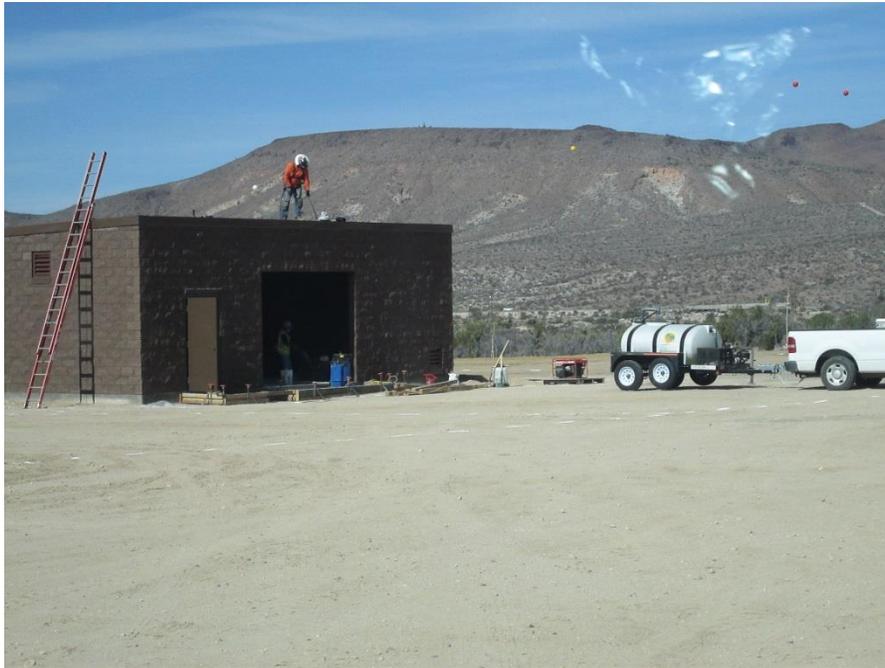
Photo 8: Fire suppression tools and emergency water supply area readily available during construction activities at the ECO substation in accordance with MM-FF-1.

All construction equipment and active sites were equipped with fire suppression tools and emergency water supply as stipulated in MM-FF-1 (see Attachment A - Photo 8).
