MyPlan Report

Office of Planning and Environment
Federal Transit Administration

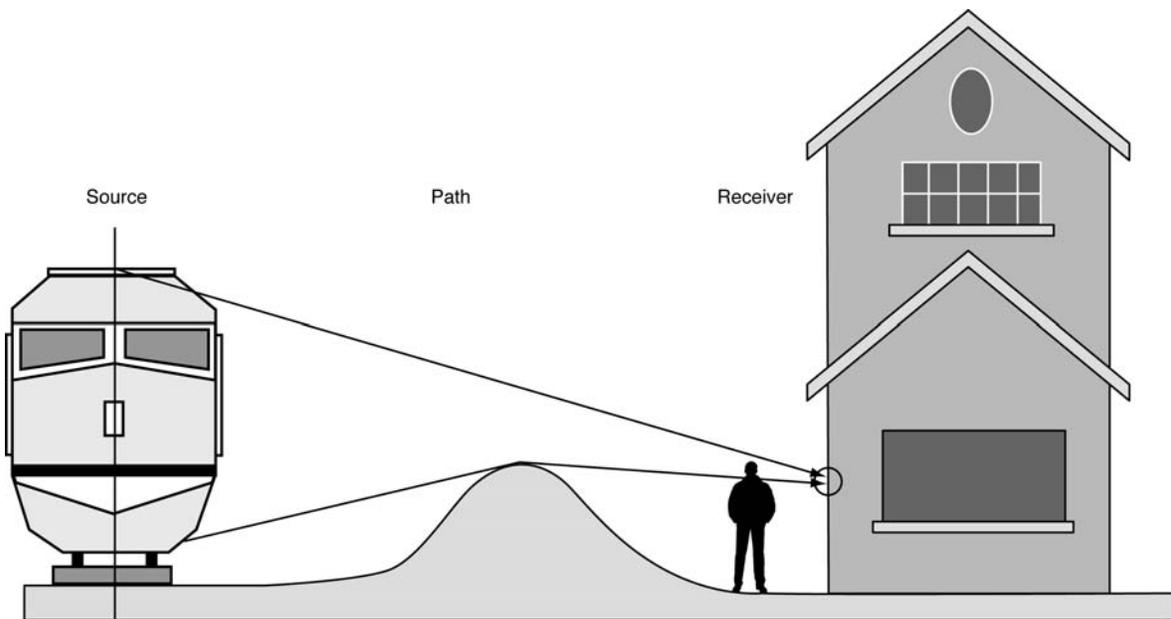
Figure 2-1. The Source-Path-Receiver Framework

This chapter discusses the basic concepts of transit noise which provide background for Chapters 3 through 6, where transit noise is computed and assessed. The Source-Path-Receiver framework sketched in Figure 2-1 is central to all environmental noise studies. Each transit **source** generates close-by noise levels which depend upon the type of source and its operating characteristics. Then, along the propagation **path** between all sources and receivers, noise levels are reduced (attenuated) by distance, intervening obstacles and other factors. And finally at each **receiver**, noise combines from all sources to interfere, perhaps, with receiver activities. This chapter contains an overview of this Source-Path-Receiver framework. Following this overview is a primer on the fundamentals of noise characteristics.

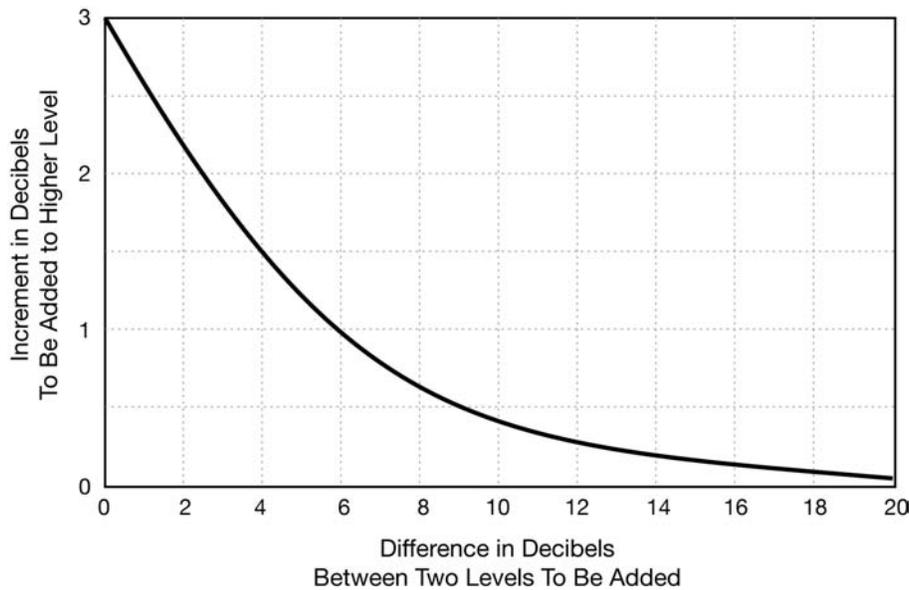
Figure 2-2. Graph for Approximate Decibel Addition

$$10 \log_{10}(2 p_{\text{rms}}^2 / p_{\text{ref}}^2) = 10 \log_{10}(p_{\text{rms}}^2 / p_{\text{ref}}^2) + 10 \log_{10}(2) = 10 \log_{10}(p_{\text{rms}}^2 / p_{\text{ref}}^2) + 3.$$

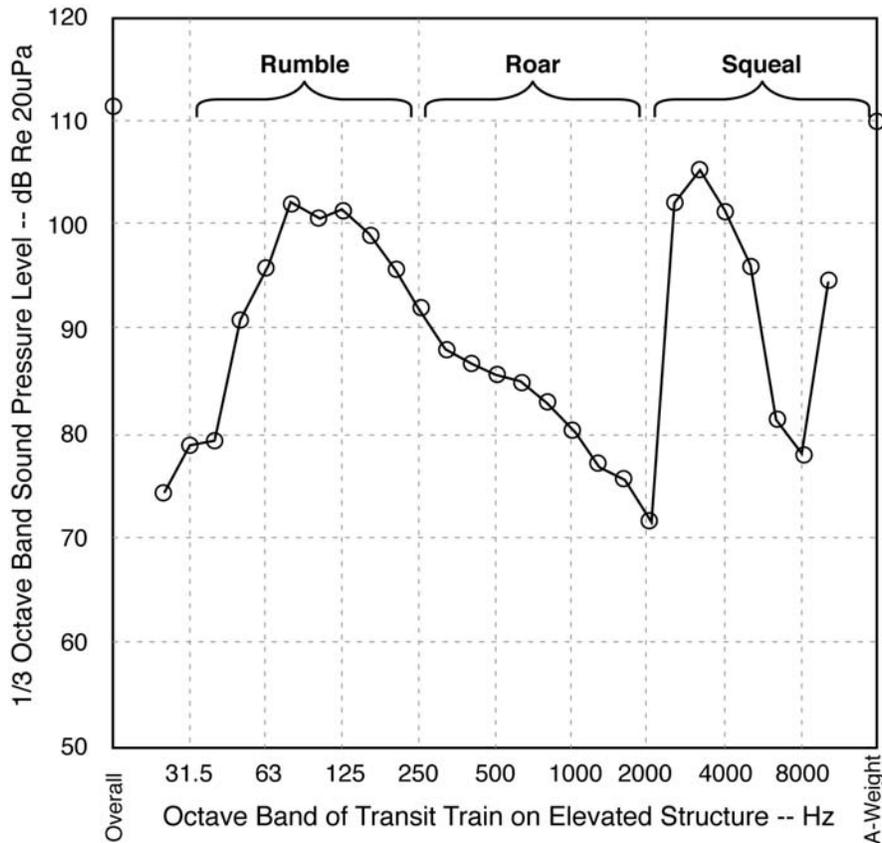
Figure 2-3. Noise Spectrum of Transit Train on Curve on Elevated Structure

frequencies that can occur near a transit system. In this example, the noise spectrum was measured near a train on a steel elevated structure with a sharp curve. This spectrum has a major low frequency peak centered around 80 Hz. Although not dominant in this example, frequencies in the range of 500 Hz to 2000 Hz are associated with the roar of wheel /rail noise. However a strong peak above 2000 Hz is associated with the wheel squeal of the train on the curve.

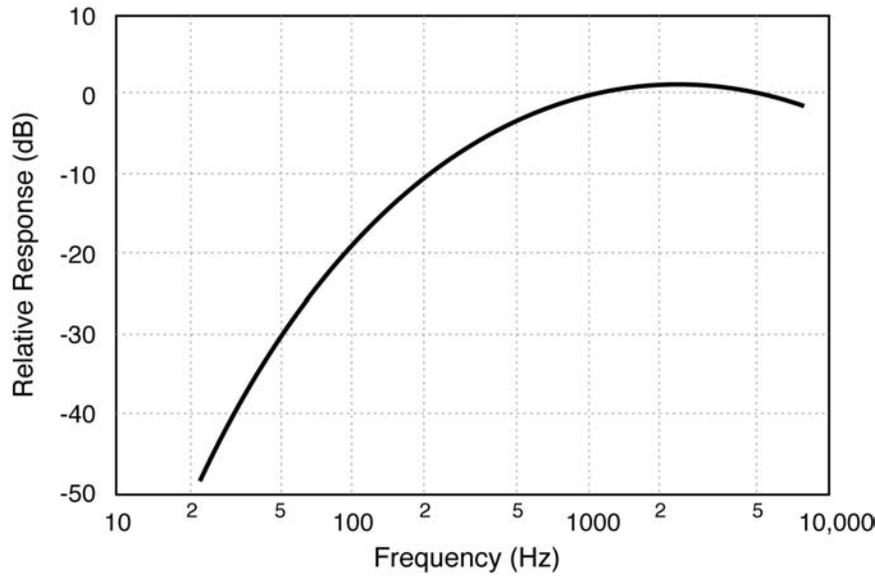
Figure 2-4. A-weighting Curve

Figure 2-4. This curve shows that sounds at 50 Hz would have to be amplified by 30 dB to be perceived equally as loud as a sound at 1000 Hz at normal sound levels.

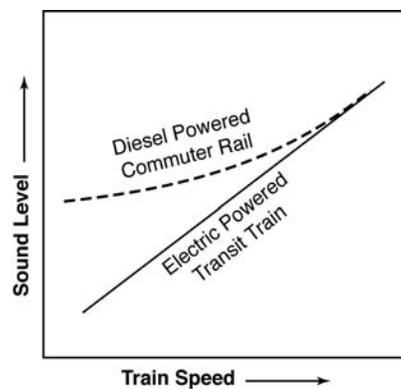
Figure 2-5. Example Sound Level Dependence on Speed

Figure 2-5 illustrates typical dependence of source strength on vehicle speed for two types of transit vehicles. Plotted vertically in this figure is a qualitative indication of the maximum sound level during a passby. In the figure, speed dependence is strong for electric-powered transit trains because wheel/rail noise dominates, and noise from this source increases strongly with increasing speed. On the other hand, speed dependence is less for diesel-powered commuter rail trains, particularly at low speeds where the locomotive exhaust noise dominates. As

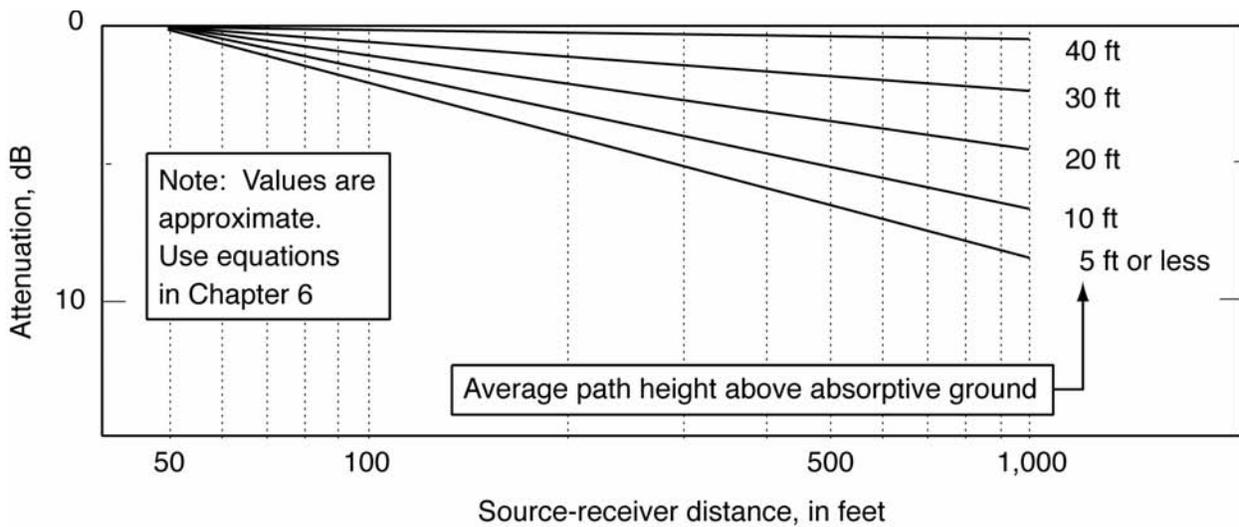
Figure 2-7. Attenuation due to Soft Ground

Absorption/Diffusion. In addition to distance alone, sound levels are further attenuated when sound paths lie close to freshly-plowed or vegetation-covered ground. Plotted vertically in Figure 2-7 is this additional attenuation, which can be as large as 5 decibels as close in as several hundred feet. At very large distances, wind and temperature gradients sometimes modify the ground attenuation shown here; such variable atmospheric effects are not included in this manual because they generally occur beyond the range of typical transit-noise impact. Equations for the curves in this figure appear in Chapter 6.

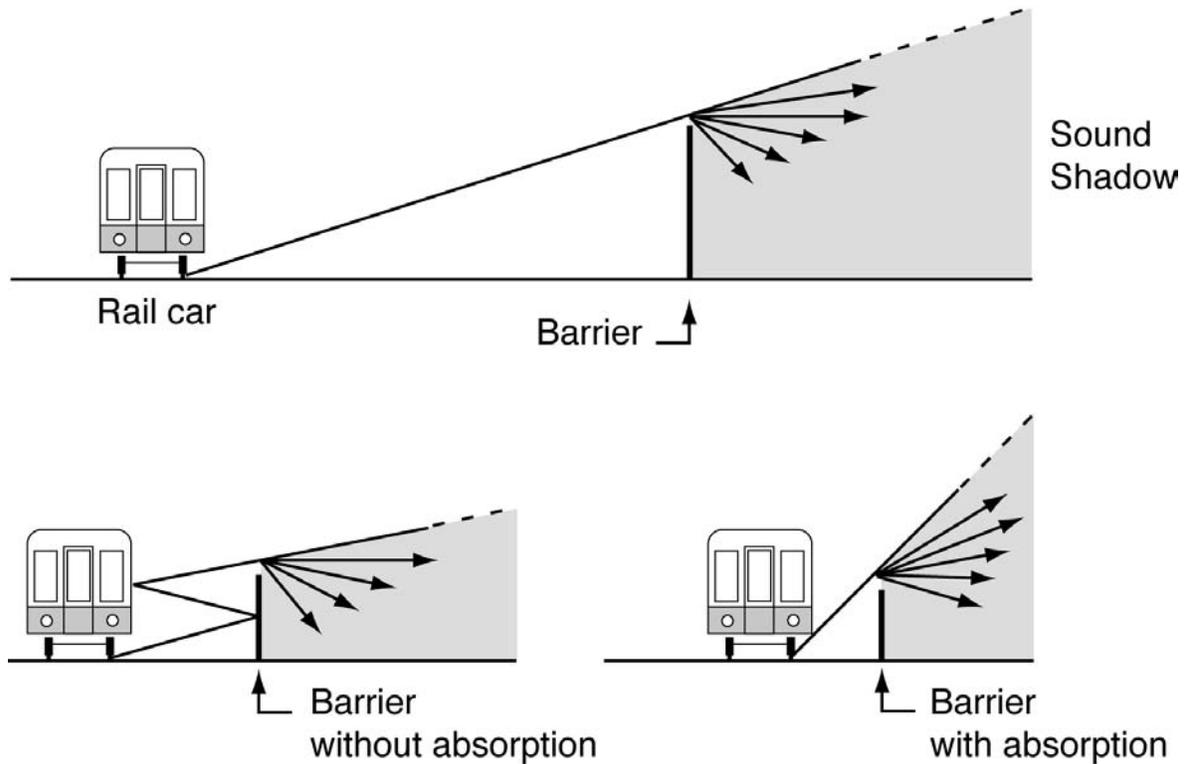
Figure 2-8. Noise Barrier Geometry

bending (diffracting) over the top of the barrier, as shown in Figure 2-8, and this diffraction reduces the sound level at the receiver.

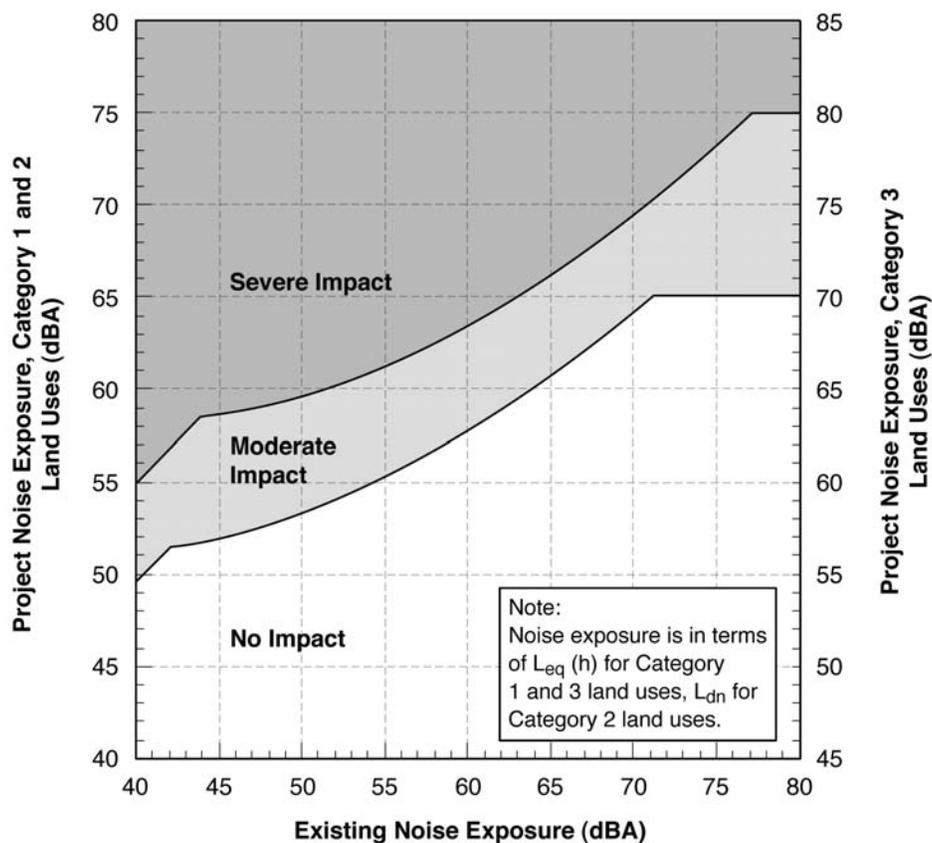
Figure 3-1. Noise Impact Criteria for Transit Projects

The noise impact criteria in Figure 3-1 and Table 3-1 are based on comparison of the existing outdoor noise levels and the future outdoor noise levels from the proposed project. They incorporate both absolute criteria, which consider activity interference caused by the transit project alone, and relative criteria, which consider annoyance due to the change in the noise environment caused by the transit project.

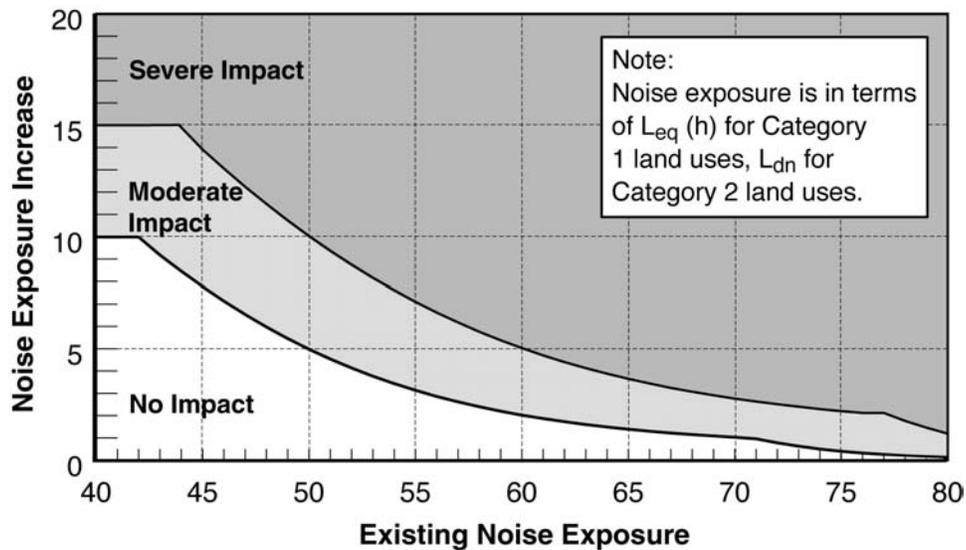
Figure 3-2. Increase in Cumulative Noise Levels Allowed by Criteria (Land Use Cat. 1 & 2)

of cumulative noise increase described in Appendix B. To illustrate this point, Figure 3-2 shows the noise impact criteria for Category 1 and 2 land use in terms of the allowable increase in the cumulative noise exposure. The horizontal axis is the existing noise exposure and the vertical axis is the increase in cumulative noise level due to the transit project. The measure of noise exposure is L_{dn} for residential areas and L_{eq} for land uses that do not have nighttime noise sensitivity. Since L_{dn} and L_{eq} are measures of total acoustic energy, any new noise source in a community will cause an increase, even if the new source level is less than the existing level. Referring to Figure 3-2, it can be seen that the criterion for Moderate Impact allows a noise exposure increase of 10 dBA if the existing noise exposure is 42 dBA or less but only a 1 dBA increase when the existing noise exposure is 70 dBA

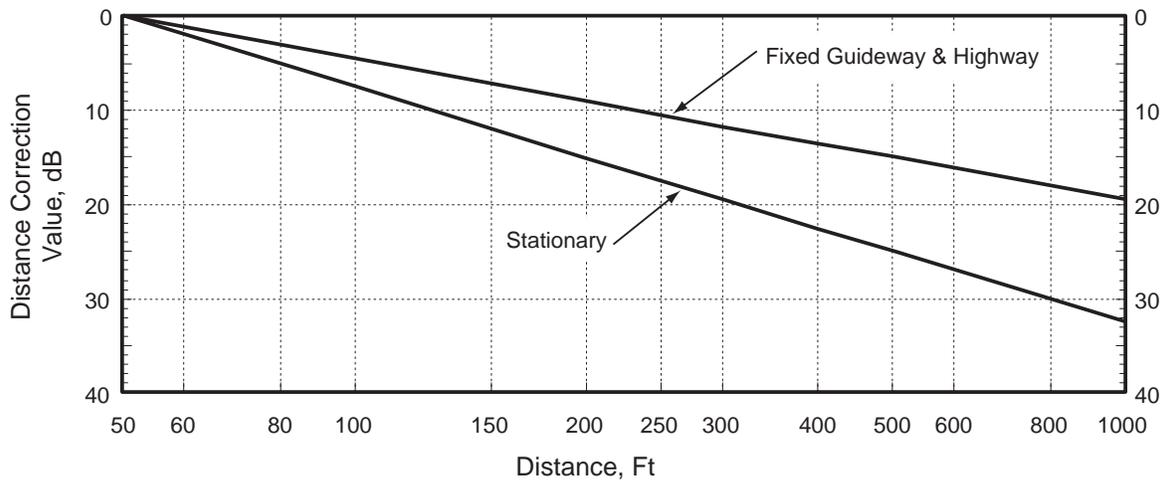
Figure 5-2. Curves for Estimating Exposure vs. Distance in General Noise Assessment

Figure 5-2 can then be used to develop a curve of noise exposure vs. distance when there is shielding. The curve of noise exposure as a function of this distance will be used to determine the location of the noise impact contours.

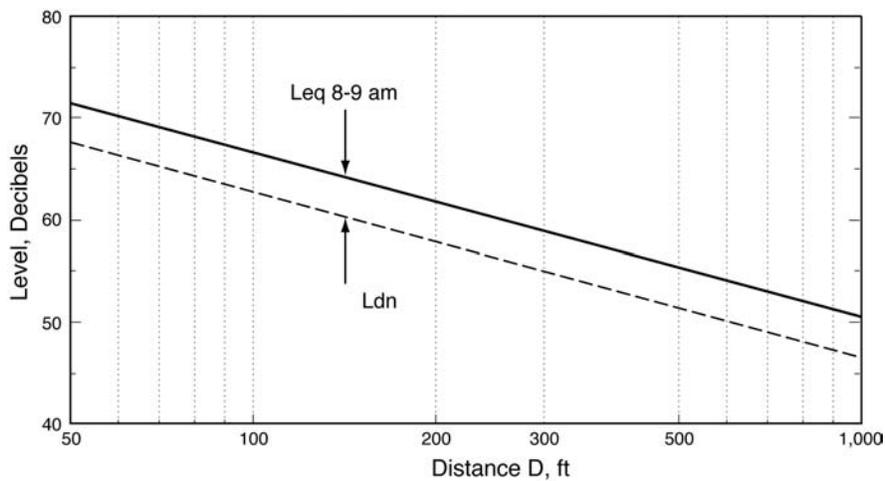
Figure 6-6. Example Exposure-vs.-Distance Curves

Plots of these two equations appear in Figure 6-6. From these curves, the noise levels due to this train operation can be determined for a receiver of interest at any distance. The only factor not accounted for is the effect of shielding between source and receiver, which is the subject of the next section.

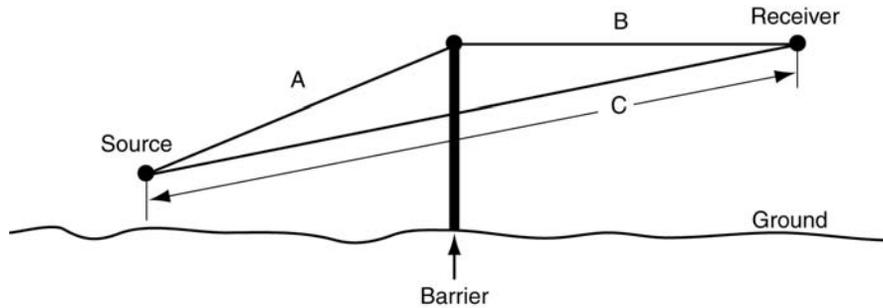
Figure 6-7. Sketch Showing Noise Barrier Parameter ‘P’

Barrier Parameter P
 $P = A + B - C$

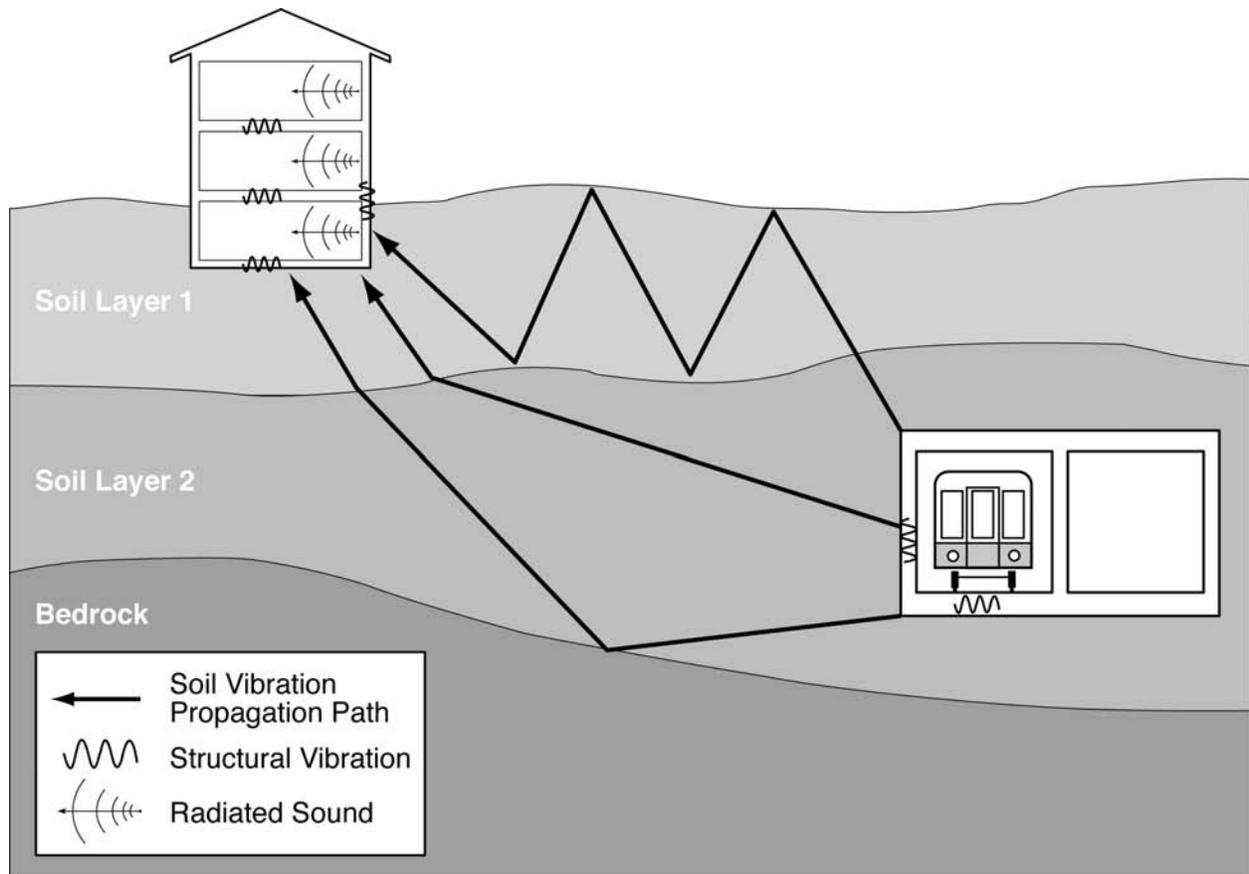
Figure 7-1. Propagation of Ground-Borne Vibration into Buildings

The vibration of the transit structure excites the adjacent ground, creating vibration waves that propagate through the various soil and rock strata to the foundations of nearby buildings. The vibration propagates from the foundation throughout the remainder of the building structure. The maximum vibration amplitudes of the floors and walls of a building often will be at the resonance frequencies of various components of the building.

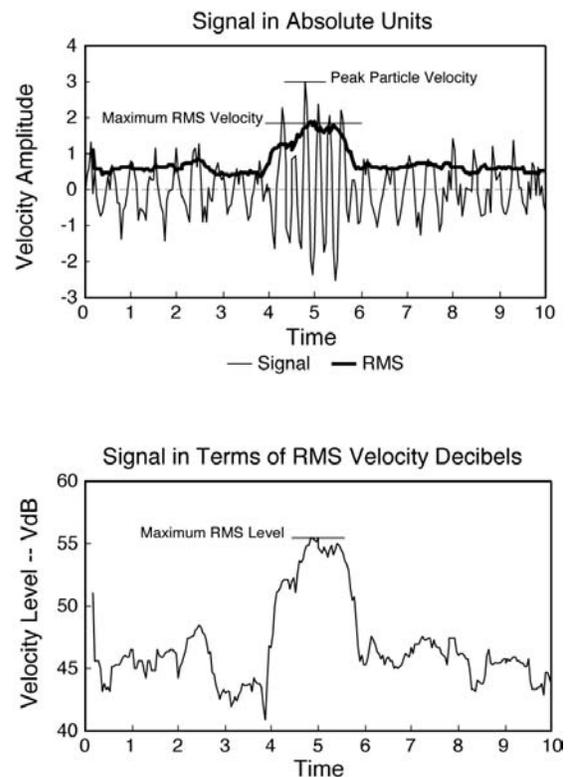
Figure 7-2. Different Methods of Describing a Vibration Signal

Although peak particle velocity is appropriate for evaluating the potential of building damage, it is not suitable for evaluating human response. It takes some time for the human body to respond to vibration signals. In a sense, the human body responds to an average vibration amplitude. Because the net average of a vibration signal is zero, the root mean square (rms) amplitude is used to describe the "smoothed" vibration amplitude. The root mean square of a signal is the square root of the average of the squared amplitude of the signal. The average is typically calculated over a one-second period. The rms amplitude is shown superimposed

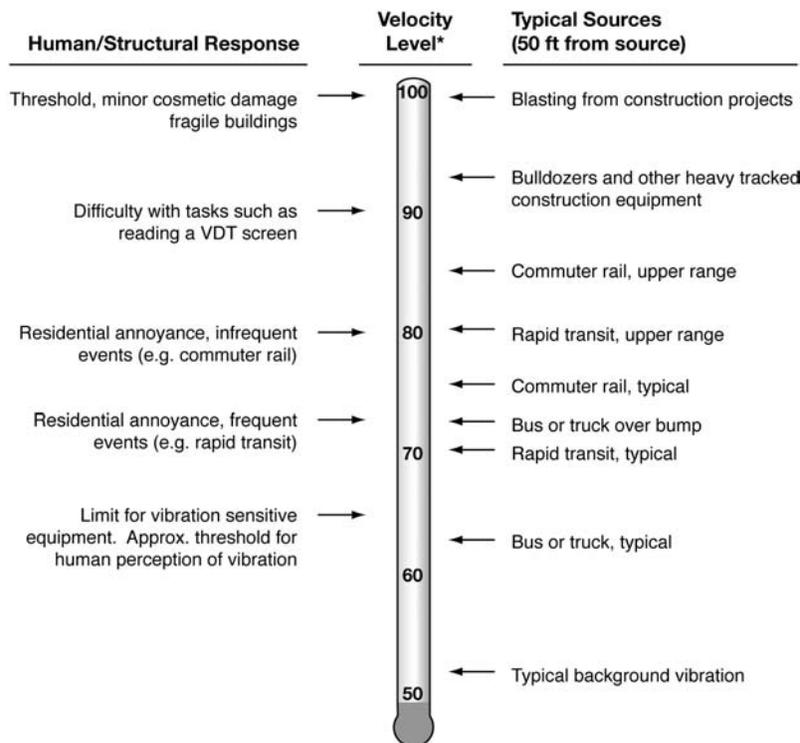
Figure 7-3 illustrates common vibration sources and the human and structural response to ground-borne vibration. The range of interest is from approximately 50 VdB to 100 VdB. Background vibration is usually well below the threshold of human perception and is of concern only when the vibration affects very sensitive manufacturing or research equipment. Electron microscopes and high-resolution lithography equipment are typical of equipment that is highly sensitive to vibration.

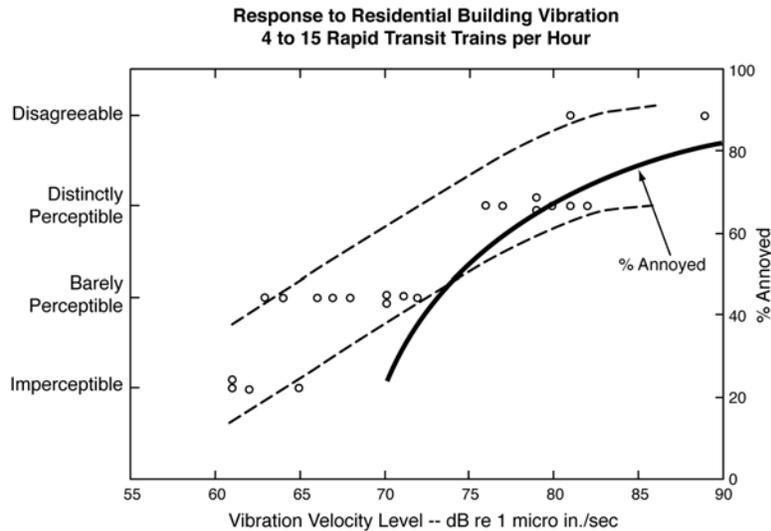
Figure 7-4. Response to Transit-induced Residential Vibration

Figure 7-4 illustrates the relationship between the vibration velocity level measured in 22 homes and the general response of the occupants to the vibration. The data shown were assembled from measurements performed for several transit systems along with subjective ratings by the researchers and residents. These data were previously published in the "State-of-the-Art Review of Ground-borne Noise and Vibration."⁽⁴⁾ Both the occupants and the people who performed the measurements agreed that floor vibration in the "Distinctly Perceptible" category was unacceptable for a residence. The data in Figure 7-4 indicate that residential vibration exceeding 75 VdB is unacceptable for a repetitive vibration source such as rapid transit trains that pass every 5 to 15 minutes. Also shown in Figure 7-4 is a curve showing the percent of people annoyed by vibration from high-speed trains in Japan.⁽⁵⁾ The scale for the percent annoyed is on the right-hand axis of the graph. The results of the Japanese study confirm the conclusion that at a vibration velocity level of 75 to 80 VdB, many people will find the vibration annoying.

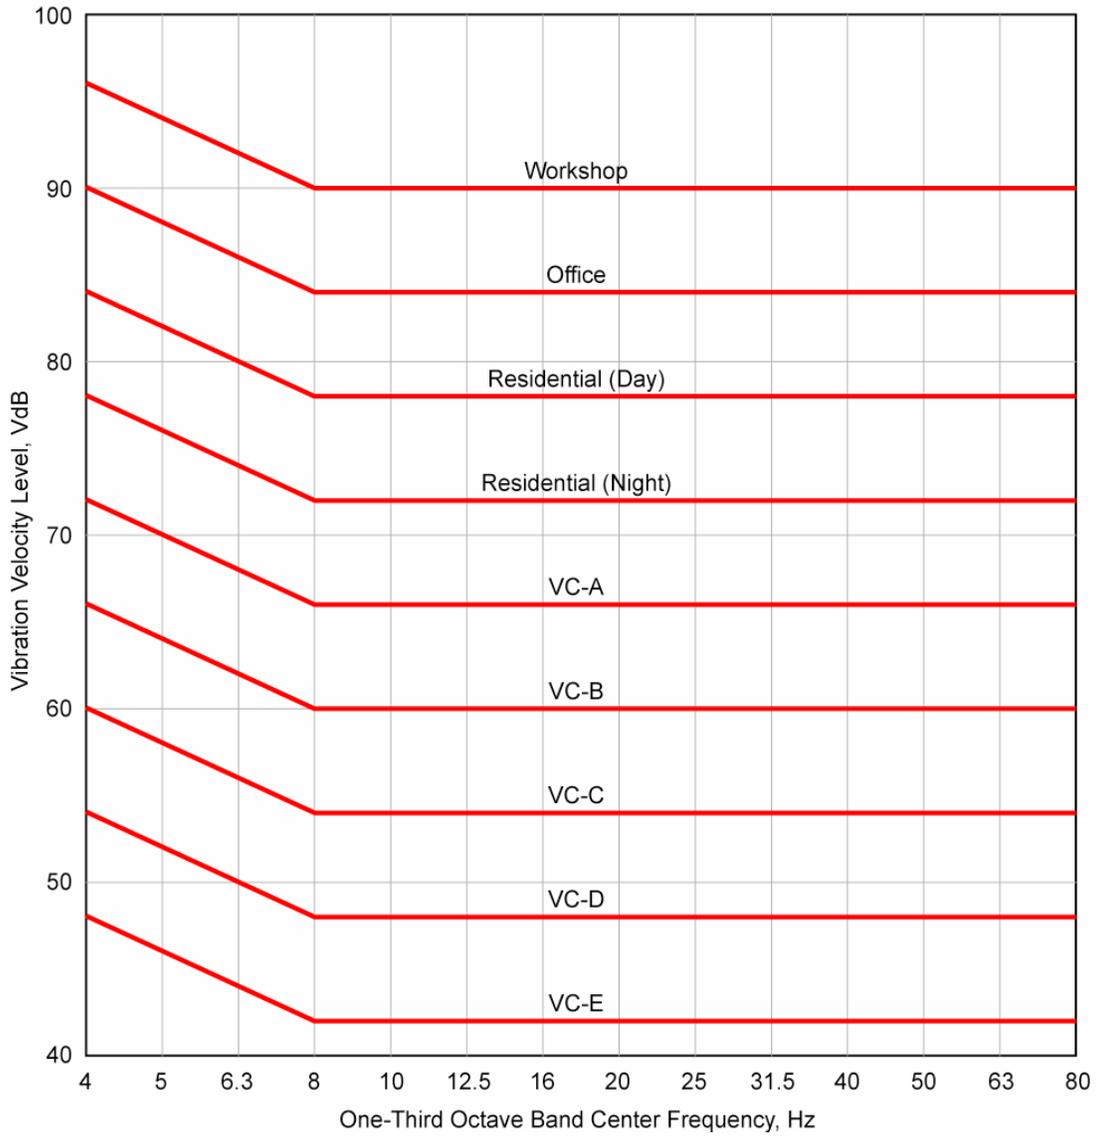
Figure 8-1. Criteria for Detailed Vibration Analysis

The vibration impact criteria are shown in Figure 8-1 where the international standard curves and the industry standards are plotted on the same figure. Interpretations of the various levels are presented in Table 8-3. Detailed Analysis results in one-third octave band spectra levels that are plotted over the curves shown in Figure 8-1. Band levels that exceed a particular criterion curve indicate the need for mitigation and the frequency range within which the treatment needs to be effective.

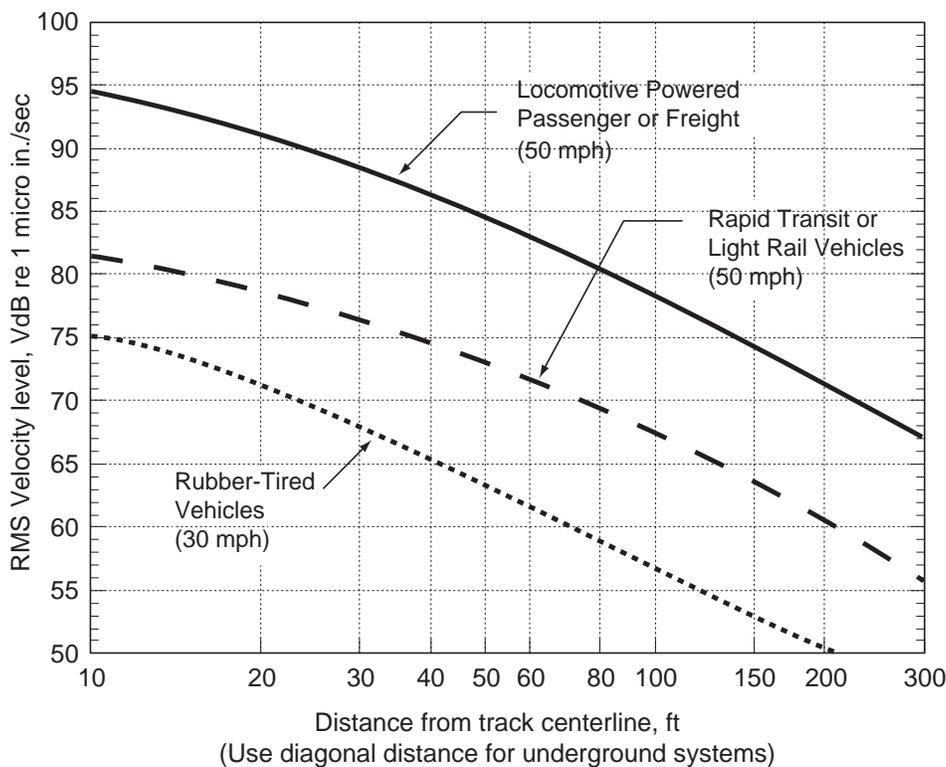
Figure 10-1. Generalized Ground Surface Vibration Curves

The curves in Figure 10-1 are based on measurements of ground-borne vibration at representative North American transit systems. The top curve applies to trains that are powered by diesel or electric locomotives. It includes intercity passenger trains and commuter rail trains. The curve for rapid transit rail cars covers both heavy and light-rail vehicles on at-grade and subway track. It is somewhat surprising that subway and at-grade track can be represented by the same curve since ground-borne vibration created by a train operating in a subway has very different characteristics than vibration from at-grade track. However, in spite of these differences, the overall vibration velocity levels are comparable. Subways tend to have more vibration problems than at-grade track. This is probably due to two factors: (1) subways are usually located in more densely developed areas, and (2) the airborne noise is usually a more serious problem for at-grade systems than the ground-borne vibration. Another difference between subway and at-grade track is that the ground-borne vibration from subways tends to be higher frequency than the vibration from at-grade track, which makes the ground-borne noise more noticeable.

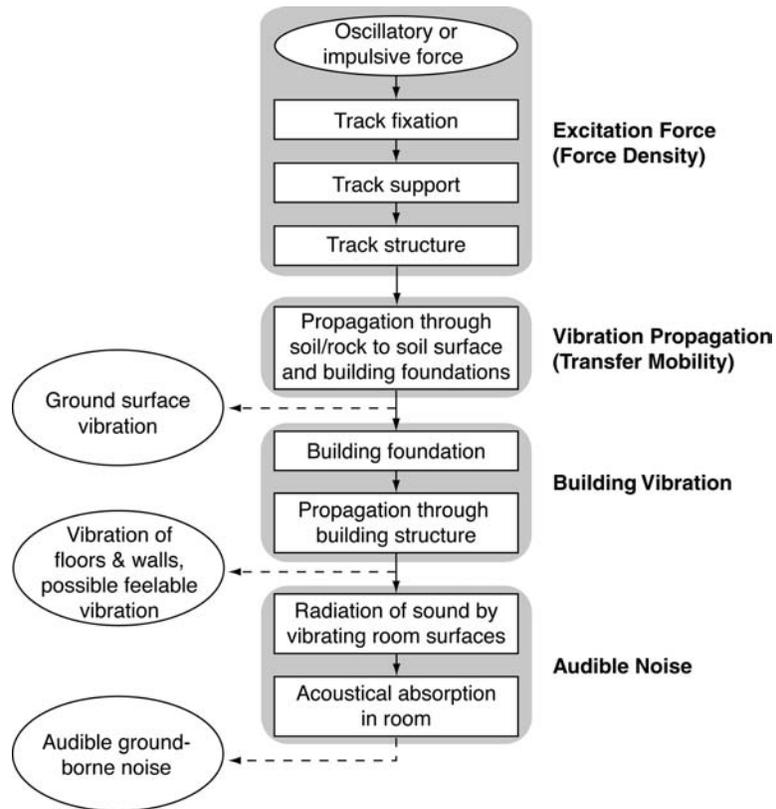
Figure 11-1. Block Diagram of Ground-Borne Vibration and Noise Model

Transfer mobility represents the relationship between a vibration source that excites the ground and the resulting vibration of the ground surface. It is a function of both frequency and distance from the source. The transfer mobility between two points completely defines the composite vibration propagation characteristics between the two points. In most practical cases, receivers are close enough to the train tracks that the vibration cannot be considered to be originating from a single point. The vibration source must be modeled as a line-source. Consequently, the point transfer mobility must be modified to account for a line-source. In the following text, TM_{point} is used to indicate the measured point-source transfer mobility and TM_{line} is used for the line-source transfer mobility derived from TM_{point} .

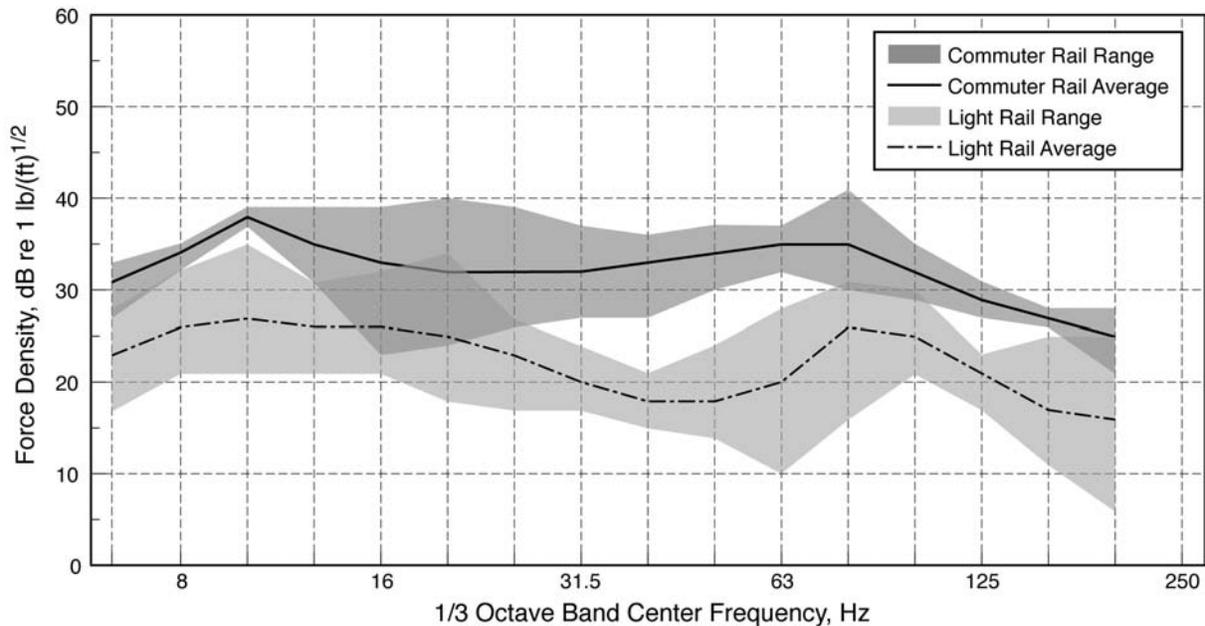
Figure 11-2. Typical Force Densities for Rail Transit Vehicles, 40 mph

The two key elements of the transfer mobility procedure are a measured force function that represents the vibration energy put into the ground and a measured transfer mobility that characterizes the propagation of the vibration from the source to the receiver. The unit of force density is force divided by square root of train length, represented here in decibels relative to $1 \text{ lb}/(\text{ft})^{1/2}$. The force density represents an incoherent line of vibration force equal to the length of transit trains. The process of estimating force density from train vibration and transfer mobility tests is discussed in Section 11.3. Figure 11-2 shows some trackbed force densities that have been developed from measurements of vibration from heavy and light rail transit vehicles. This figure provides a comparison of the vibration forces from heavy commuter trains and light rail transit vehicles with different types of primary suspensions illustrating the range of vibration forces commonly experienced in a transit system. A force density of a vehicle includes the characteristics of its track support system at the measurement site. Adjustments must be made to the force density to account for differences between the facility where the force density was measured and the new system being analyzed.

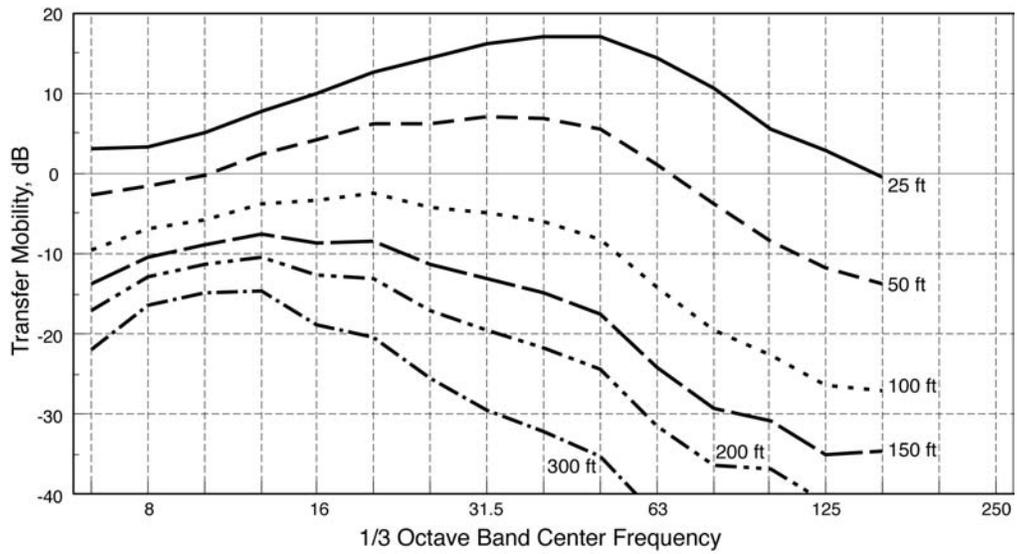
Figure 11-3. Example of Point-Source Transfer Mobility

Once the point-source transfer mobility has been defined, the line-source transfer mobility can be calculated using numerical integration techniques. This process has been described in a Transportation Research Board paper.⁽¹⁾ Figure 11-4 shows the line-source transfer mobilities that were derived from the point-source transfer mobilities shown in Figure 11-3. The line-source transfer mobilities are used to normalize measured vibration velocity levels from train passbys and to obtain force density.

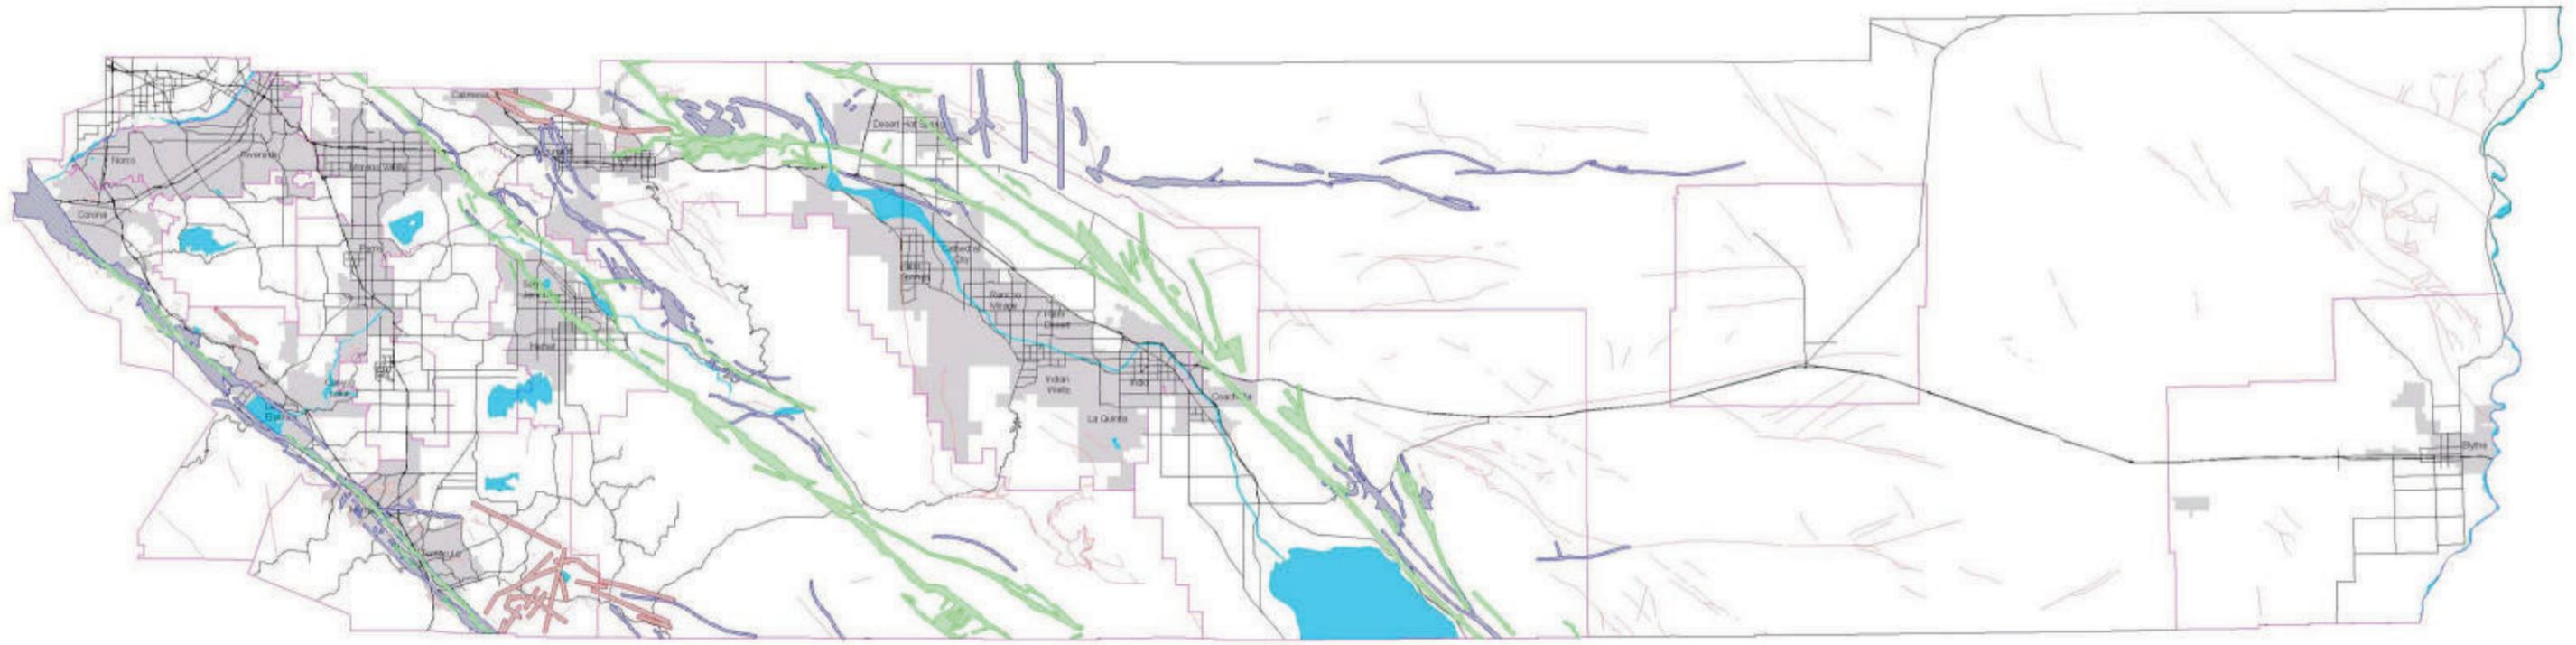
Fault Zones

- Alquist-Priolo Zone
- Existing County Zone
- Recommended Zone
- Faults
- Major Roads & Highways
- Area Plan Boundaries
- Cities

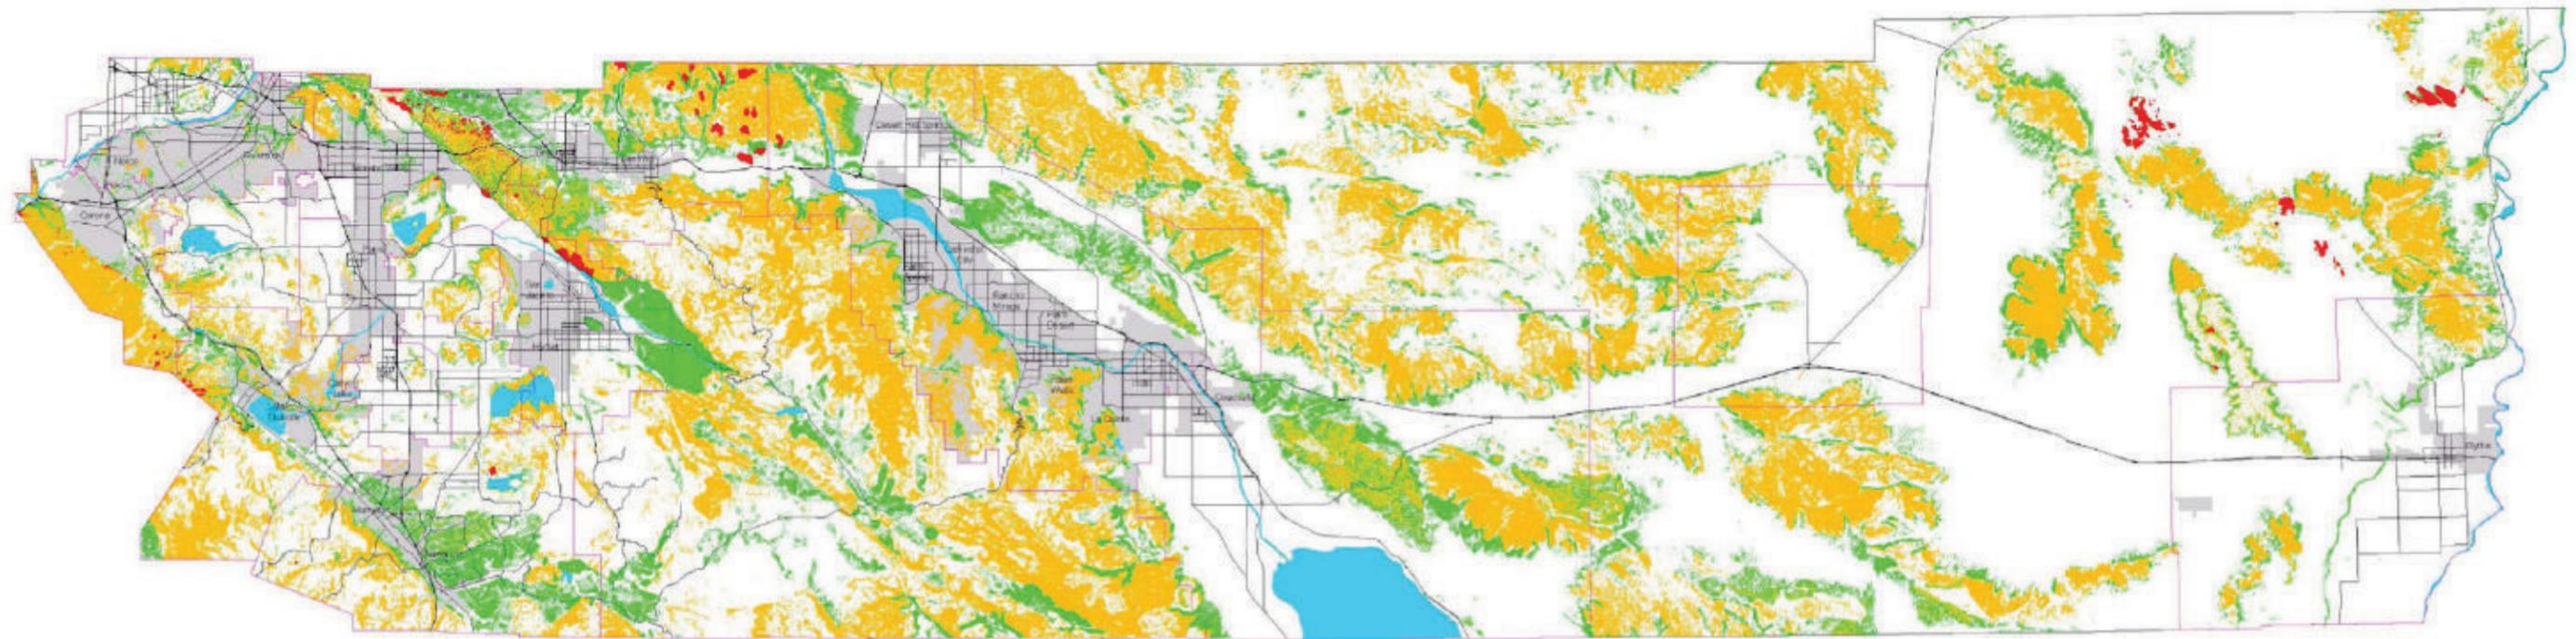
Figure 5.2.6

- Existing Landslides
- High susceptibility to seismically induced landslides and rockfalls.
- Low to locally moderate susceptibility to seismically induced landslides and rockfalls.
- Major Roads & Highways
- Area Plan Boundaries
- Cities

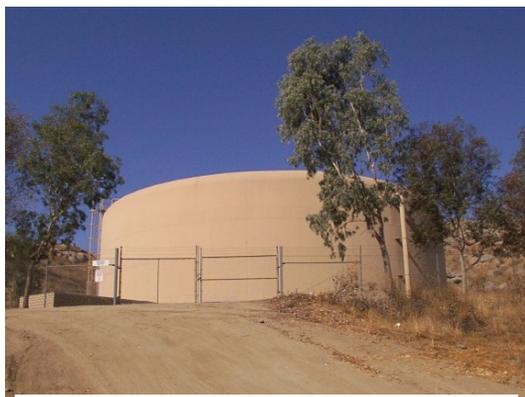
Water tank
