Re: A.13-09-014/Salt Creek Substation – Response to Data Request dated December 20, 2013 (AD2-ED-004)

A.13-09-014 SDG&E 01/21/14 Response
Salt Creek Substation Project PTC
Energy Division Additional Data Request #2 Dated December 20, 2013
AD2-ED-004

Table 1: Salt Creek A.13-09-014 Data Request #2

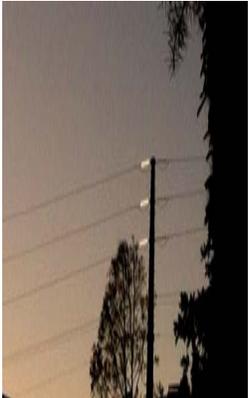
<p>The insulators for the new TL6965 are planned to be the same as those installed on the existing TL6913. These insulators are silicone rubber polymer, manufactured by NGK Locke, and have been used in the majority of SDG&E lower voltage transmission lines (below 500kV) since the early 1990's. The potential for glare from these silicone rubber insulators is generally less than glazed porcelain glass insulators, which were a previous standard for insulators.</p>

Table 1: Salt Creek A.13-09-014 Data Request #2			
#	PEA Section, Page #	Project Description	SDG&E Response
Aesthetics			
14		<p>Clarify the type of insulators that are proposed and their potential to produce glare. The photo below shows a recently hardened portion of TL 6913. It portrays conditions near sunset. The insulators are exhibiting significant glare, an aesthetics threshold of significance. The insulators that created this glare could be construed as specular. Is the same type of insulator proposed for TL 6965?</p>

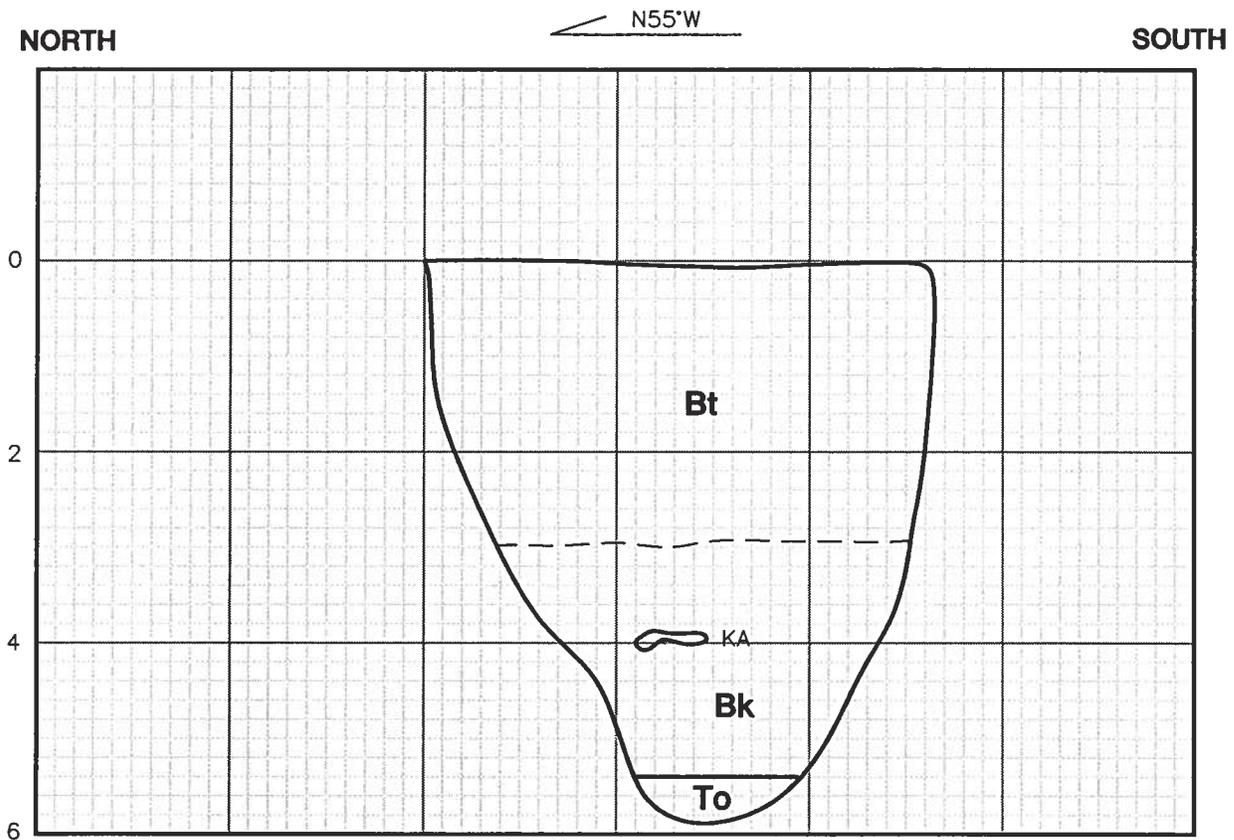
PROJECT NO. 67735		LOG OF TEST PIT NO. 1			SHEET 1 of 1	
EXCAVATION EQUIPMENT BACKHOE		PROJECT NAME OTAY RANCH SUBSTATION			LOCATION	
DATE: 12/20/2006	LOGGED BY: SHR	CHECKED BY: KMC	DEPTH: 6'	ELEVATION: 530'	DIRECTION:

DEPTH IN FEET	MATERIAL DESCRIPTION
0 to 3'	TOPSOIL: Bt CLAYEY SILT (ML), DARK BROWN, MOIST, SOFT
3' to 5.5'	Bk SANDY SILT (ML), WHITE, DRY, MEDIUM STIFF, LIGHT ???
5.5' TO 6'	OTAY FORMATION: To SILTY SANDSTONE, YELLOW BROWN, MOIST, VERY DENSE, FINE TO COARSE GRAINED WITH TRACE GRAVEL

K – KROTOVINA ANIMAL BURROWS

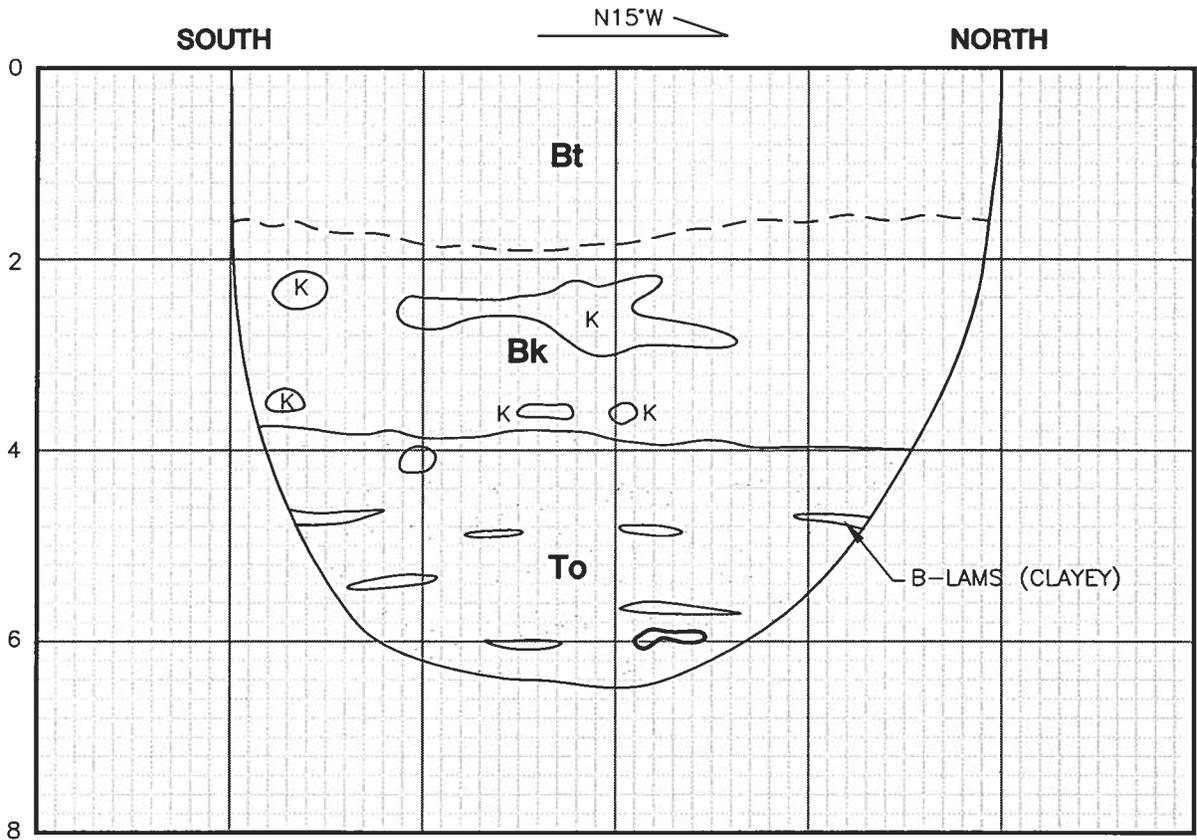
PROJECT NO. 67735		LOG OF TEST PIT NO. 3			SHEET 1 of 1	
EXCAVATION EQUIPMENT BACKHOE		PROJECT NAME OTAY RANCH SUBSTATION			LOCATION	
DATE: 12/20/2006	LOGGED BY: SHR	CHECKED BY: KMC	DEPTH: 6.5'	ELEVATION: 507'	DIRECTION:

DEPTH IN FEET	MATERIAL DESCRIPTION
0 - 2'	Bt TOPSOIL: CLAYEY SILT (ML), DARK BROWN, MOIST, SOFT
2' - 4'	Bk SANDY SILT (ML), WHITE, DRY, MEDIUM STIFF
4' - 6.5'	To OTAY FORMATION: SILTY SANDSTONE, WHITE GRAY, MOIST, DENSE, FINE TO COARSE GRAINED, TRACE GRAVEL

K - KROTOVINA ANIMAL BURROWS

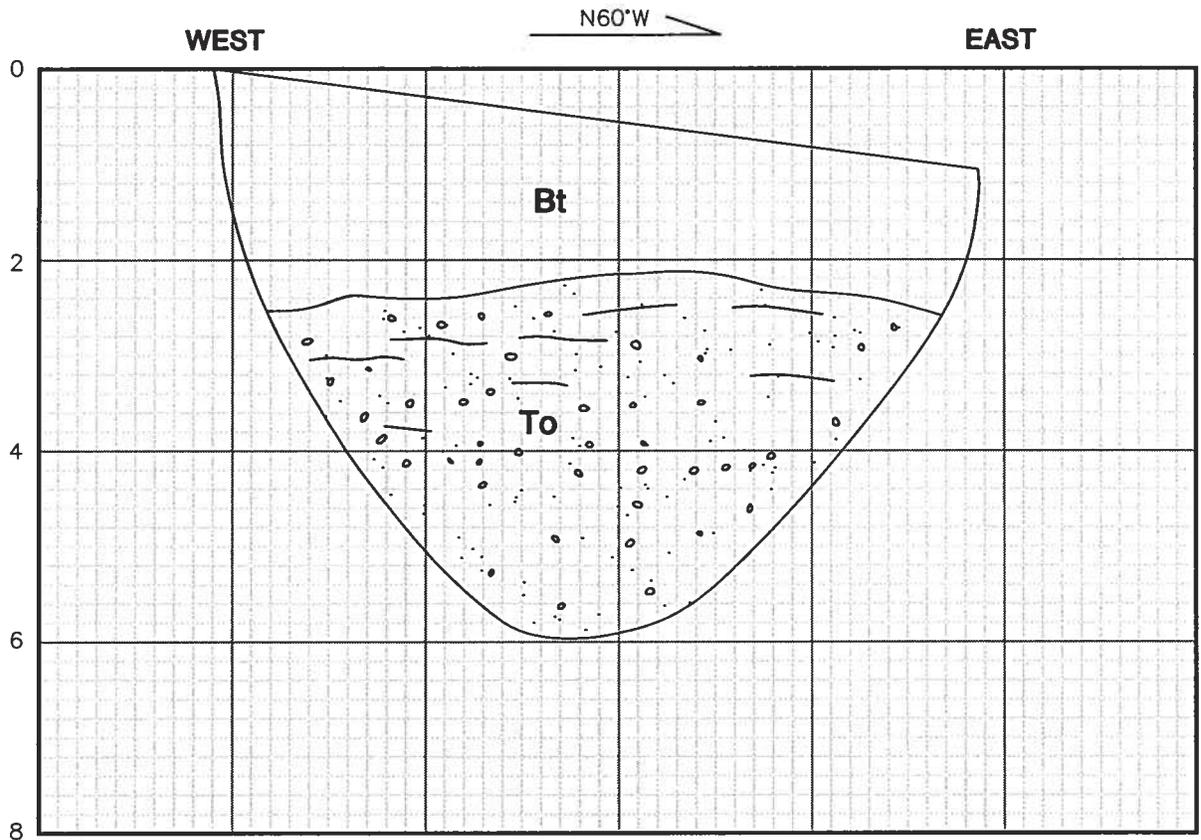
PROJECT NO. 67735	LOG OF TEST PIT NO. 5	SHEET 1 OF 1
EXCAVATION EQUIPMENT BACKHOE	PROJECT NAME OTAY RANCH SUBSTATION	LOCATION
DATE: 12/20/2006	LOGGED BY: SHR	CHECKED BY: KMC
DEPTH: 6'	ELEVATION: 471'	DIRECTION:

DEPTH IN FEET	MATERIAL DESCRIPTION
0 to 2'	Bt TOPSOIL: SANDY SILTY CLAY (CL), DARK BROWN, MOIST, SOFT
2' to 6'	To OTAY FORMATION: SANDY SILT STONE, YELLOW BROWN MOIST, VERY DENSE, COARSE GRAINED WITH GRAVEL AND TRACE COBBLE

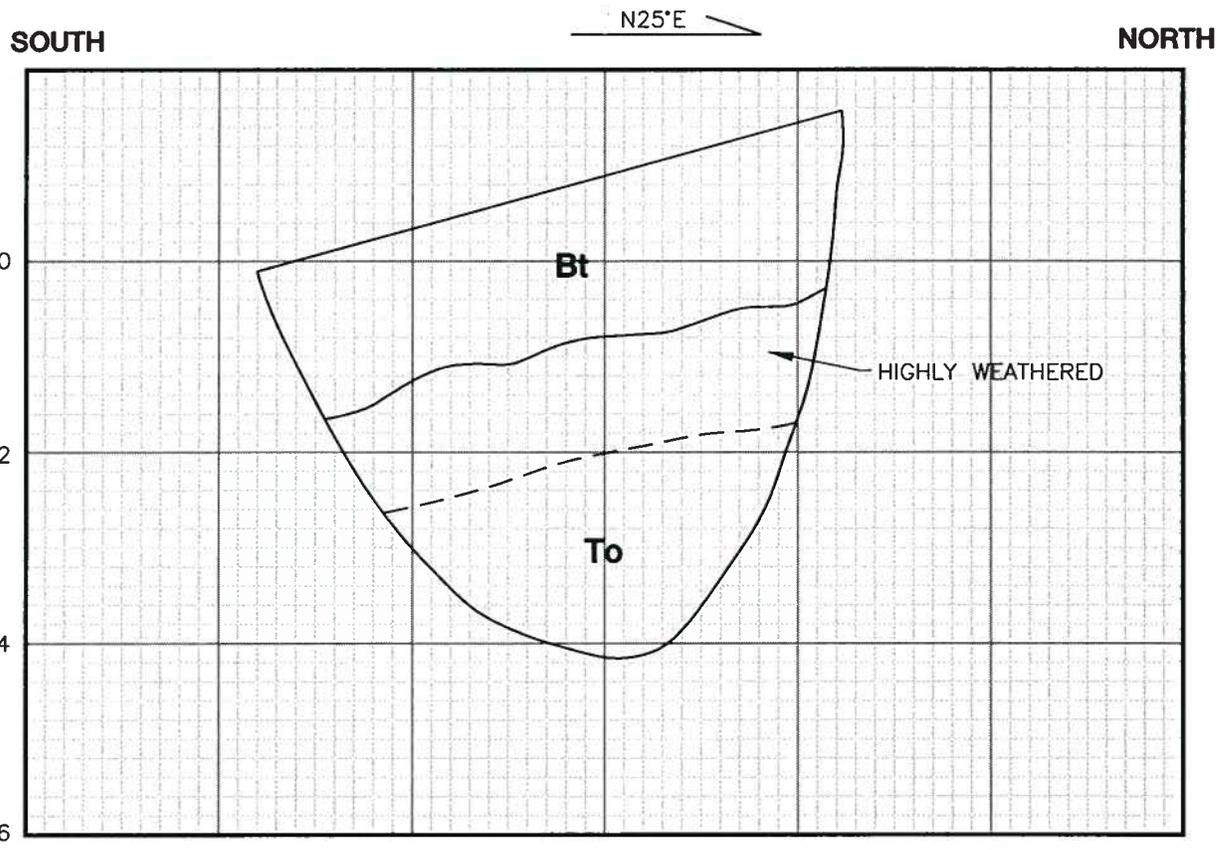
PROJECT NO. 67735		LOG OF TEST PIT NO. 6			SHEET 1 of 1	
EXCAVATION EQUIPMENT BACKHOE		PROJECT NAME OTAY RANCH SUBSTATION			LOCATION	
DATE: 12/20/2006	LOGGED BY: SHR	CHECKED BY: KMC	DEPTH: 4'	ELEVATION: 453'	DIRECTION:

DEPTH IN FEET	MATERIAL DESCRIPTION
0' TO 2'	<u>TOPSOIL:</u> Bt CLAYEY SAND (SC), DARK BROWN, MOIST, MEDIUM DENSE
2' TO 4'	<u>OTAY FORMATION:</u> To SILTY SANDSTONE, YELLOW BROWN, MOIST, VERY DENSE, UPPER PART REDDISH BROWN, CONTAINS TRANSLOCATED CLAY

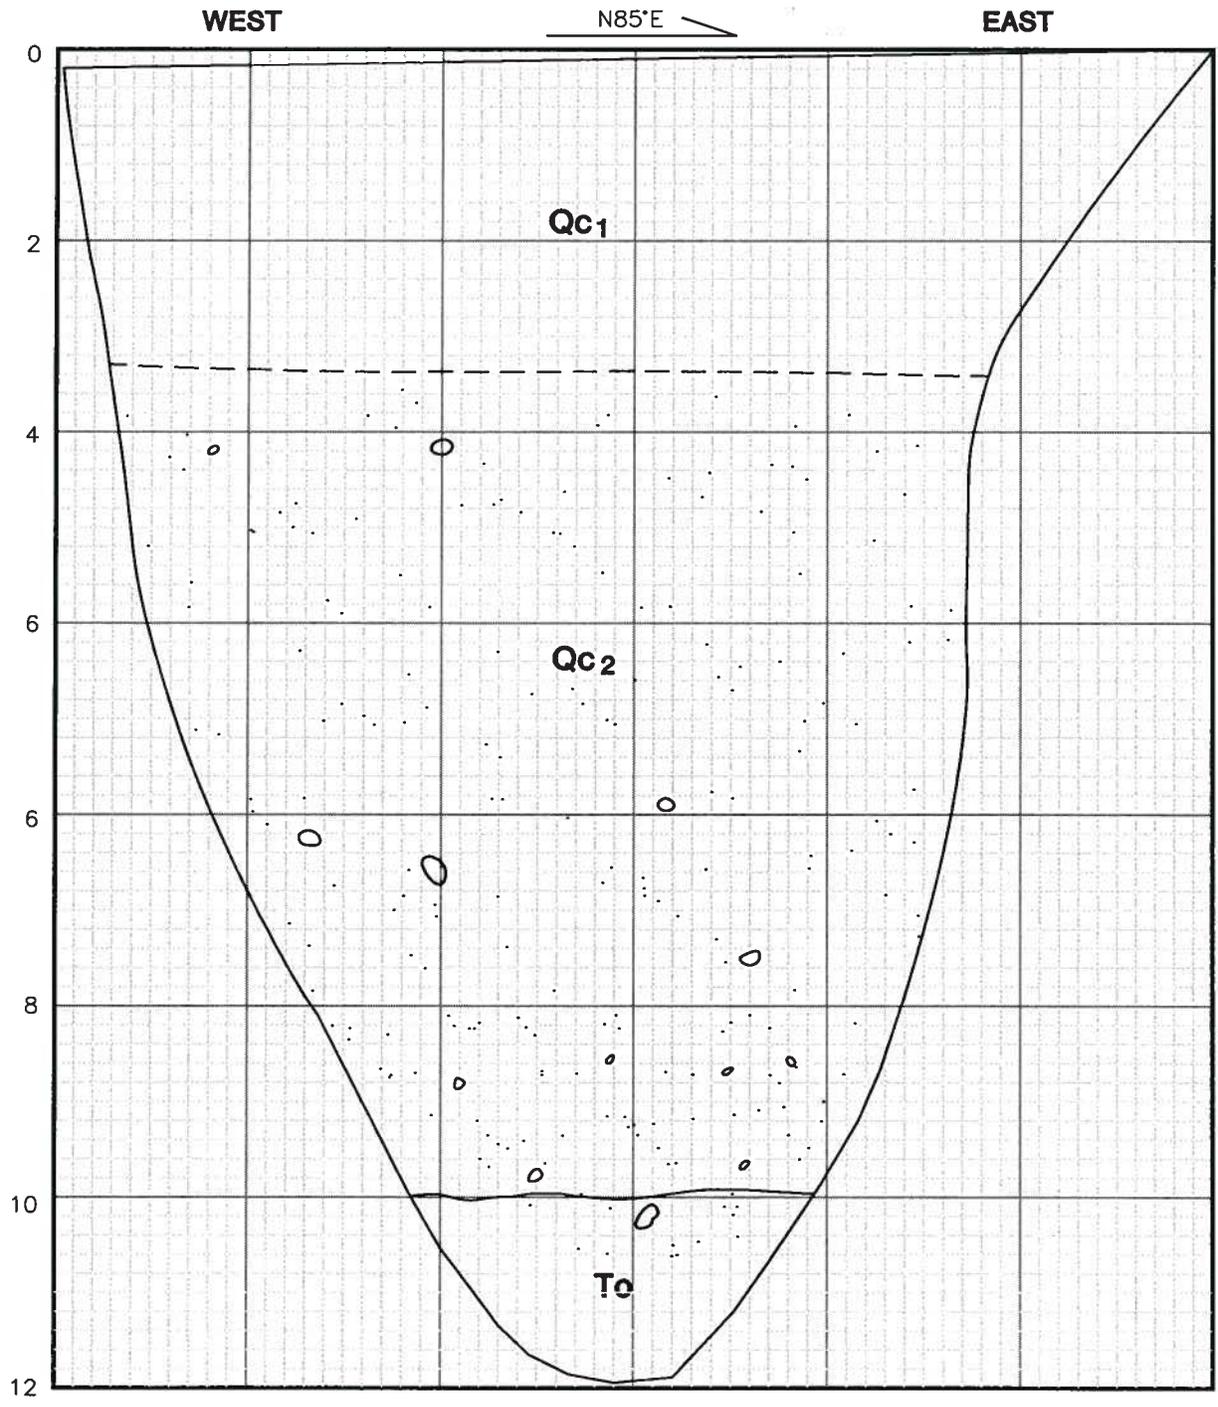
PROJECT NO. 67735	LOG OF TEST PIT NO. 7			SHEET 1 of 1
EXCAVATION EQUIPMENT BACKHOE	PROJECT NAME OTAY RANCH SUBSTATION		LOCATION	
DATE: 12/20/2006	LOGGED BY: SHR	CHECKED BY: KMC	DEPTH: 12'	ELEVATION: 427'
DIRECTION:

DEPTH IN FEET	MATERIAL DESCRIPTION
0 to 3.4'	COLLUVIUM Qc1 CLAYEY SAND (SC), DARK BROWN, MOIST, SOFT
3.4' to 10'	COLLUVIUM Qc2 SANDY CLAY (CL), STIFF TO VERY STIFF, MOIST
10' to 12'	OTAY FORMATION: To CLAYEY SANDSTONE (SC), YELLOW-REDDISH BROWN, MOIST, DENSE, HIGHLY WEATHERED

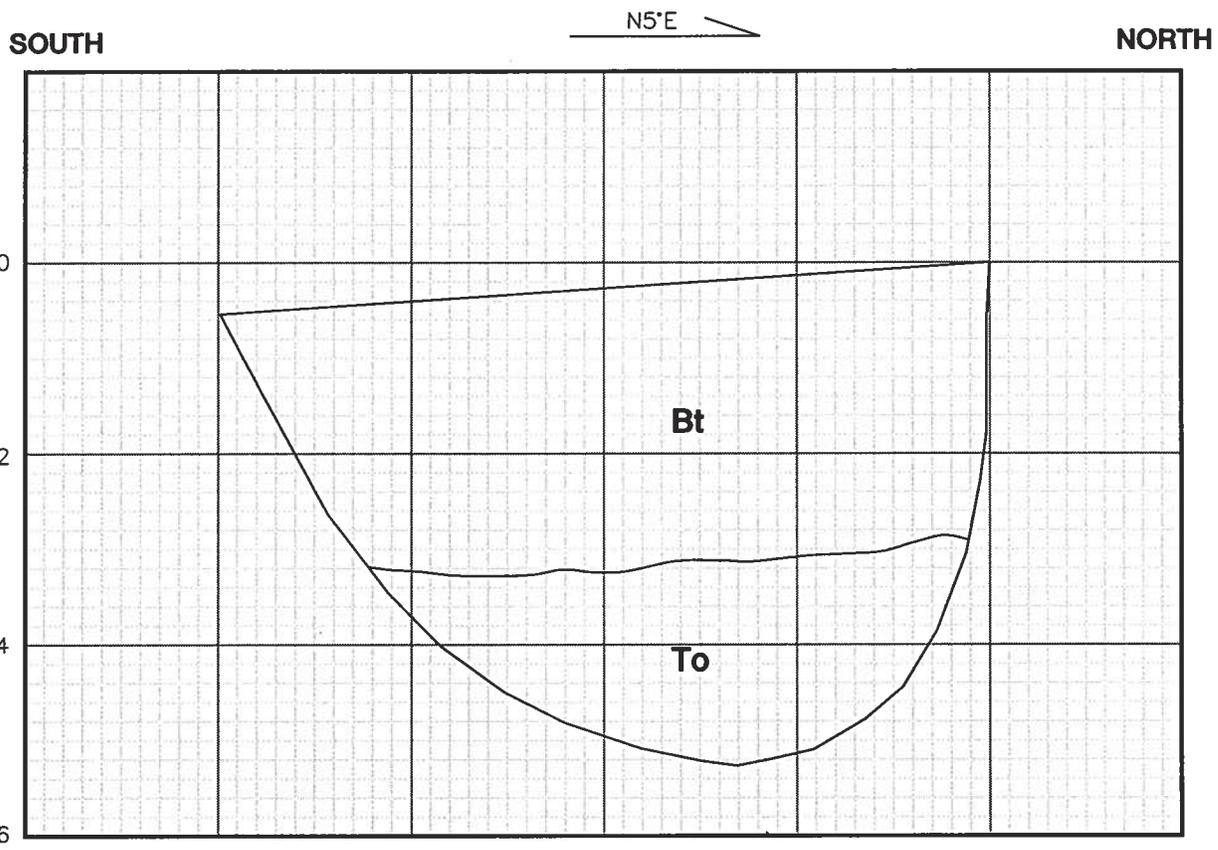
PROJECT NO. 67735	LOG OF TEST PIT NO. 8			SHEET 1 OF 1
EXCAVATION EQUIPMENT BACKHOE	PROJECT NAME OTAY RANCH SUBSTATION	LOCATION		
DATE: 12/20/2006	LOGGED BY: SHR	CHECKED BY: KMC	DEPTH: 5'	ELEVATION: 465'
DIRECTION:

DEPTH IN FEET	MATERIAL DESCRIPTION
0 to 3'	TOPSOIL: Bt SANDY CLAY (CL), DARK BROWN, MOIST, MEDIUM STIFF
3' to 5.2'	OTAY FORMATION: To SILTY SANDSTONE, YELLOW BROWN, MOIST, VERY DENSE FINE TO COARSE GRAINED

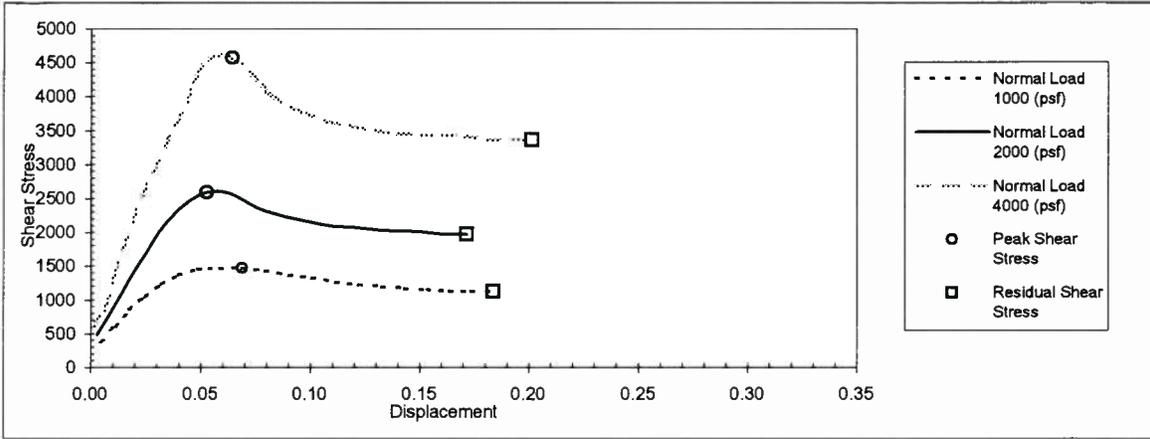
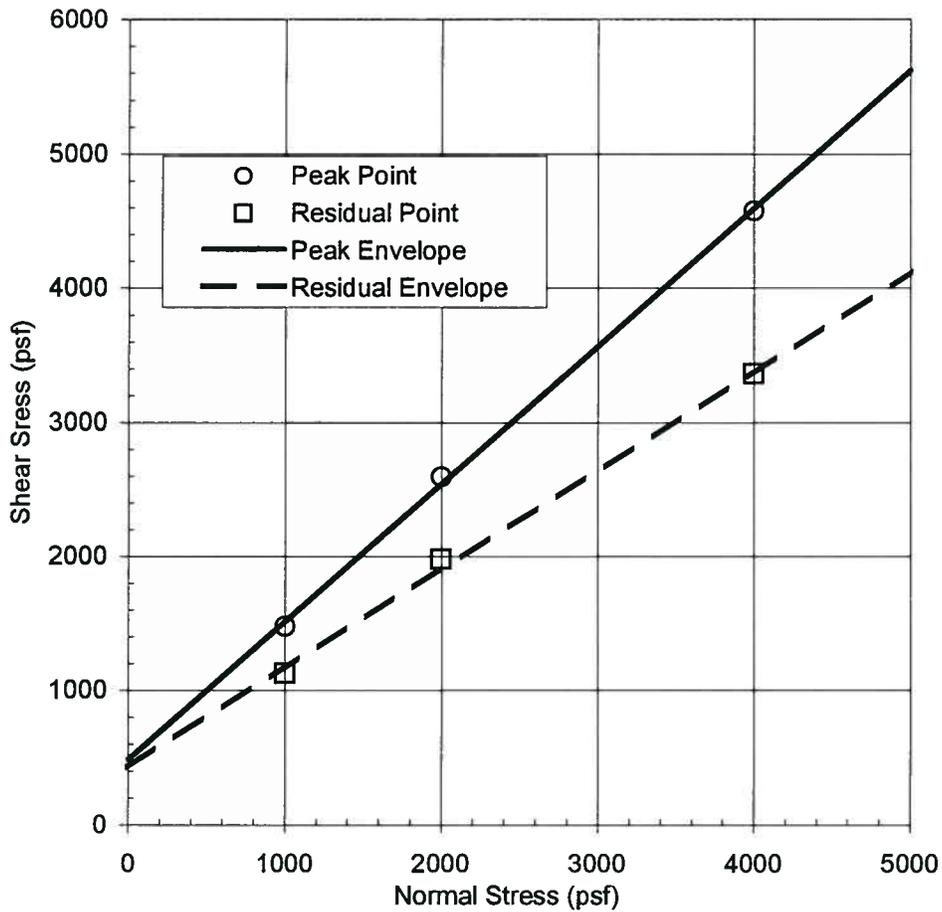
An employee owned company	Remolded Shear	Figure
	SDG&E Otay Ranch Substation Otay California	B5
Checked Uly	FN: LAB	
Project # 67735	24-Feb-07

Strain Rate = 0.0158 inch/min

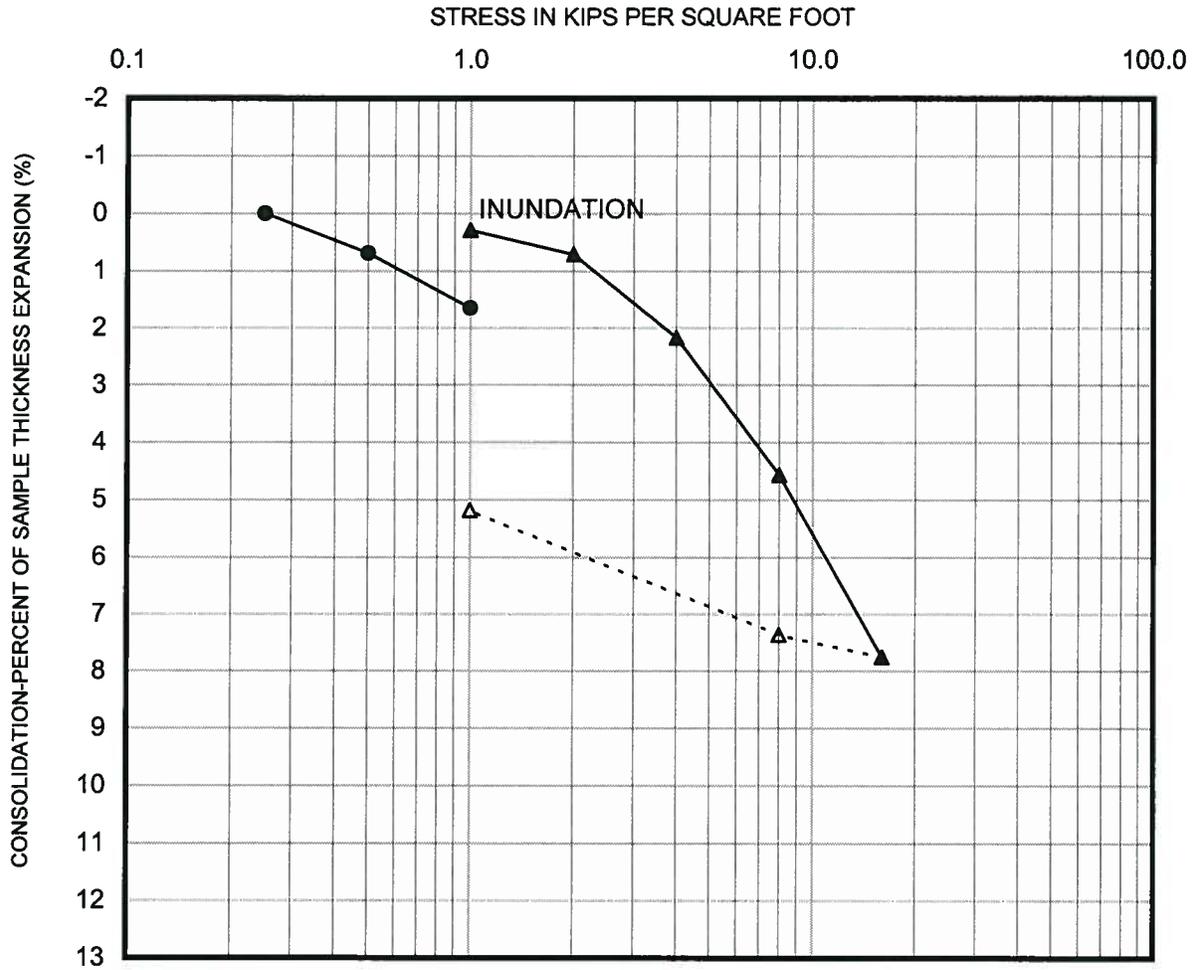
---●--- Seating Cycle **Boring No. B4-18a**
 —●— Loading Prior to Inundation **Depth (ft) 85**
 —▲— Loading After Inundation
 ---△--- Rebound Cycle
