MEMORANDUM

RE: Final Supplemental Jurisdictional Delineation Memorandum for the Encina Hub Portion of the Proposed Sycamore to Peñasquitos 230 Kilovolt Transmission Line Project, San Diego County, California

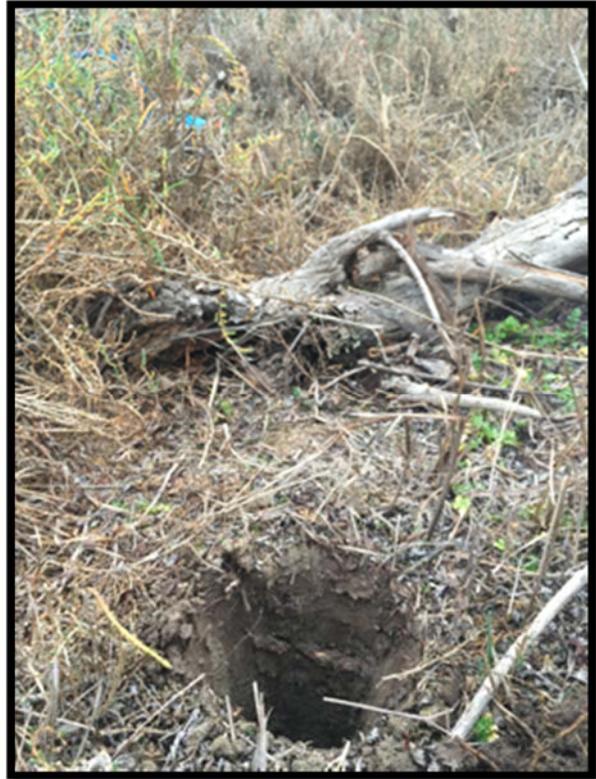
Sample Point 1 / Photo Point 1. View of Feature 1 - USACE wetland waters of the U.S., RWQCB wetland waters of the State, CDFW Riparian, and CCC Wetland.

Feature 1 is approximately 0.05 acre (approximately 160.72 linear feet) of USACE adjacent wetland waters of the U.S. and RWQCB wetland waters of the State, approximately 0.12 acre (approximately 200.78 linear feet) of CDFW Riparian and CCC Wetland (Table 1). The detailed USACE data forms and photographs of Sample Points 1 through 3 are provided in Appendix B (USACE Data Forms) and Appendix C (Site Photographs).

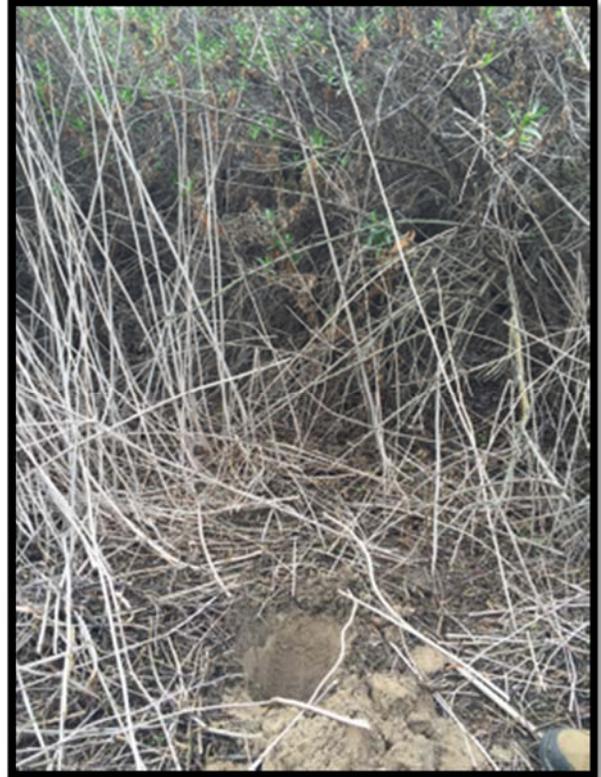
Sample Point 2 / Photo Point 2. View of Feature 1 - CDFW Riparian and CCC Wetland.

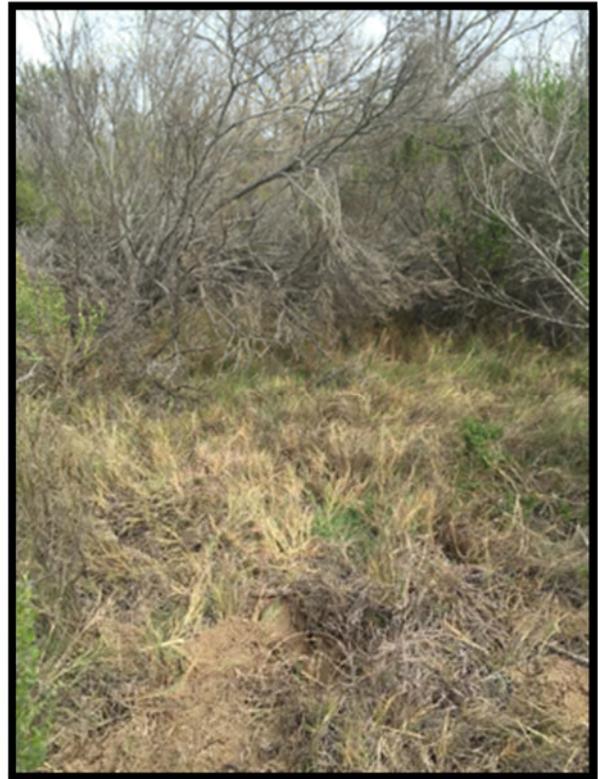
Sample Point 3 / Photo Point 3. View of area outside and west of Feature 1 - non-jurisdictional.

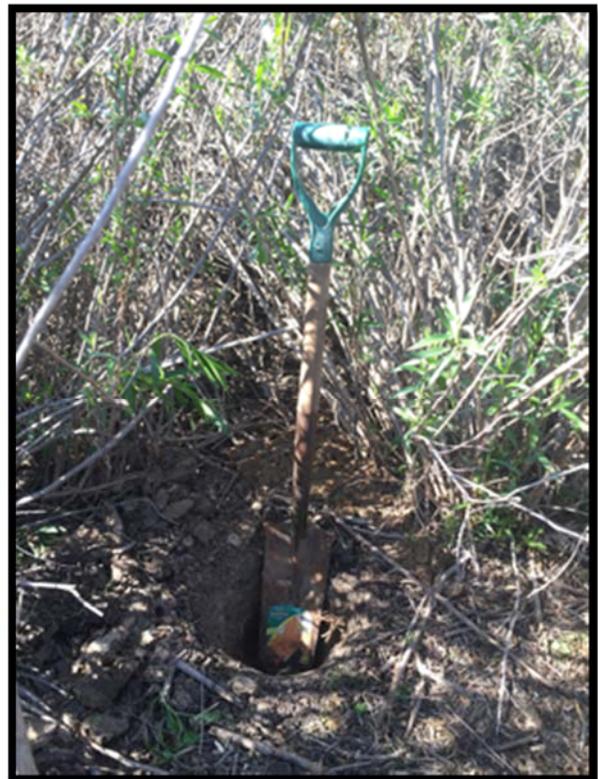
Sample Point 4 / Photo Point 4. View of Feature 2 - CCC Wetland.

Feature 2 contains a total of approximately 0.08 acre (approximately 136.69 linear feet) of CCC Wetland (Table 1). The detailed wetland data forms and photographs of Sample Points 4 and 5 are provided in Appendix B (USACE Data Forms) and Appendix C (Site Photographs).

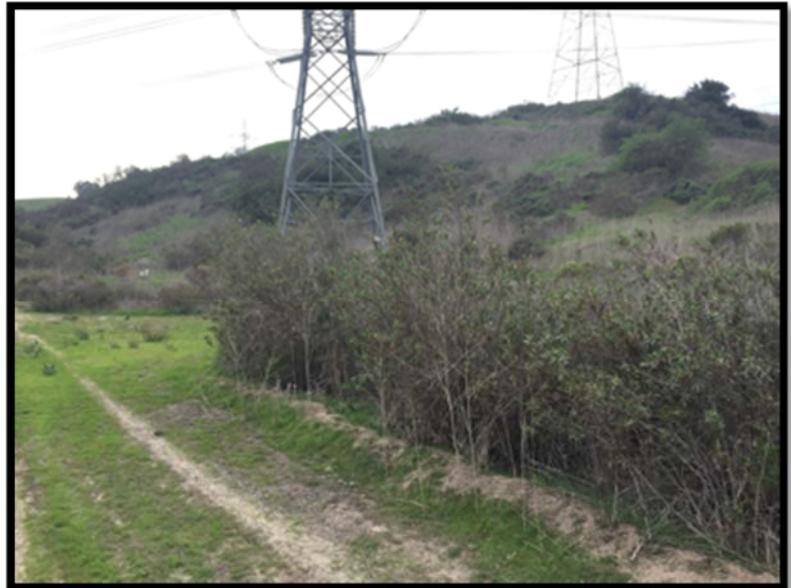
Photo Point 4.1. View of edge of Feature 2 where soil disturbance along the road has formed a berm that has resulted in an atypical situation creating conditions that unnaturally support hydrophytic vegetation.

Remarks:
 Atypical situation exists causing the establishment of hydrophytic vegetation which are FAC, and mainly upland in nature. Soils are high in clay content allowing for persistence of soil moisture.

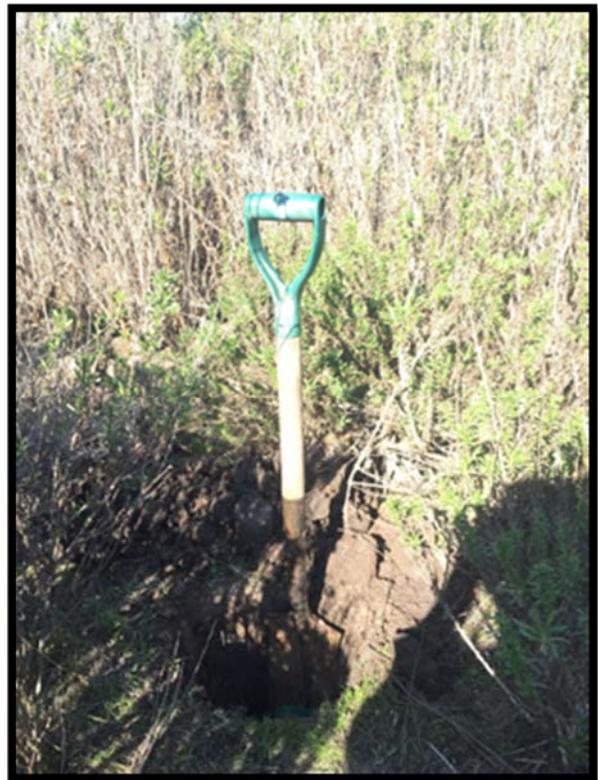
Sample Point 5 / Photo Point 5. View of area outside and west of Feature 2 - non-jurisdictional.

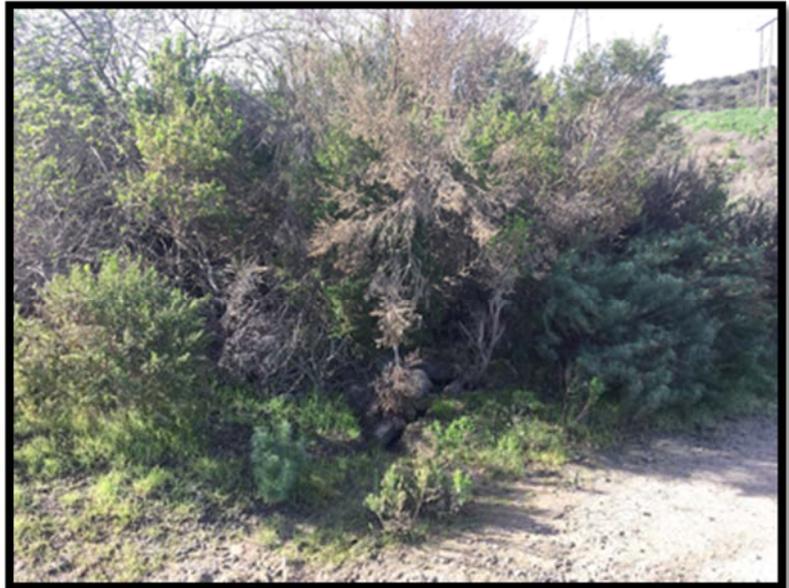
Sample Point 6 / Photo Point 6. View of Feature 3 - USACE waters of the U.S., RWQCB waters of the State, CDFW unvegetated streambed, and CCC Wetland.

Feature 3 contains a total of approximately 0.01 acre (approximately 107.23 linear feet) of USACE waters of the U.S., RWQCB waters of the State, CDFW unvegetated streambed, and CCC Wetland (Table 1). The location of Feature 3 and the boundaries of these jurisdictions are provided in Page 3 of Figure 4 (Appendix A). The detailed USACE data form and photograph of Sample Points 6 is provided in Appendix B (USACE Data Forms) and Appendix C (Site Photographs).

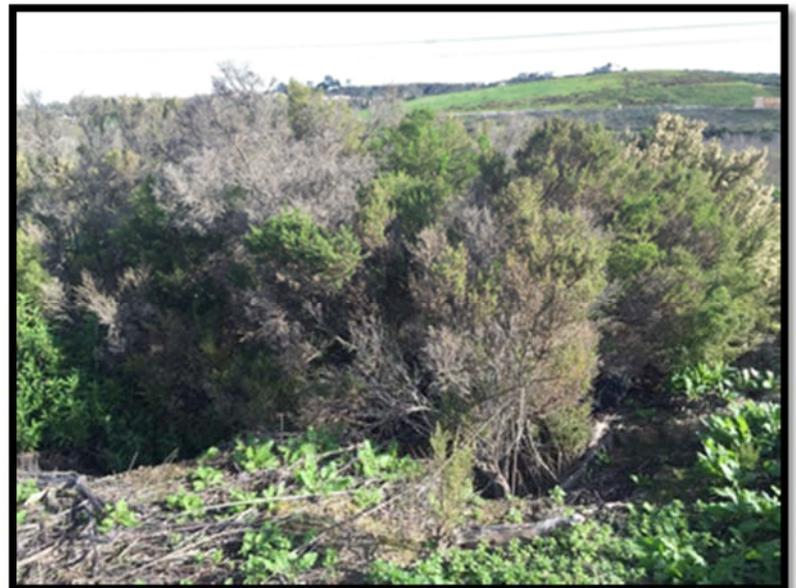
Sample Point 7 / Photo Point 7. View of Feature 4 - USACE waters of the U.S., RWQCB waters of the State, CDFW unvegetated streambed, and CCC Wetland.

Feature 4 contains a total of approximately 0.01 acre (approximately 137.45 linear feet) of USACE waters of the U.S., RWQCB waters of the State, CDFW unvegetated streambed, and CCC Wetland (Table 1). The location of Feature 4 and the boundaries of these jurisdictions are provided in Page 3 of Figure 4 (Appendix A). The detailed wetland data form and photograph of Sample Points 7 is provided in Appendix B (Wetland Data Forms) and Appendix C (Site Photographs).

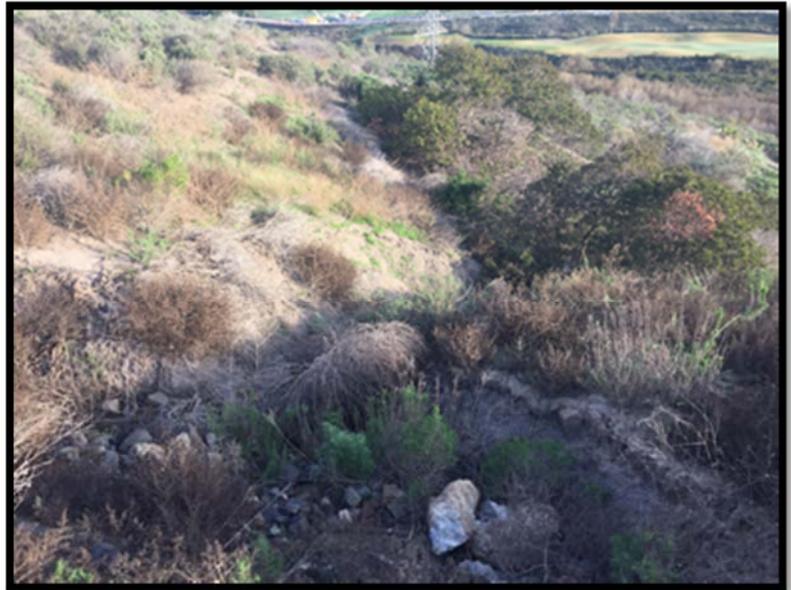
Sample Point 8 / Photo Point 8. View of Feature 5 - USACE waters of the U.S., RWQCB waters of the State, CDFW unvegetated streambed, and CCC Wetland.

Feature 5 contains an OHWM and is moderately incised with hard sands and cobbles which are associated with high water velocities during and directly after storm events. This feature is approximately 4 feet wide and 3 feet deep below the surrounding uplands. The surrounding vegetation above the OHWM at the top of the bank contains disturbed Diegan coastal sage scrub.

Feature 5 contains less than 0.01 acre (approximately 29.22 linear feet) of USACE waters of the U.S., RWQCB waters of the State, CDFW unvegetated streambed, and CCC Wetland (Table 1). The location of Feature 5 and the boundaries of these jurisdictions are provided in Page 5 of Figure 4 (Appendix A). The detailed USACE data form and photograph of Sample Points 8 is provided in Appendix B (USACE Data Forms) and Appendix C (Site Photographs).
