Office of Rail Safety

April 7, 2016

Highway-Rail Crossing Safety Issues

Integrated Pavement Markings and Signage Improvements for At-Grade Crossings

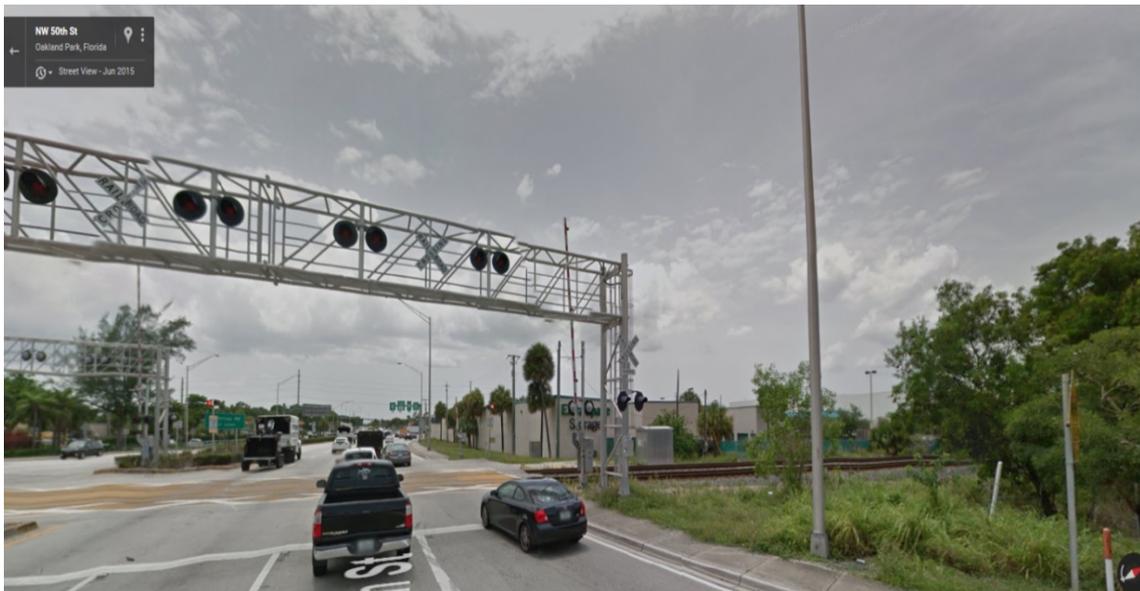
Example: The approaches of this Florida grade crossing have a total of seven railroad (RR) crossing signs and two areas of RR crossing pavement markings.

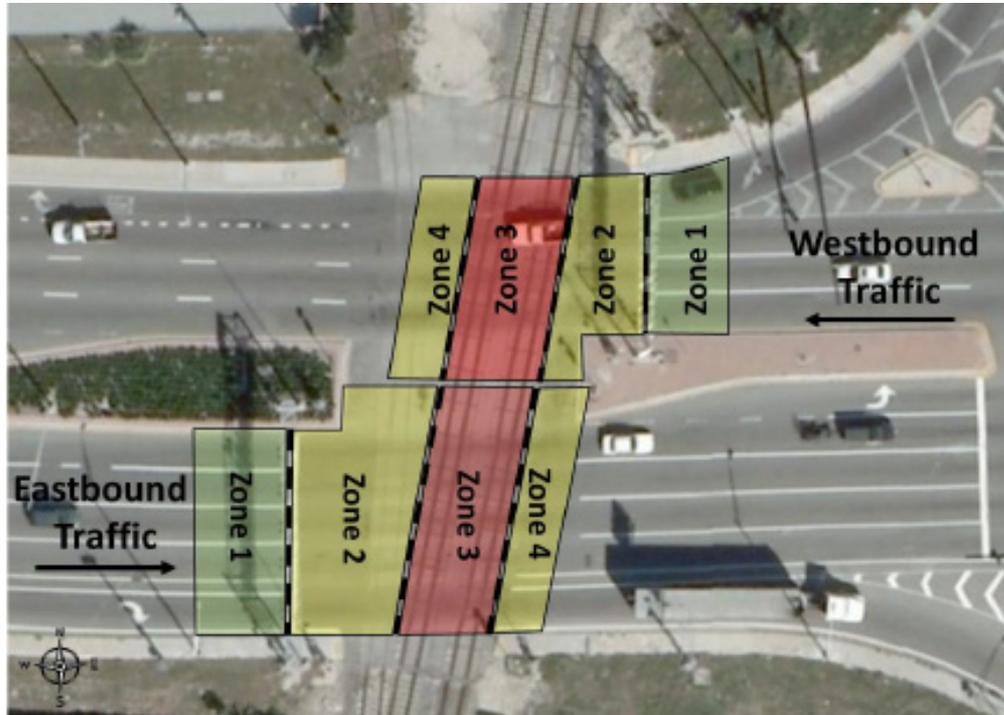
Commercial Blvd & FECR crossing. Picture and graphic from Page 19, Figure 14, DOT Report: DOT/FRA/ORD-14/04

Zone 1 (not dangerous): A motorist who stops in Zone 1 has stopped before the stop line where the gate descends during an activation. Motorists stopping in this zone are behaving safely.

Zone 2 (moderately dangerous): A motorist who stops in Zone 2 has stopped after the stop line, but before the dynamic envelope. Motorists stopping in Zone 2 would be stuck inside of a descended gate but not struck by a train.

Zone 3 – Dynamic Envelope Zone (very dangerous): A motorist who stops in Zone 3 has stopped in the most dangerous part of the crossing—the dynamic envelope zone. In this zone, a train and vehicle would collide.

Zone 4 (moderately dangerous): A motorist who stops in Zone 4 has stopped past but adjacent to the dynamic envelope zone. Motorists stopping in Zone 4 would not be struck by a train.

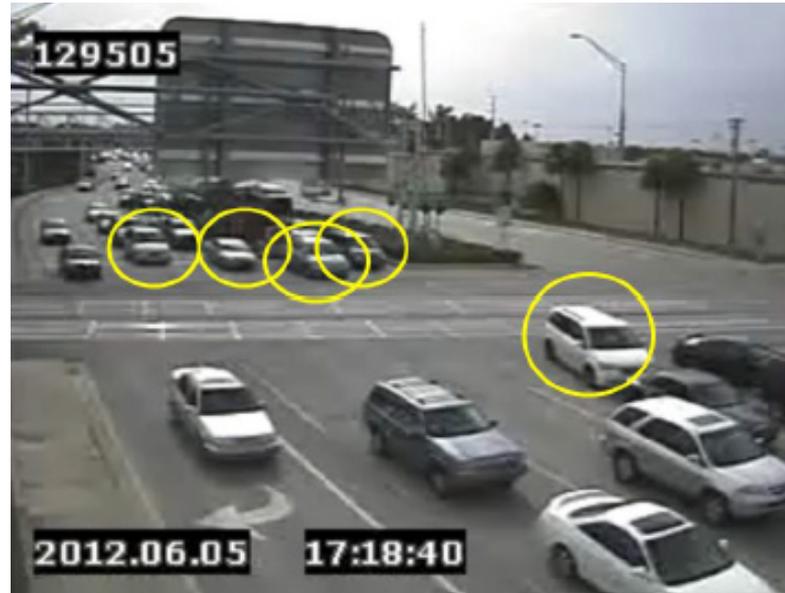
- The crossing was filmed for over 80 hours before, and 80 hours after the installation of pavement markings and improved signage.
- Over 6,000 vehicles and associated stopping and corrective behaviors were observed in each phase (12,000 total).
- Driver stopping behavior was observed before and after improvements.
- Driver corrective behavior was observed before and after improvements.

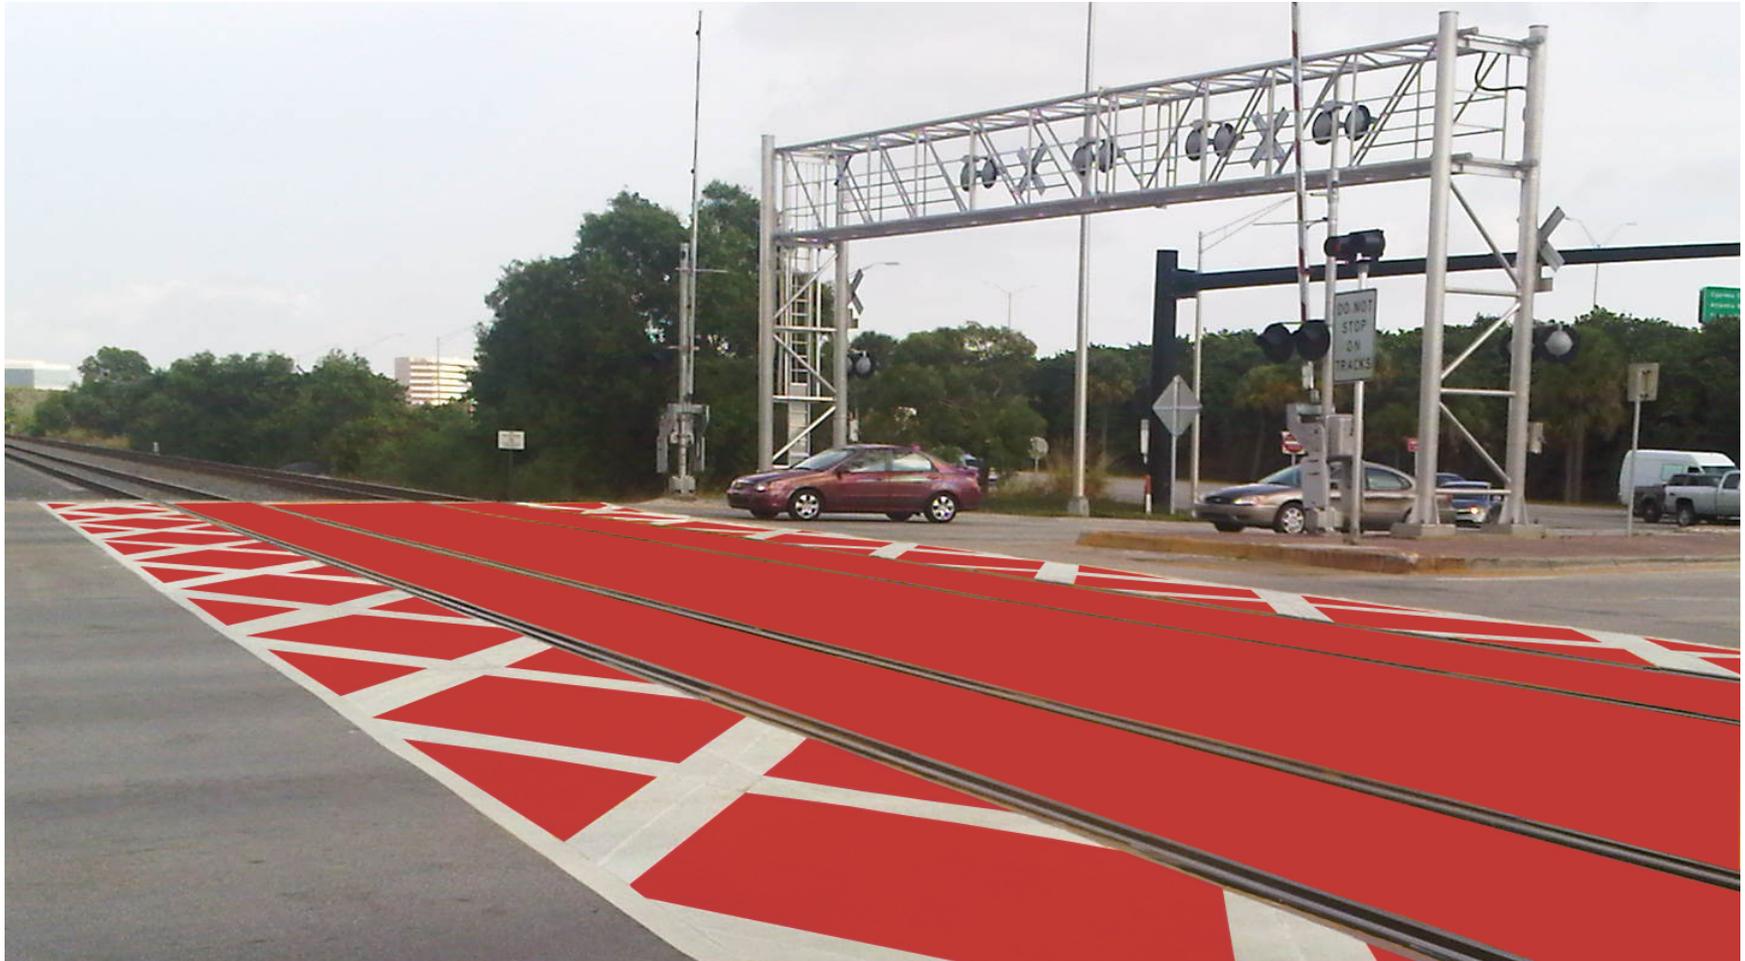
Railroad Crossing utilizing "Color-Safe® Pavement Marking for Dynamic Envelope

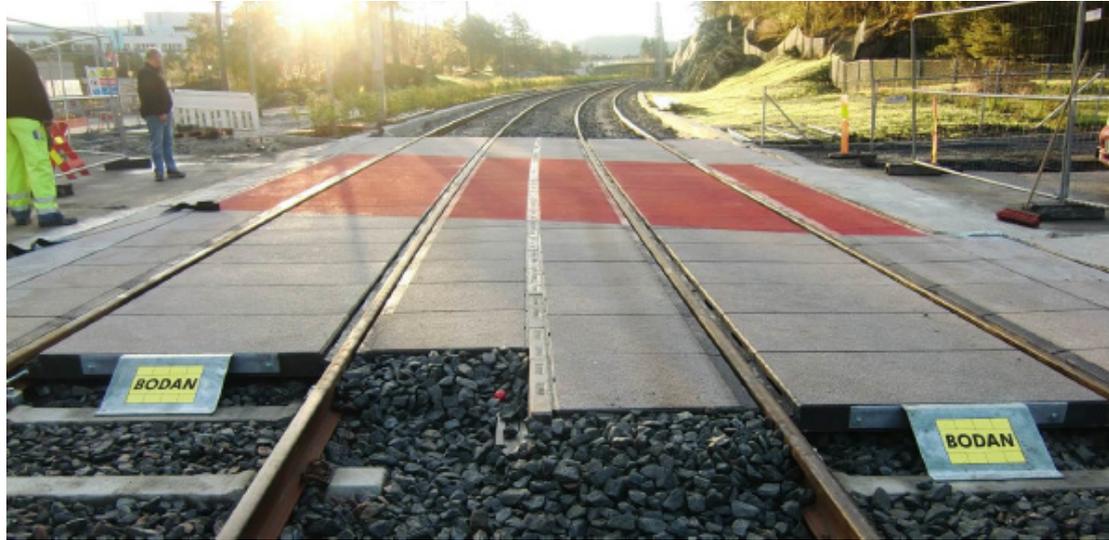
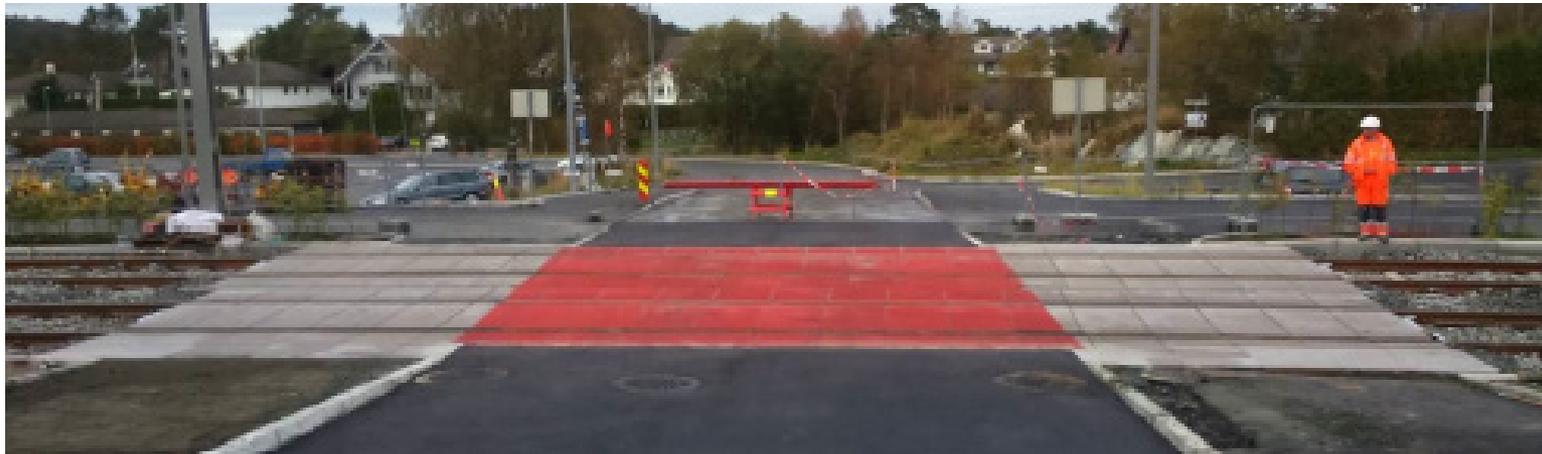
Examples of "BODAN" concrete system in "RED" with train and driver views.

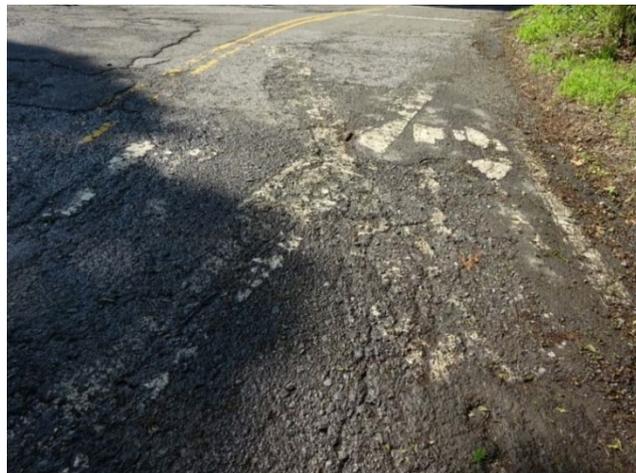
Faded Cleveland Street pavement markings

Evaluate the railroad pavement markings in advance of the highway-rail crossing. The railroad crossing pavement marking symbol should be refreshed and evaluated for appropriate placement in accordance with MUTCD Chapter 8, Section 8b.27. The advance railroad warning signs may need to be relocated based on the placement of the railroad pavement marking symbols.

Extend edge lines and double yellow centerline through the crossing.

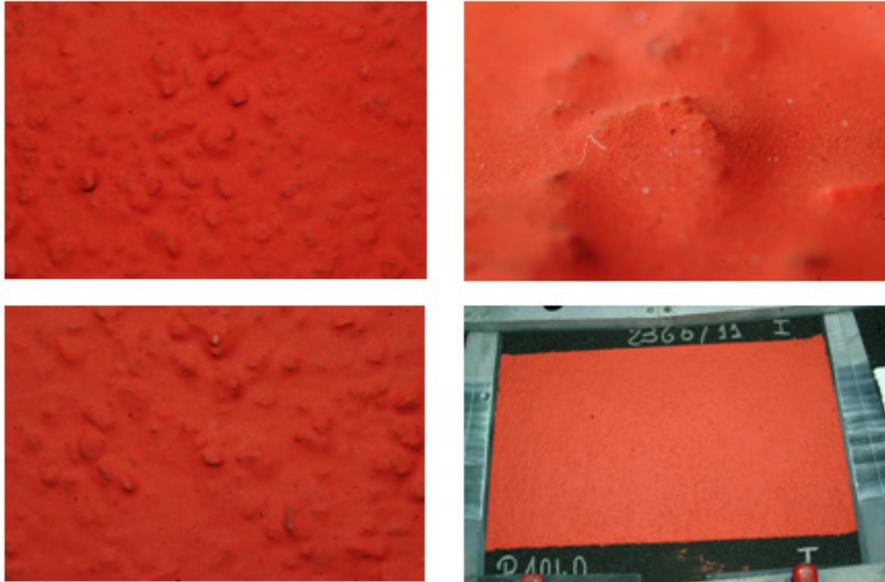
Pictures taken at the beginning
(prior to test run)

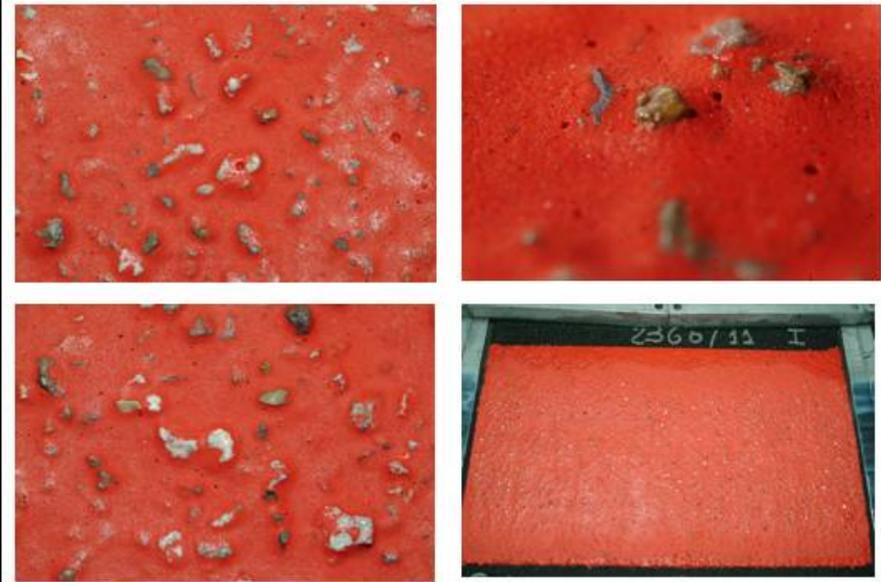
After 8,000,000 wheel passages

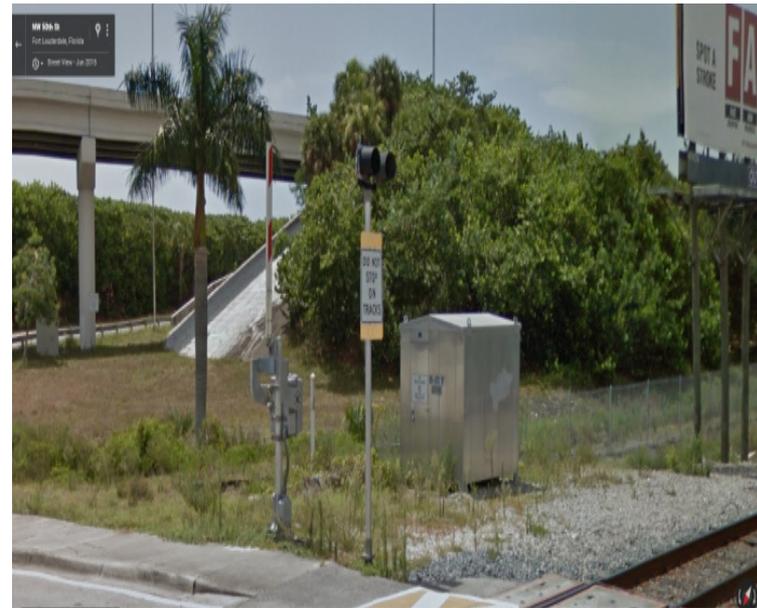
Ft Lauderdale pedestrian gate arm and
"Do Not Stop On Tracks" sign with flashing warning device
