New York “Metro-North” Derailment, December 1, 2013

NTSB Investigation

Paul King, PhD, Deputy Director
Office of Rail Safety
Safety and Enforcement Division
December 5, 2013

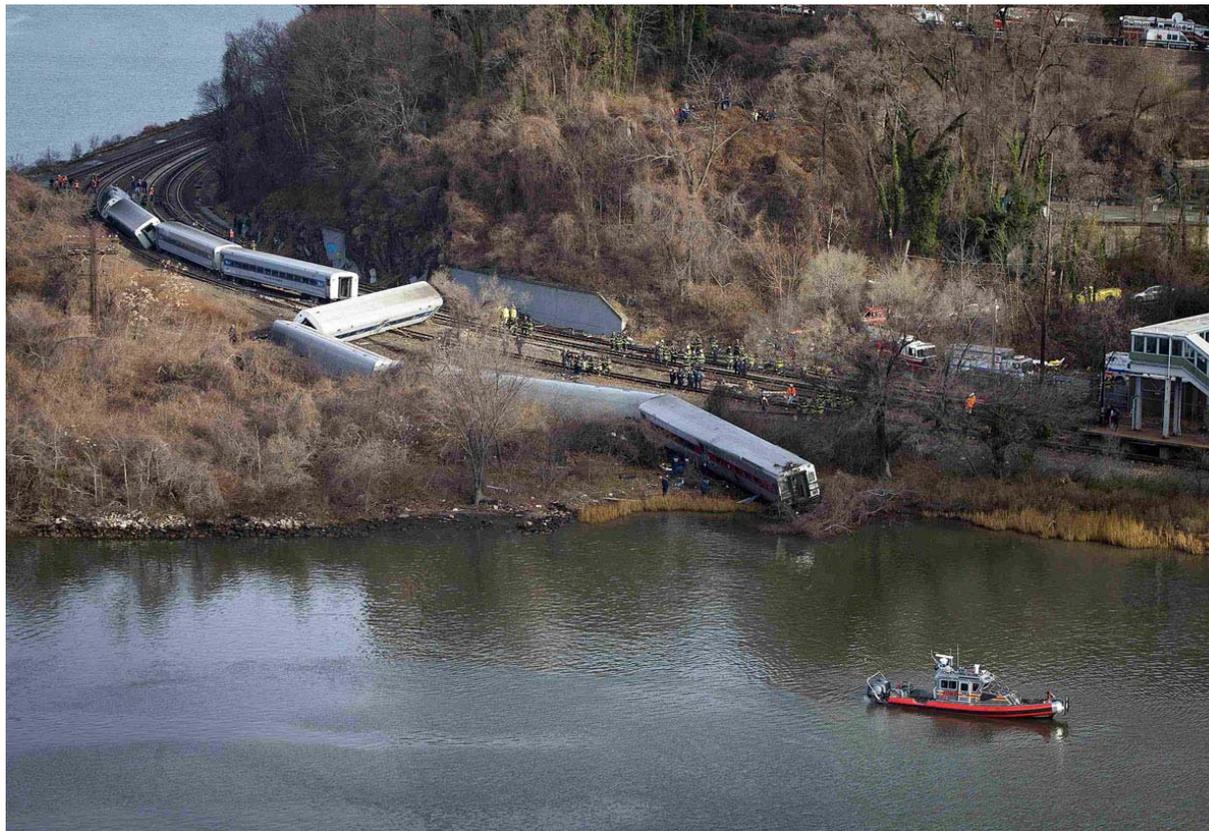
Head-end of train ("cab car") rests at edge of river

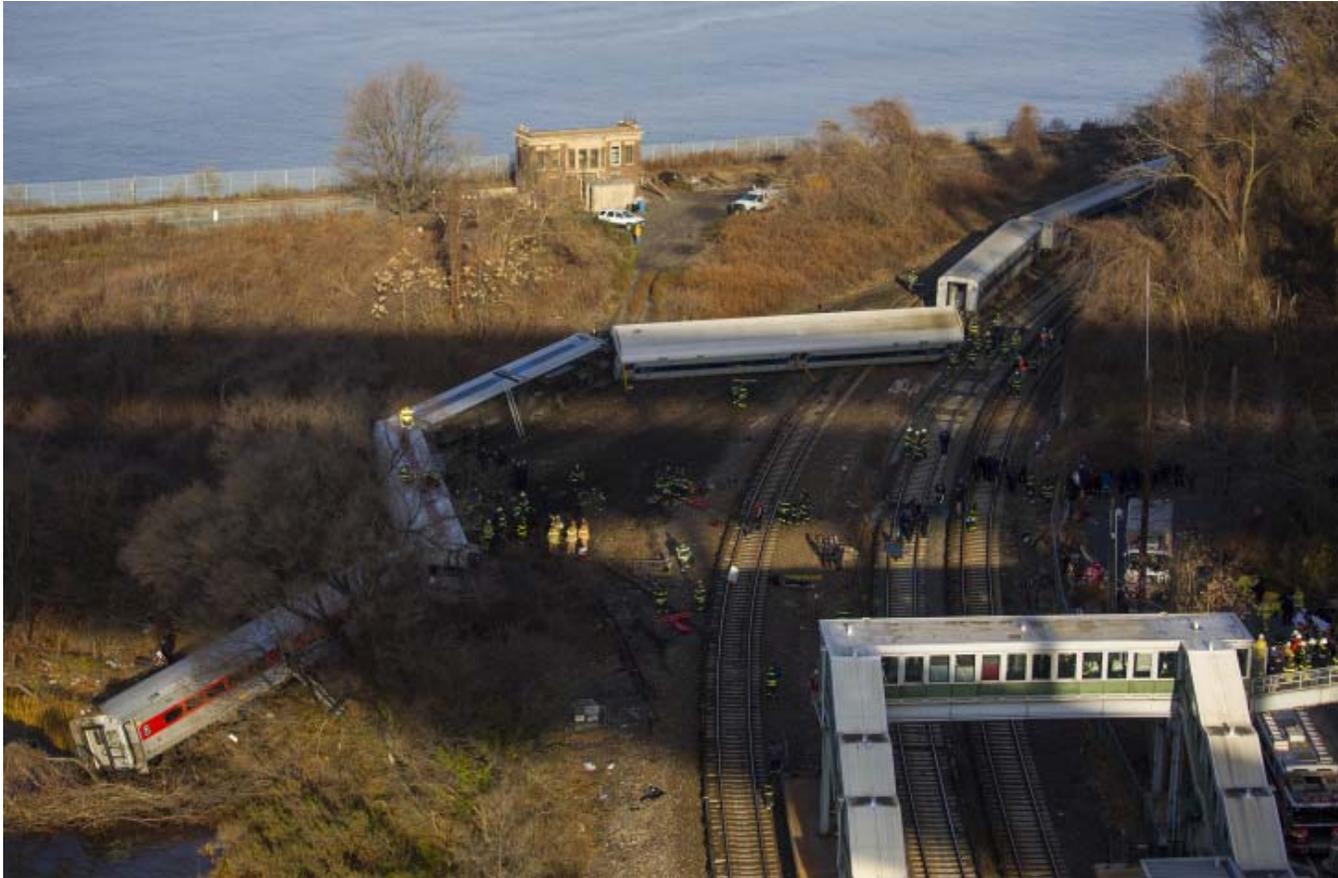
Two cars on their sides, three cars leaning, two upright

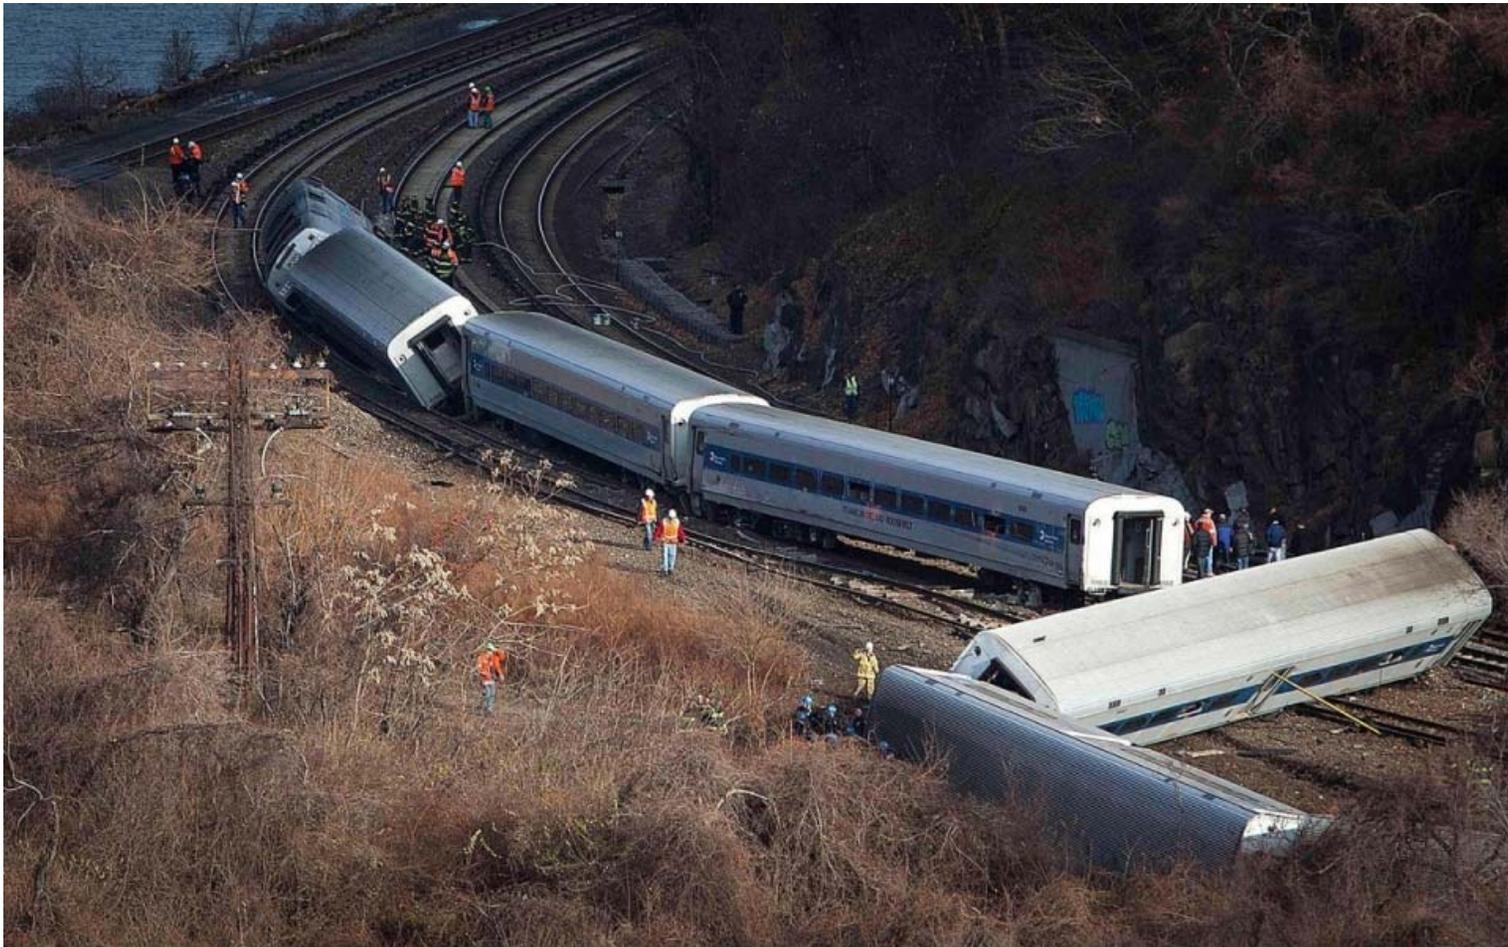
View from middle towards rear of train

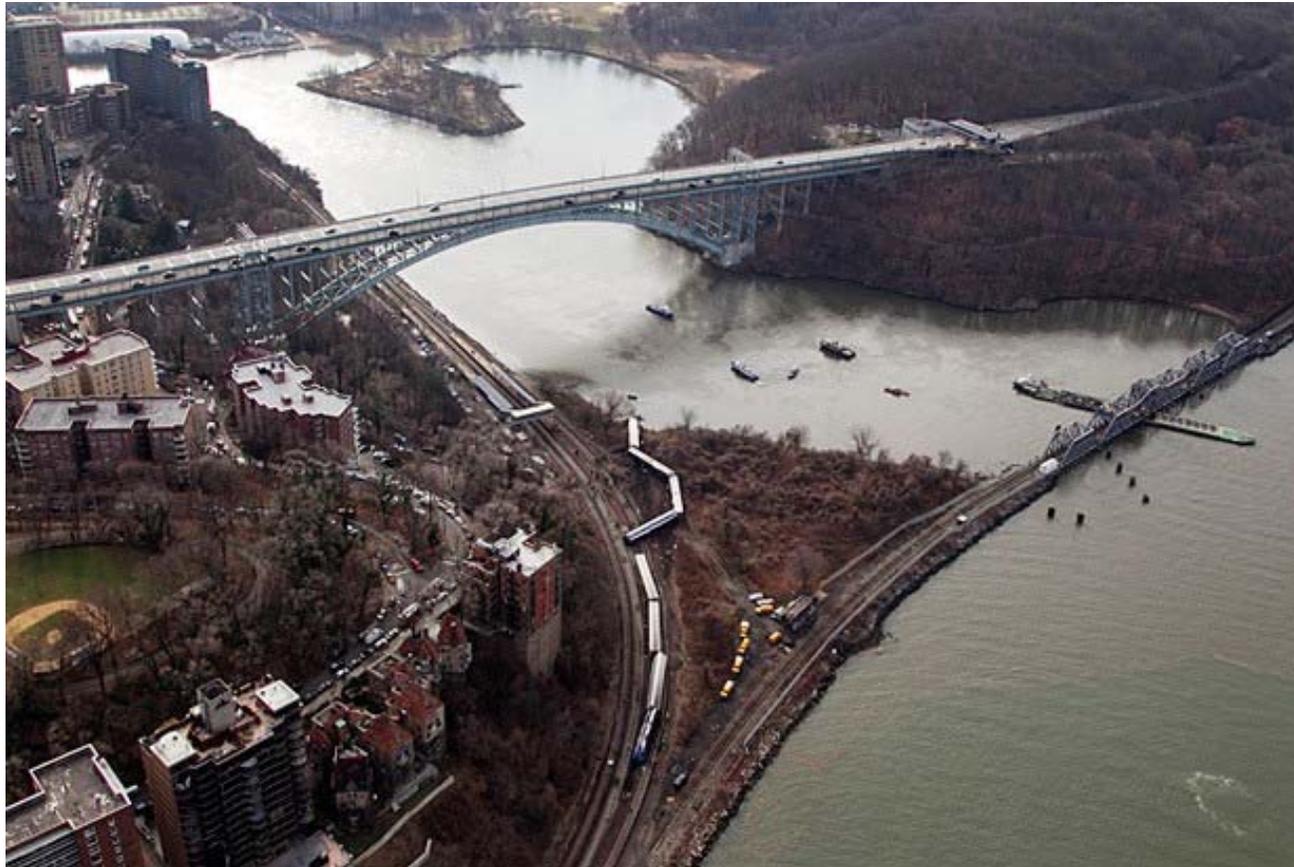
View of curve, surrounding area

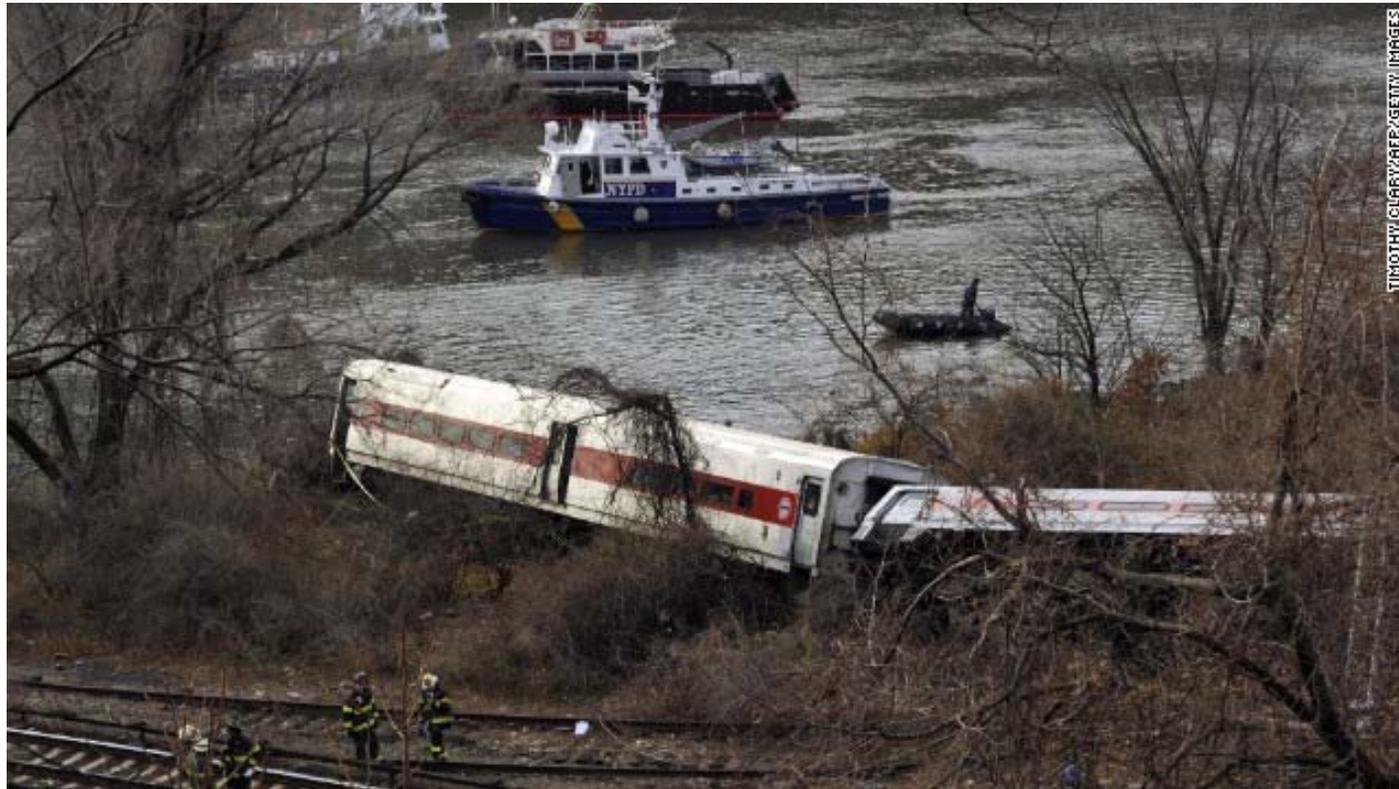
Head-end of train

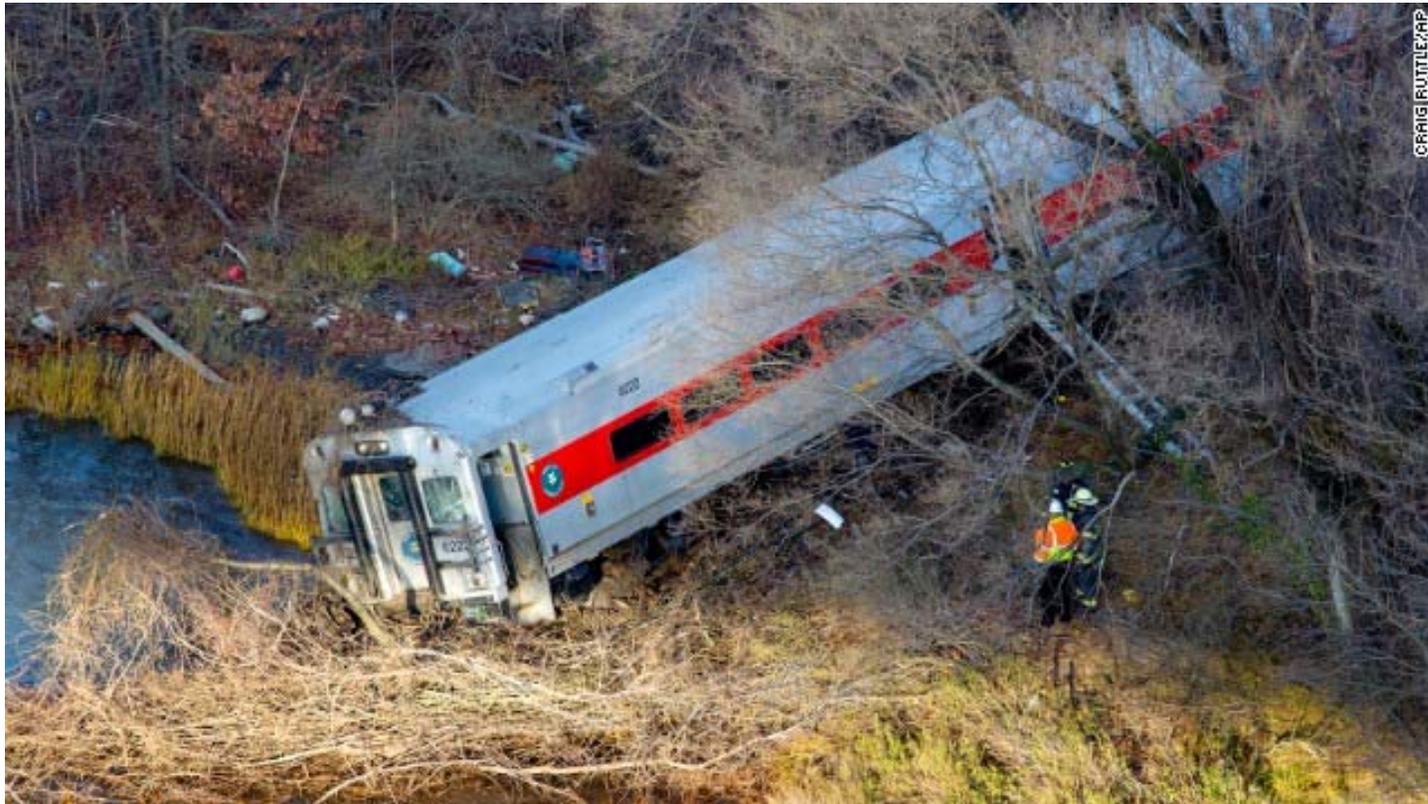
Controlling “cab car” head-end at edge of river

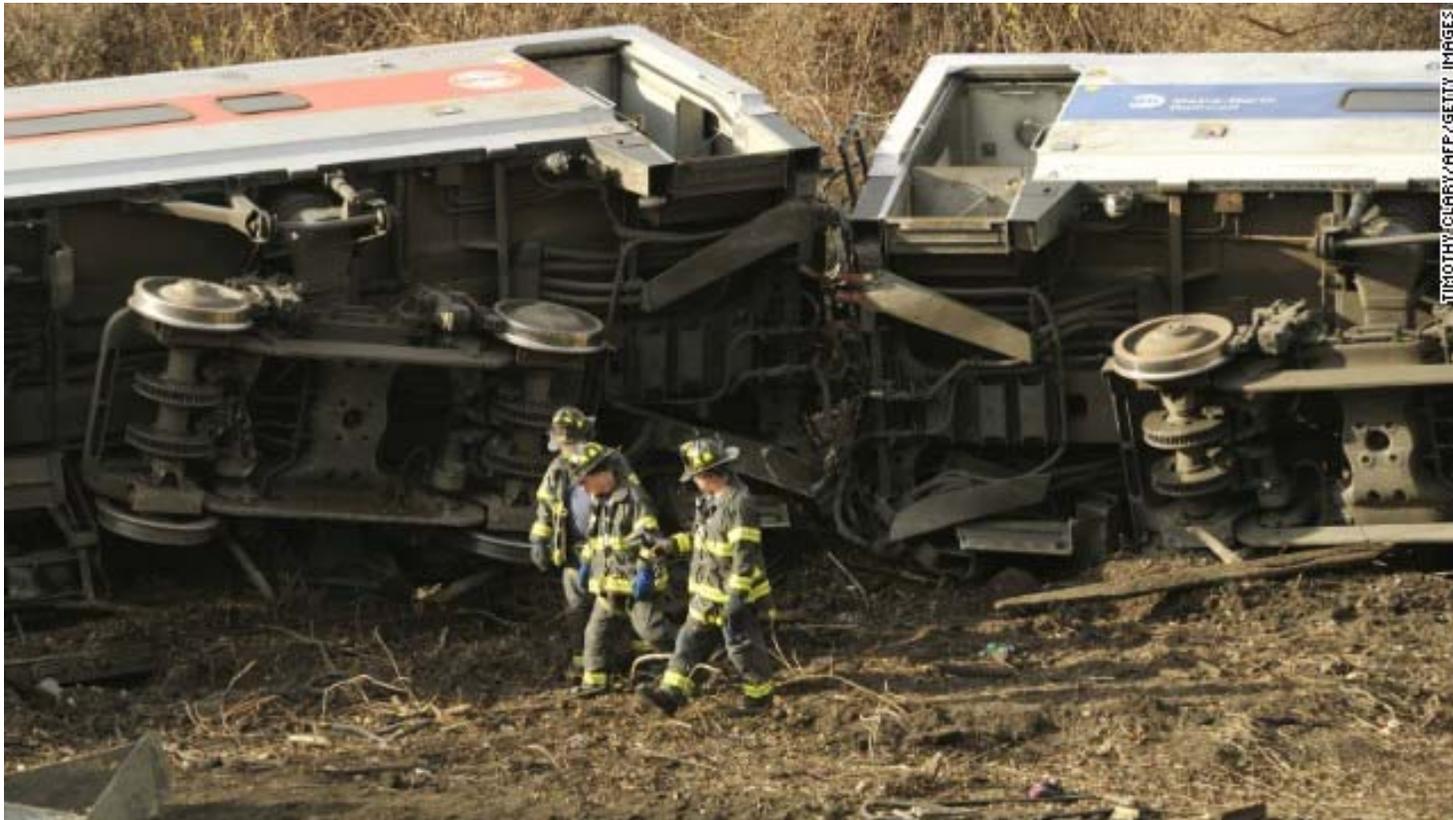
Cars that slid on their sides

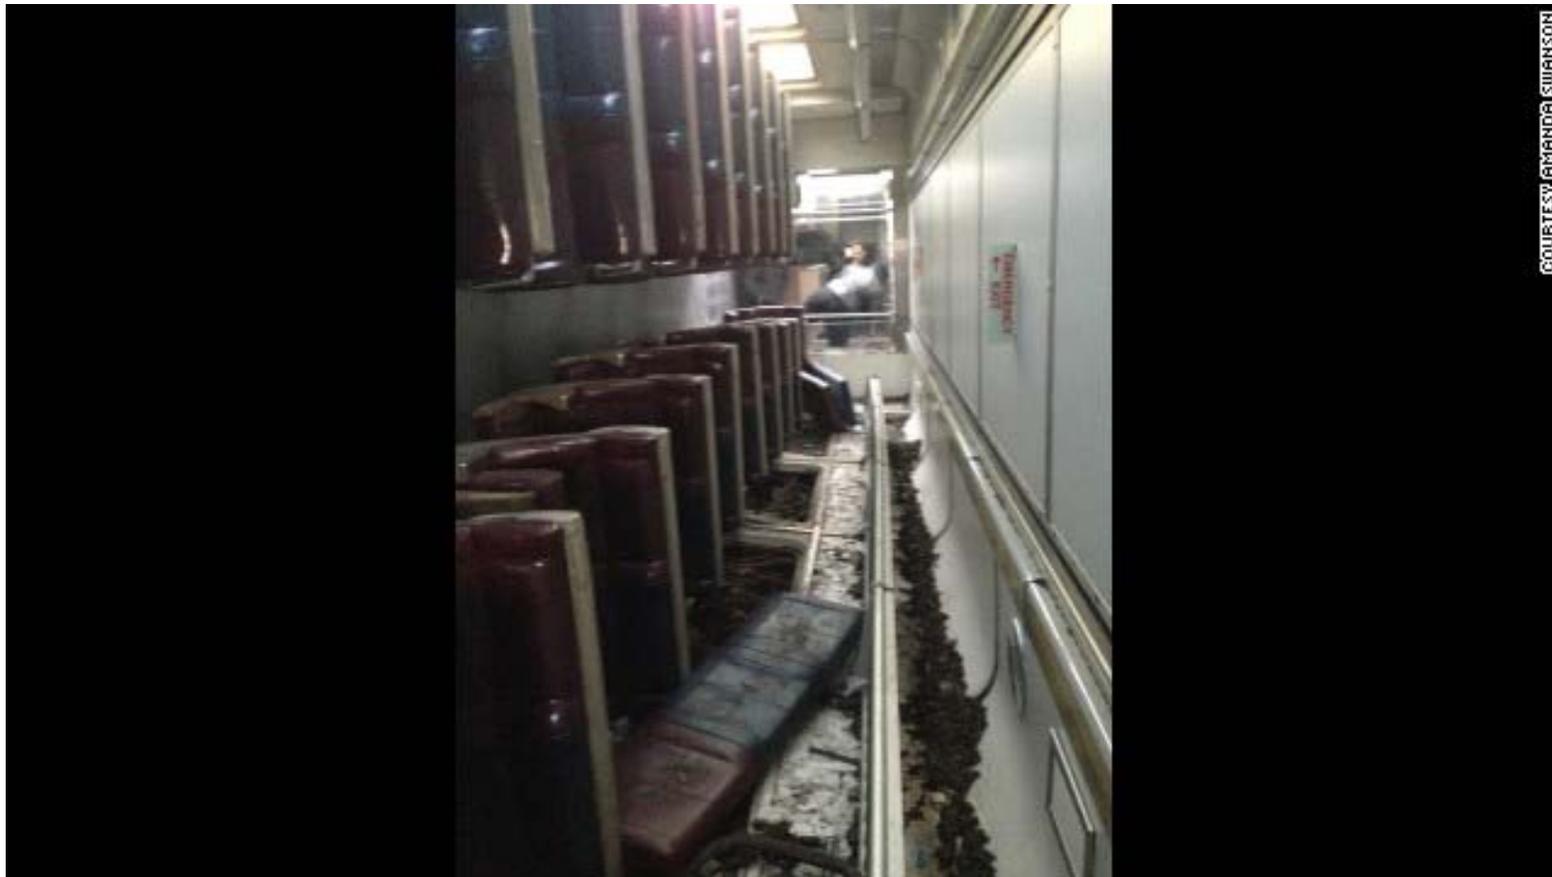
Inside of car on its side, showing broken windows, gravel (“ballast”) incursion

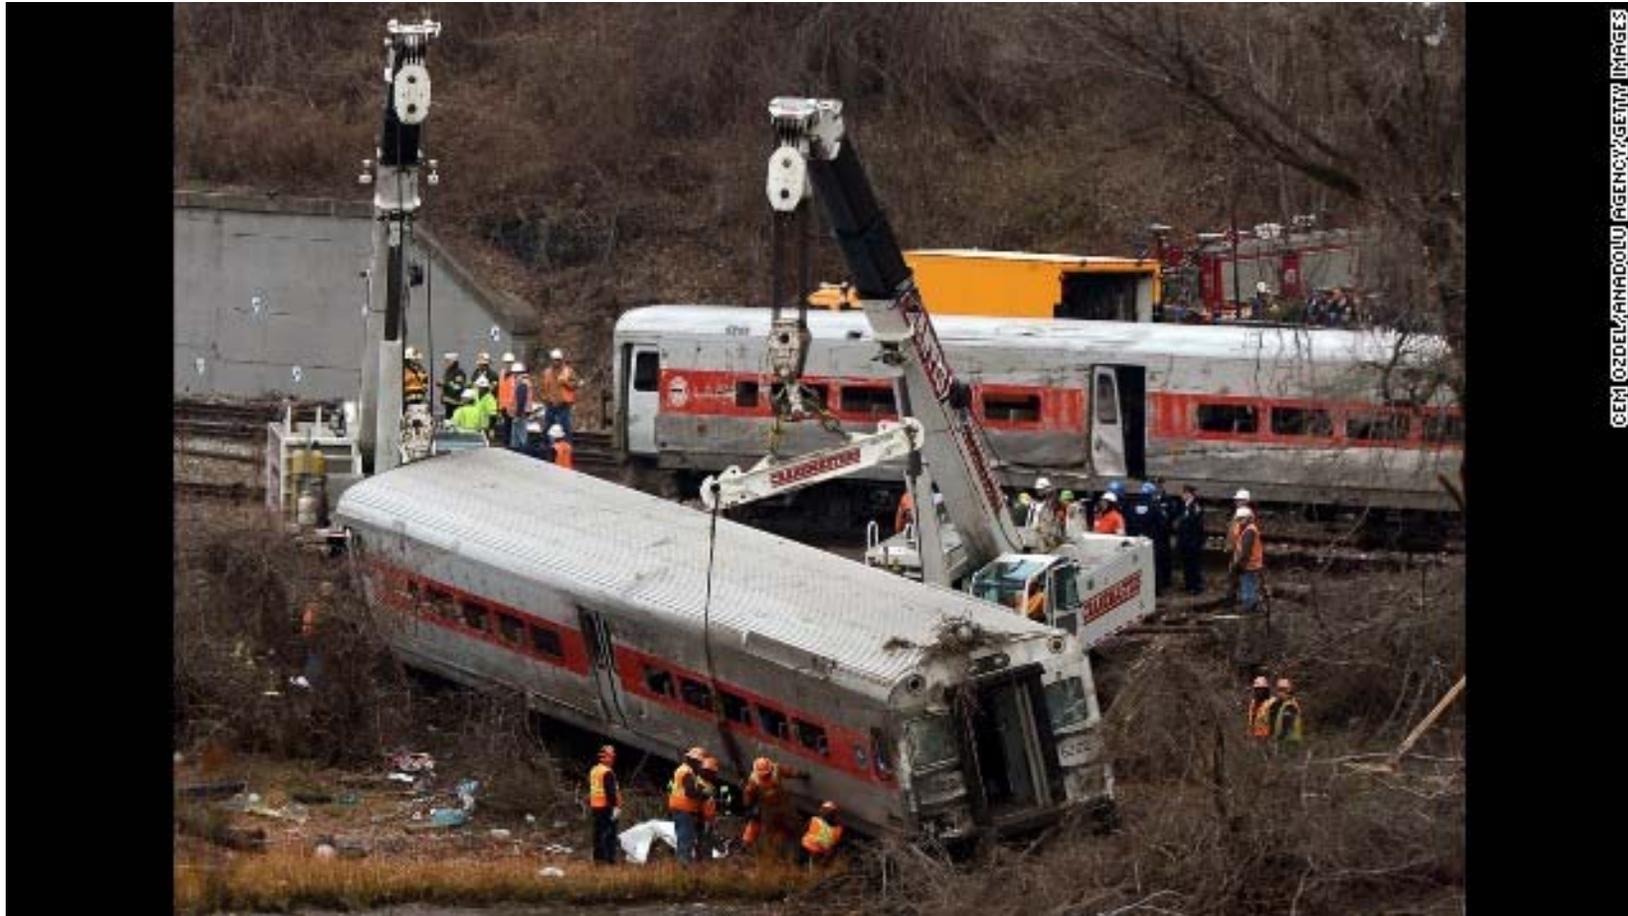
Service restoration work, removing cars
