INVESTIGATION REPORT OF THE AUGUST 3, 2013 IMPLOSION INJURY AT THE KERN POWER PLANT OWNED BY PACIFIC GAS AND ELECTRIC COMPANY

PUBLIC REPORT

PREPARED BY THE SAFETY AND ENFORCEMENT DIVISION ELECTRIC SAFETY AND RELIABILITY BRANCH

SAN FRANCISCO NOVEMBER 2015

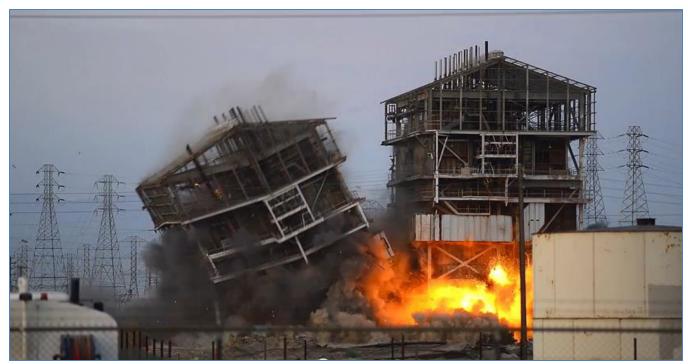
Photo 1: Kern Power Plant Boilers Implosion. *Source:* https://www.youtube.com/watch?v=6N3p-cbSkU8

On August 3, 2013 at approximately 6:00 a.m., Pacific Gas and Electric Company (PG&E) detonated explosives to topple the boilers at its retired Kern Power Plant in Bakersfield, California. The implosion did not go as planned. Shrapnel from the collapsing structure flew over a thousand feet and sprayed a Lowe's parking lot where a group of people had gathered to witness this historic event. Steel fragments hit and injured at least five spectators, one critically, and damaged nearby cars and buildings.

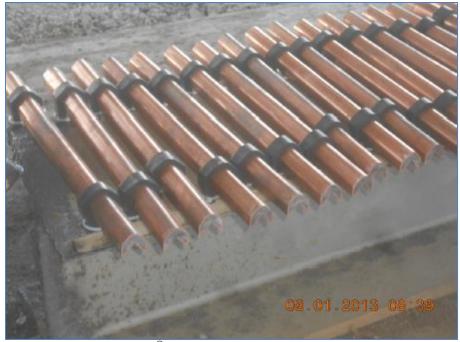
Photo 2: UNIGEL[©] Linear Shaped Charges. Source: PG&E

First, Demtech failed to use any scientific approach to determine the proper blast loads, including which type or how much explosives to use for the implosion. Demtech's blast plan prescribed the use of UNIGEL® in Linear Shaped Charges (LSC) to explosively-cut the columns. It stated that it will match the LSC's size to the respective steel column to be cut. In using LSC, there must be a precise standoff from the surface to be cut. This standoff is computed based on the explosive's density (grains per foot) in the shaped charges and the metallurgy of the steel to be cut. In its blast plan, Demtech stated that it will calculate and employ the proper standoff to maximize severing effect and minimize explosives used. This optimum standoff will also minimize air blast and shrapnel broadcast. However, SED found no evidence that Demtech calculated the standoff nor conducted a test blast to determine the proper blast loads.

Standoff is the distance between the steel surface to be explosively-cut and the mounting explosive. If the charge is too close to the surface, there'll not be enough time for the explosive jet to develop fully as it detonates. If it's too far, the jet disperses. Either case lessens the explosive's cutting force.

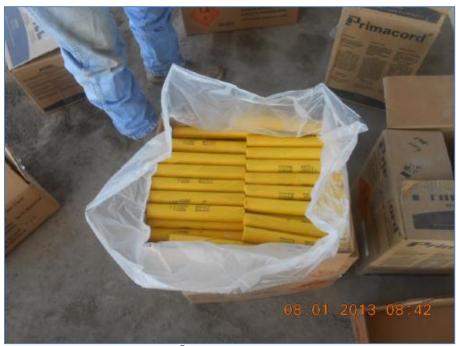
Photo 3: UNIGEL[©] Kicker Charges. Source: PG&E

The plan also prescribed the use of a UNIGEL[©] kicker charge. The kicker charge is designed to detonate after the column is explosively-cut by LSC. Its purpose is to kick the severed support column out so that the structure the column supports can collapse. Again, SED found no evidence that Demtech performed any calculation or a test blast to determine the right amount of explosives to use in the kicker charge.

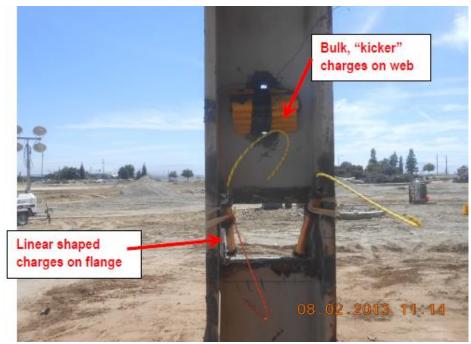
Photo 4: Explosives Installation. Kicker charge is designed to go off after the LSC explosively-cut the column. Its purpose is to kick the severed support column out so that the structure the column supports can collapse. Source: PG&E

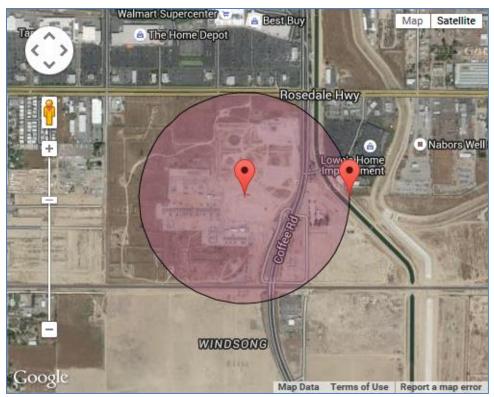
Photo 5: Shrapnel flew as far as 1,400 feet from the blast zone.

Second, Demtech failed to apply scientific criteria to calculate the proper safety zone distance. Demtech's specified safety zone of an 800-foot radius was too small, as shrapnel flew over 1,400 feet from the blast zone into the Lowe's parking lot. This safety zone also contradicted with Demtech's own plan which "strongly suggested that ALL personnel within ½ mile [2,640 feet] of the event be behind cover. In response to SED's question on how it determined the safety zone distance, Demtech stated that the safety zone was determined based on "Distances of recognized industry standards and past experience (reviewing of numerous surface building structure blasts and bridge demolition project video tapes looking for shrapnel impacts on water or grounds in the blast area)." This approach is subjective at best and archaic at worst, as it failed to consider the site's unique topography and the physical properties of the columns. No two implosions are alike. Demtech failed to properly determine the proper safety zone distance.

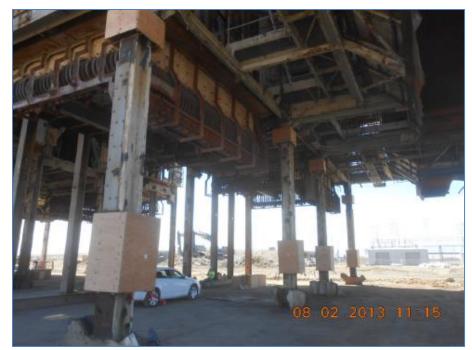
Photo 6: Plywood boxes installed over LSC and kicker charge to contain flying debris.

Third, Demtech failed to prescribe adequate blast shields to contain flying debris or fragmentation. In response to SED's inquiry about blast shields, Demtech stated "We prefer to use custom built wood boxes lined with conveyer belting and wrapped with heavy woven Geo-Tech fabric. We have blasted many steel structures with greater quantities of explosives and at closer distances than this project, and with no resulting damage." This re-illustrated Demtech's faulty approach and its reliance on judgement based on past projects. Further, SED found no evidence that conveyer liner or geo-fabric were used to reinforce the wood shields. Demtech also underestimated the potential for damage or injury from flying debris, as evidenced by this statement in its blast plan: "On this project the exposure to other structures is worthy of consideration but not of alarming concern."
