Castroville Incident Investigation Report

SAFETY AND ENFORCEMENT DIVISION
GAS SAFETY AND RELIABILITY BRANCH

June 5, 2025
Final Report

Report Date:	June 5, 2025
Investigators:	Aleksandr Fastovich
Date incident reported to CPUC	August 15, 2024
Utility:	Pacific Gas and Electric Company (PG&E)
Date and Time of the Incident:	August 15, 2024 @ 13: 25 Hours
Location of the Incident:	Castroville, CA, Monterey County

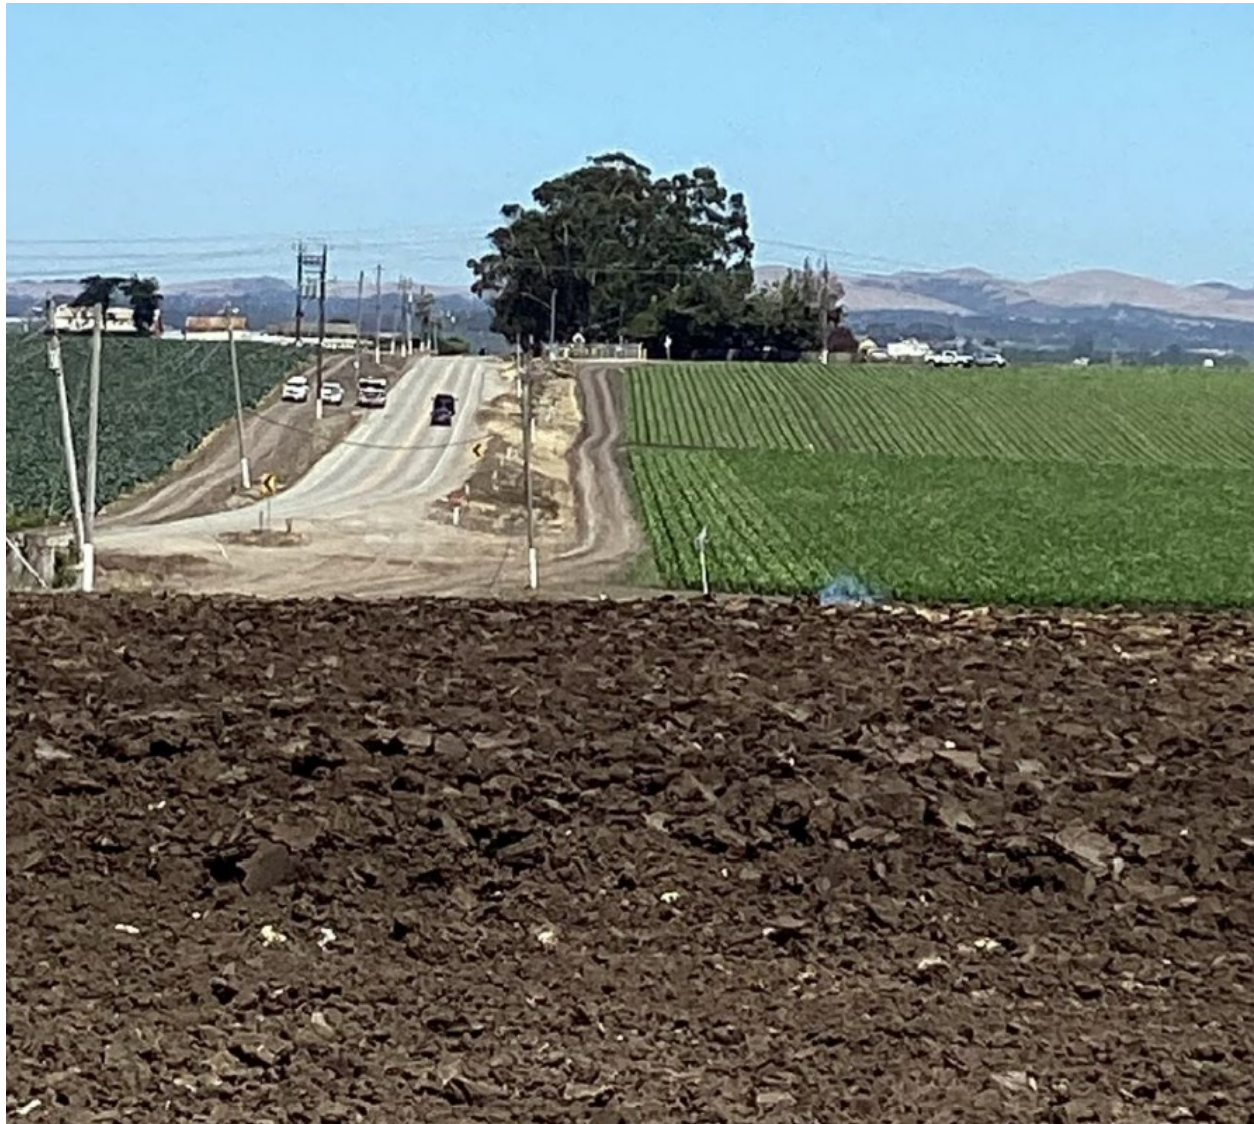
Rancher personnel were operating without USA utilities marking, relying on distant pipeline markers, making them susceptible to hitting underground utilities.

Figure 2. Photo from the incident location, following the line to a valve station. Note the pipeline marker, and missing USA markings on the ground.

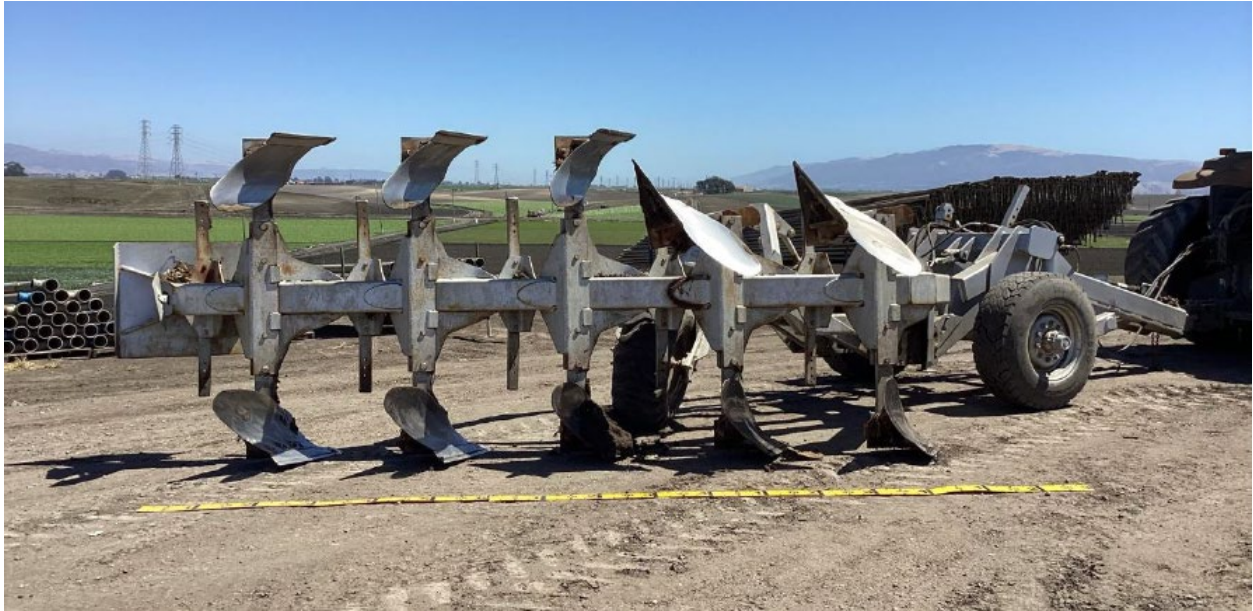
Figure 3. Photo of the ripper that struck the pipe.

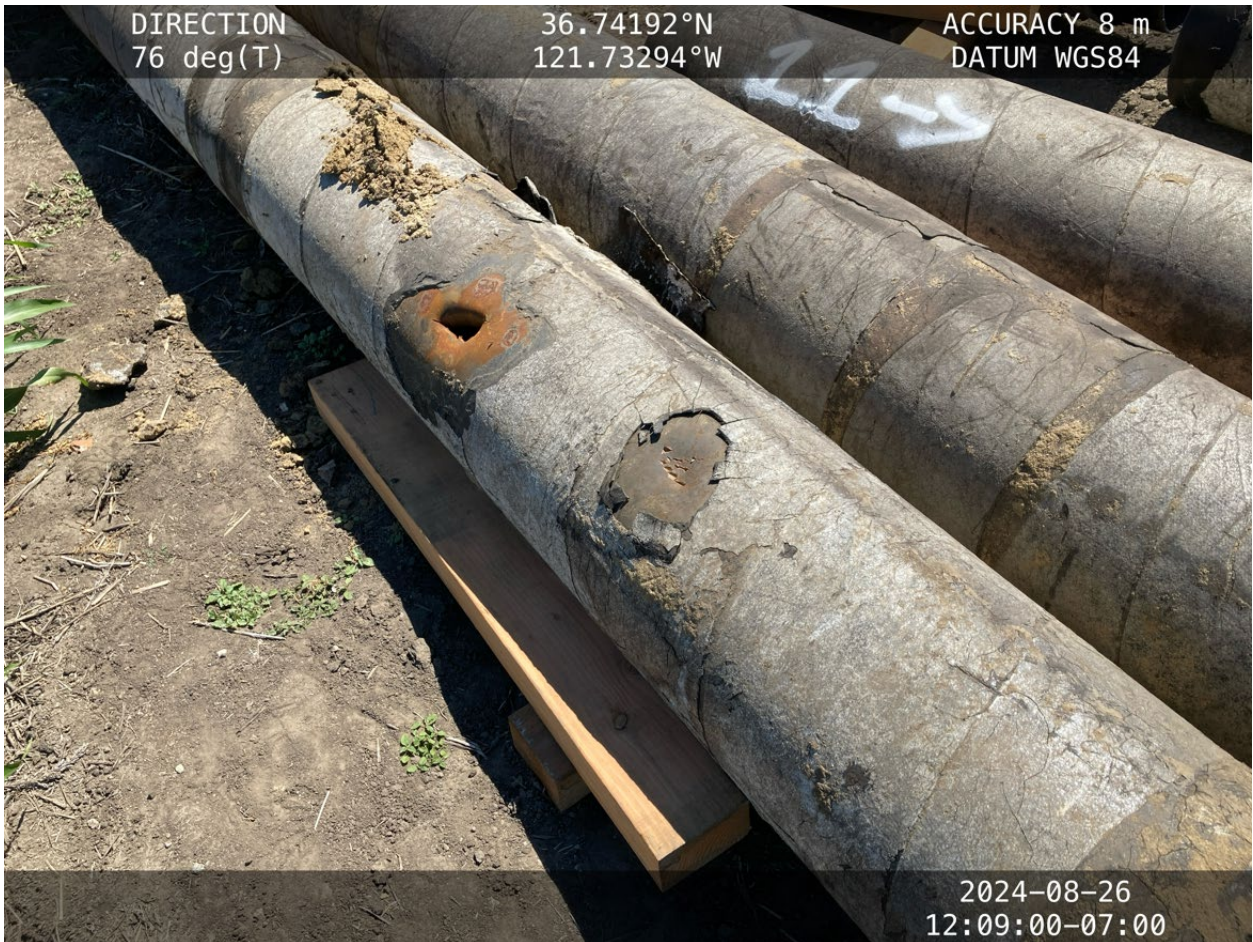
Figure 4. Photo of the impact site after the pipe was removed

UE visited the site again. Observed damaged pipe removed from ground. Took photos of damaged sections and surveyed the location where the incident happened.
