San Bernardino Blizzard Incident Investigation Report

CPUC - SAFETY AND ENFORCEMENT DIVISION
GAS SAFETY AND RELIABILITY BRANCH

CPUC SED No. G20240531-3691

CPUC Report Date:	October 21, 2025
Investigators:	Randy Holter, Mahmoud Intably
Date incident reported to CPUC	February (23), 2023 Initial; May 31, 2024
Utility:	Southern California Gas Company (SoCalGas)
Date and Time of the Incident:	02/24/2023, 0600 Hours
Location of the Incident:	Lake Arrowhead, Running Springs, Twin Peaks, Rimforest, San Bernardino County, California

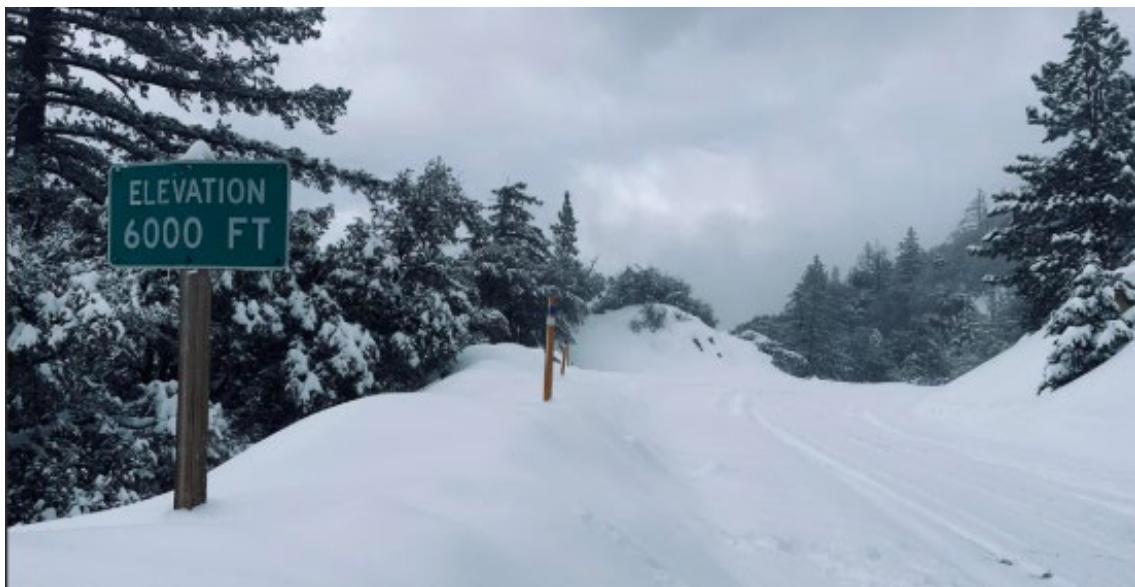
Figure 1. February 23, 2023, State Highway 18 near Rim Forest, CA

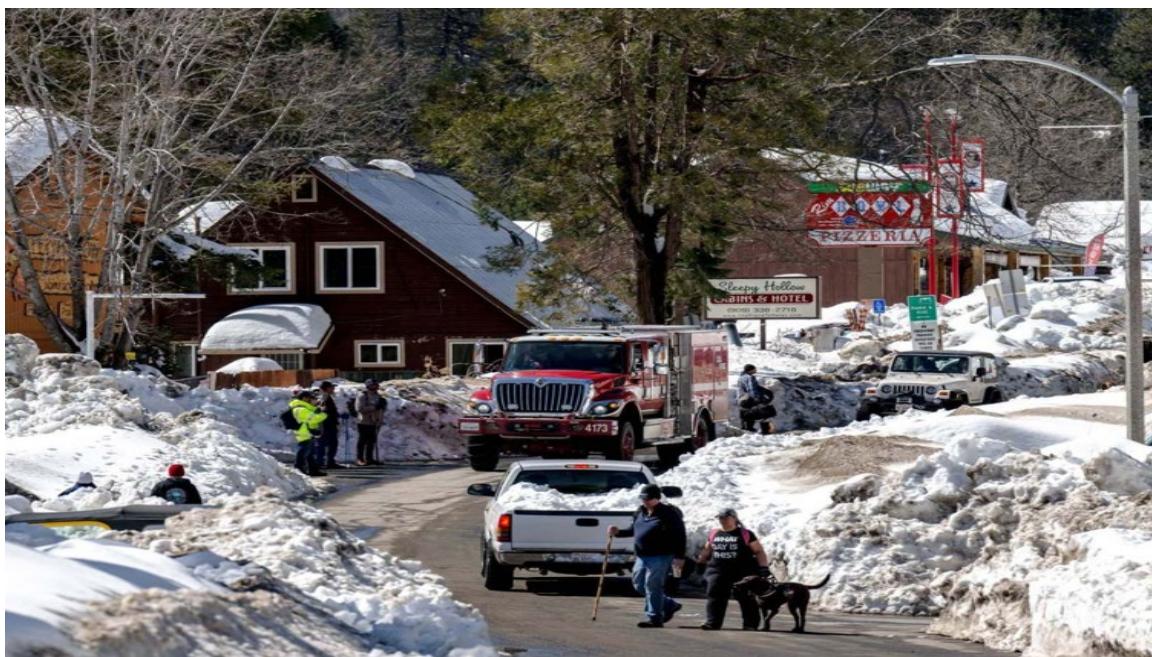
Figure 2. Lake Dr., Crestline, March 15, 2023, after being opened by CalTrans.

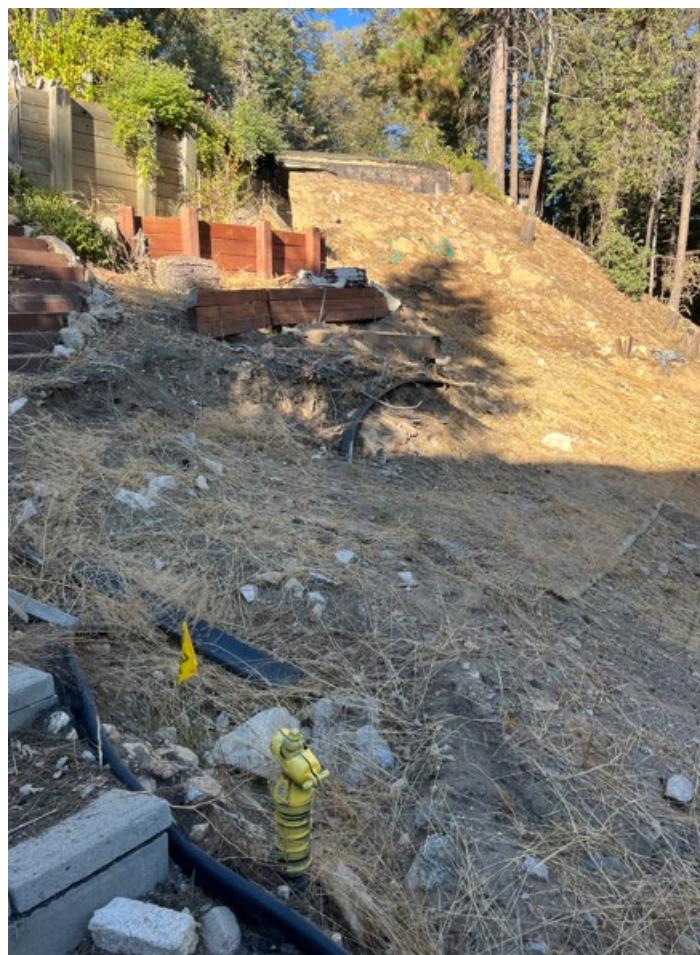
Figure 3. SoCalGas removed MSA from service and locked service riser at [REDACTED] Augusta Drive, Lake Arrowhead

On March 4, 2023, SoCalGas' Crews arrived on the scene at [REDACTED] Augusta Drive, Lake Arrowhead. There were no road closures nor evacuations. There were no injuries or fatalities reported. SBCFD reported to SoCalGas that there was a structure fire caused by downed power lines and SoCalGas facilities were not affected by this fire. SoCalGas conducted a post incident leak investigation at the MSA, along the SoCalGas gas service line, and found zero gas indication.

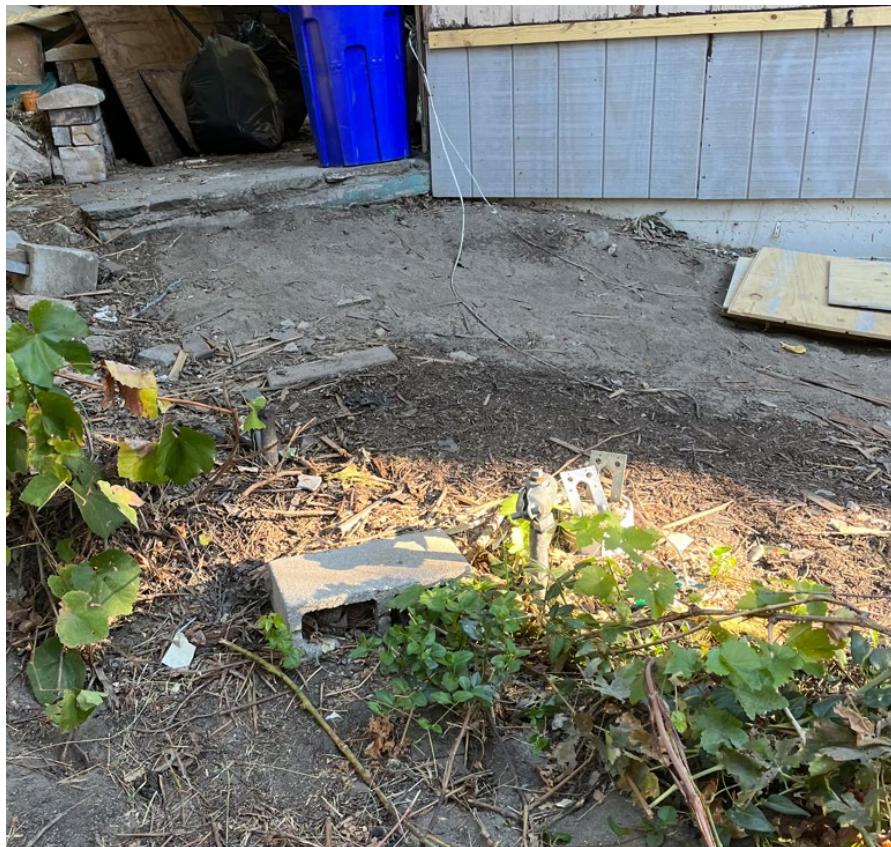
Figure 4. SoCalGas removed MSA from service and locked service riser at █ Bear Springs Road, Rimforest.

On March 2, 2023, SoCalGas' Crew arrived on the scene at 1171 Bear Springs Road, Rimforest. There were no fires, no police, no road closures or evacuations. There were no injuries or fatalities reported. SBCFD reported to SoCalGas that customers' deck collapsed due to the weight of snow, shearing off the house line, causing damage and a release of gas. SoCalGas' Crew shut off stop cock/valve to meter and locked service. The last recorded customer service order was for 10/28/2022 regarding an inoperative furnace. SoCalGas conducted a post incident leak investigation at the MSA below ground where service would run underground and found zero gas indication.

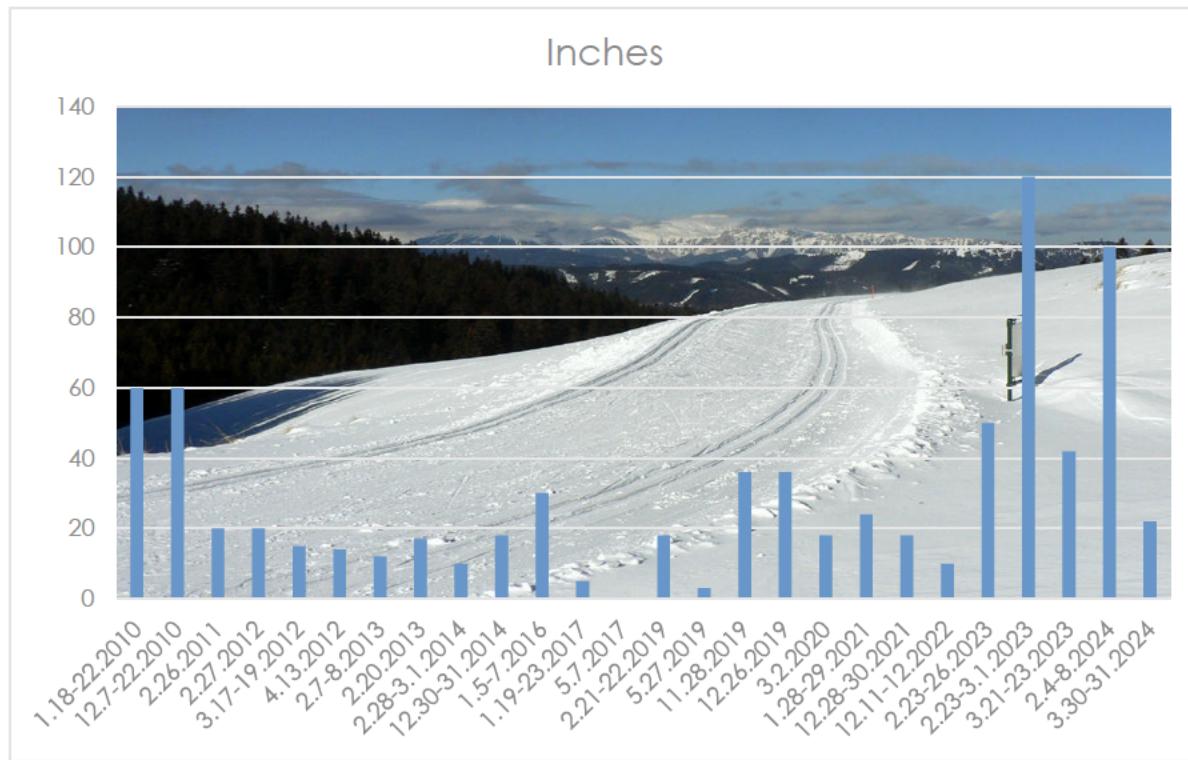
Figure 5. Comparative snowfall chart showing the unprecedented February-March 2023 snowfall - National Weather Service, San Bernardino County

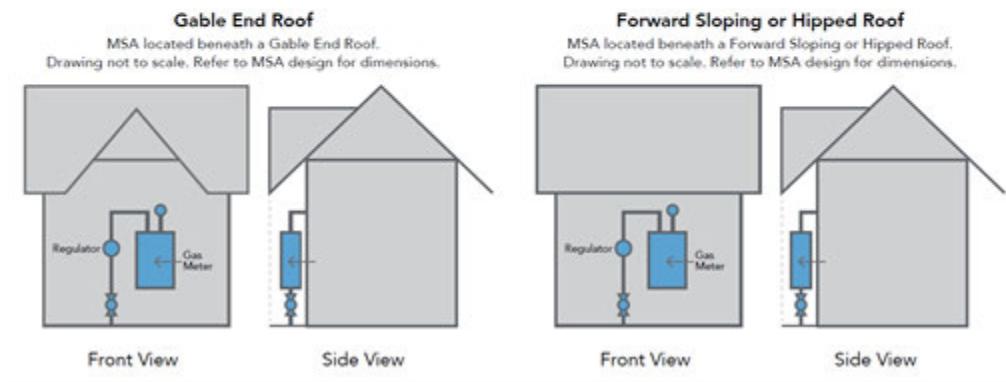
FIGURE 15 - Meter Locations — Impacted by Snow

- This applies to all MSA locations above 3,500 ft in elevation or where snow or ice buildup can be expected.
- Gas meters should be located such that potential damage from falling ice, snow, snow accumulation and other objects is minimized. Preferred locations include, but are not limited to:
 - Locate the MSA on a wall beneath the gable end, forward sloping or hipped roof.
 - Fully locate the MSA within the roof's overhang (eave).
 - Center the MSA as practicable within the roof's overhang (eave).
- For other recommendations, please contact SoCalGas planning department.

- 4.1.7. Gas meter locations impacted by snow and/or ice for new installations and/or meter relocation requests.
 - 4.1.7.1. Gas meters should be located such that, it limits the potential damage from falling ice, snow, snow accumulation and other objects. Preferred locations include but not limited to:

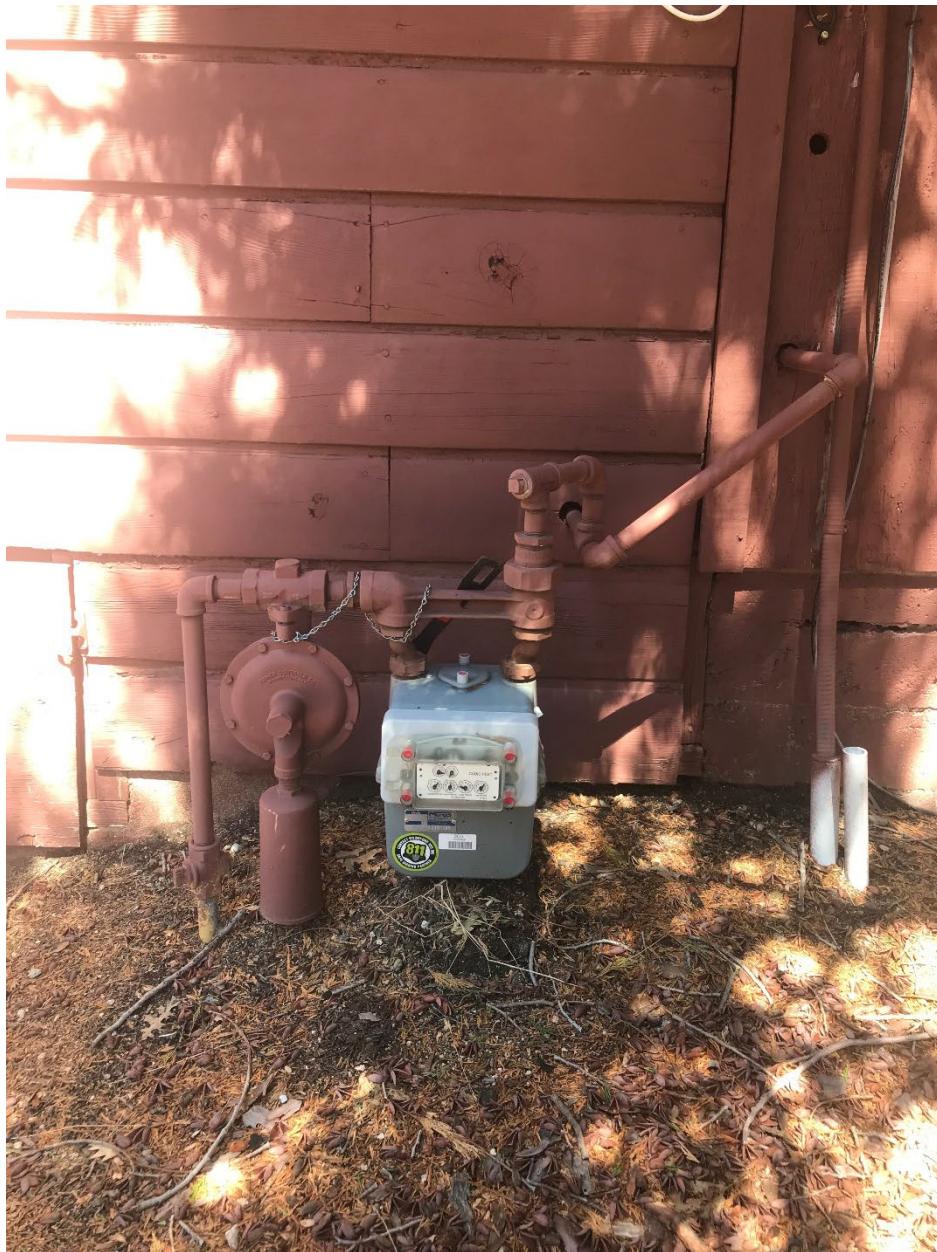
Rim Forest district is now installing snow bars on residential sized meters to reinforce the Meter Set Assembly (MSA) during projects that require the rebuilding/resetting of gas meters in the mountainous areas. See picture below for an example of a snow bar installation across the service and custom side of the MSA. (A copy of the complete document may be found in the adjoining SED folder “G20240531-3691-DOT1400498-RH3-Final Appendixes”).

- SoCalGas stated that the Rim Forest Distribution District is now installing support bars to the houseline on the MSA to protect against damage from heavy snow. This strengthens the MSA during falling snow to prevent the service line connecting nipple and customer side house line from being sheared off in heavy snow conditions. The integrity of the riser and MSA pipe is key to eliminating gas build-up under snow more than five feet that accumulates under the eaves of residential structures.
