CPUC SUBSTATION AUDIT FINDINGS

PG&E Pismo Beach Headquarters

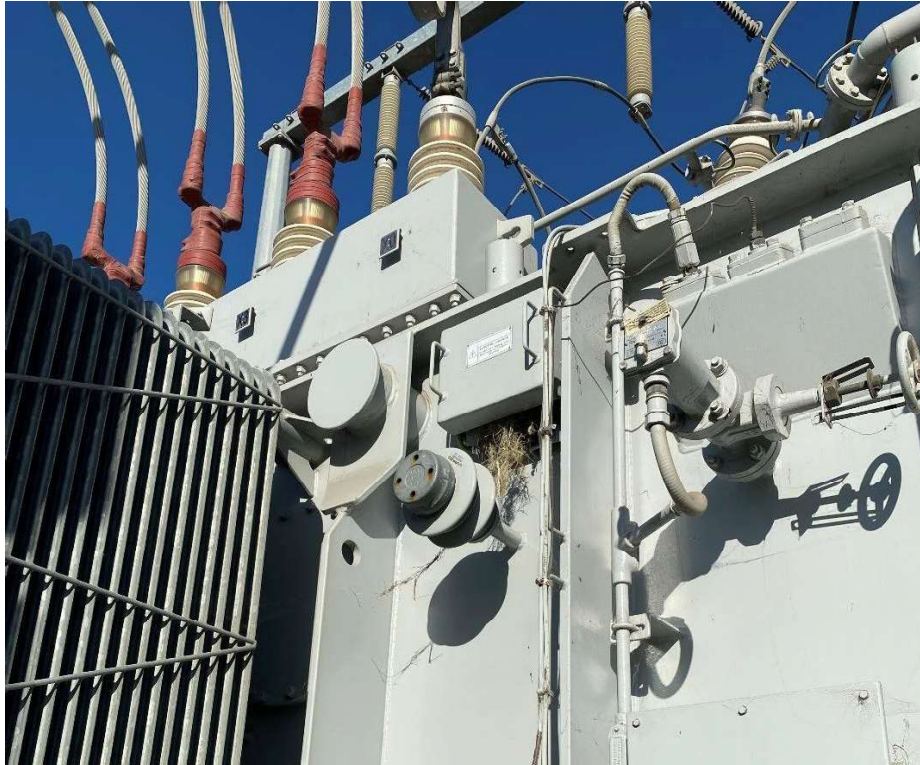
- 1.1. There are bird nests on Transformer Bank 2. PG&E has existing Notification #126370460 for this issue.

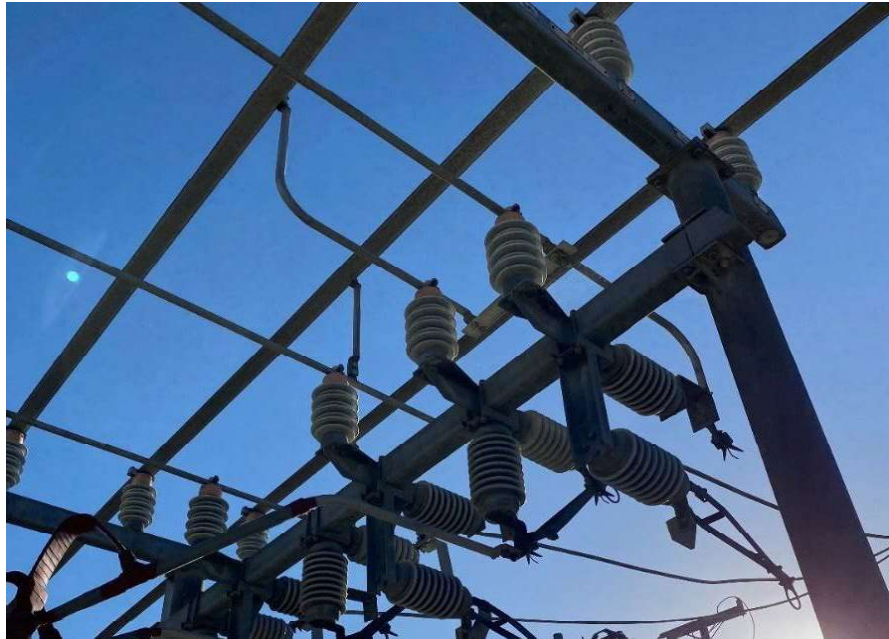
- 1.2. The insulators throughout the substation are dirty. PG&E has existing Notification #126730044 for this issue.

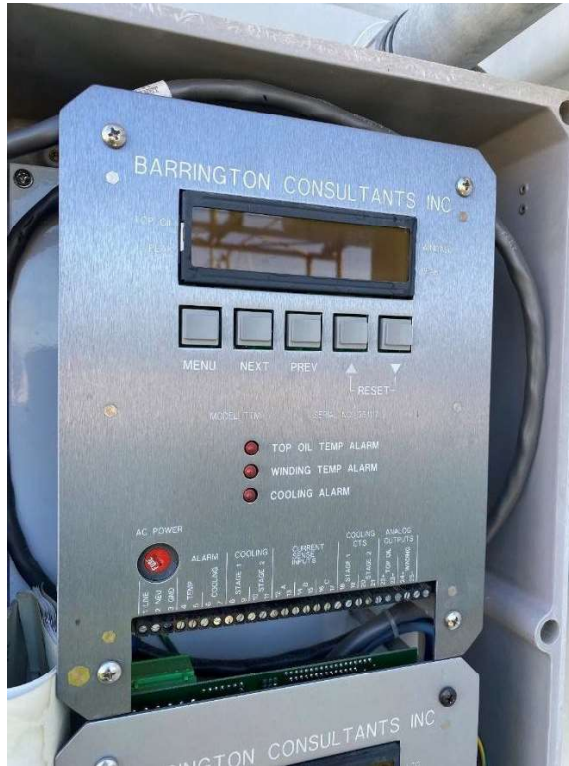
- 2.1. The display screen on the temperature monitor is damaged. PG&E has existing Notification #124514393 for this issue.

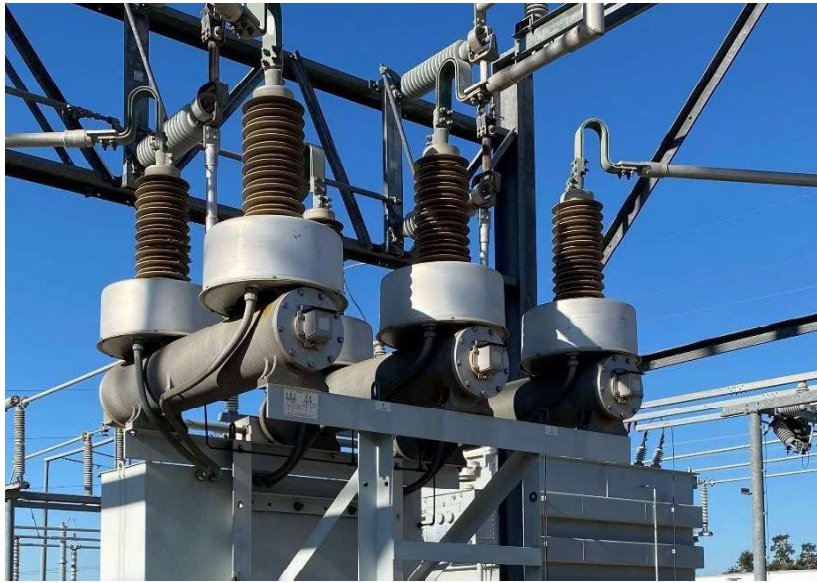
- 2.2. The insulator bushings for Circuit Breaker (CB) 22 have moss growing on them. PG&E has existing Notification # 128726581 for this issue.

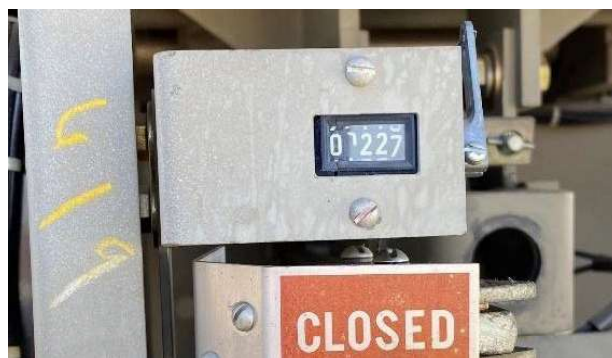
- 2.3. The counter on CB 2111/2 is faded. PG&E has existing Notification #129655496 for this issue.

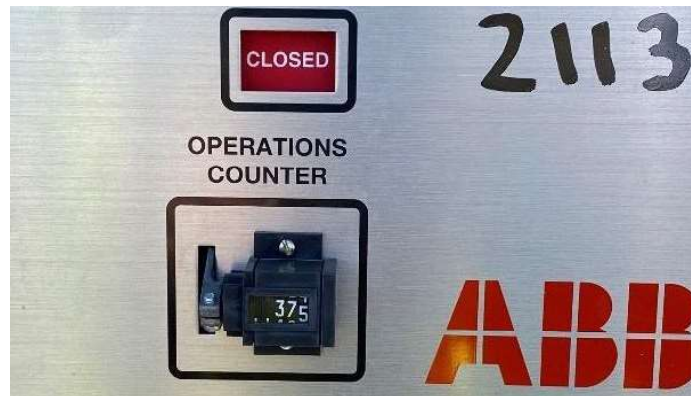
- 2.4. The counter on CB 2113/2 is faded. PG&E has existing Notification #126878033 for this issue.

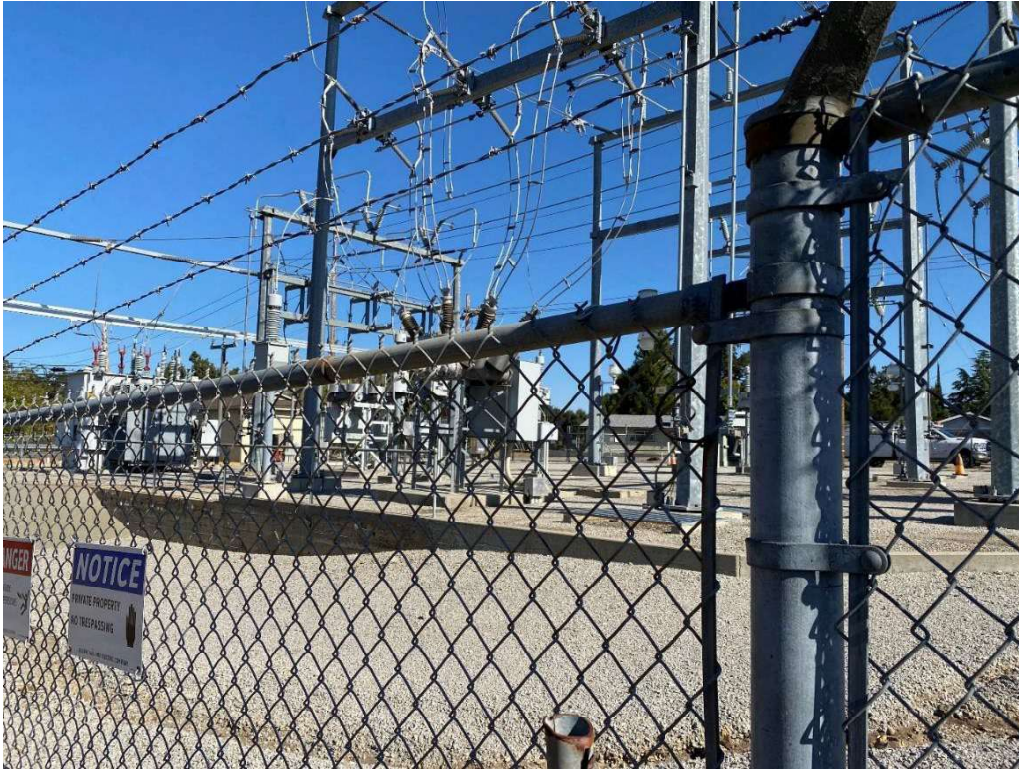
- 3.2. One of the bushings on Transformer 1 is damaged. PG&E has existing Notification #128243310 for this issue.

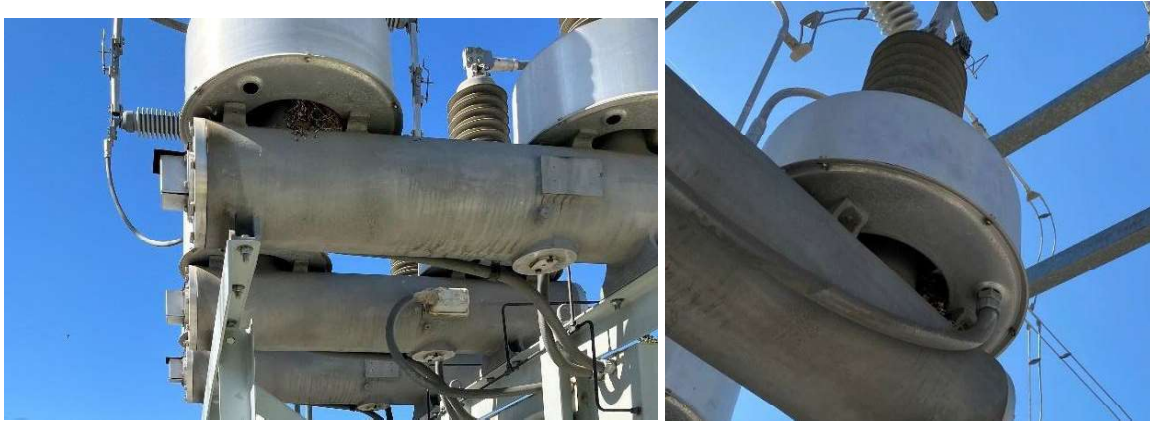
3.3 There are bird nests underneath the current transformers on CB 12 (left) and CB 32 (right). PG&E has existing Notification #129670237 for these issues.

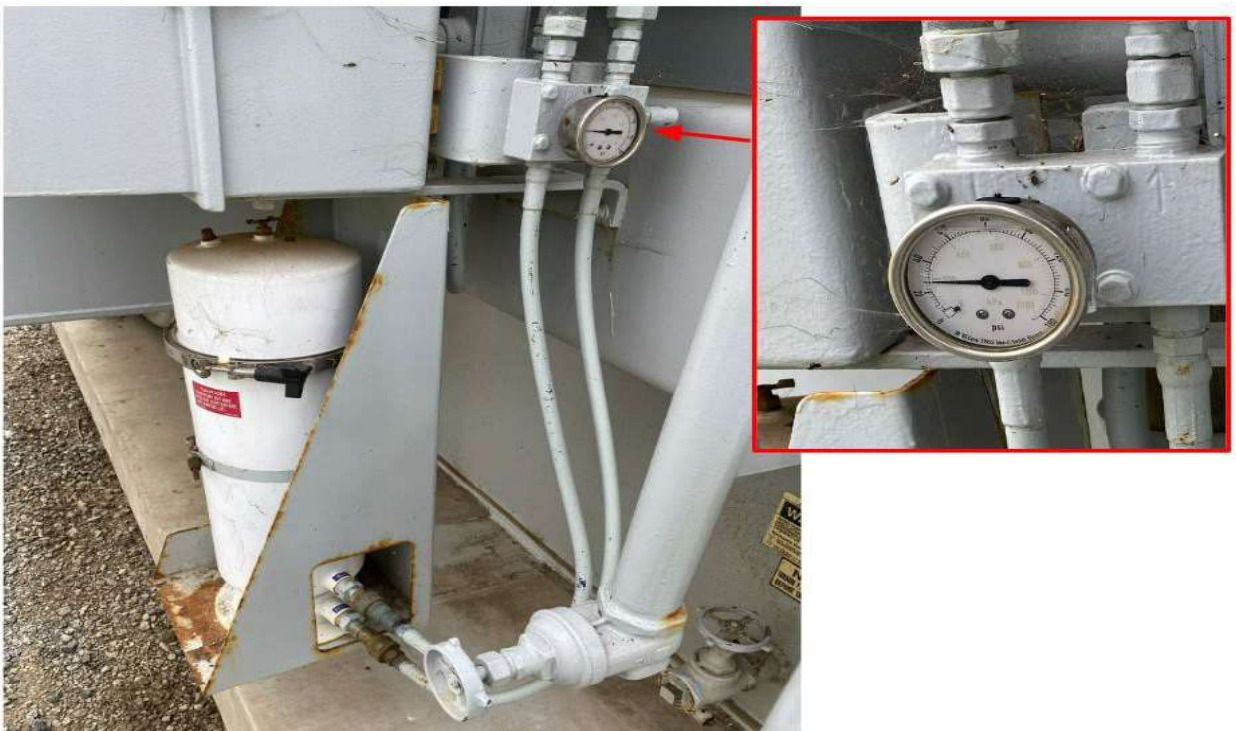
4.1. The transformer oil filter is approaching its replacement threshold of 30 psi. PG&E has existing Notification #128436108 to replace the oil filter.

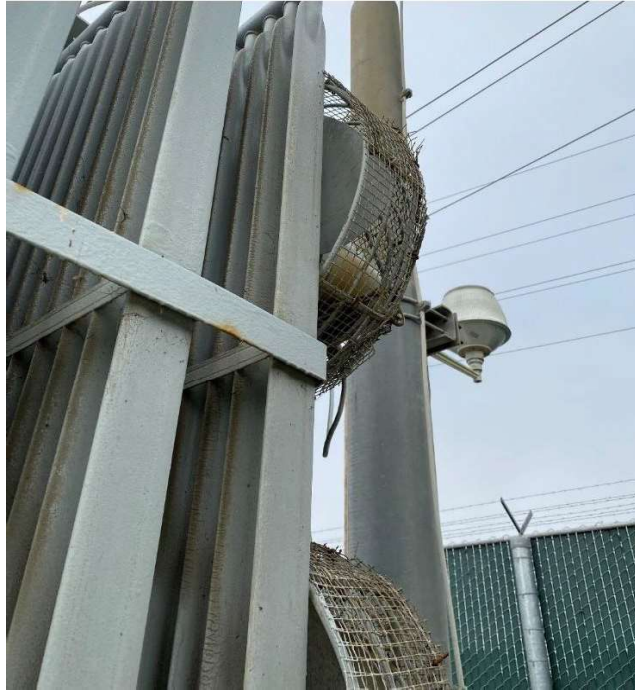
- 4.2. The top cooling fan on Transformer 21 could not start automatically and required manual assistance to start rotating. Additionally, there are large gaps in the fan blade covers that can expose workers to hazards. PG&E immediately created the Notification #129692075 to address the issue.

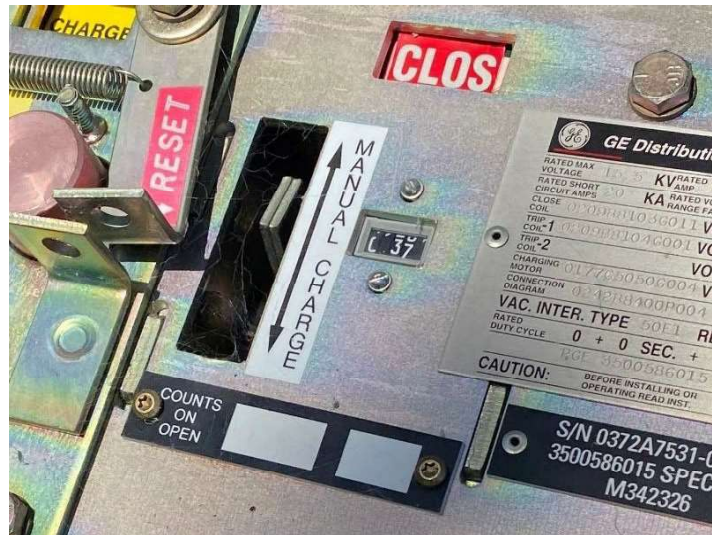
- 5.2. The counter on CB 1102/2 is faded. PG&E has existing Notification #124782774 for this issue.

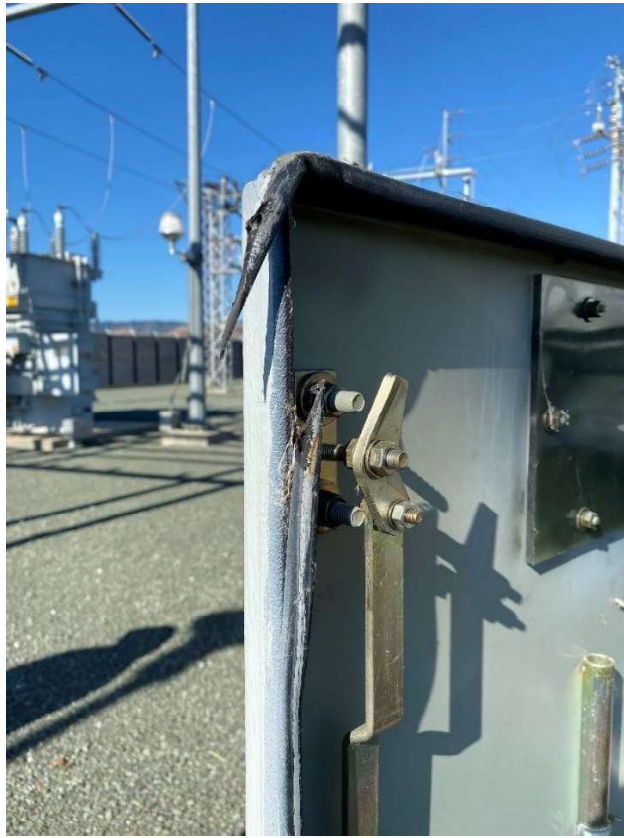
- 5.3. The weather stripping around the cabinet door on CB 1102/2 is damaged and needs to be replaced. PG&E immediately created the Notification #129692076 to address the issue.

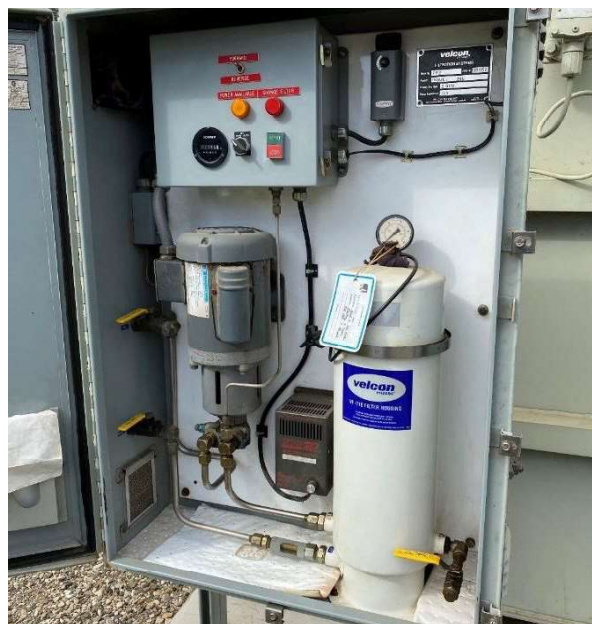
- 7.1. The Load Tap Changer (LTC) Oil Filter Pump has been out of service since October 27, 2022, due to a leak. PG&E has existing Priority F Notification #124791416 for this issue. Although this Notification is not out-of-compliance yet, PG&E must repair the leak when practicable to ensure the oil in the LTC is being filtered and maintained properly.

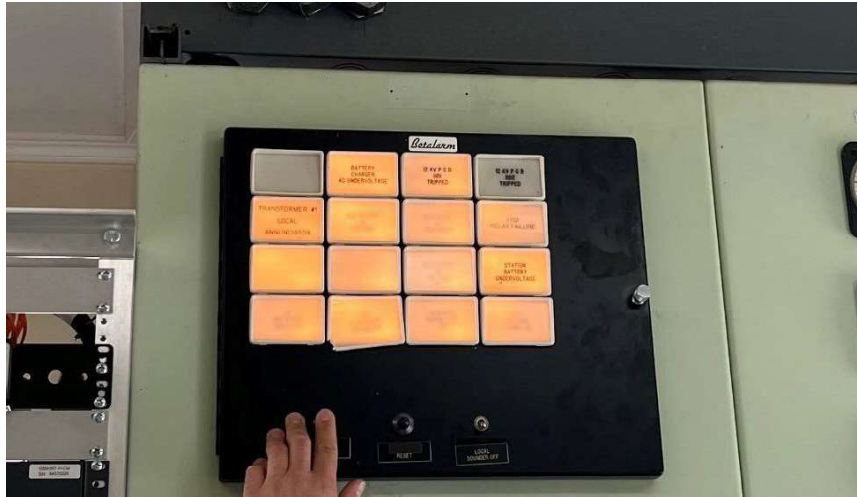
- 8.1. The light for the “12 KV PCB 1102 TRIPPED” indicator on the station annunciator panel is burned out. PG&E has existing Notification # 129659693 for this issue.

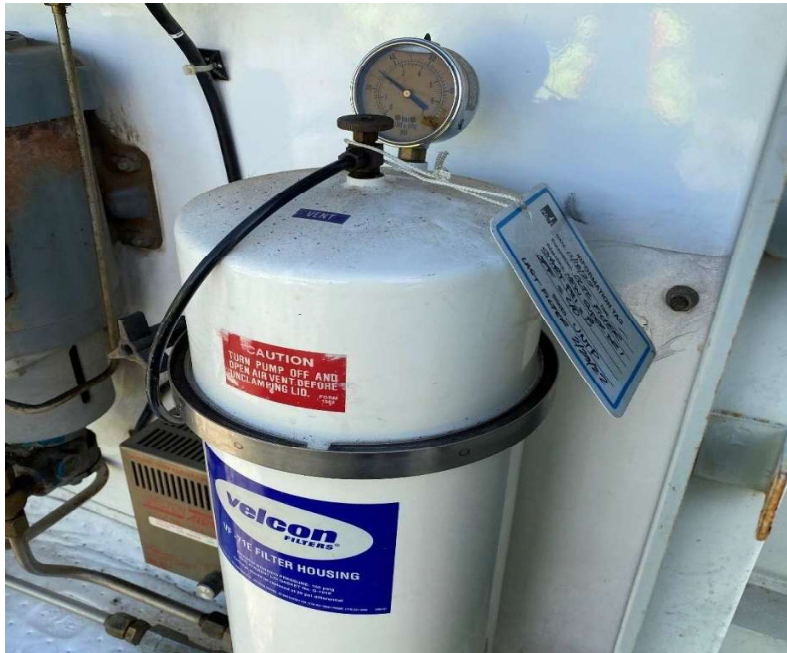
- 8.2. The LTC oil filter is at its replacement threshold of 30 psi and needs to be replaced.

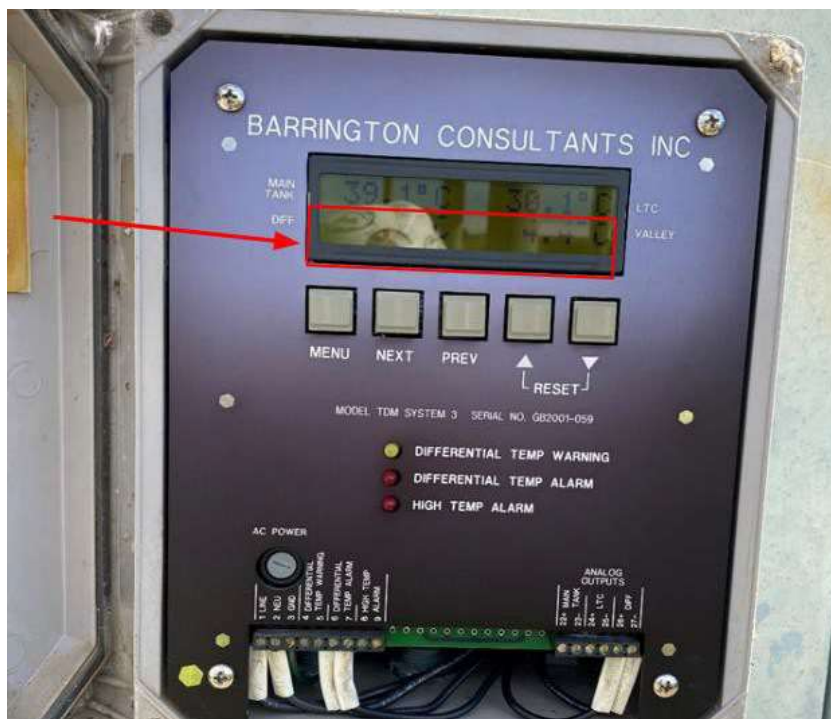
- 8.3. The bottom row of the display screen for the transformer oil temperature monitor is damaged and makes reading the values difficult.

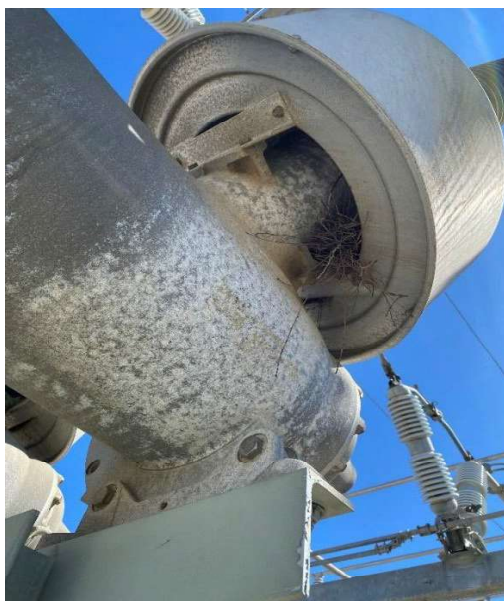
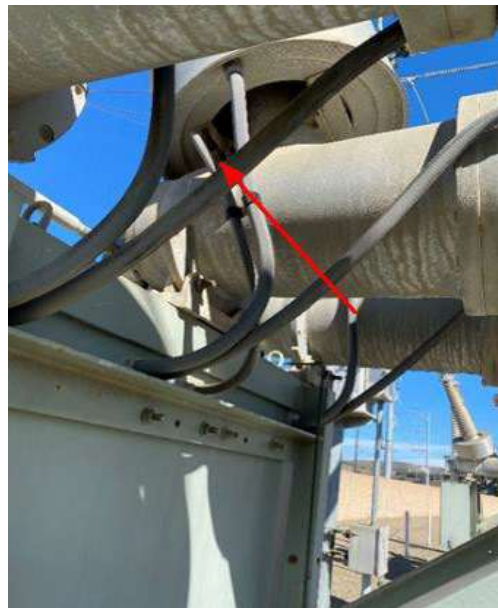
- 9.1. There are bird nests under CB 152 (left) and CB 122 (right). PG&E has existing Notification # 129658296 for these issues.

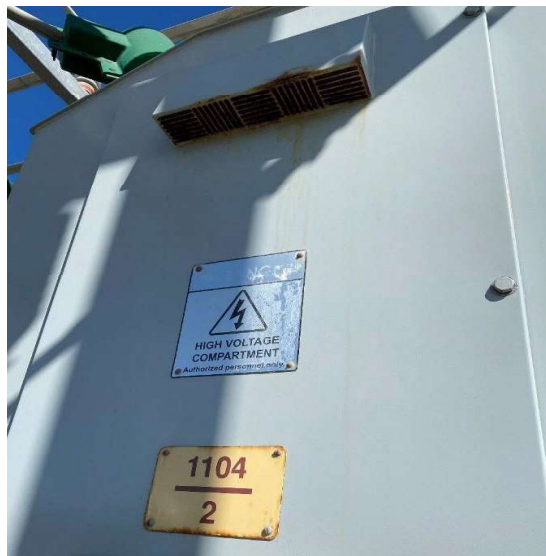
- 9.2. CB 1104/2 is showing evidence of corrosion. PG&E has existing Notification #127388956 for this issue.

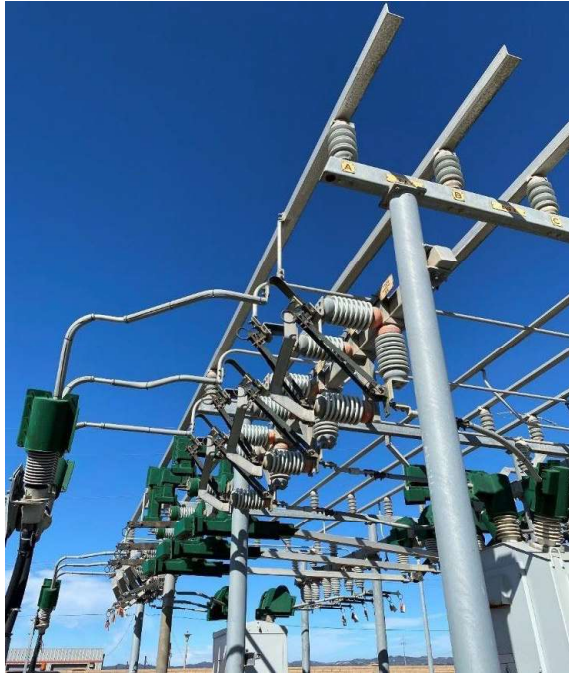
- 9.3. The 12kV Bus 2A is loose at one of the insulator supports and is making an audible buzzing noise.

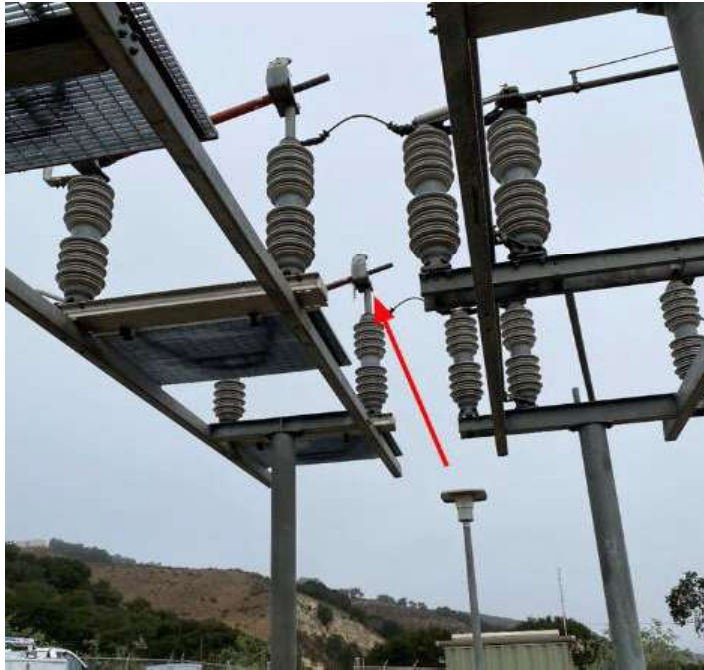
- 10.1. The high-side A phase fuse holder has a bird nest. PG&E has existing Notification #129669639 for this issue.

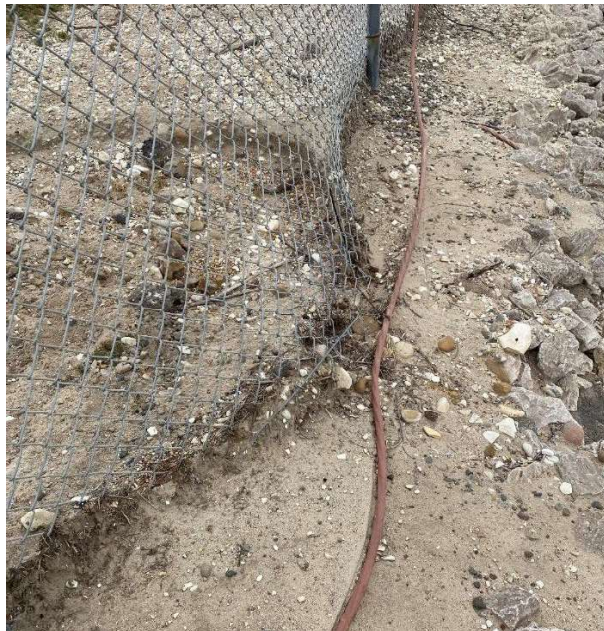
10.2. The substation's perimeter fence is being affected by washout and erosion. PG&E has the existing Capital Project #74051741 for this issue.

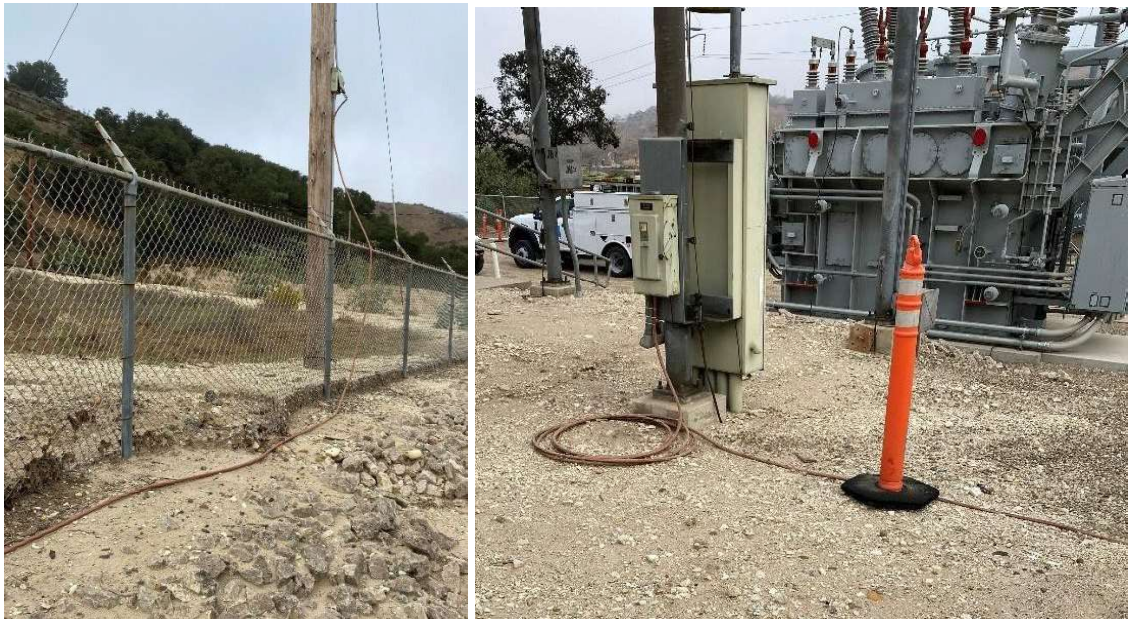
- 10.3. There is a station service power cable running throughout the substation. PG&E has existing Notification #128225301 to remove the cable.

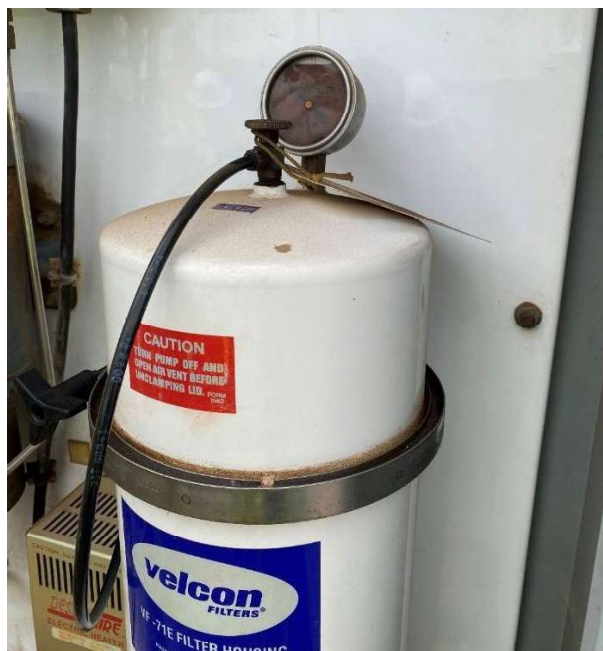
30 psi. PG&E has existing Notification #127576246 to replace the oil filter.

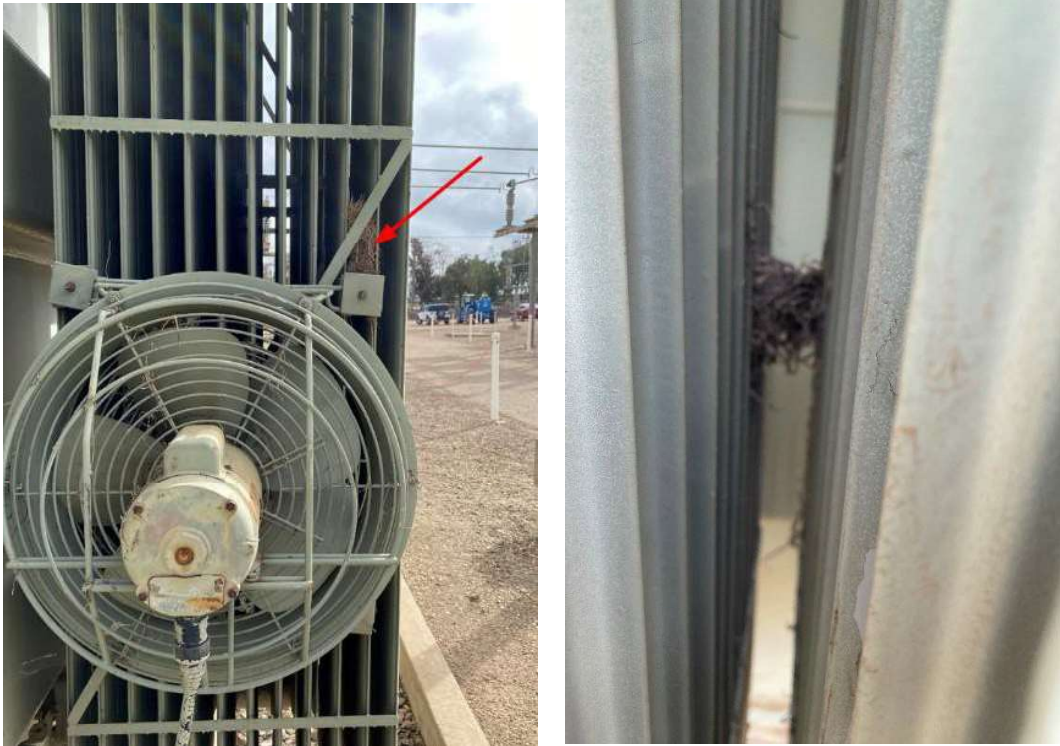
- 11.2. There are abandoned bird nests and debris in the radiator fins on Transformer Bank
3. PG&E has existing Notification # 129670676 for this issue. During the audit, PG&E confirmed the bird nests were abandoned and cleaned debris out of the radiator fins.

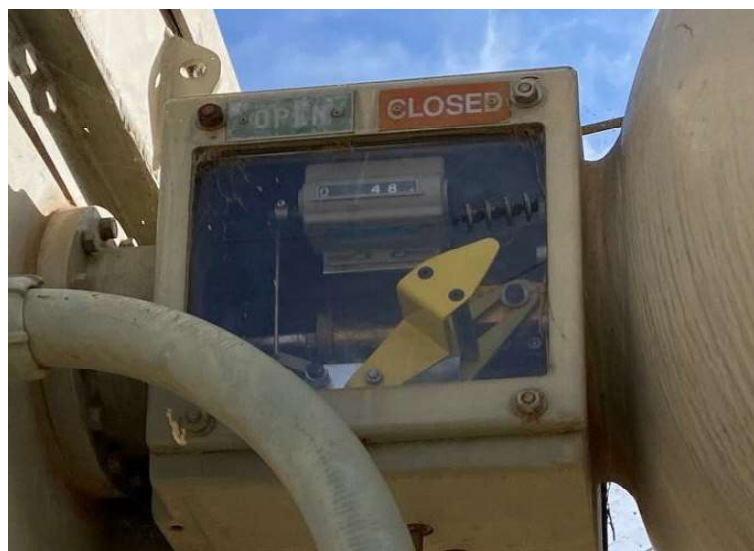
- 11.3. The counter on CB 152 is faded. PG&E has existing Notification #125554093 for this issue.

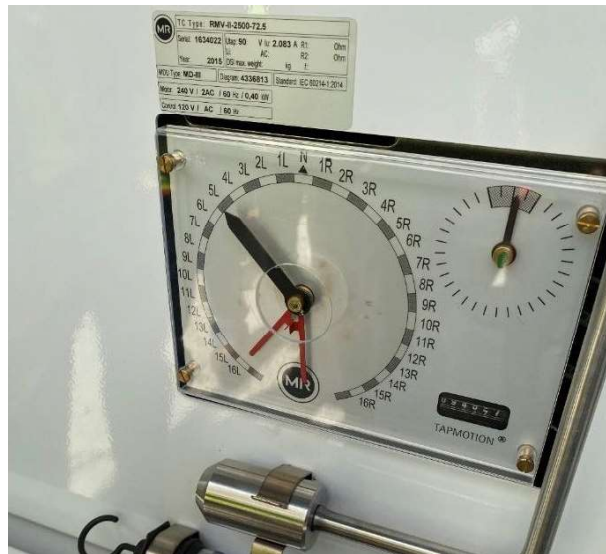
- 12.1. The upper limit (raise) drag handle on the Transformer Bank 2 LTC is loose. PG&E has existing Notification #129599623 for this issue.

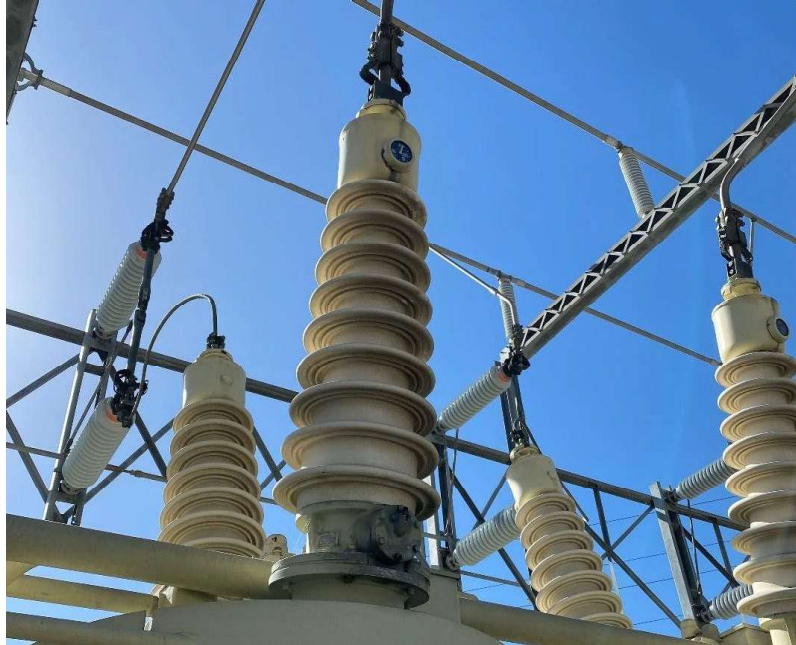
13.1 The oil level on the C Phase for Breaker 132 is high. PG&E has existing Notification #129670923 for this issue.

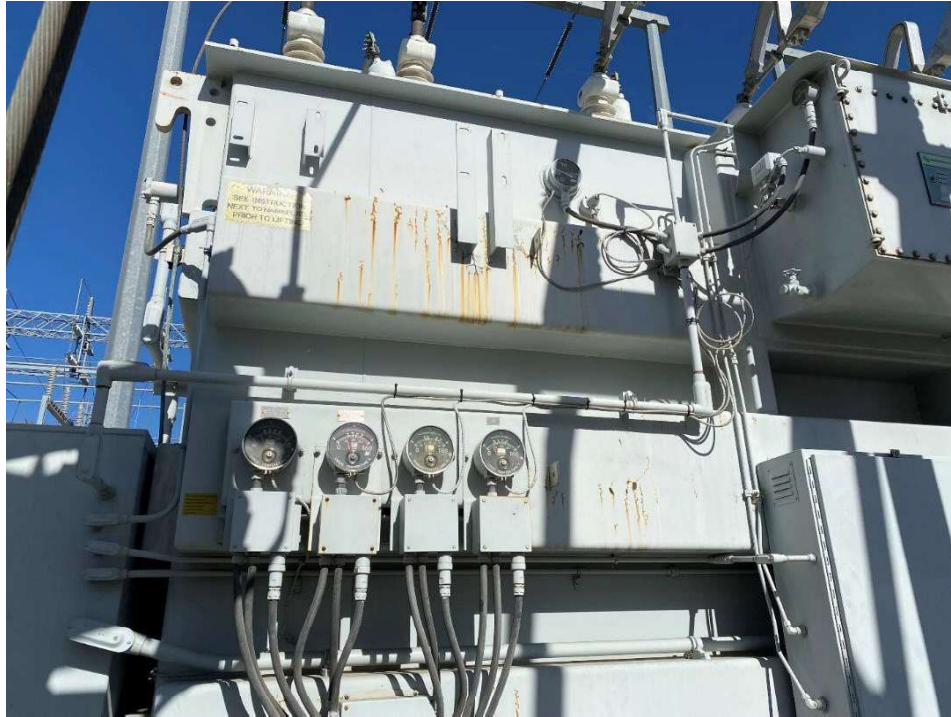
13.2 Transformer Bank 4 is beginning to corrode. PG&E has existing Notification #127195590 to paint the transformer.

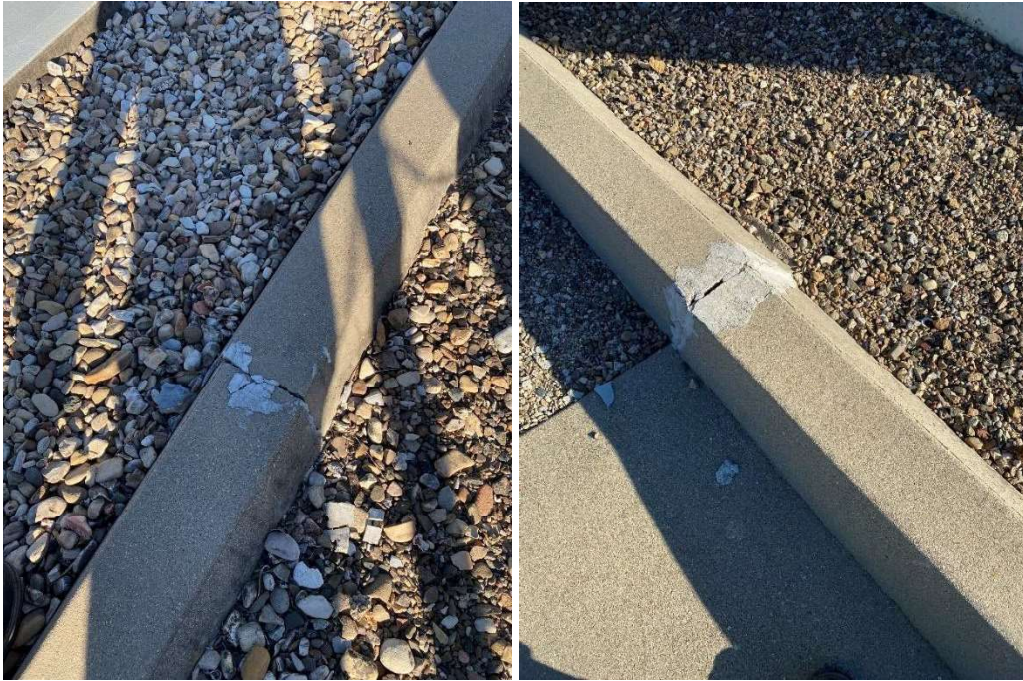
- 14.1. There are cracks in the secondary containment concrete berms around Transformer Banks 1 and 2. PG&E has existing Notification #129658915 for these issues.
