**Incident Investigation Report**

**Incident Number:** E20220901-01 (Border 32 Fire)

**Regulated Utility Involved:** San Diego Gas and Electric Company (SDG&E)

**Regulated Utility Facilities Involved:** Circuit 157 12kV Distribution Circuit originating from Barrett Substation

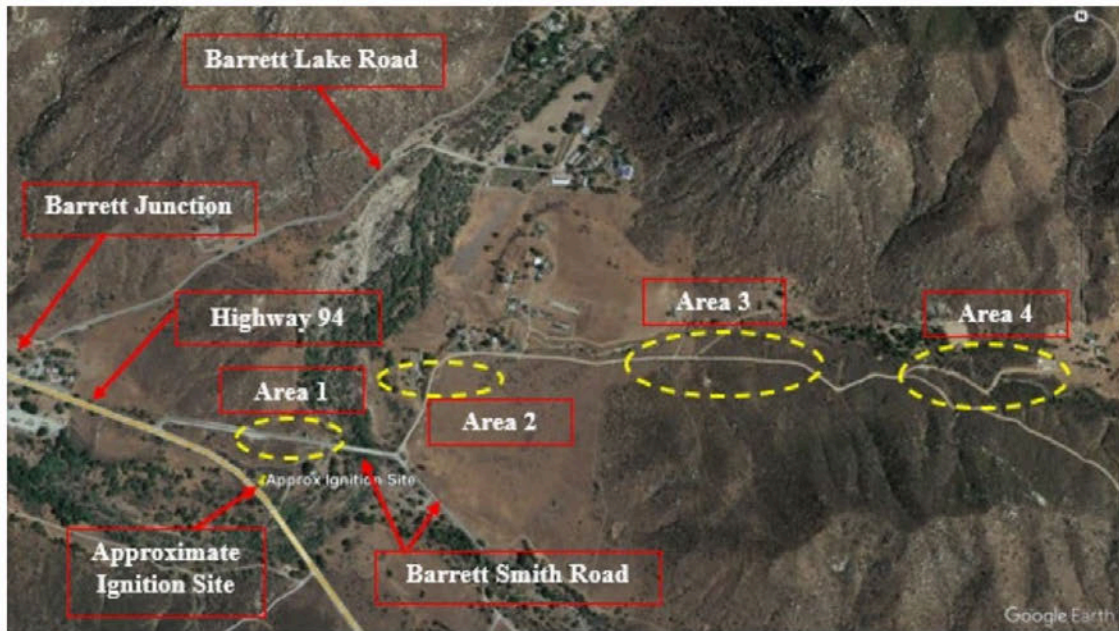
Figure 2: Areas where electric power poles were damaged by the fire. Google Earth

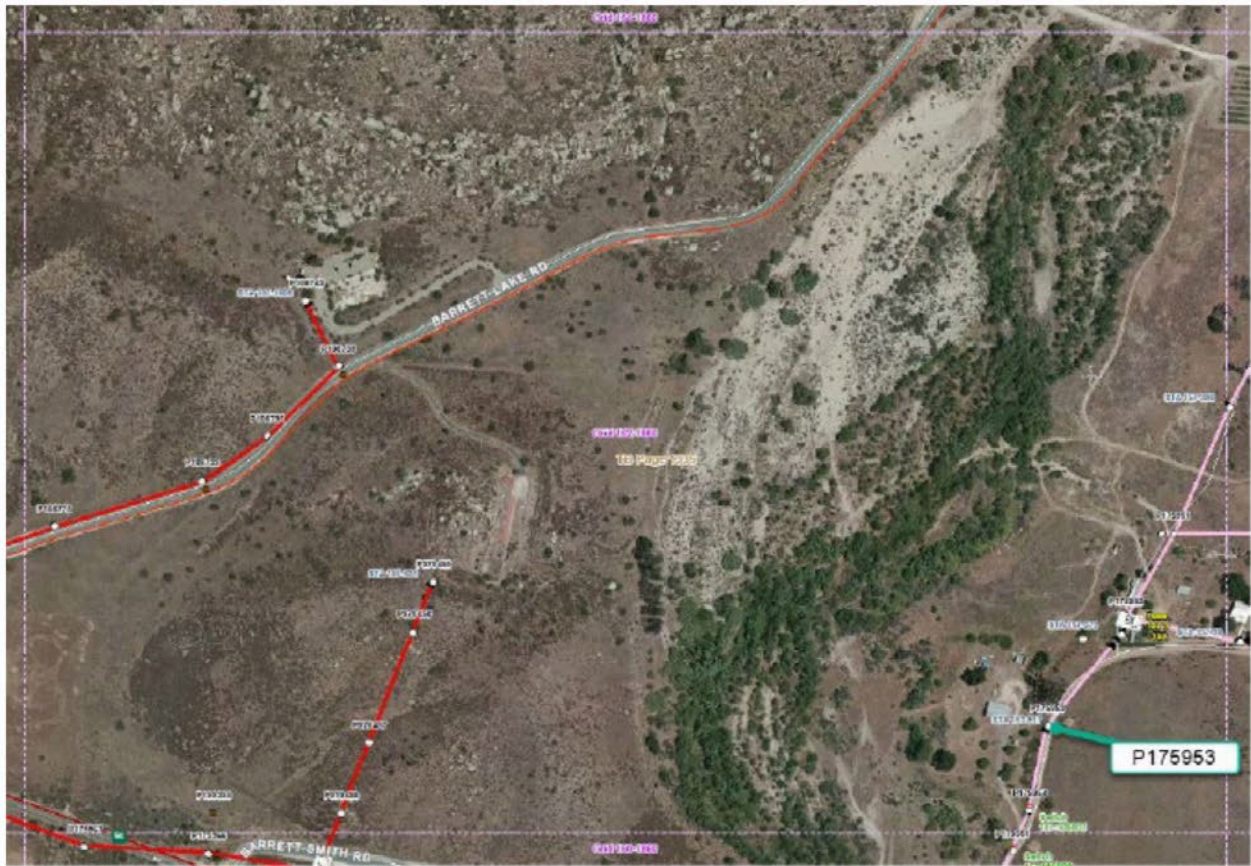
Figure 4. Detailed map of Area 2.<sup>8</sup>

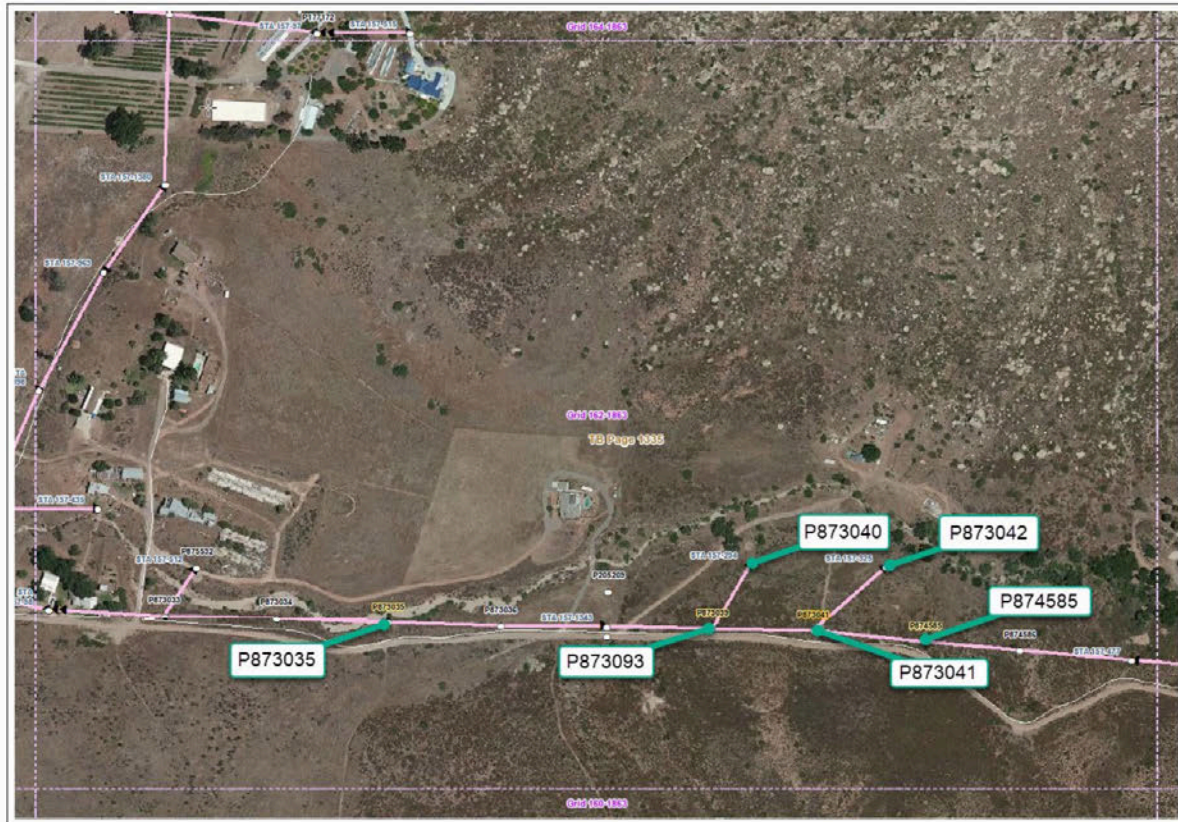
Figure 5: Detailed map of Area 3.<sup>9</sup> P873039 (pole 873039) is incorrectly labeled as P873093 by SDG&E.<sup>10</sup>

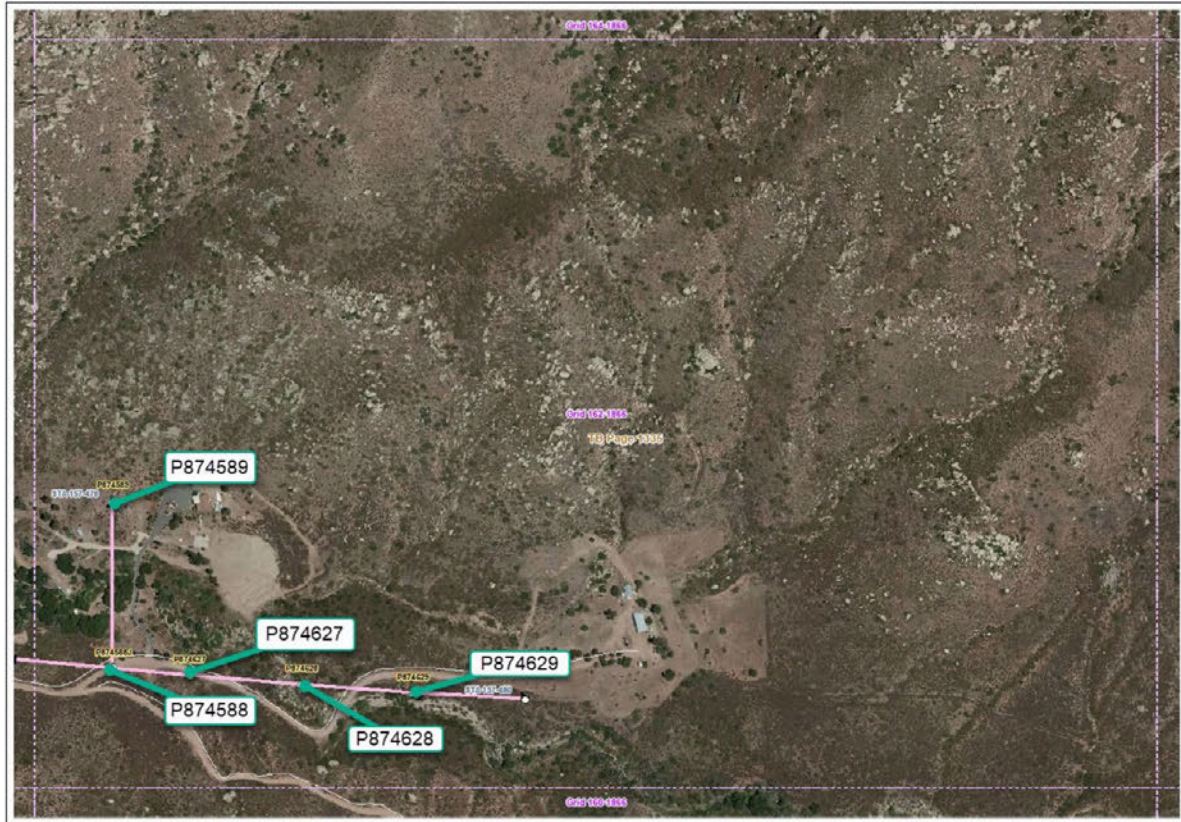
Figure 6: Detailed map of Area 4.<sup>11</sup>

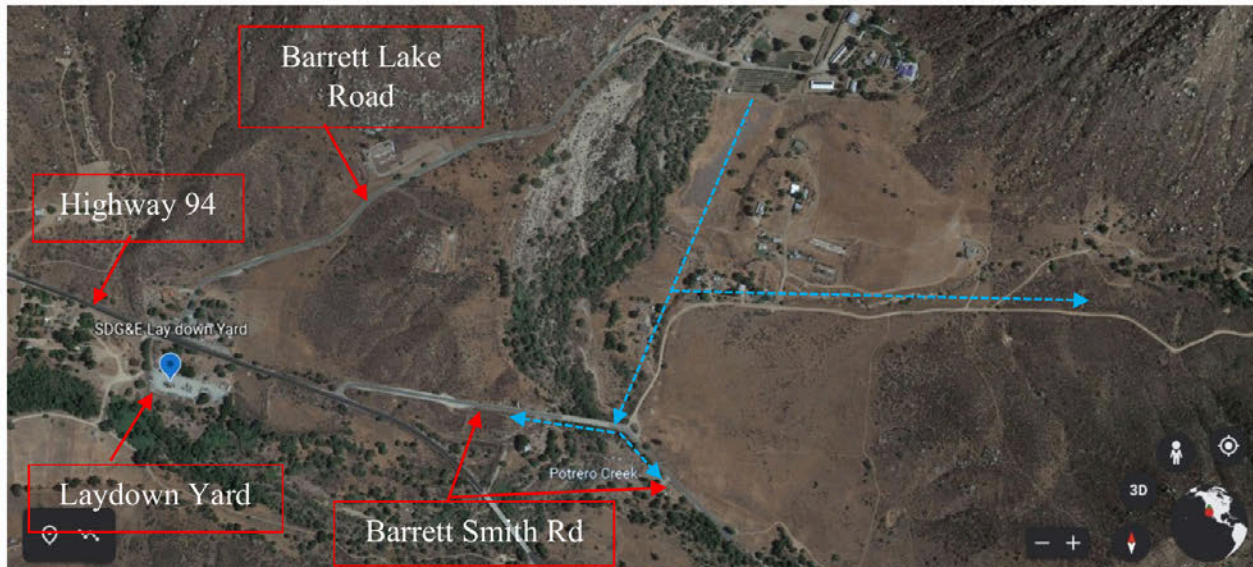
Figure 8. Map of the laydown yard shown by blue pin drop and approximate location of the power lines in the area indicated by light blue dashed arrows.

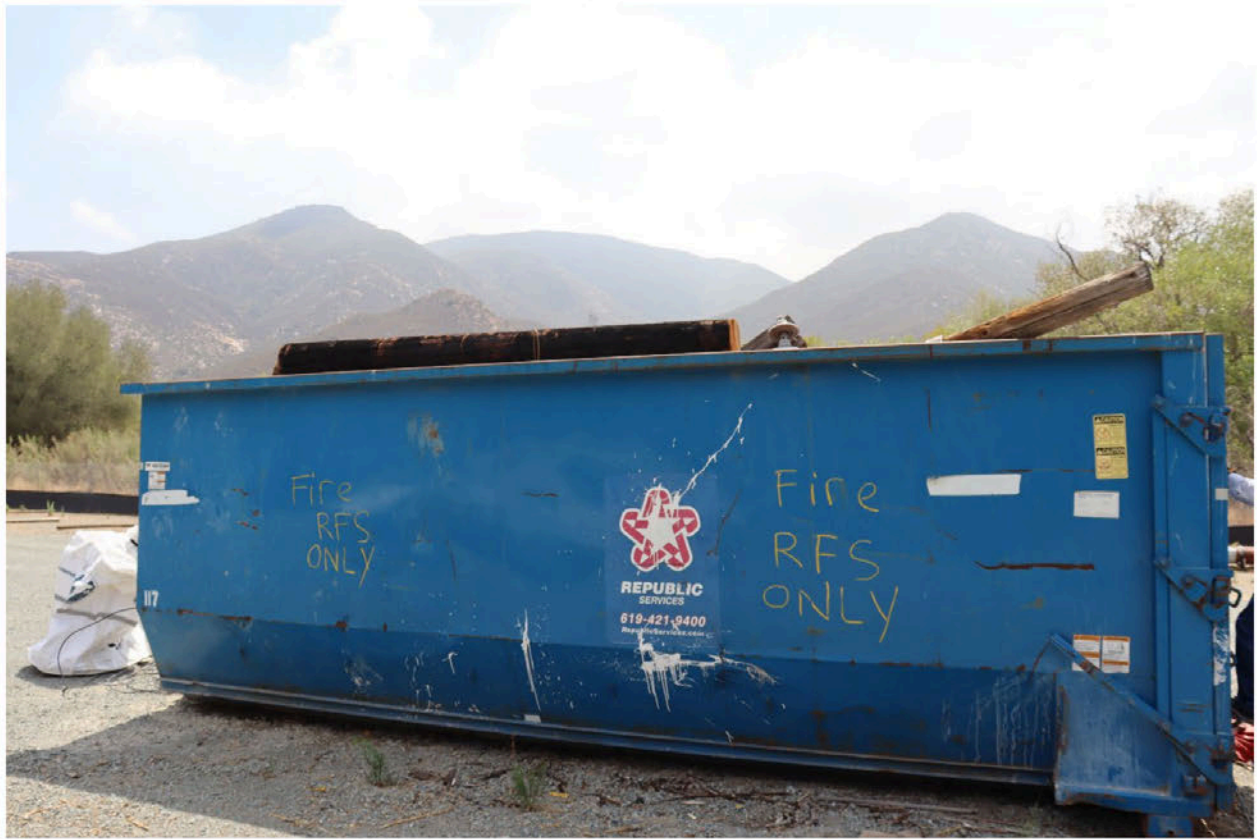
The electric supervisor said the replacement of 14 damaged poles began on September 1, 2022, and was completed on September 2, 2022. The electric supervisor stated that he attempted to find and gather the damaged poles and equipment after SDG&E had implemented restoration construction. Some of the damaged poles were stored in a 23-foot metal container labeled “RFS” (Removed From Service) in the laydown yard. (See Figure 9.) Inside the container, SED investigators observed segments of poles and cross arms, insulators, and wires. SED investigators observed that cross arms and other equipment had been separated from the poles, and that the poles were cut into segments.

Figure 9. The container in which some of the damaged equipment was stored.

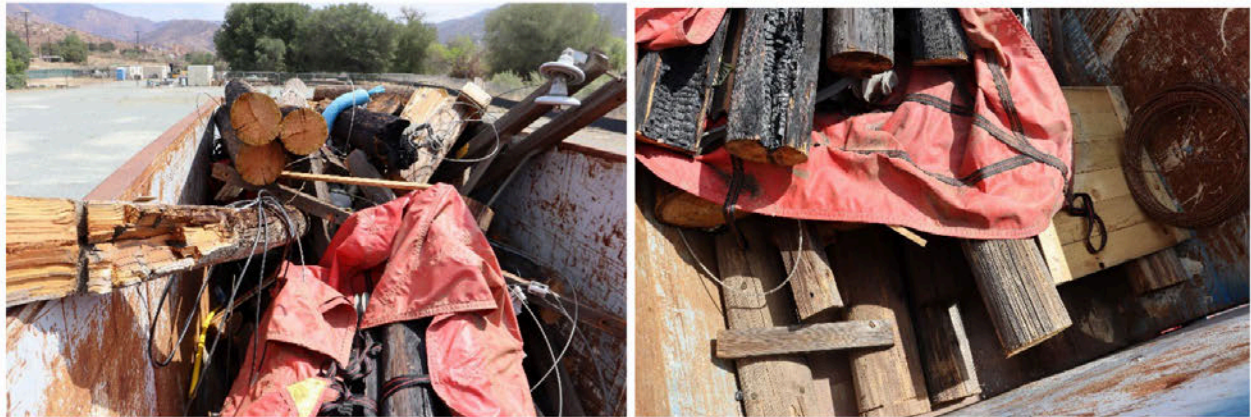
Figure 10. Pole segments, cross arms, and other equipment inside the container.

Some of the damaged poles had been gathered and stored in the container at the laydown yard. However, because these poles had been cut up into segments and stacked on top of one another in a container, with the attached equipment<sup>29</sup> removed, it was not possible for SED to access them or to identify the poles. Further, SDG&E did not properly preserve evidence related to the Incident when it gathered and stored unidentified segments of wires. In addition, even if SED could have accessed and identified the equipment, the equipment was extensively modified which reduced or destroyed the value of the equipment as potential evidence. Thus, SDG&E's failure to preserve and store evidence in a manner as to provide SED access to inspect the evidence violates GO 95, Rule 19 in addition to SDG&E's practice and procedure.
