Pole Brushing 2021

557274E, Approved, Standard Environmental Requirements

On Thursday, February 10, 2022 at approximately 4:10 a.m., a wildland fire that would become known as the Emerald Fire was reported near 1425 Emerald Bay in Laguna Beach, CA 92651. The Emerald Fire consumed approximately 145.8 acres of natural vegetation and there was no reported third-party damage.

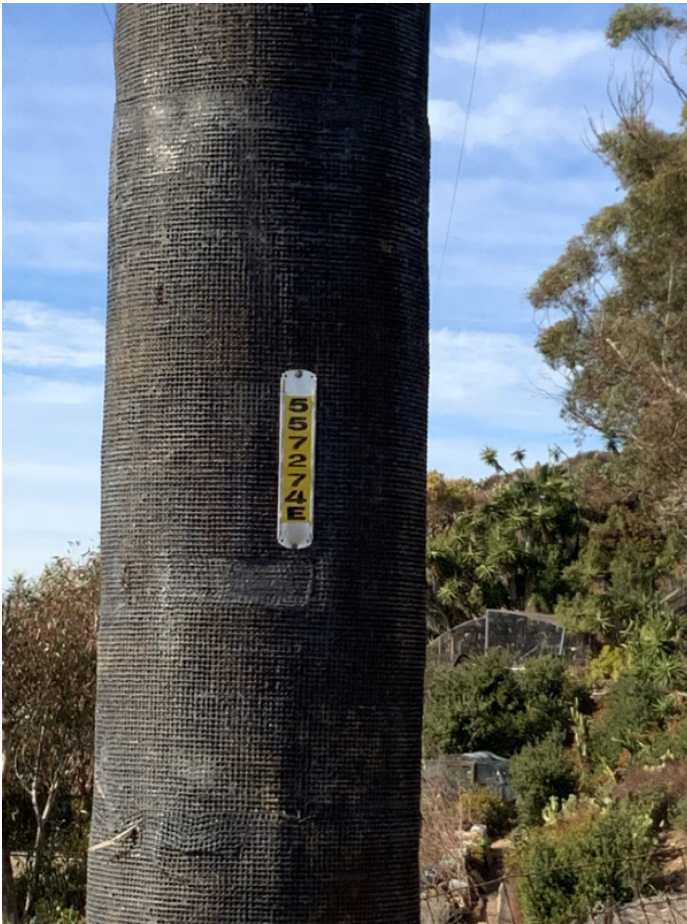
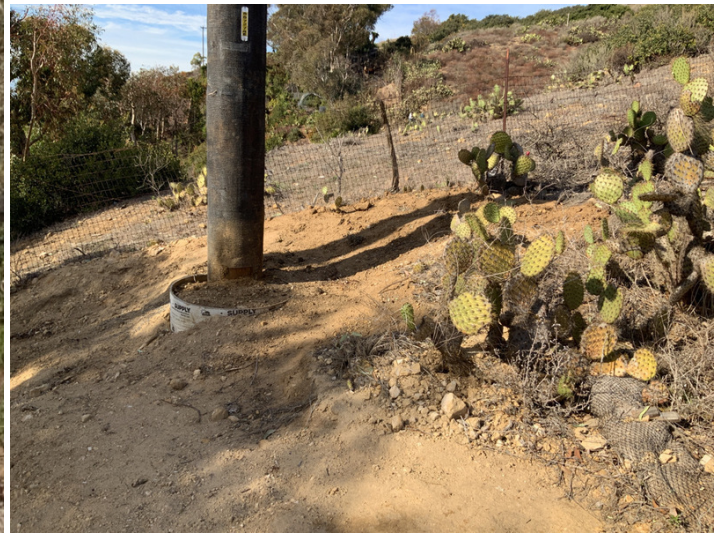
Photos Before

No Vegetation Found Details	
-----------------------------	--

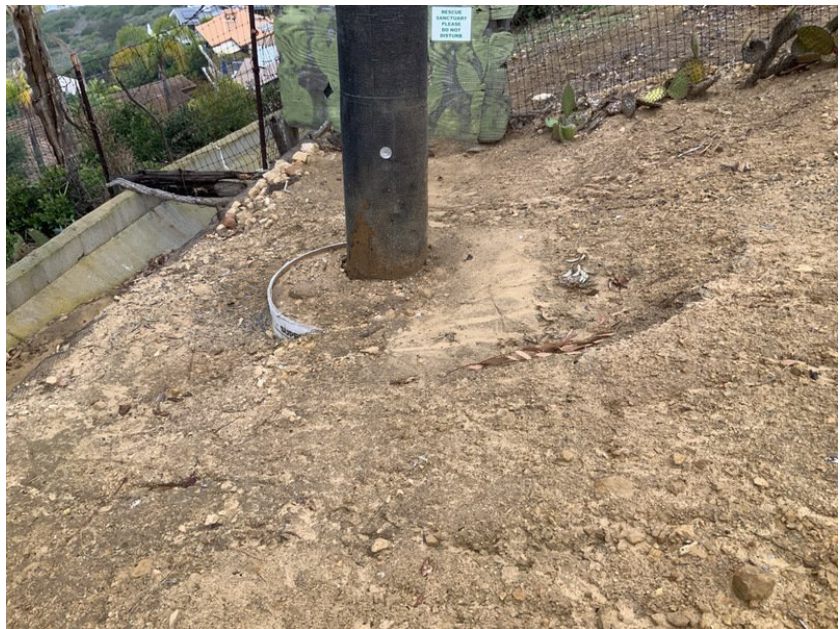
Photos Before

Structure Contractor Notes	Excessive hiking
----------------------------	------------------

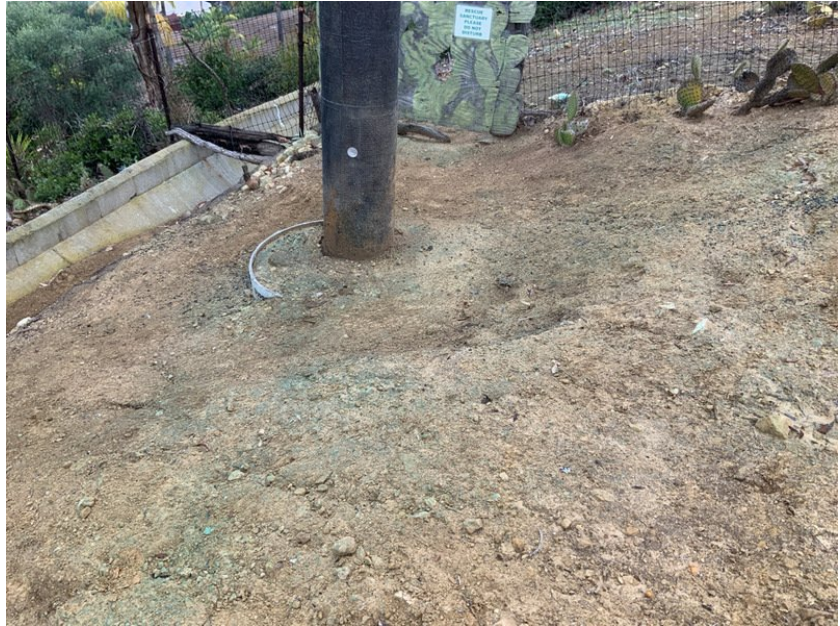
Photos After

Is Structure on Public Land? (No herbicide spray is permitted on any Public Land) No

Spraying Permitted Yes

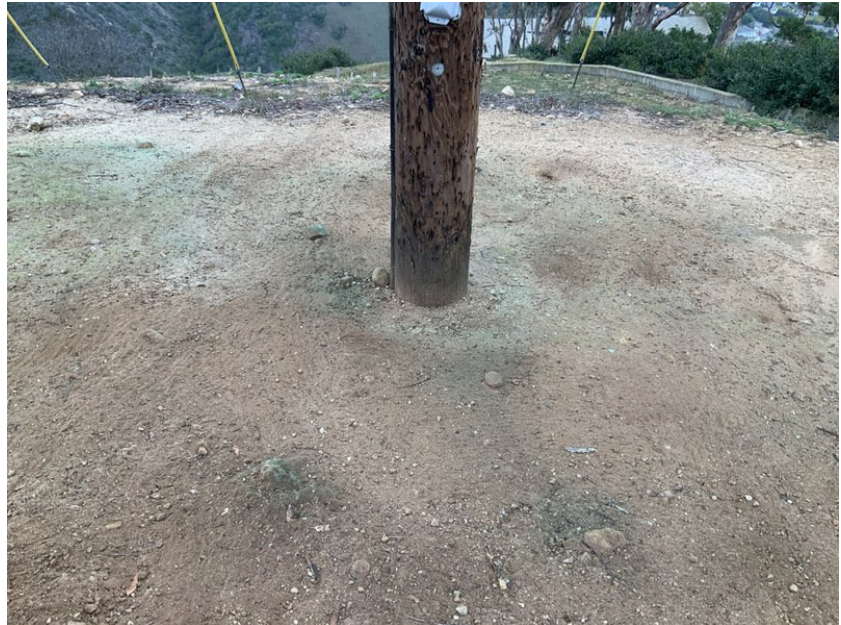
Photos After

Is Structure on Public Land? (No herbicide spray is permitted on any Public Land)	No
Spraying Permitted	Yes
Spray Used	Herbicide
Structure Cleared on Overtime?	No
Vegetation Over 8' -- OR -- Tree with DBH > 3.5" within 10' Structure	No
Company Performing Work	Pacific Weed Control
Excessive brush clearance required	No
Structure Contractor Notes	Excessive hiking
Structure Contractor Notes (2021)	Hiking
Show QC Section?	true

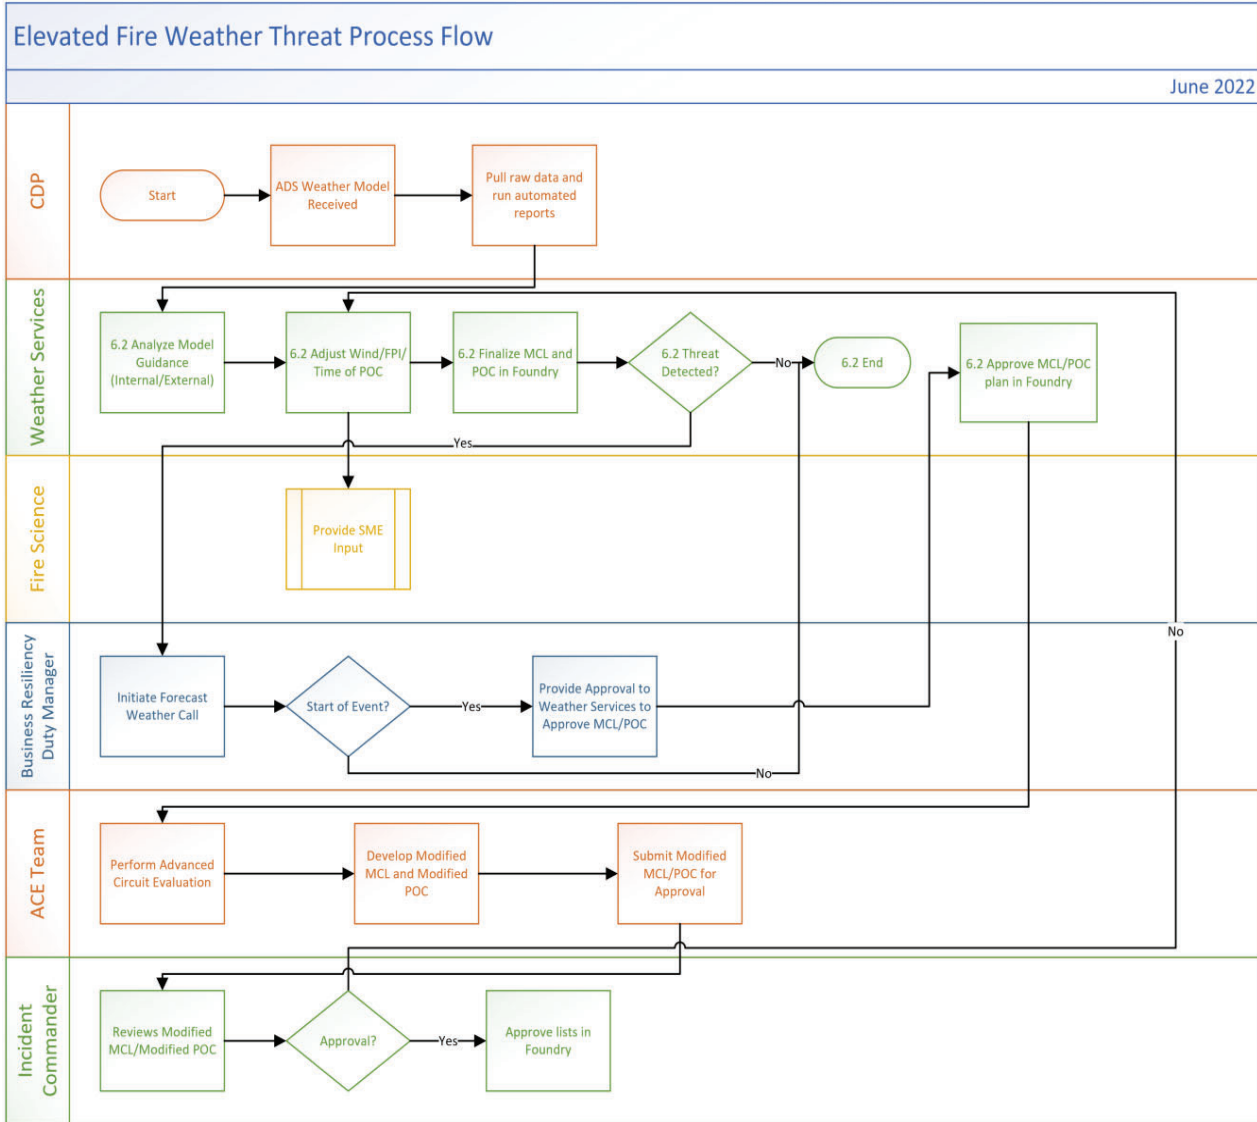
5.4 MONITORED CIRCUIT LIST AND PERIOD OF CONCERN REPORTS

The Monitored Circuit List is created using Foundry and displays all circuits that will meet the specified criteria for activating a PSPS IMT. This report is produced up to twice daily. In the event that there is no model update, Weather Services will continue to use the most recent update for decision making.

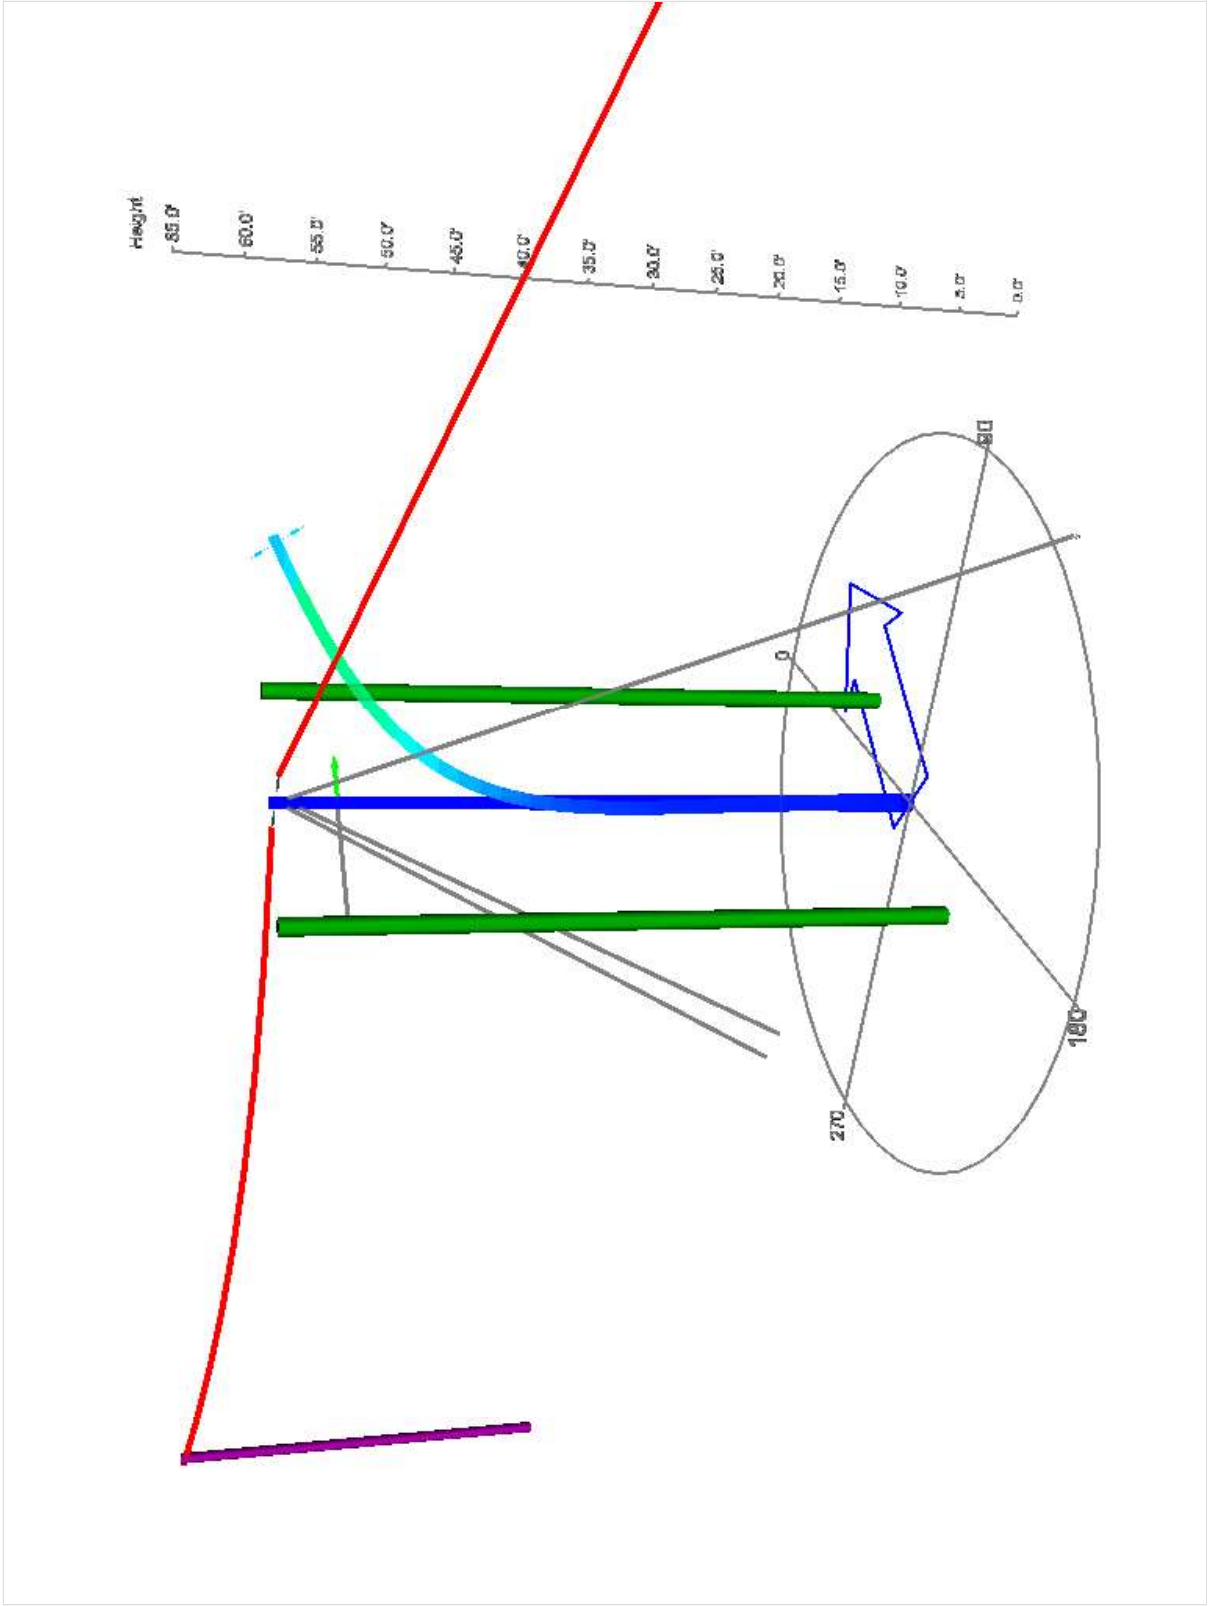
Recommended: Recommended

Component	New, 12 lb. Grade B (Governing Case)			Client File	Maximum Rating
	Safety Factor	Load (Applied / Allowable)	Wind Direction		
Pole	8.28 from stress at 52' 6"	918 / 7600 lbf/in ²	30 °	7600 lbf/in ²	
Guy#6	3.33	4629 / 15400 lbf	200 °	15400 lbf	
Guy#8	3.13	4913 / 15400 lbf	200 °	15400 lbf	
Guy#9	72.04	214 / 15400 lbf	300 °	15400 lbf	
SpanGuy#1	2.91	5299 / 15400 lbf	30 °	15400 lbf
