**Potrero Power Plant Final Audit Report
General Order 167-1001 Audit**

**Final Report on the Audit of Potrero Power Plant
For Conformance with General Order 167**

**Electric Generation Performance Branch
Consumer Protection and Safety Division**

Audit Number: GO167-1001

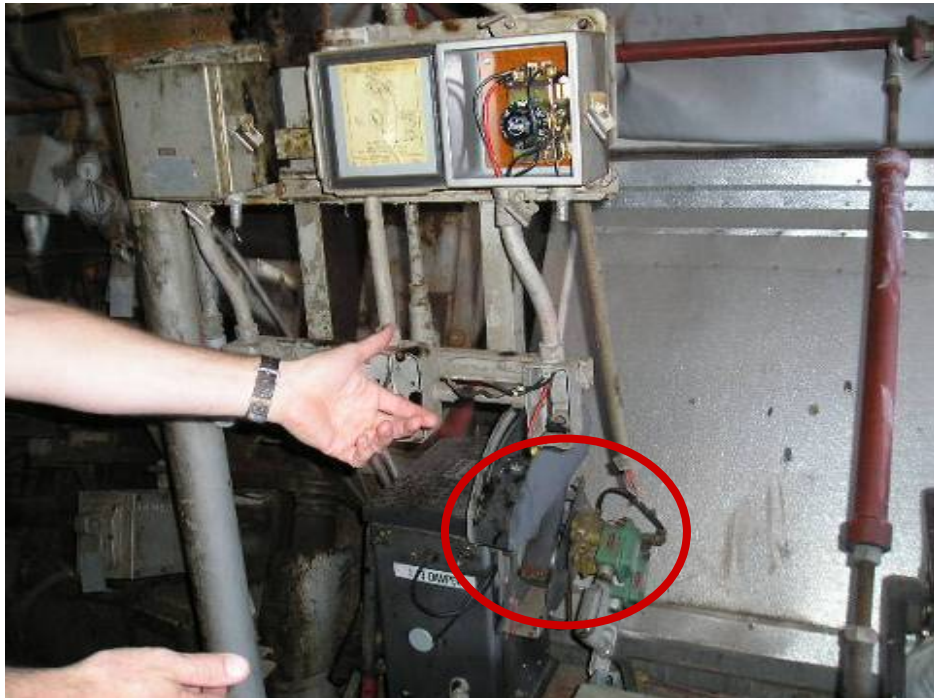
Photo 1 Uncovered wiring

- The auditor found open junction boxes with exposed wires in the Unit 3 boiler area. These wires were cut at both ends and therefore were de-energized. However, the boxes and fittings should be closed to prevent confusion and to prevent accidental re-energizing of these wires. (See Photos 1 and 2)

Photos 1 and 2 are opposite ends of a de-energized wire abandoned in place. No covers on the electrical boxes.

Exposed wiring was observed on the Unit 3 boiler structure, as seen in Photos 1 thru 5. Locations were reported to Mirant at the time of the audit.

CPSD auditors notified plant management of this finding during the audit visit. CPSD auditors verified on subsequent inspections that Potrero has corrected the wiring. Potrero should inspect the plant regularly for unsafe conditions.

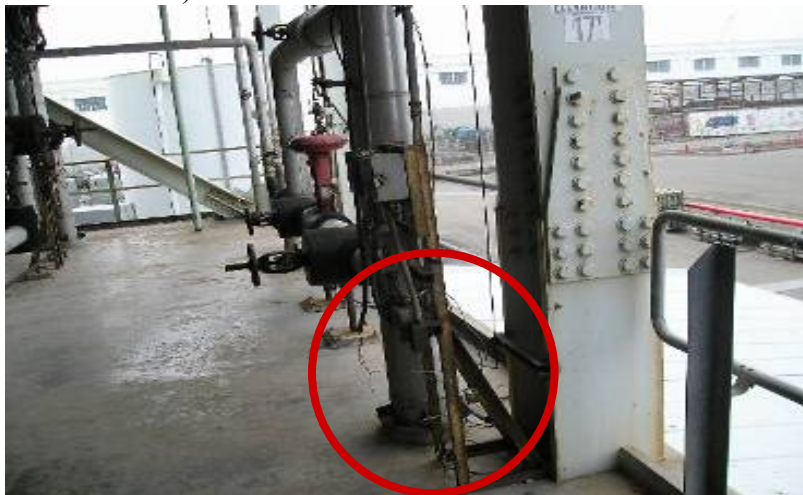
- The auditor found exposed wiring not enclosed by conduit on Unit 3 Elevation 17, Column 11-L. This wiring, which hung loosely on and above the deck, appeared to be energized because it was connected to an outdoor light. The wiring is vulnerable to mechanical damage, is exposed to the elements and may be mistaken for de-energized wiring that has been abandoned. The National Electric Code contains no approved methods for running exposed wiring along the floor. (See Photos 3 and 4)

Photo 3 Loose wiring at Elevation 17, Column 11-L – See Photo 4 for close-up view.

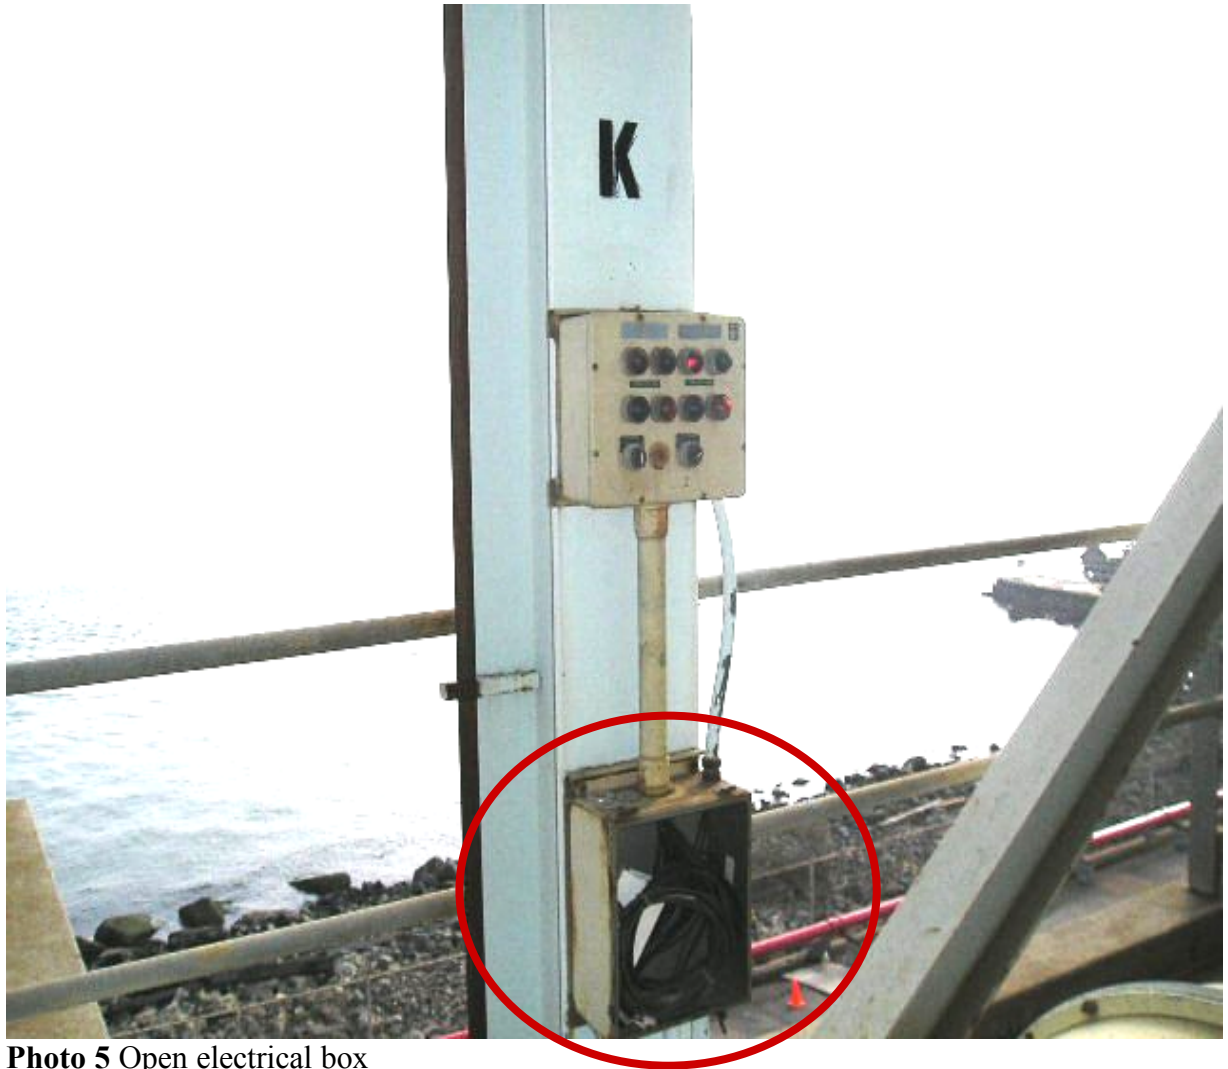
Photo 5 Open electrical box

- The auditor observed an open junction box with exposed, energized wiring in the Unit 3 boiler area. Connections, covered by electrical tape, are exposed to the elements, and could easily degrade, subjecting workers to electrical shock. The 1999 edition of the National Electric Code, Section 370-17 (a) states, “Openings through which conductors enter shall be adequately closed.” See Photo 5.

Photo 5 shows an open electrical box, with wires covered only by electrical tape. The wiring in this box is energized, as evidenced by the lights on the box above it.

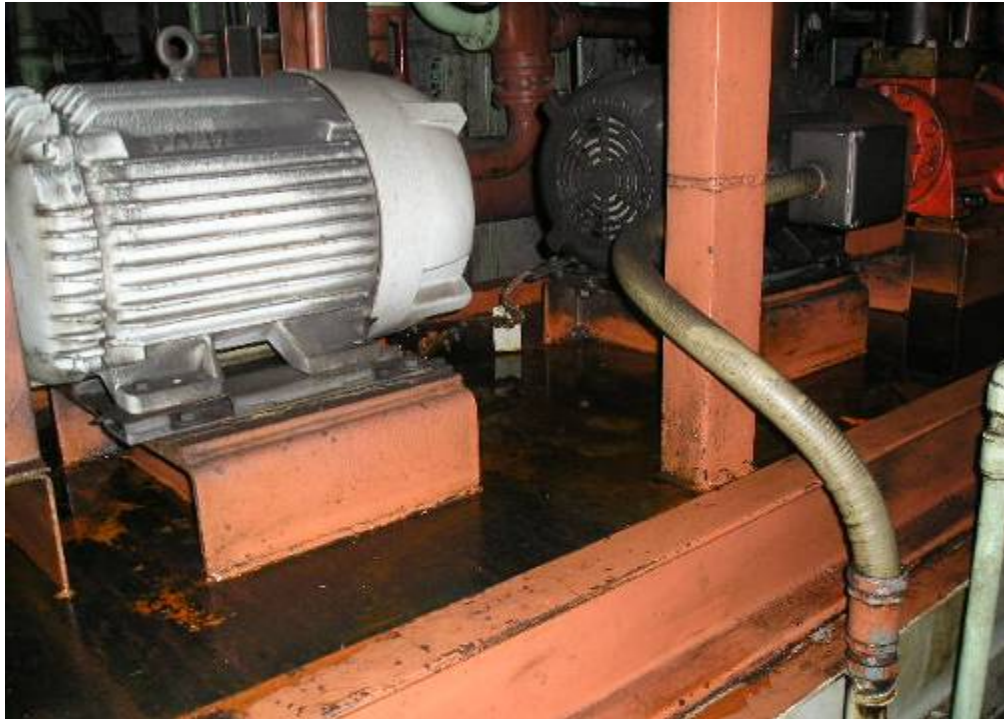
A fire hazard found at the Potrero Power Plant is a potential violation of Maintenance Standard 1 - Safety. The CPSD auditor observed a large pool of oil contained in the oil pan on the skid of the Lube Oil Supply Pump to the Main Boiler Feed Pump. The pool of oil was a potential fire hazard. The pan's drain hole appeared to be located at the highest point of the drain pan preventing the oil from draining completely. (See Photo 6)

Photo 6 Pooling of oil was observed on the skid of the Lube Oil Supply Pump to the Main Boiler Feed Pump.

CPSD auditors notified plant management of this finding during the audit visit. On subsequent inspections, CPSD auditors verified that Potrero had installed two extra drain holes in the oil pan to prevent oil from pooling there. Potrero should inspect the plant regularly for unsafe conditions.

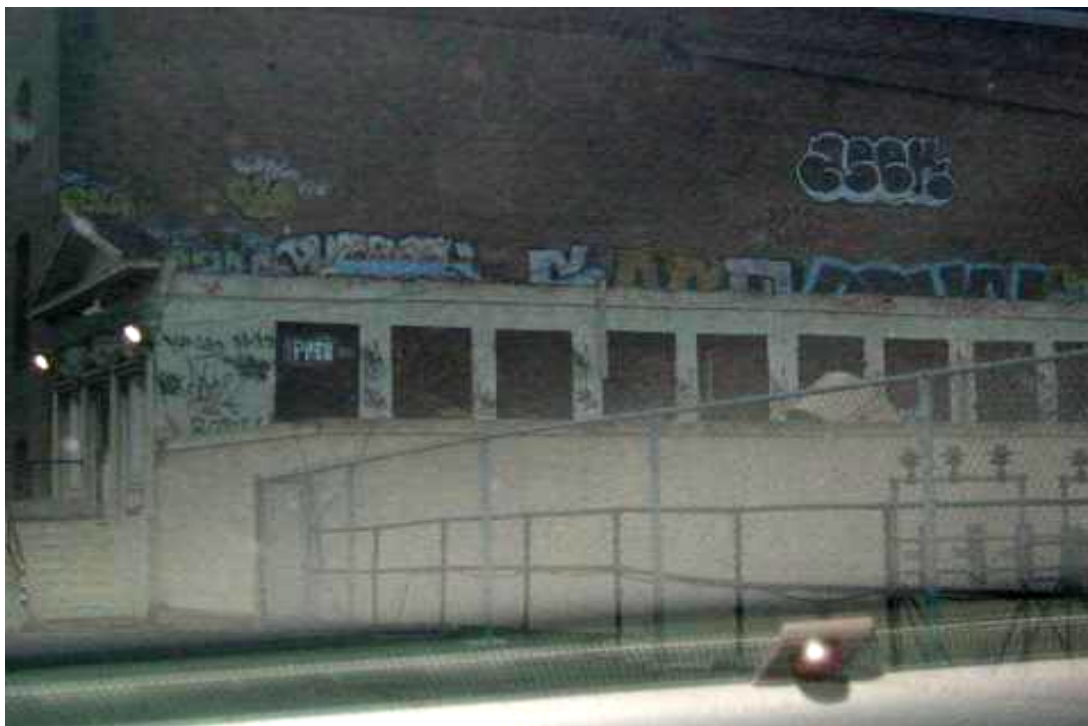
Photo 8 “Tagging” observed [REDACTED] Mirant property that is adjacent to the peaker units. [REDACTED]

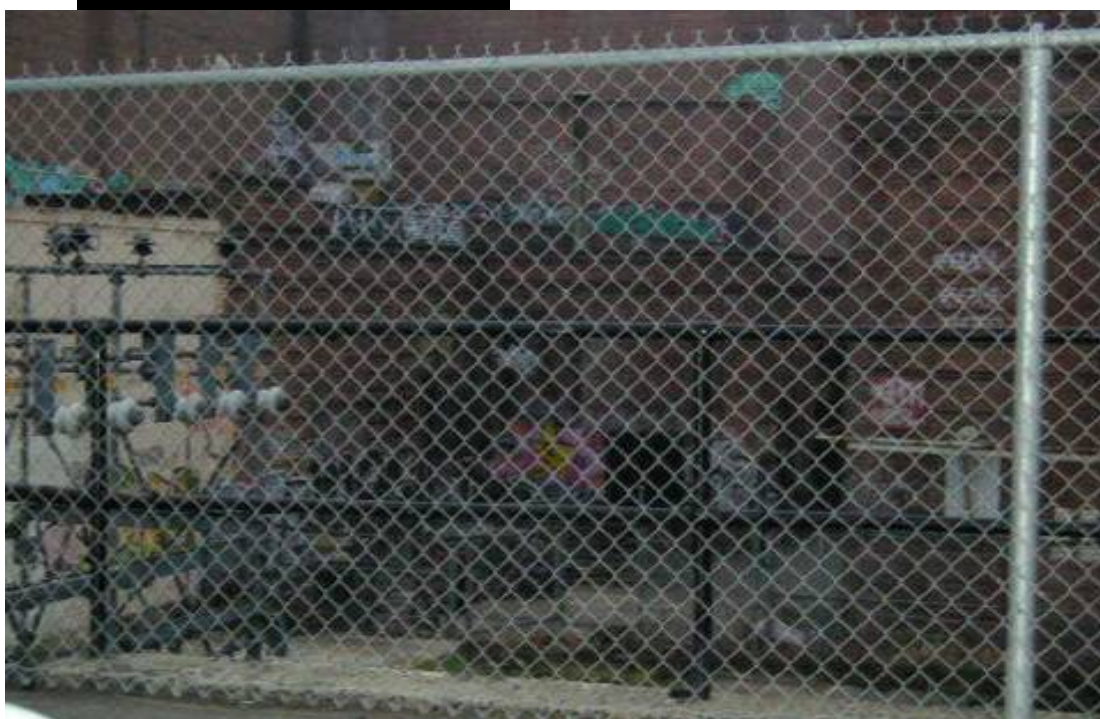
Photo 9 More “Tagging”. [REDACTED]

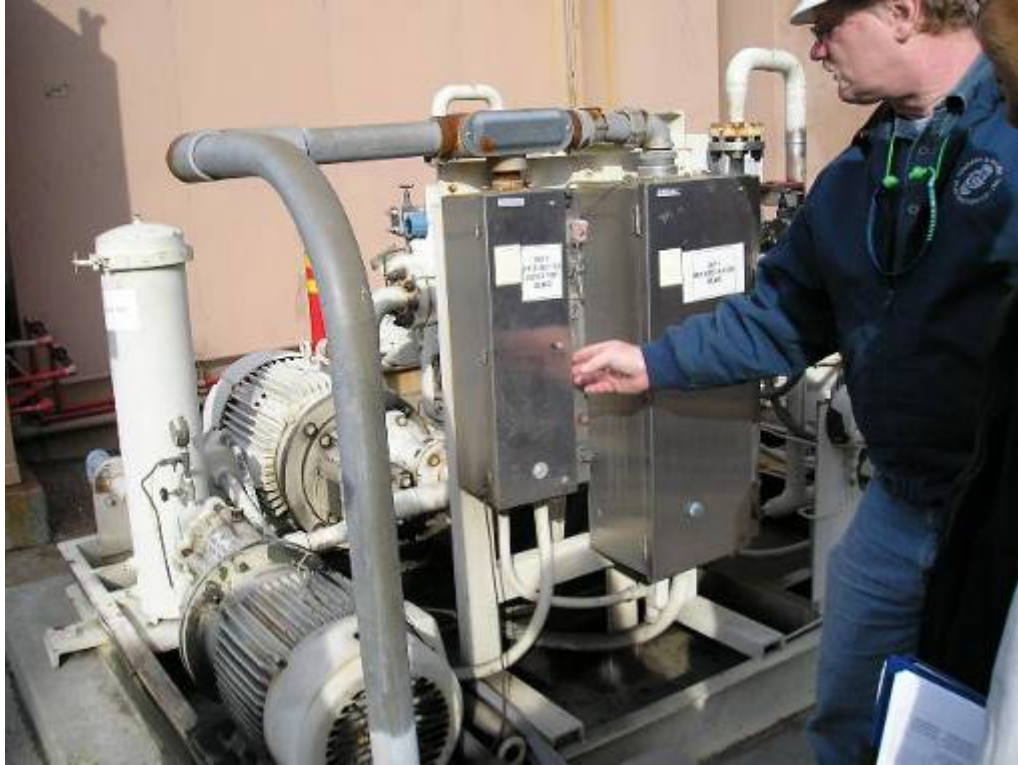
- There is extensive graffiti on the abandoned old boiler building area (see photos 7 through 11).
- On 1/5/04 intruders damaged the Unit 4 water injection 480 V breaker by prying open the access door of breaker box 52-33-9B. The plant took Unit 4 out of service for two days while repairs were made (see photo 12).
-

Photo 12 An intruder had tripped this Circuit Breaker (52-33-9B) causing a previous outage

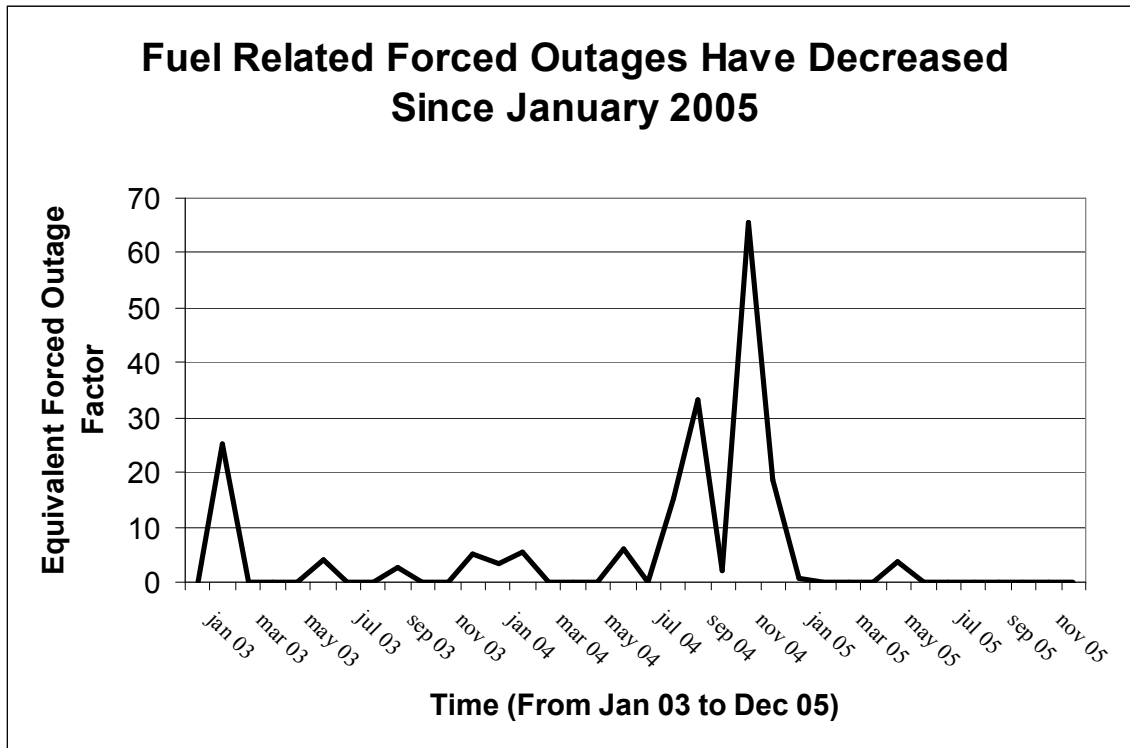
Studies by both Potrero and CPSD have confirmed that the performance of Units 4, 5 and 6 has improved since the modifications to the fuel system. First, in response to the preliminary audit report, Potrero sent an analysis showing that fuel related outages have decreased. Potrero analyzed the forced outage factors⁴ for the units using NERC GADS data for the years 2003 thru 2005. The data shows that the forced outage factors have decreased dramatically since January, 2005, as shown in Figure 1. CPSD staff confirmed that the GADS data supported Potrero's conclusion.

Source: CPSD Staff using GADS data

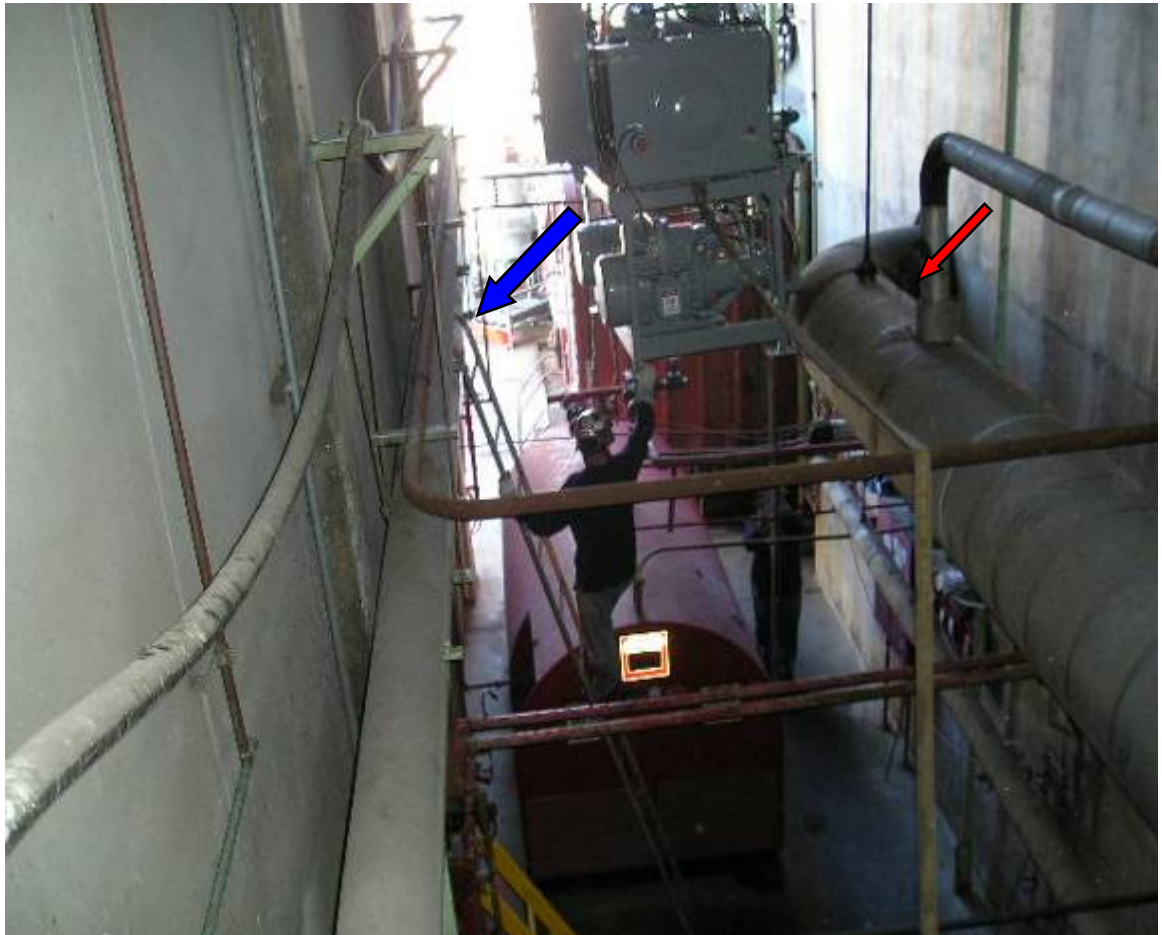
Photo 15 The ladder is not secure. The top right of the ladder (blue arrow) swings back and forth rapidly approximately 6 inches or more from the wall as the worker is attempting to position the hanging structure. Note: The structure on the pulley has moved closer to the camera. It is now close to the steam pipe insulation (red arrow) on the right, forward and above the person standing below.

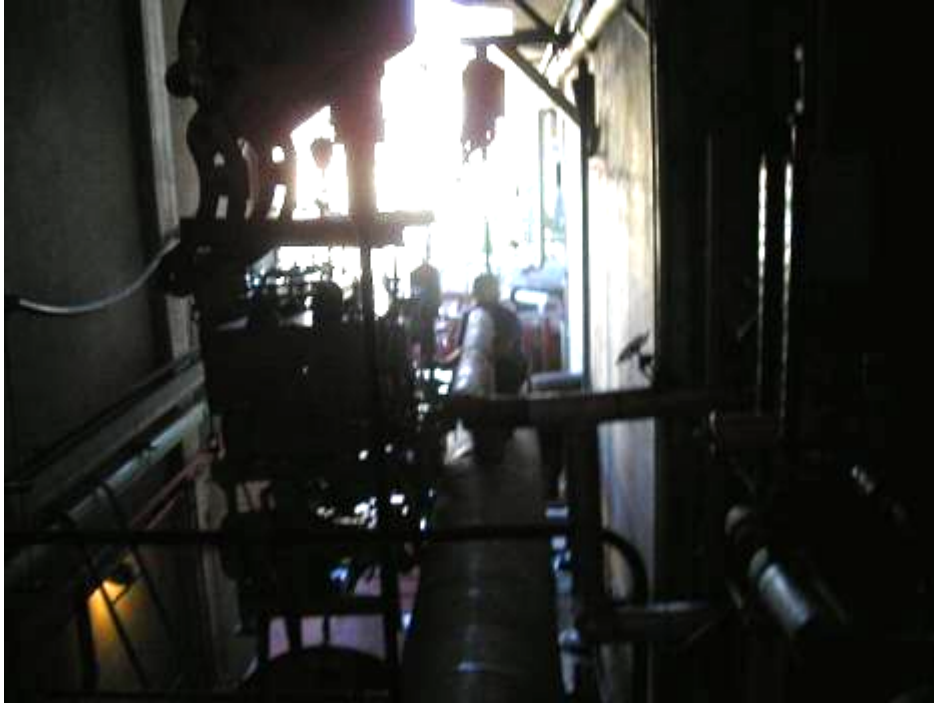
Photo 16 Auditor returned with other CPSD staff and plant staff to observe personnel, including contractors. Note: structure has been lowered.

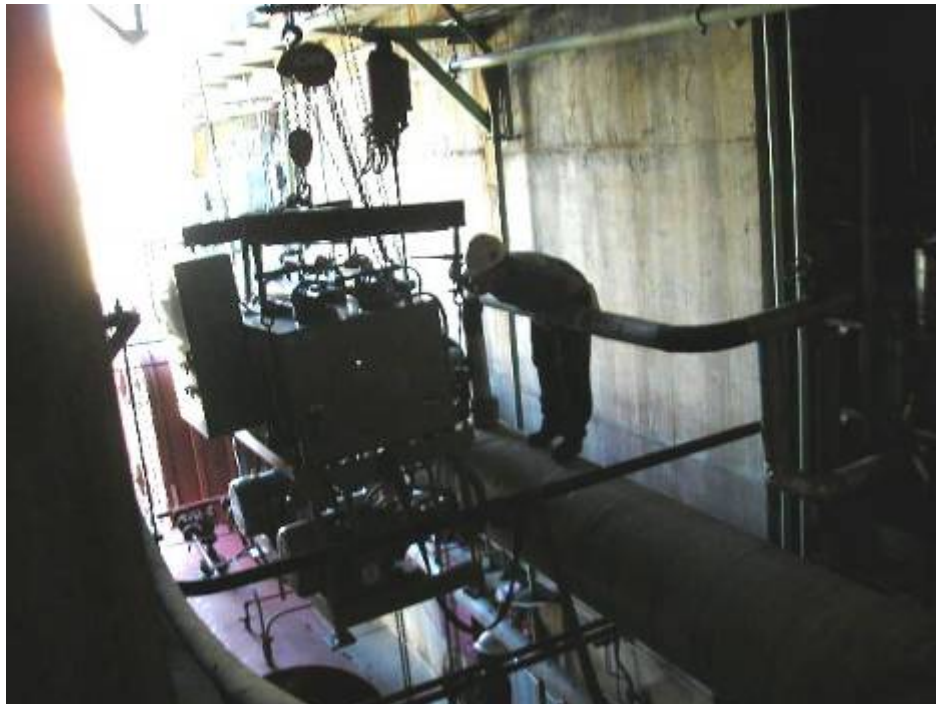
Photo 17 Worker lacks fall protection (Worker on pipe is near red arrow in Photo 15.) When CPSD auditors expressed safety concern, the plant manager responded that a worker on a steam pipe may be a safety concern and went to the lower level to discuss the concerns with the workers involved.

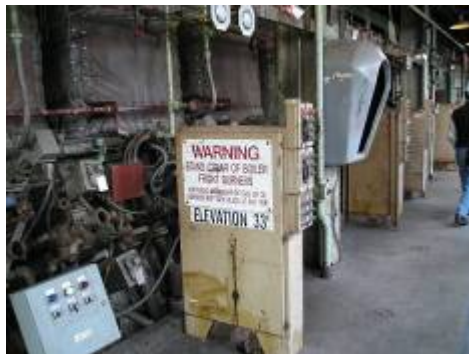
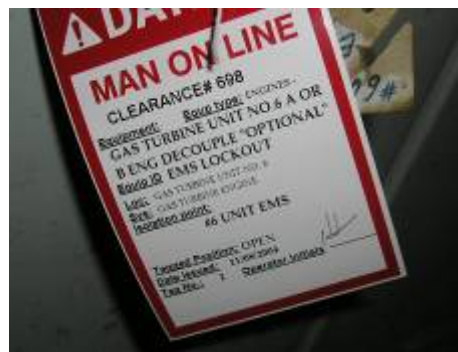
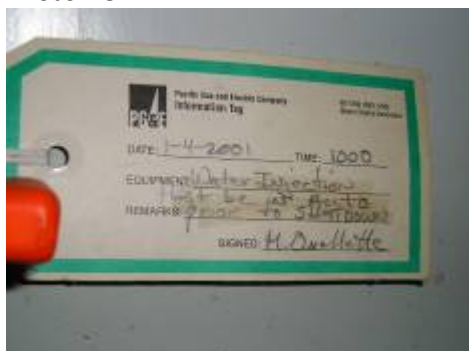
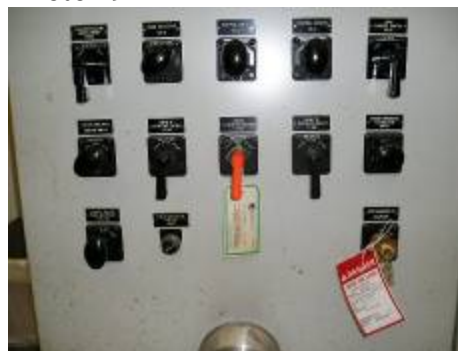
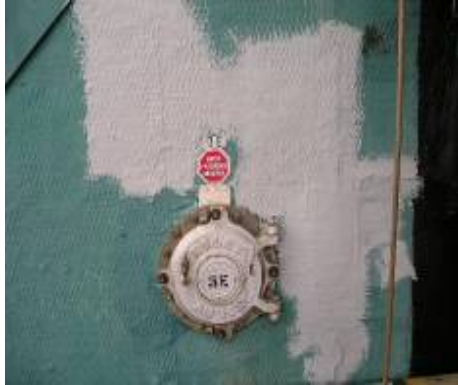
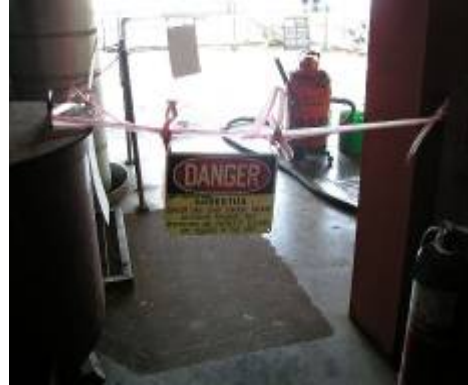
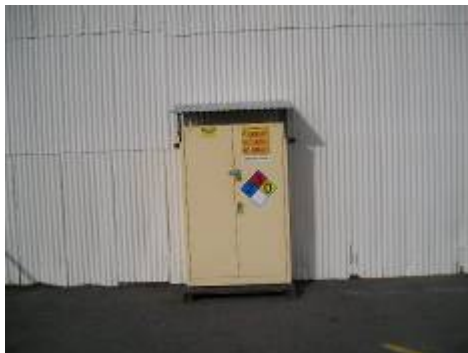
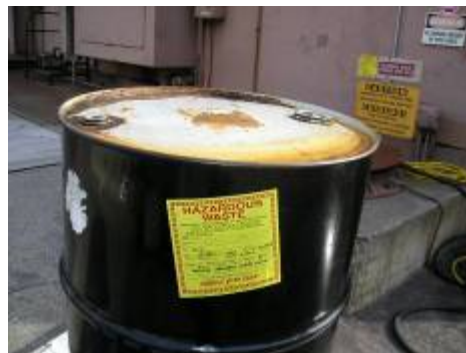
Warning, information, and clearance tags were observed throughout the plant which is a good indicator and an essential part of a good safety program.
