MSA- Threaded Fitting Specification Research Update
2021 Winter Workshop (R. 15-001-08)— Jan 22, 2021

» Threaded Fitting Specification Research Update

- To understand the influence thread quality has on sealing performance by evaluating the thread specifications from National Pipe Taper (NPT) and Aeronautical NPT (ANPT) and testing representative samples for sealing performance.

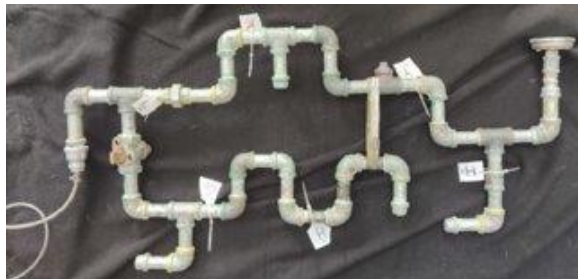
Summary Totals for NPT and ANPT Thread Measurements			
Threaded Outlets			
198 NPT INTERNAL		118 ANPT INTERNAL	
426 NPT EXTERNAL		109 ANPT EXTERNAL	
Outlet type		Outlet type	
97 Elbows		55 Elbows	
26 Valves		6 Valves	
70 Tees		35 Tees	
5 Misc internal		22 Misc internal	
426 Pipe nipples		109 Pipe nipples

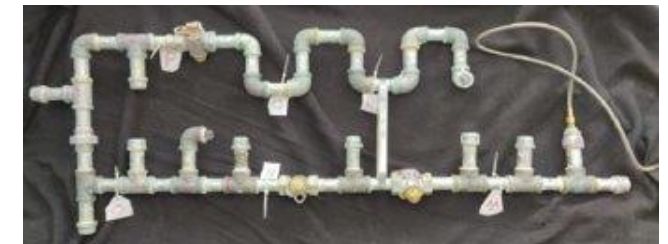
- Tested 109 NPT and 109 ANPT joints at the most common fitting size ($\frac{3}{4}$ "")
 - All test variables were kept the same as in Phase I (temperature, pressure, number of cycles, pipe sealant, tightening torque)
 - Checked for leaks at 0, 5, 10, 15, 20, 25, and 30 thermal cycles

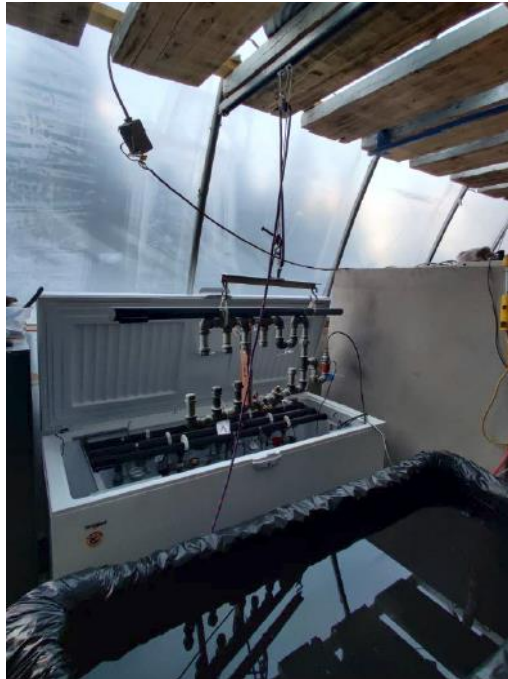
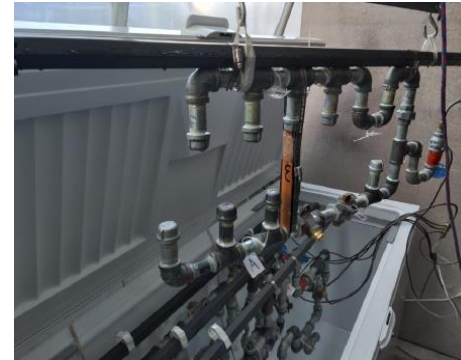
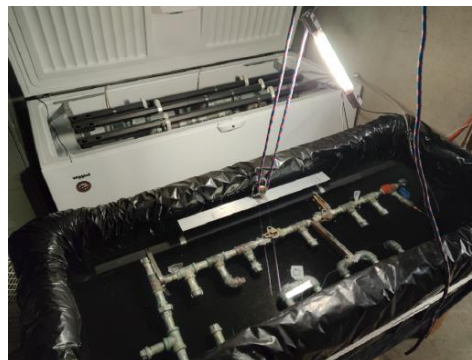
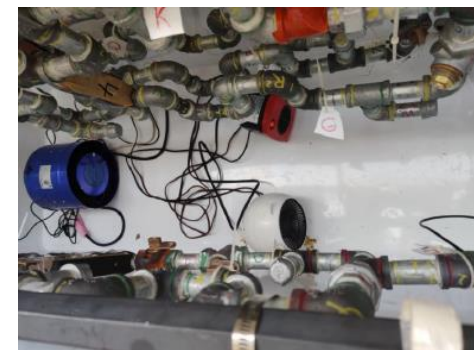
- Out of 218 total joints, zero NPT joints leaked and zero ANPT joints leaked
