**Enclosure 3 – PG&E Root Cause
Analysis (RCA)**

2014 Internal Electric Incident Review

Metcalf Substation Unauthorized Entry 8/27/2014

Metcalfe Substation Security Breach

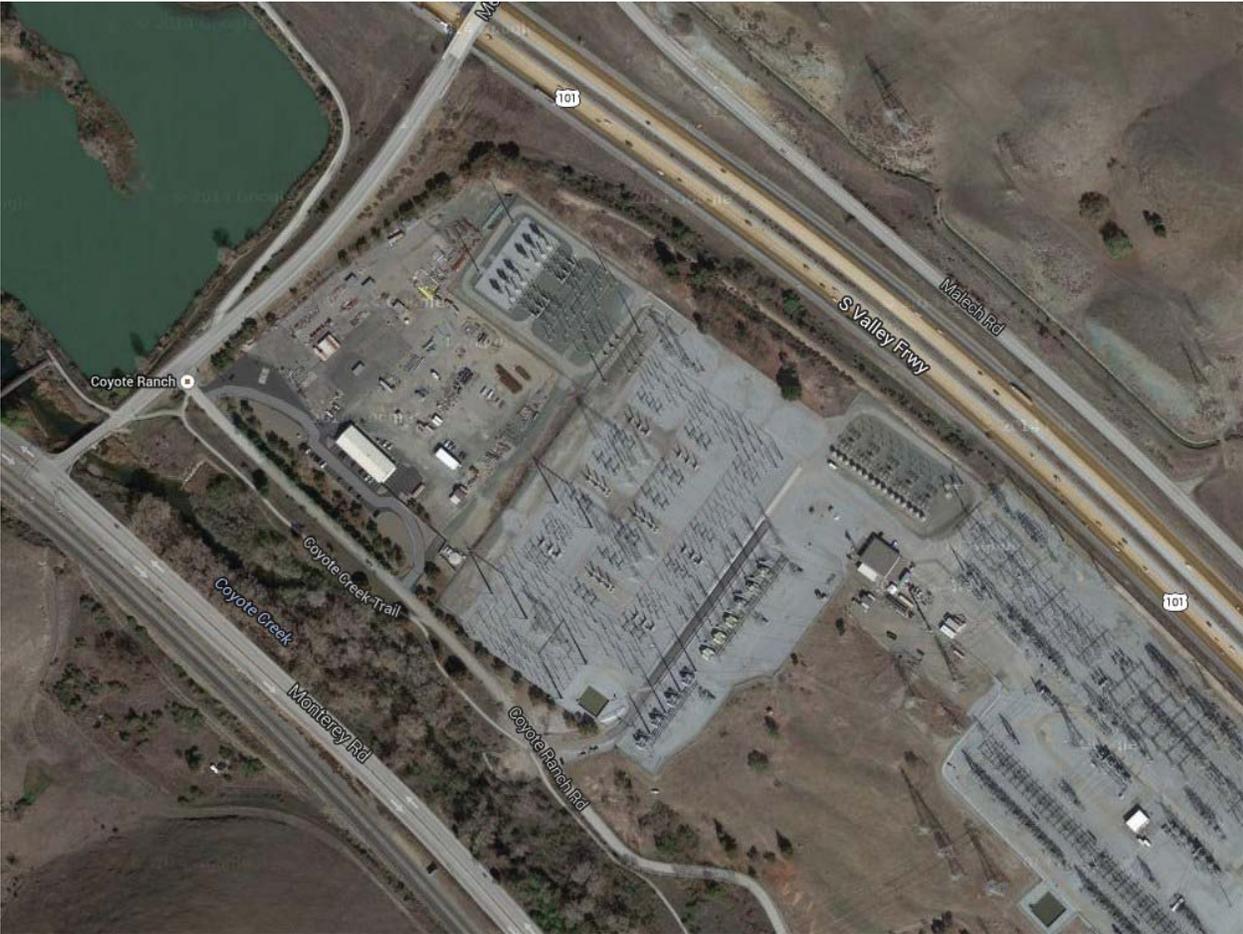
Attachment 1 – Metcalf Substation and General Construction Yard

Beginning at 2210 hours on 8/26/2014, multiple alarms were generated in the General Construction (GC) yard adjacent to Metcalf Substation. This yard is not within the security perimeter of Metcalf Substation
