## PROJECT MEMORANDUM SCE DPV2 TRANSMISSION PROJECT

**To:** Billie Blanchard, Project Manager, CPUC  
**From:** Vida Strong, Aspen Project Manager  
**Date:** April 6, 2012  
**Subject:** Weekly Report 33, February 27 to March 4, 2012

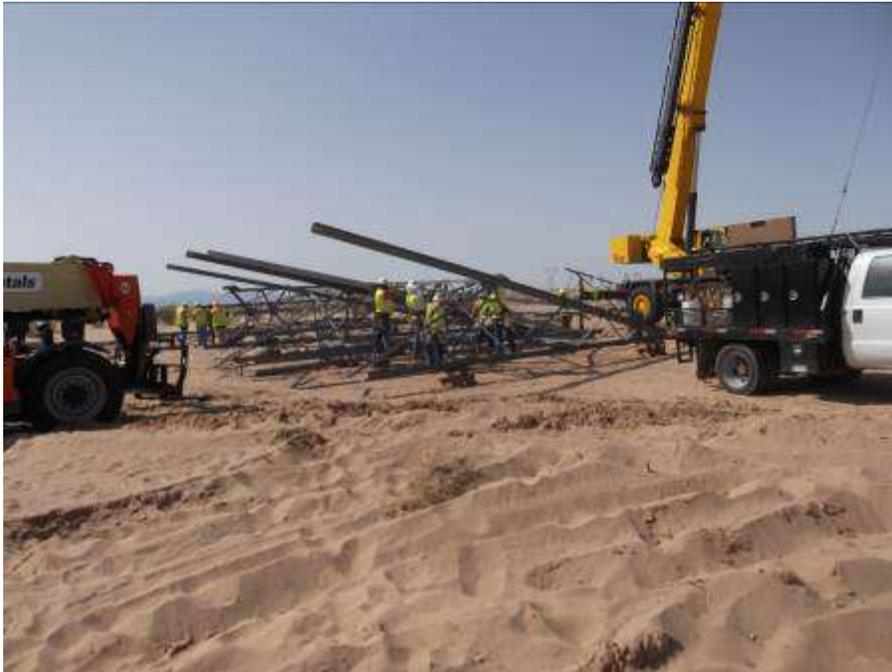
**Figure 1.** Tower assembly activities at Tower CR1-2W.

1. Colorado River Substation (CRS) to Red Bluff Substation
  - Tower assembly crews worked at CRS Loop-in Towers CR1-1W, CR1-2W, CR1-3W, and CR1-4E. Tower erection activities were initiated at Tower CR1-2W during the subject period (see Figure 1).

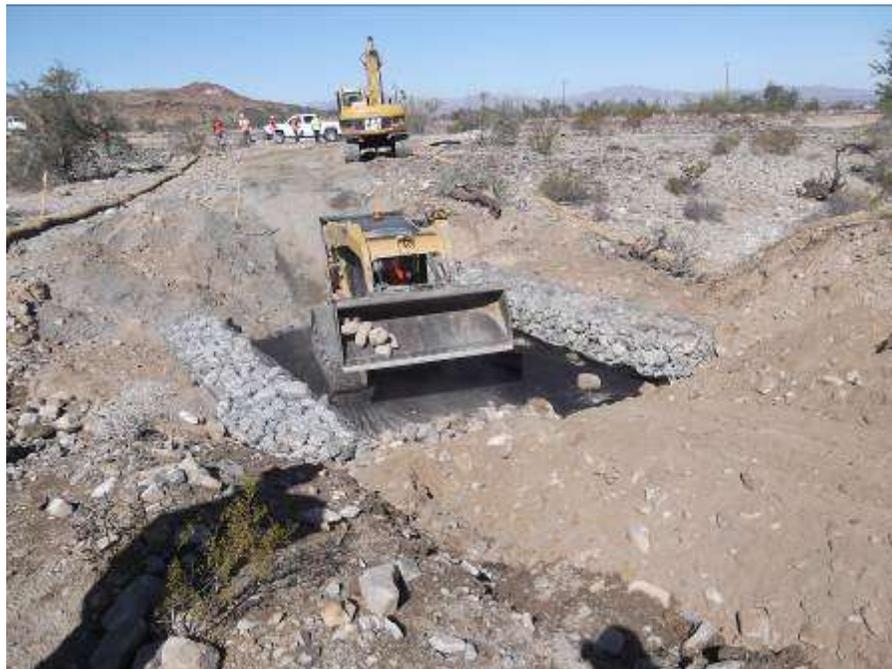
**Figure 2.** Construction of a wet crossing along the spur road to Tower RB1-4E.

- Activities associated with the installation of a wet crossing along the spur road to Red Bluff Loop-in Tower RB1-4E were conducted (see Figure 2).
  - BMP installation/maintenance activities were conducted at Red Bluff Loop-in Towers RB1-1W, RB2-1W, RB1-5W, RB2-5W, and RB1-4E.

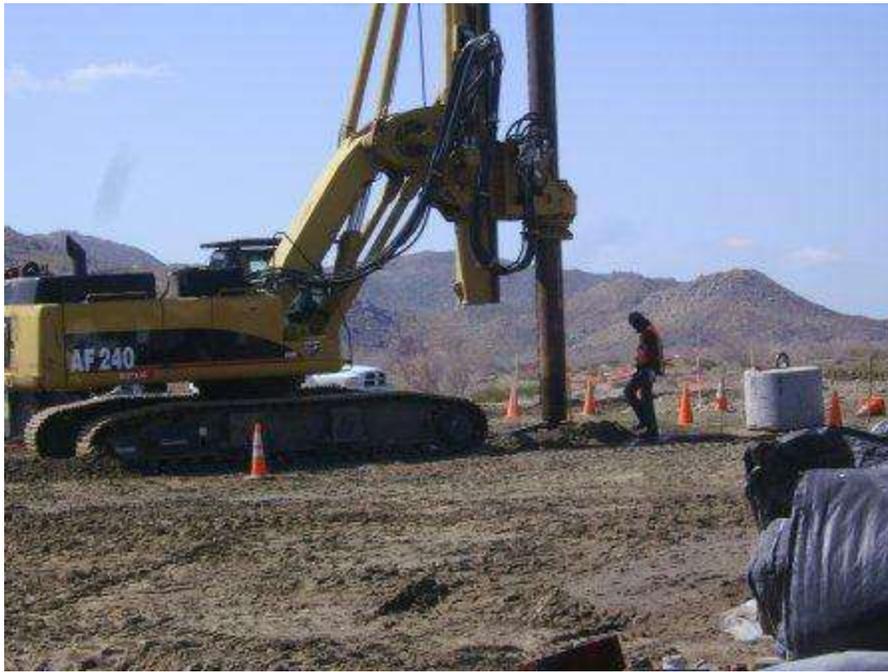
**Figure 3.** Foundation drilling at Tower 1062.

- BMP installation occurred at Towers 1011, 1014, 1015, 1061, and 1064.
- BMP maintenance occurred at Towers 1011-1016, 1018-1019, 1021-1024, 1027-1031, 1051-1054, 1057-1060, 1061/R1, 1062/R2, 1064/R4, and 1065.
- Foundation drilling occurred at Towers 1062, R2, and R4 (see Figure 3).
- Foundation concrete pouring occurred at Towers 1062, R2, and R4.
- Tower assembly occurred at Tower 1061 (see Figure 4).

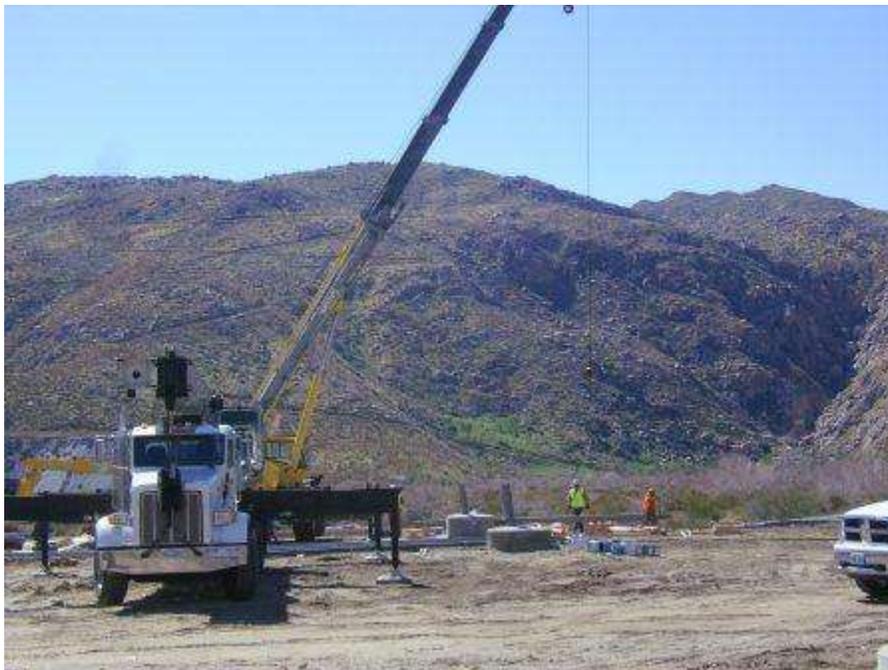
**Figure 4.** Crews begin tower assembly at Tower 1061.

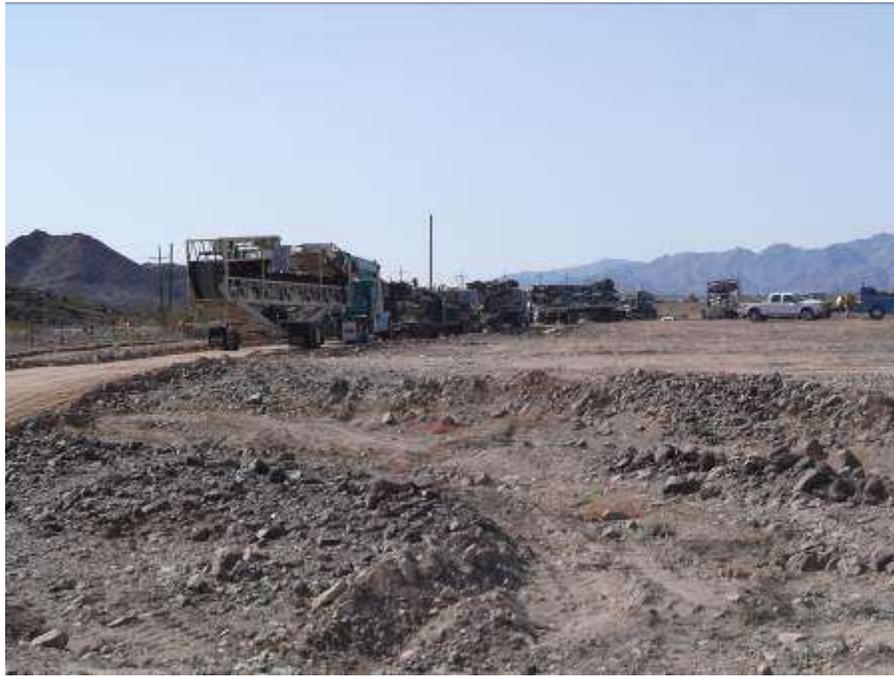
**Figure 5.** Rock crushing equipment being delivered to the Red Bluff Substation site.

4. Red Bluff Substation (BLM Lands) – Major civil work, including vegetation removal and grading (cut and fill) activities, continued at the Red Bluff Substation site throughout the subject period. Sprinkler system installation and modifications were conducted to facilitate pre-soaking of the site and water well testing. Rock crushing equipment was delivered on several trucks on February 28 (see Figure 5). Skid plates and rock base were installed at the entrance to Corn Springs Road at Chuckwalla Road.

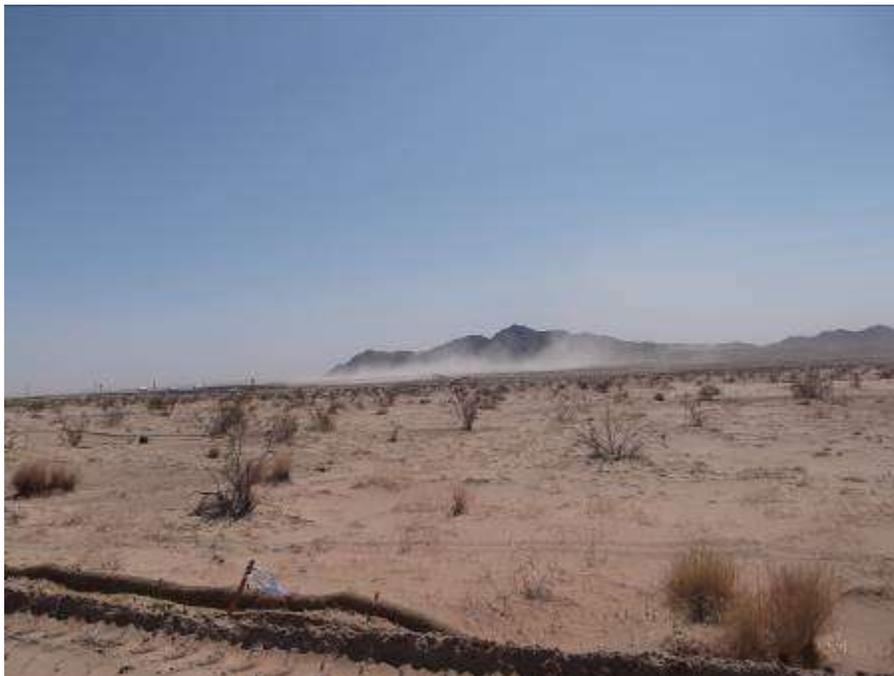
- While traveling east along the CRS primary access road, the CPUC EM observed excessive dust originating from the CRS site on March 2 (see Figure 6). The CPUC EM notified the SCE General Monitor of the concern, who informed the CPUC EM that he was aware of the issue and it was being resolved. Work at the CRS site was later stopped for the day due to a lack of water for dust suppression.

**Figure 6.** View southeast towards CRS from primary access road. Note excessive fugitive dust escaping project site.

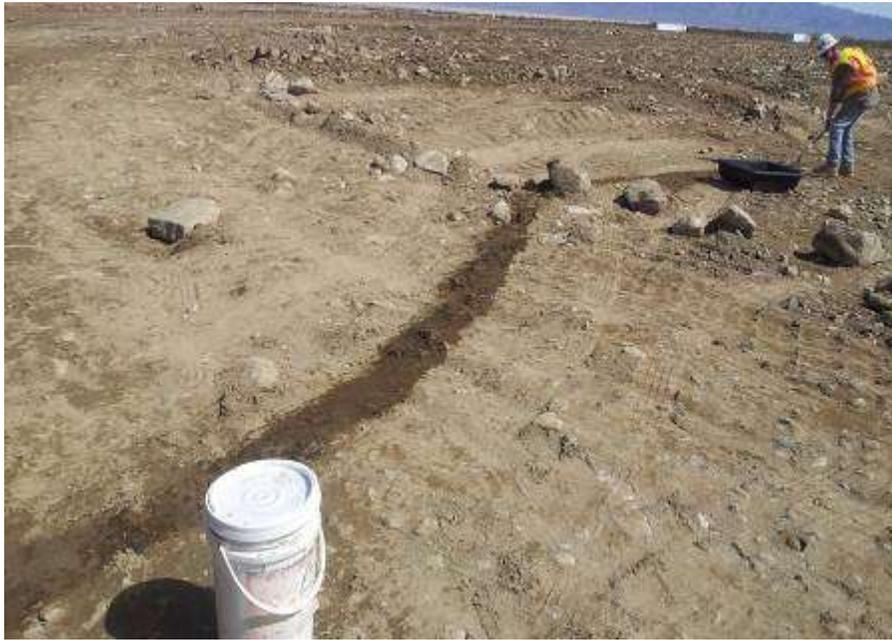
- On February 28, the SCE General Monitor reported that a truck delivering a Baker tank to the Red Bluff Substation site ruptured its gas tank on a large rock. The delivery driver and Cattrac workers immediately contained the leaking diesel with plastic sheeting and drip pans. The ruptured fuel tank was then drained into a Cattrac vehicle using a fuel pump. The delivery truck was moved away from the spill site once the fuel tank was completely drained and parked on a plastic sheeting barrier with drip pans. In total, approximately three gallons of fuel were spilled along a trail roughly six inches wide and twenty feet long (see Figure 7). The contaminated soil was removed and placed in a 55-gallon drum to be hauled offsite. A mechanic was scheduled to come make the appropriate repairs to the delivery truck and remove it from the site the following day.

**Figure 7.** Fuel leak and containment efforts at Red Bluff Substation site.

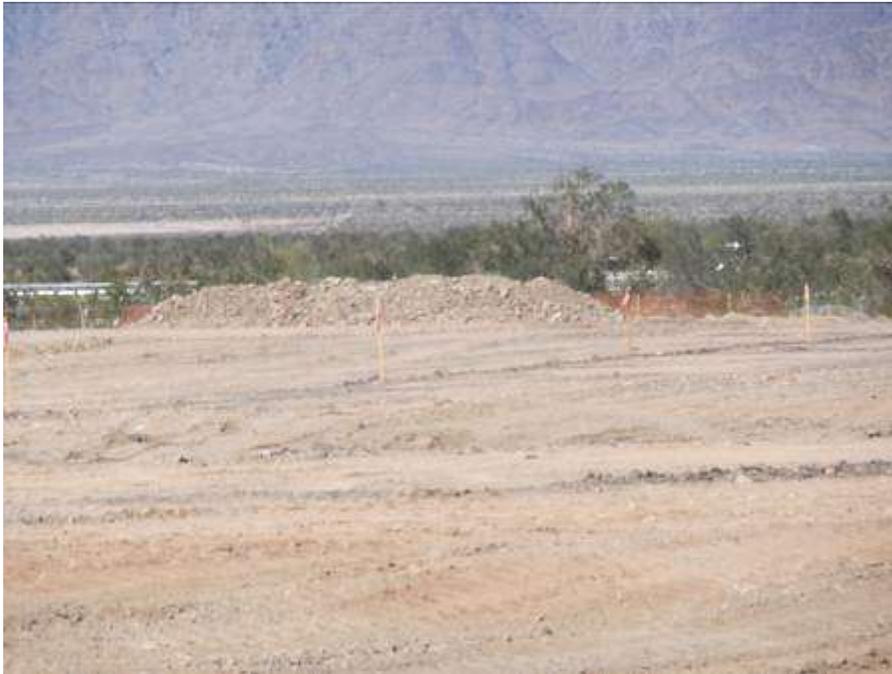
**Figure 8.** Desert pavement soils being stockpiled at Red Bluff Substation site.

- On February 28, the SCE Air Quality Specialist indicated that the cone rock crusher that had been delivered to the Red Bluff Substation site earlier that day required a PERP certification due to the dust that would be produced.
- On February 28, the CPUC EM observed a large stockpile of desert pavement soils in the northeast corner of the Red Bluff Substation site (see Figure 8). This soil was being properly salvaged per mitigation requirements.
- The CPUC EM observed water pooling behind a check dam just north of the water well site at the Red Bluff Substation on March 1 (see Figure 9). The CPUC EM notified the SCE Biological Monitor and the area of concern was filled with soil that day.

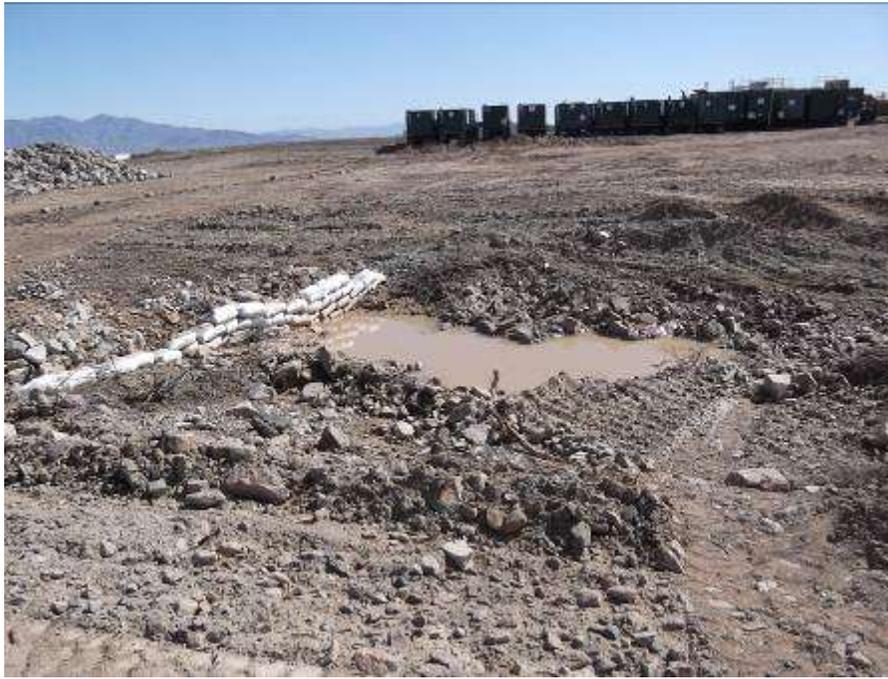
**Figure 9.** Water pooling behind check dam at Red Bluff Substation site.

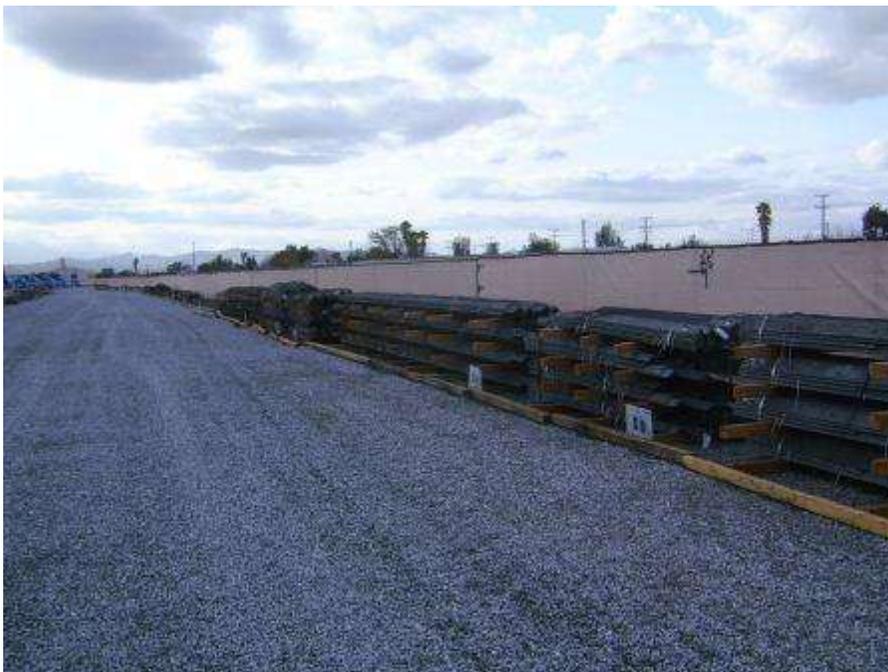
Menifee Yard (Contractor Show-Up Yard) – No construction activities were conducted during the subject period. Activities are limited to minor maintenance, implementation of BMPs, temporary storage of construction equipment and materials, and worker vehicle parking. Gravel in the yard is currently being dragged each day to prevent nesting bird activity in the yard (See Figure 10).

**Figure 10.** Materials at the Meniffee Yard covered with bird netting. The gravel shows sign of being dragged.
